# **Home Inspection Report**

## **Property Address:**

123 Main Street Fredericksburg VA 22401

# **ABI Home Inspections**

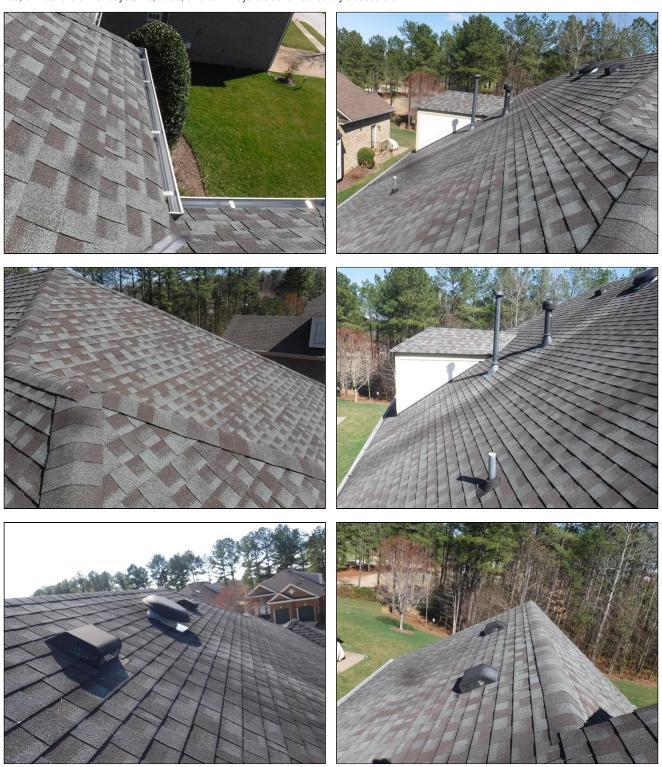
**3.0** (1) Two ridge shingles were torn. Shingles should be replaced or the tears should be sealed. Repair by a qualified roofer is recommended.

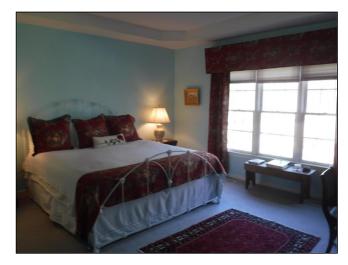
7.3 Item 1

**7.3** (1) Two front casement windows would not open. This may be due to overpainting. Repair by a qualified carpenter is recommended.

**7.3** (2) Master bedroom door did not close properly due to the door jamb being out of square. A settlement crack was observed along the wall at the corner of the door. It appears that the home experienced some settlement in this area but no evidence of any structural defects were found. Further evaluation by a qualified carpenter is recommended.
