Inspection Xpress

Property Inspection Report

1 Great Inspection Blvd., Anyplace, FL 33333
Inspection prepared for: John and Joan Jones
Date of Inspection: 10/1/2015 Time: 10am
Age of Home: 2014 Size: 3,229 SF
Weather: Hot!
Inspection performed by: Chet Peterman HI-8110

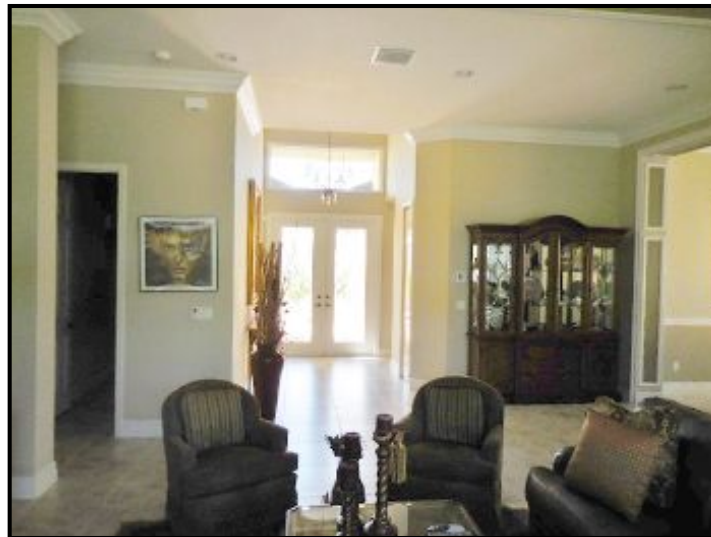
6. Doors

- Double door entryway.
- The plate at the interior area of the door is scratched and needs to be replaced for appearance purposes.

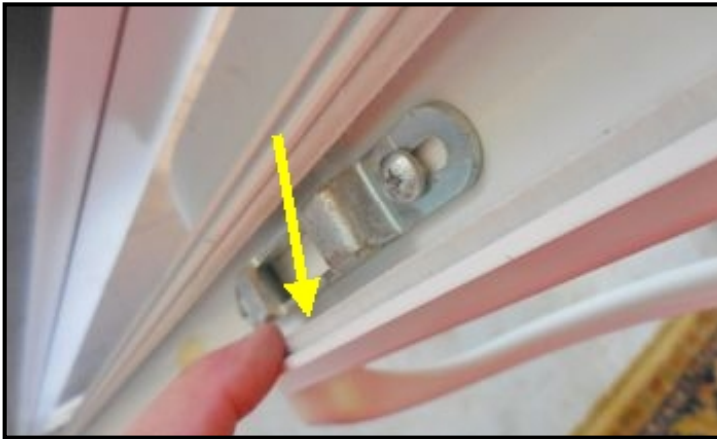
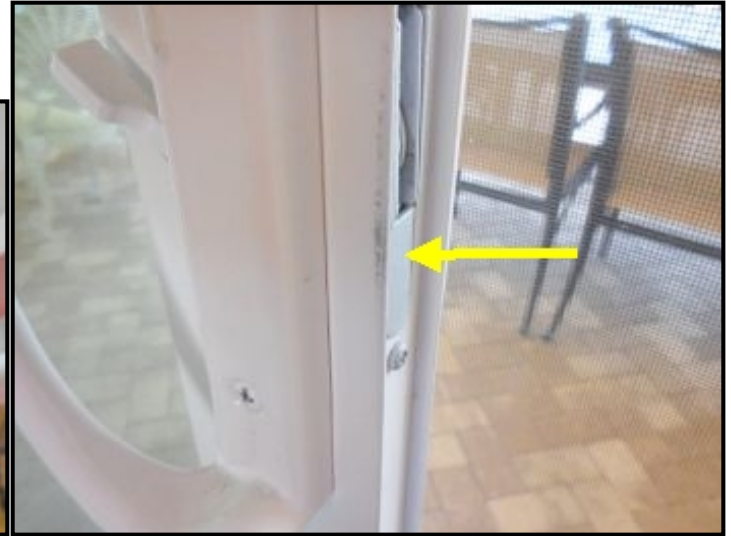
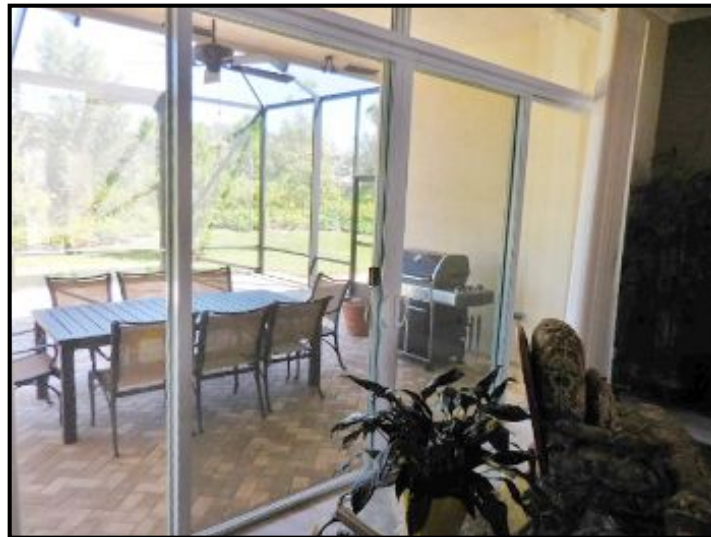
12. Patio Doors

- The sliding patio door was functional during the inspection. 2. There is an area at the living room slider where the weather strip is collapsed due to door closure which is causing abrasions on the doors. Adjustments may resolve this.

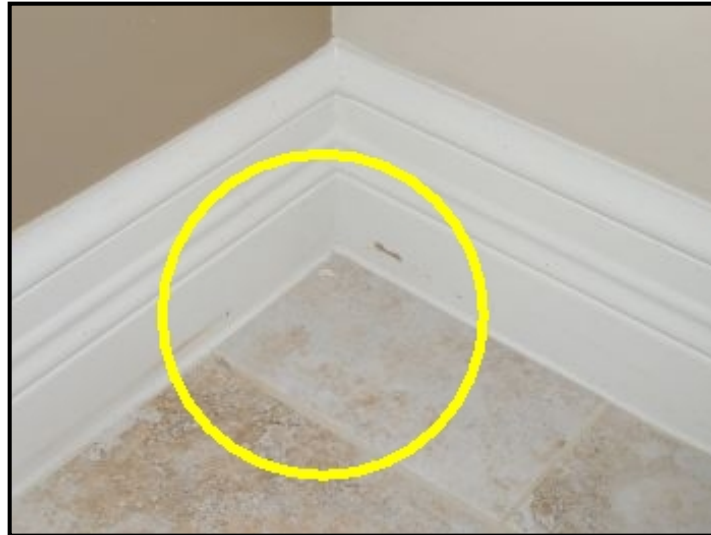
14. Wall Condition

- Construction cleanup not completed.

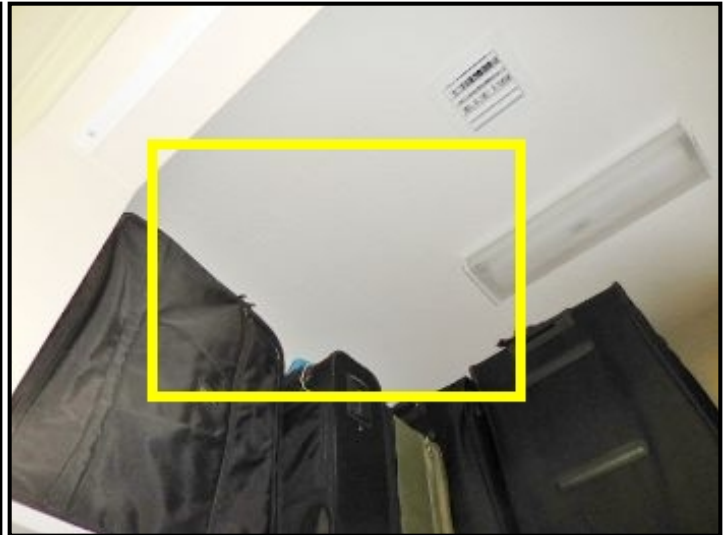
13. Ceiling Condition

- The drywall is patched in areas. The reason for the patches was due to mold remediation. It can be difficult to match ceiling finished but these areas could have been done better in terms of blending.

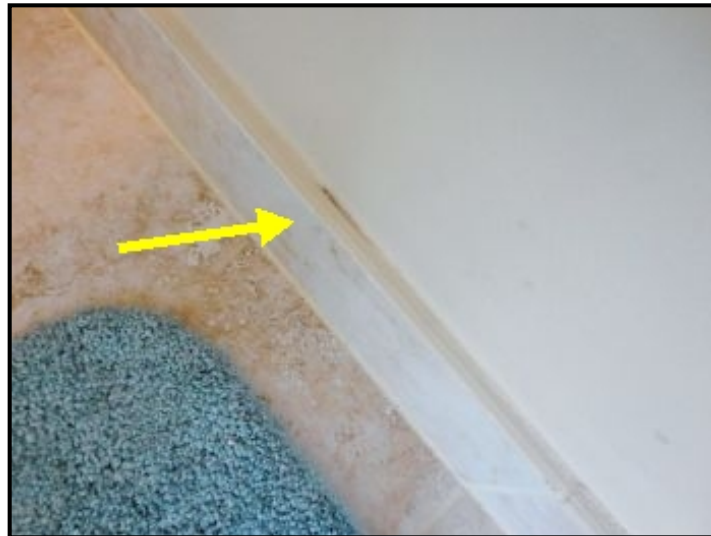
9. Floor Condition

- There are areas of fallen caulking in the master bath.

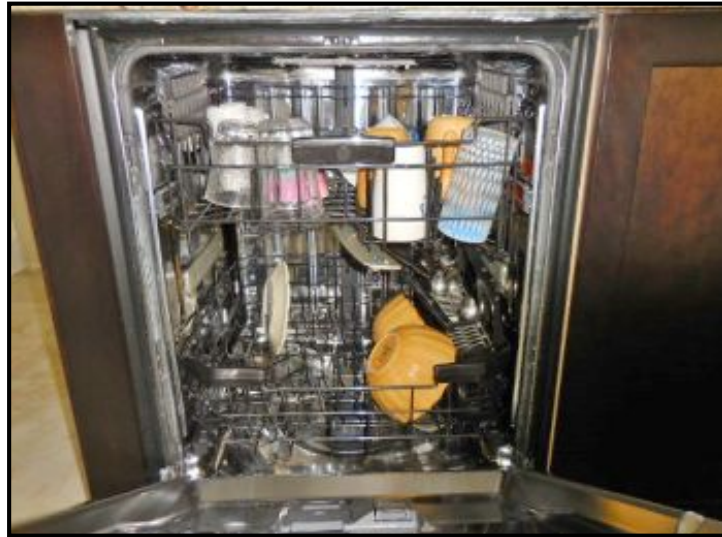
4. Doors

- Dishwasher operating upon arrival of inspector. Buyer is advised that no warranty is offered on this or any other appliance, as outlined in Inspection Agreement.

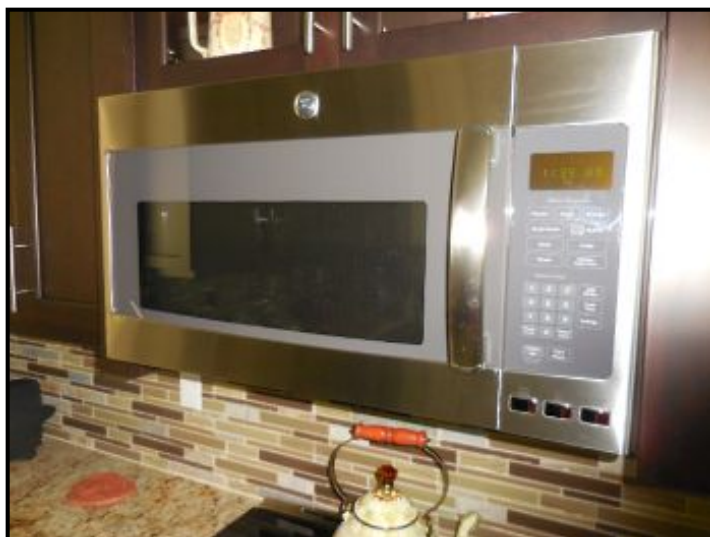
7. Cook top condition

- Built-in microwave ovens are tested using normal operating controls. Unit was tested and appeared to be serviceable at time of inspection. Leak and/or efficiency testing is beyond the scope of this inspection.

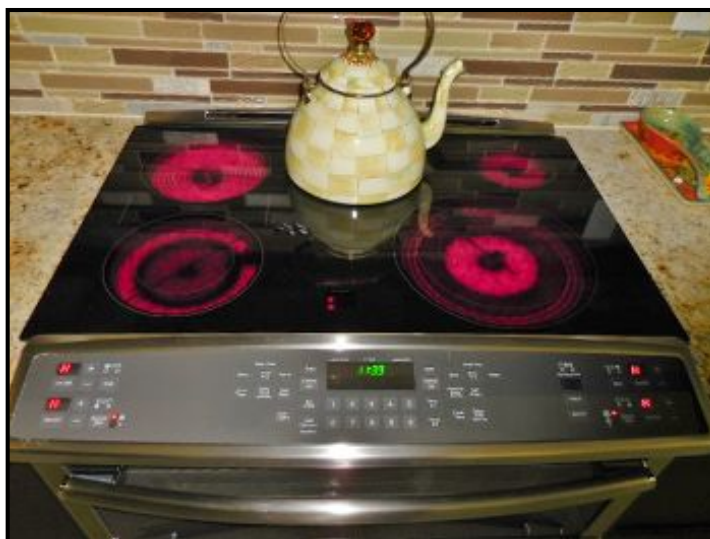
8. Oven & Range

Observations:
 • Electric cook top noted.

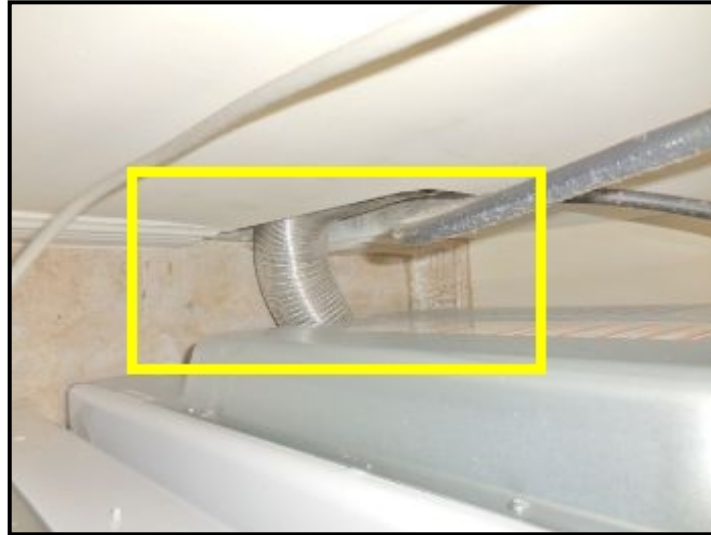
4. Dryer Vent

• Could not fully inspect the dryer vent, it is obscured by cabinetry. The area behind the dryer needs a good lint cleaning. This collection may be due to a loose dryer vent fitting / clamp. Further evaluation recommended.

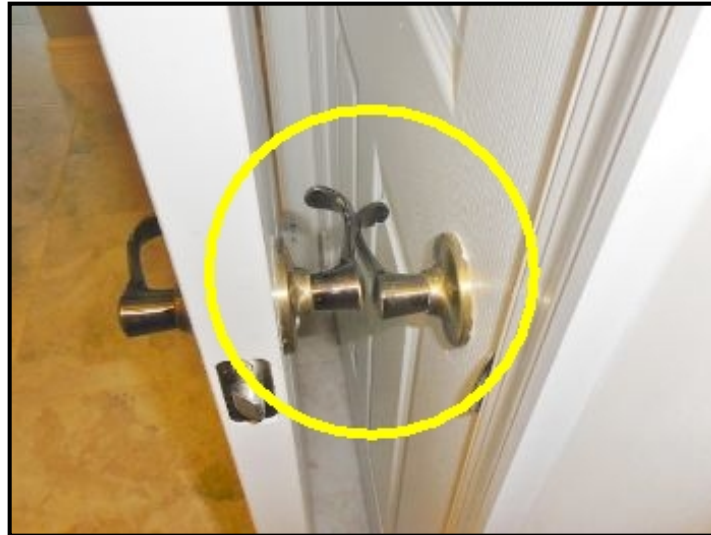
14. Doors

Observations:
 • Some door stop(s) missing / ineffective; recommend installation to avoid unnecessary wall or door damage.

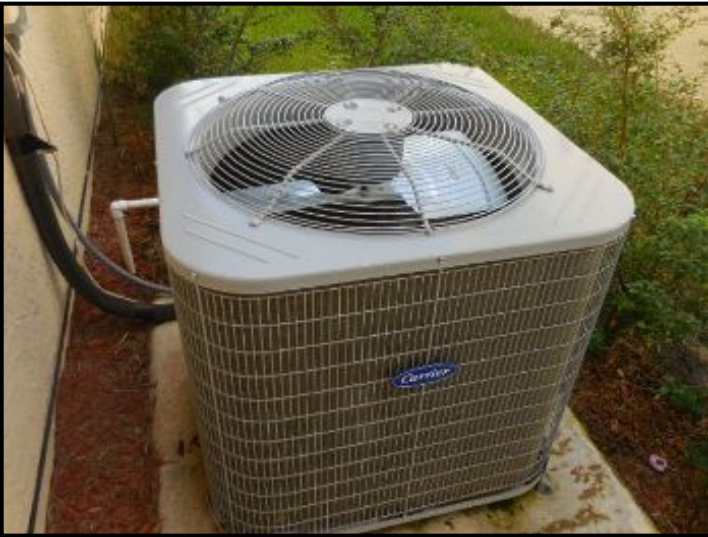
7. AC Compress Condition

Compressor Type: Electric
 Location: The compressor is located on the exterior east.
 Observations:
 • Appeared functional at the time of inspection.
 • The typical temperature differential split between supply and return air in an air conditioner of this type is 15 - 20 degrees F. This system responded and achieved an acceptable differential temperature of 13 - 17 degrees F.
 • Annual HVAC service contract is recommended.

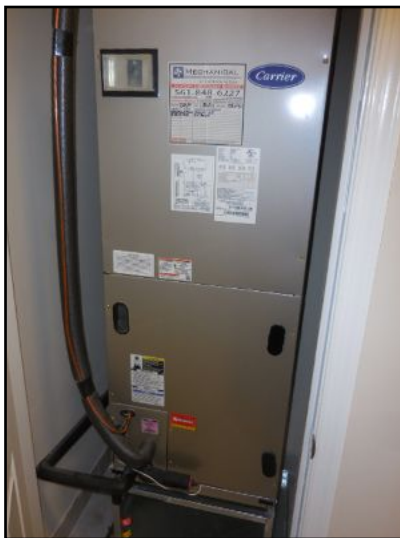
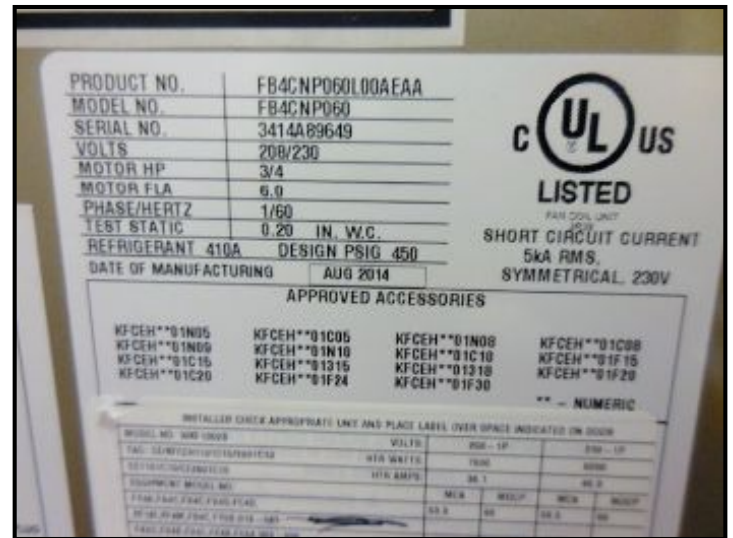
8. Air Supply

Observations:
 • The return air supply system appears to be functional.

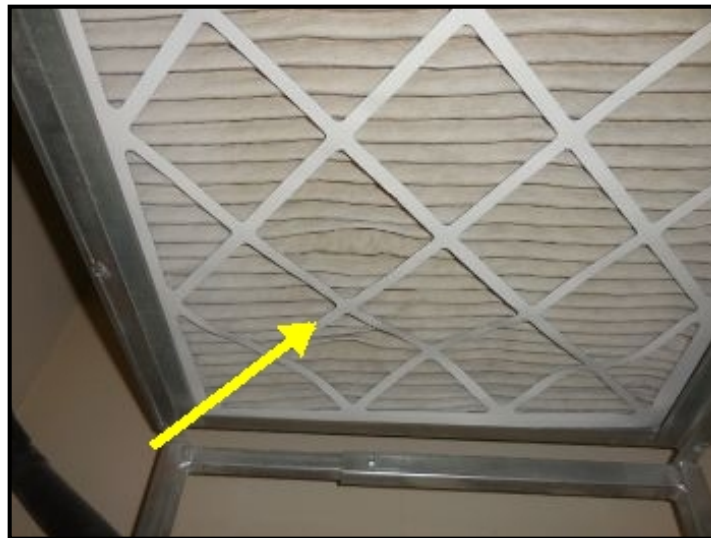
10. Filters

- **Poor type of filter installed.**

- MAINTENANCE: The air filter(s) should be inspected at least monthly and cleaned or replaced as required. There are two types of filters commonly used: (1) Washable filters, (constructed of aluminum mesh, foam, or reinforced fibers) these may be cleaned by soaking in mild detergent and rinsing with water. Or (2) Fiberglass disposable filters that must be REPLACED before they become clogged. Remember that dirty filters are the most common cause of inadequate heating or cooling performance.

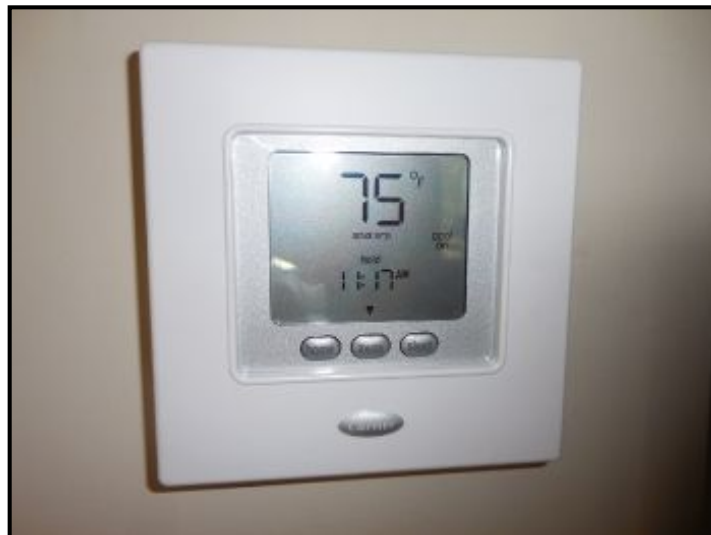
- Digital - programmable type.
- Functional at the time of inspection.
- Thermostats are not checked for calibration or timed functions.

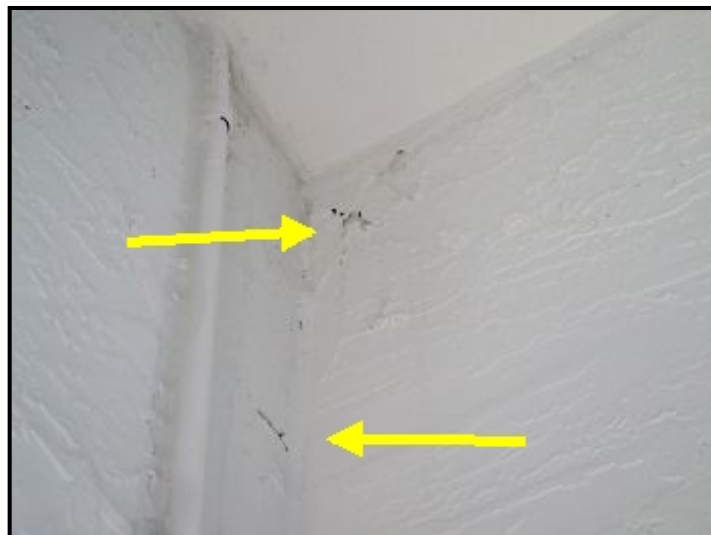
2. Walls

- There is some peeling paint at the upper area of the garage near the garage door.

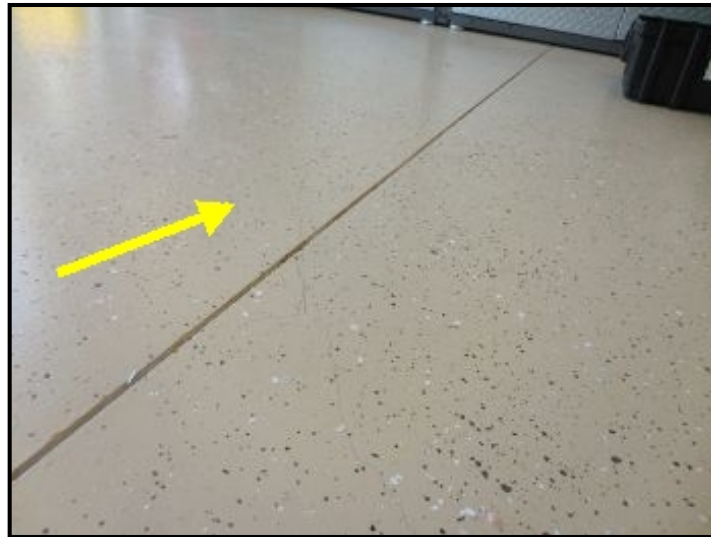
4. Floor Condition

Observations:
 • Common cracks noted.

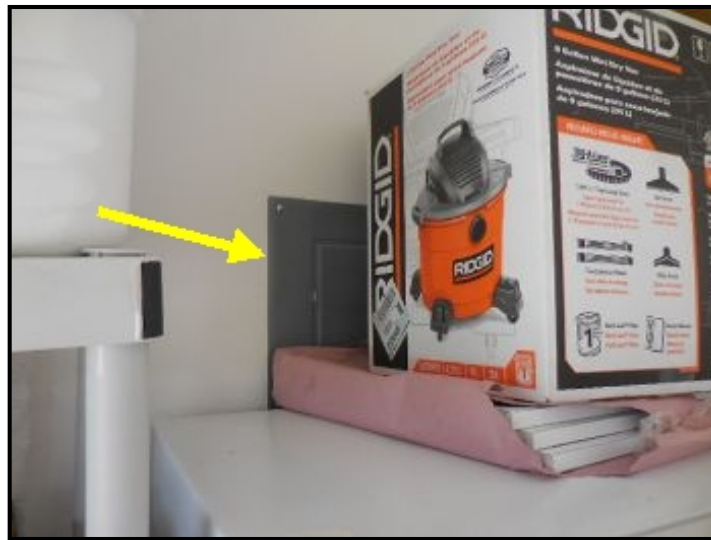
1. Electrical Panel

- Access to panel box blocked; interior not evaluated due to safety issues.

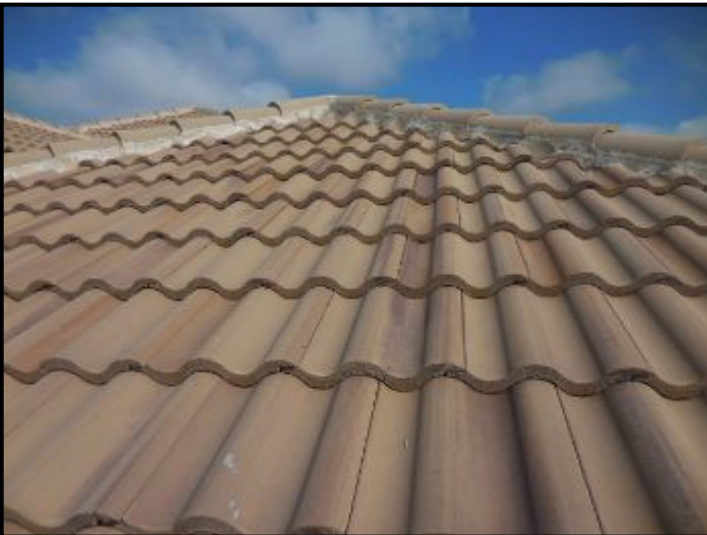
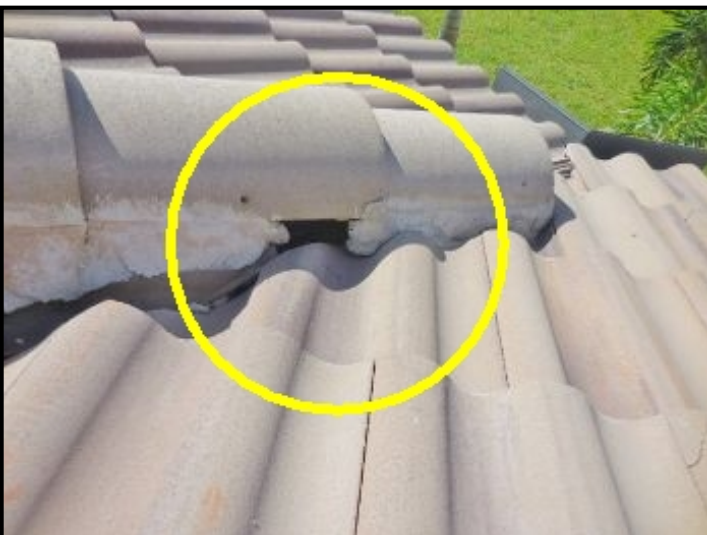
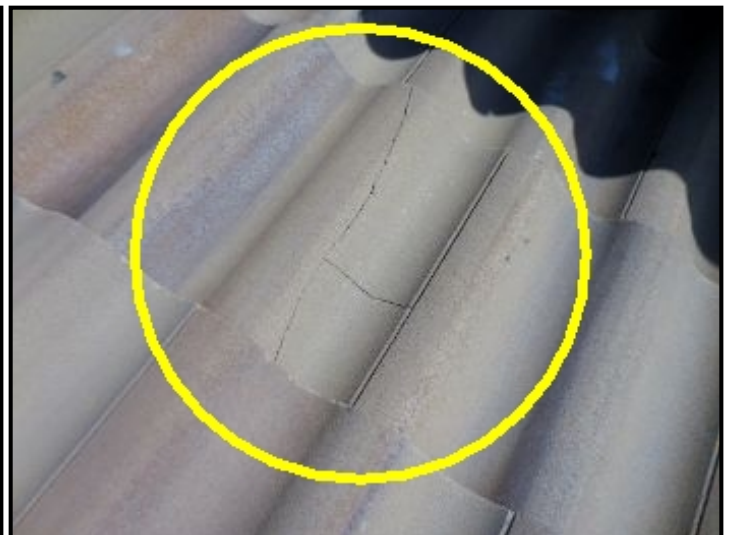
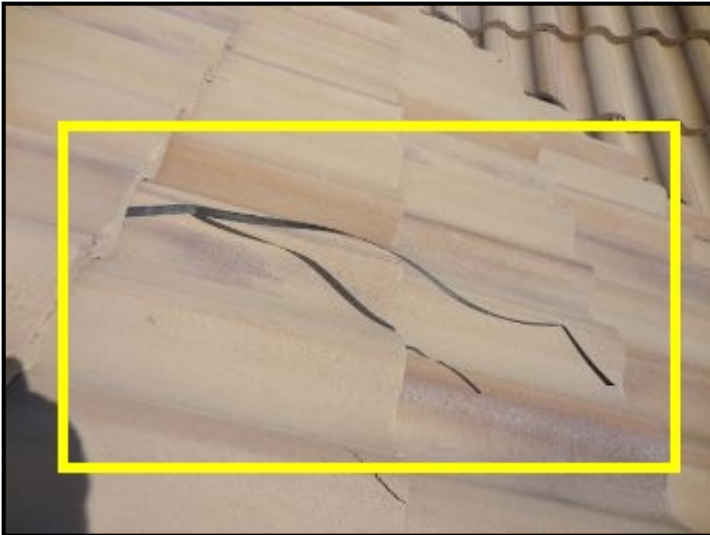
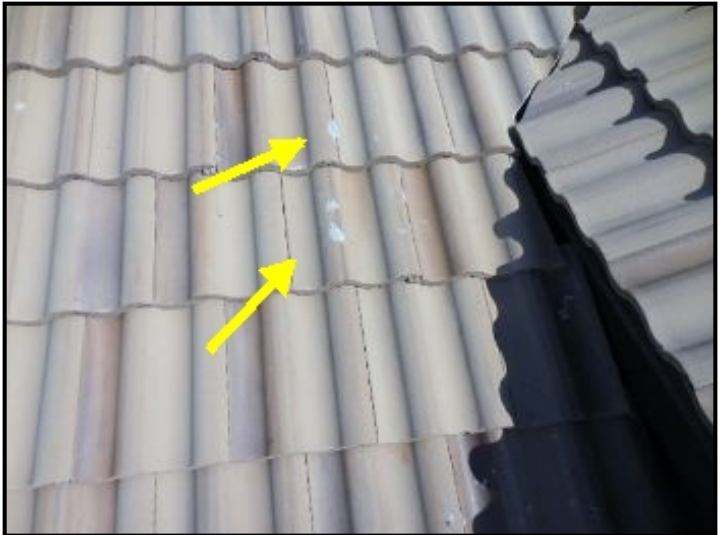
1. Roof Condition

- Ridge cap: deteriorated sealant areas.
- Some tiles are damaged / cracked and loose.
- Recommend roofing contractor to evaluate.

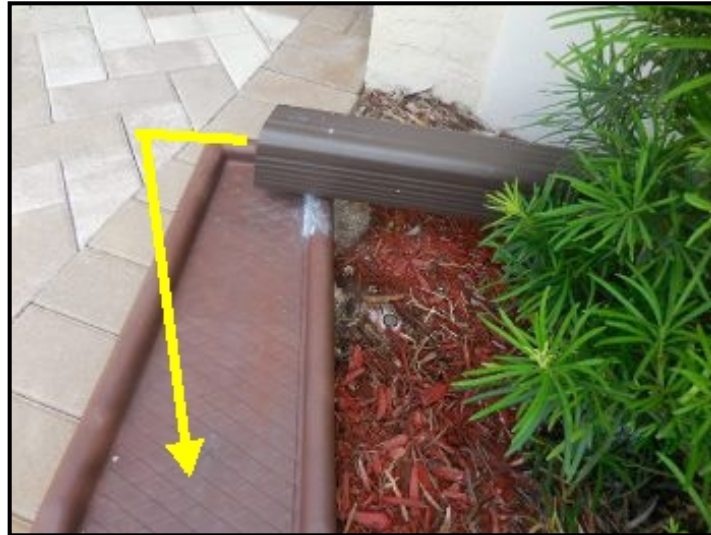
7. Gutter

- Extensions / Splash blocks missing or insufficient: Install to divert water away from the foundation. Poor placement.

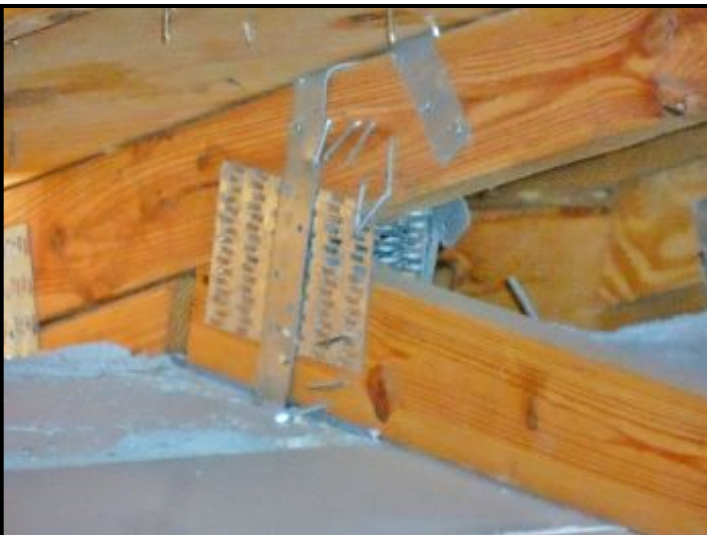
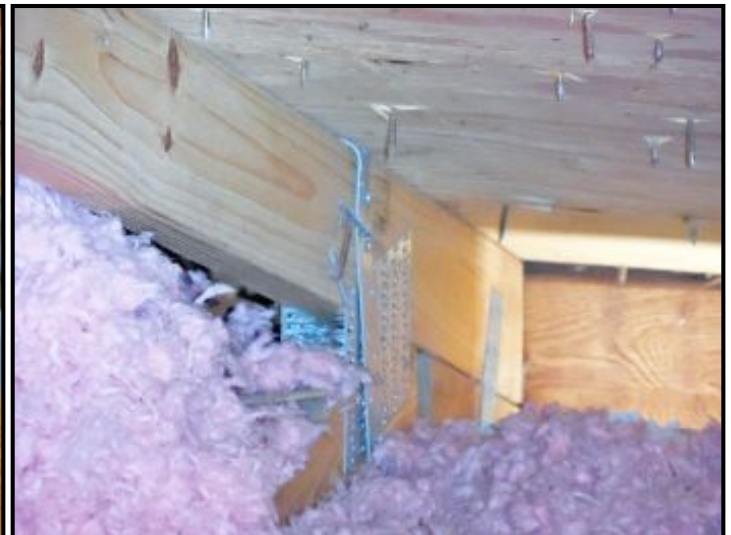
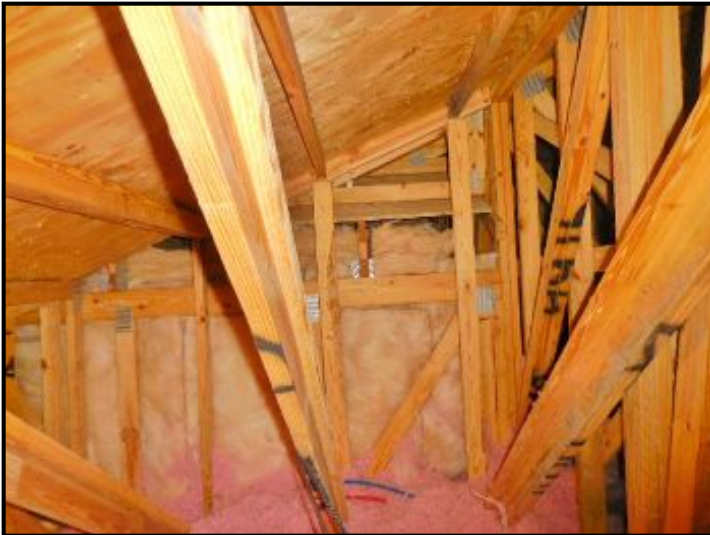
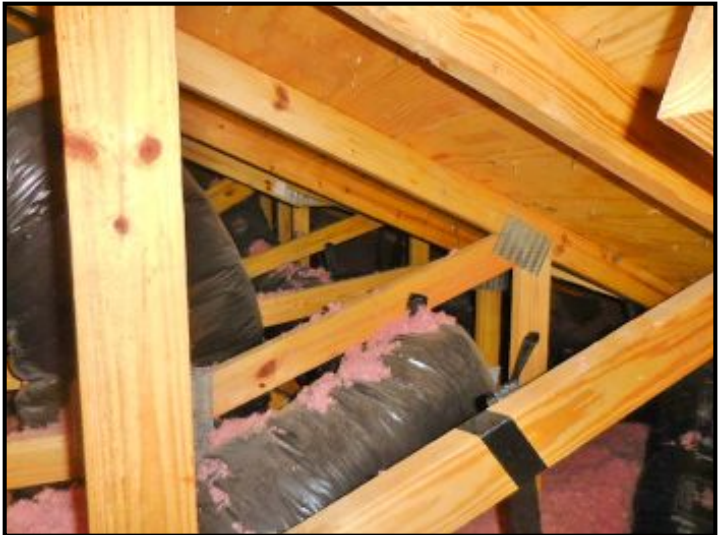
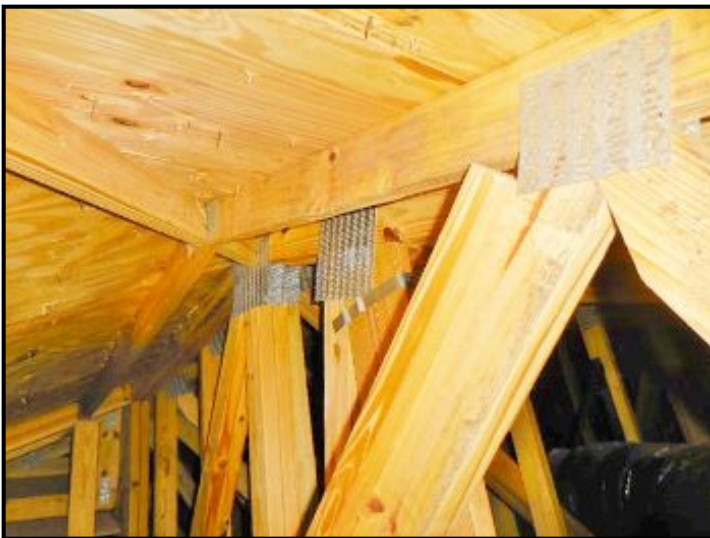
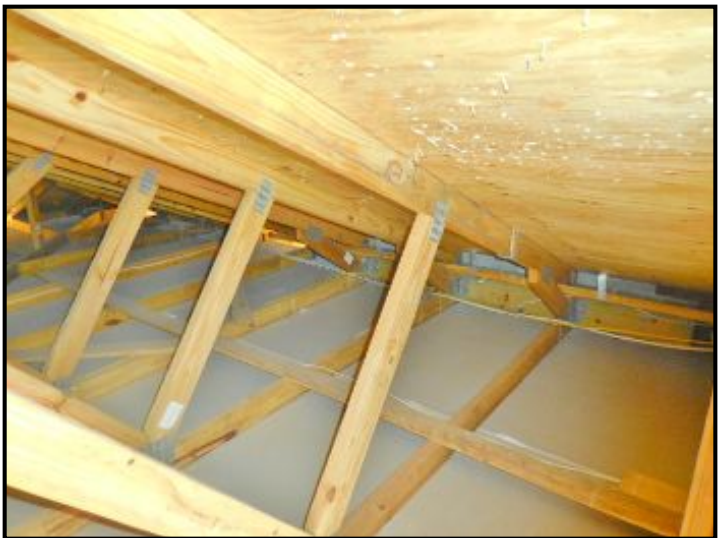
- There was limited access to visually inspect the attic area due to insulation but what could be seen appears to be in good condition.

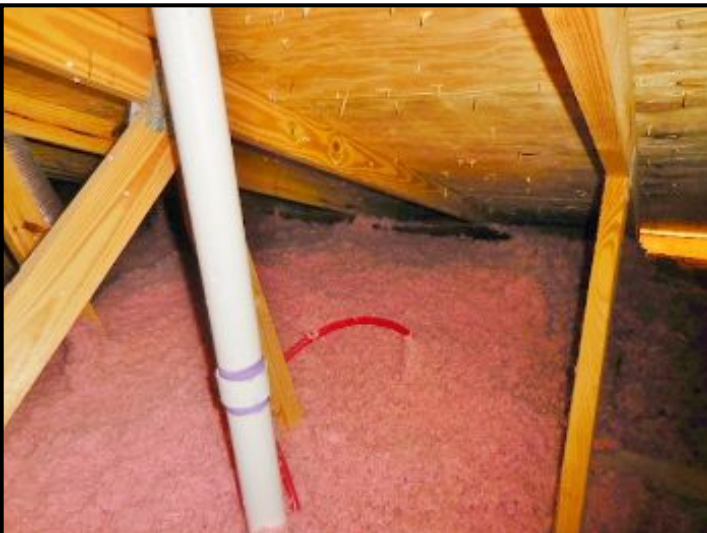
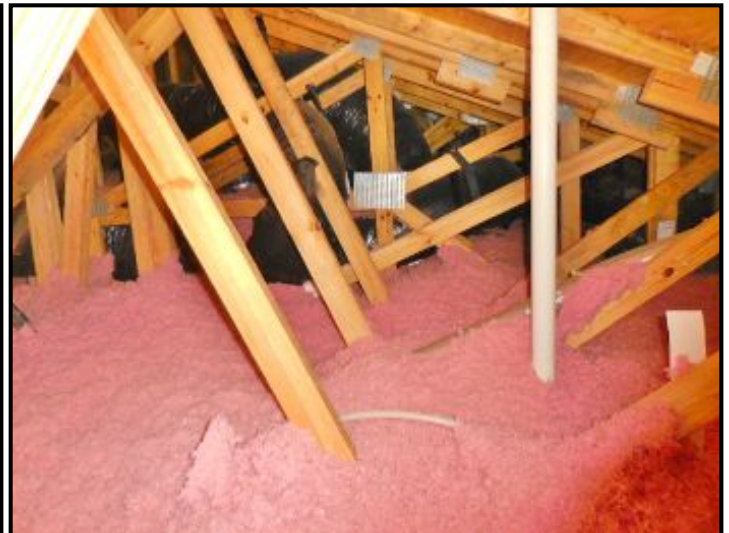
Materials: Blown in fiberglass insulation noted.
Depth: Insulation averages about 8-10 inches in depth

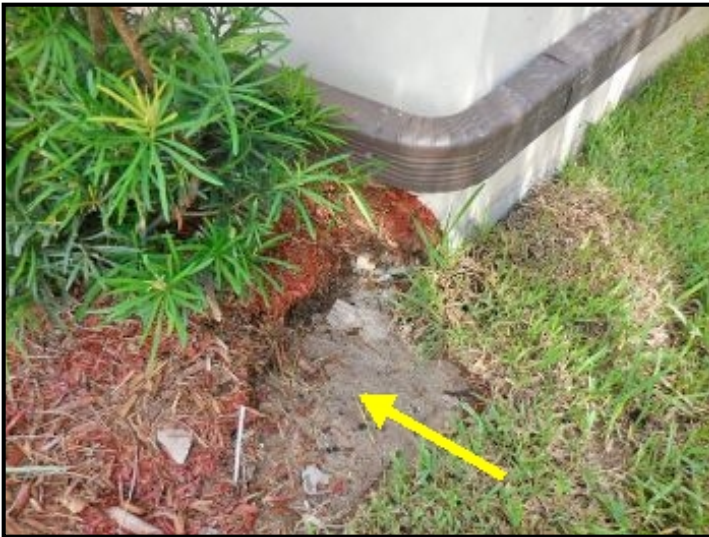
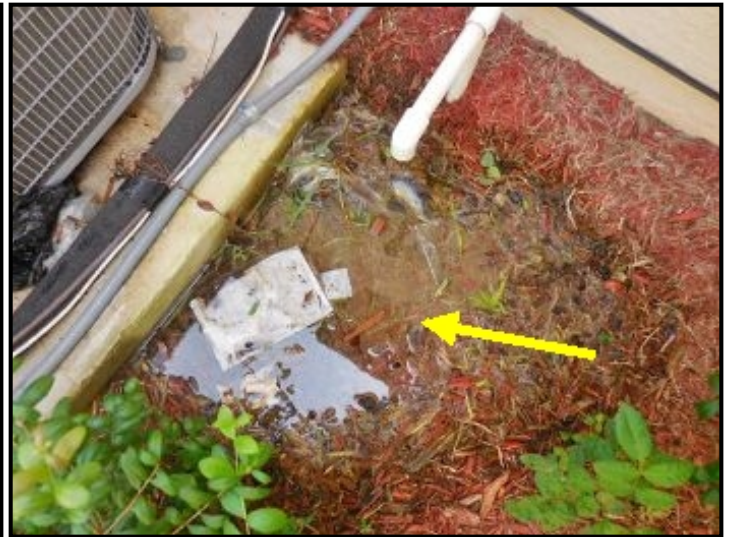
2. Grading

- There are some low spots along the foundation. Recommend adding additional backfill to create the proper slope away from the house to allow for effective drainage. 2. The area around the A/C condenser and the zero lot line are holding water which is adding to the mosquito issues around the home.
