Inspection Xpress

Property Inspection Report

1234 Palm Way, Anywhere, FL 33333
Inspection prepared for: John and Mary Smith
Date of Inspection: 10/20/2015 Time: 3:30 PM
Age of Home: 2006 Size: 2,687 SF
Weather: Hot!
Inspection performed by: Chet Peterman HI-8110

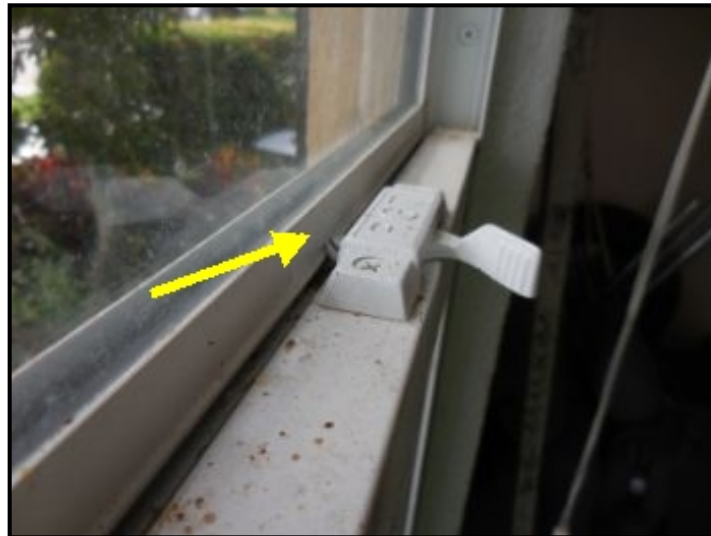
16. Window Condition

Materials: Aluminum framed single hung window noted. • Non-insulated glass noted.
 Observations:
 • One or more windows did not lock/latch properly, recommend repairs for enhanced security/safety to occupants.

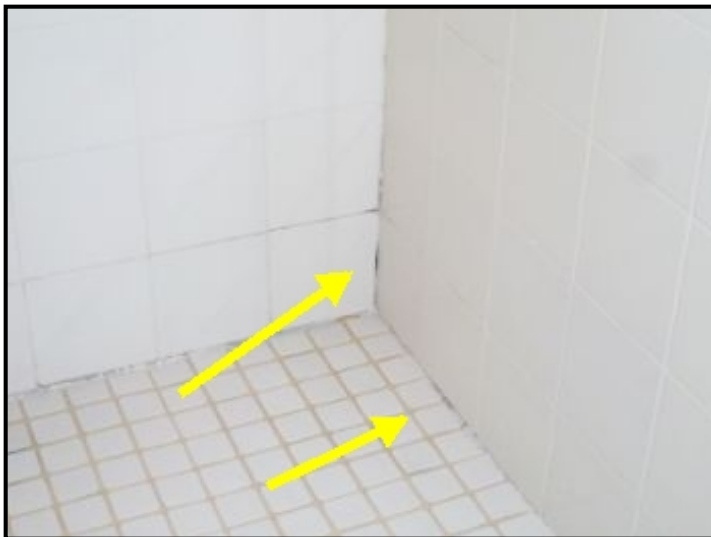
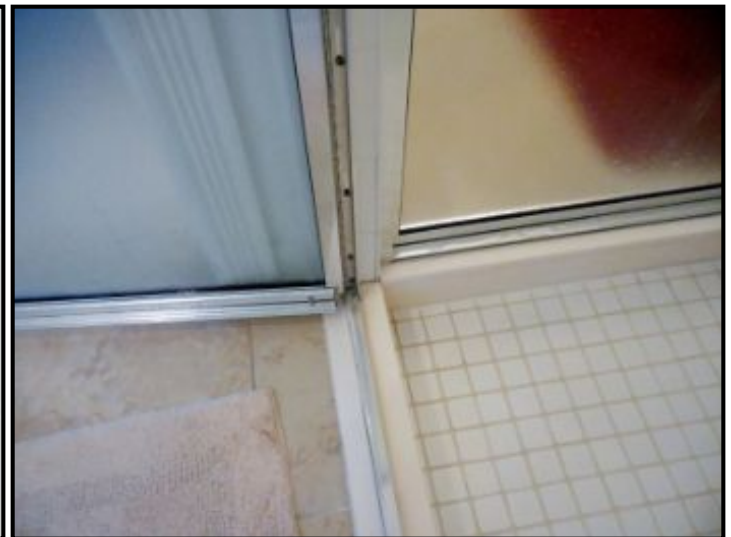
14. Shower Walls

• Suggest all tile edges and tub/shower walls be caulked and sealed to prevent moisture penetration. All missing/damaged grouting should be replaced. Failure to keep walls sealed can cause deterioration and extensive moisture damage to the interior walls and surrounding sub-flooring. This damage is not always visible or accessible to the inspector at the time of inspection.

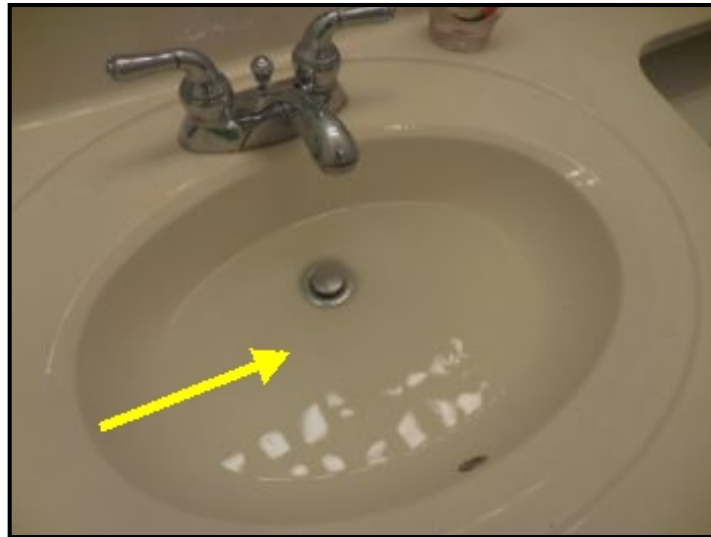
17. Sinks

- Slow drain at sink. Recommend clearing.

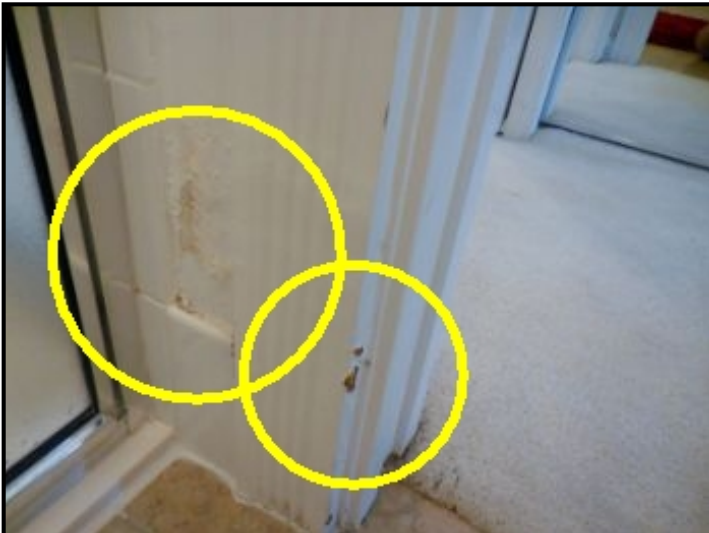
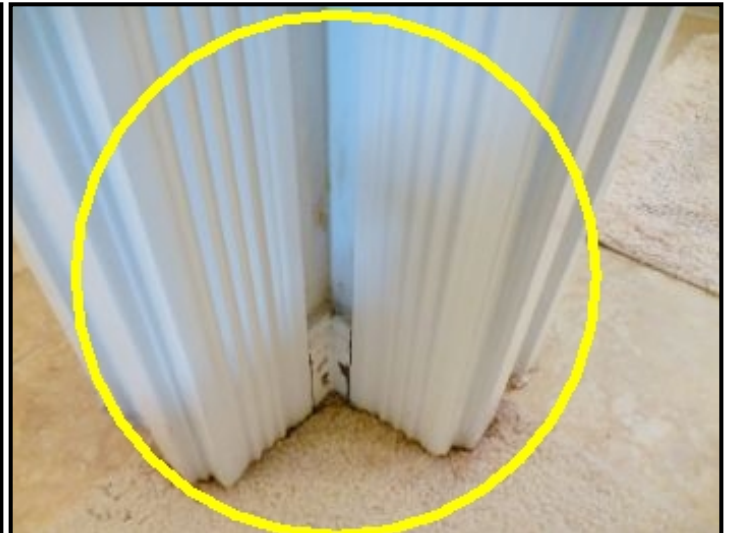
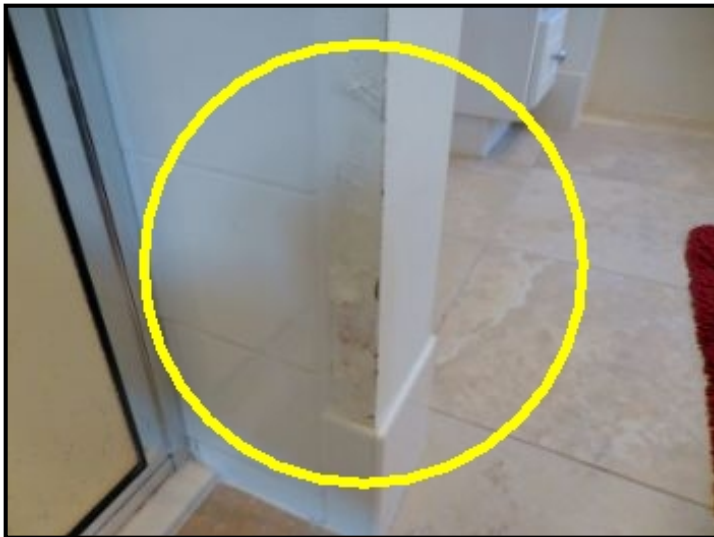
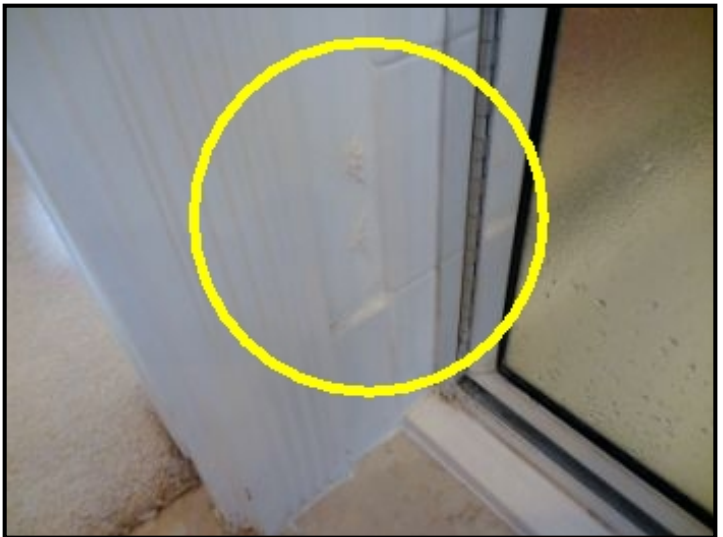
20. Walls

- There are areas outside of the master shower where there is moisture damage as we discussed. These areas need further evaluation and repair.

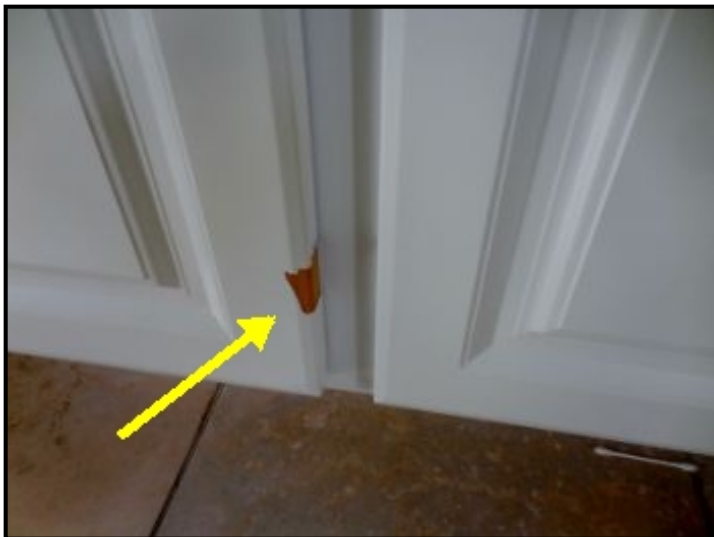
1. Cabinets

- Cabinet drawer / door face is loose / chipped.
- There appears to be water damage under sink.

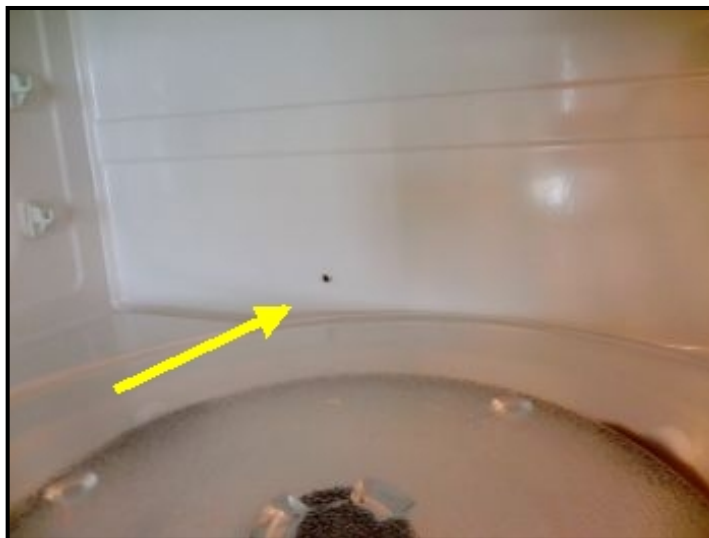
6. Microwave

- Built-in microwave ovens are tested using normal operating controls. Unit was tested and appeared to be serviceable at time of inspection. Leak and/or efficiency testing is beyond the scope of this inspection.
- **There are chips in the microwave.**

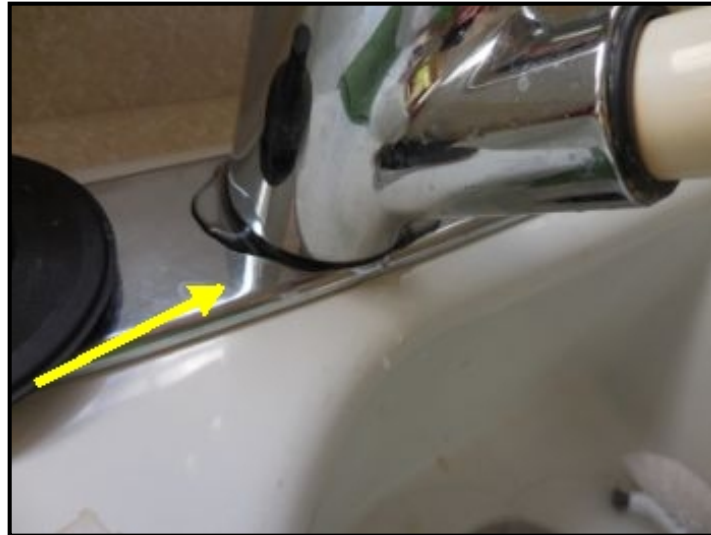
9. Sinks

- Faucet leaks at base.

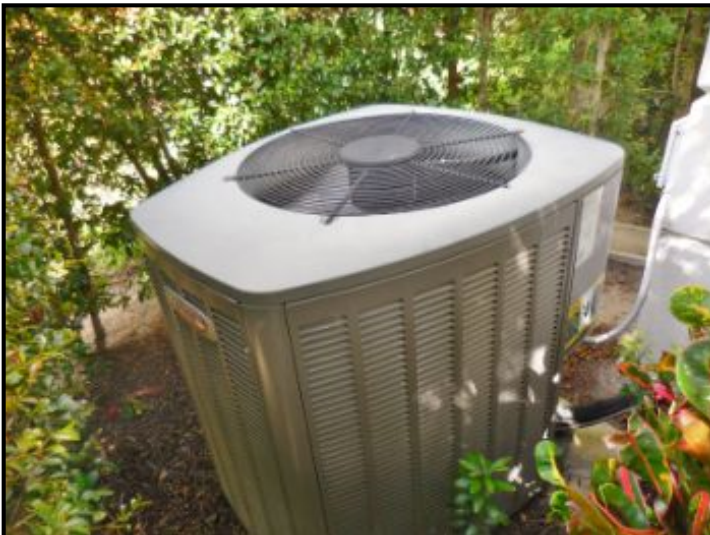
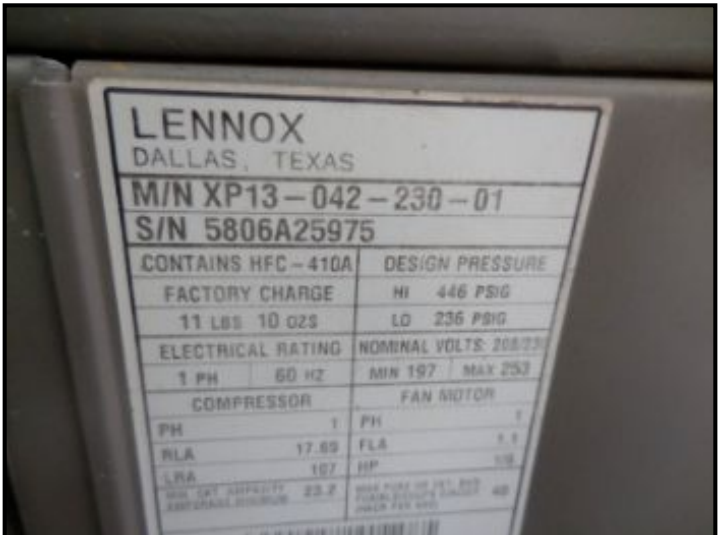
7. AC Compress Condition

Compressor Type: Electric
 Location: The compressor is located on the exterior west.
 Observations:

- Appeared functional at the time of inspection.
- Installed in 2006 / 9 years old. The typical temperature differential split between supply and return air in an air conditioner of this type is 15 - 20 degrees F. This system responded and achieved an acceptable differential temperature of 14 - 17 degrees F. We recommend that an A/C contractor perform a system service.
- Annual HVAC service contract is recommended.

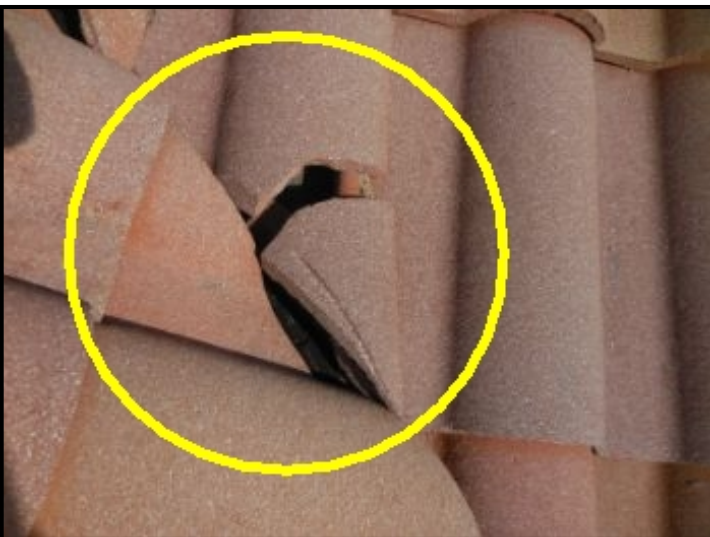
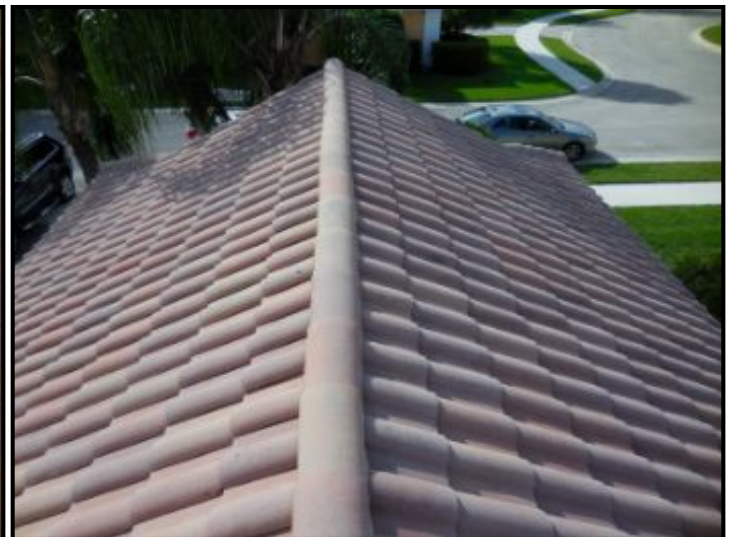
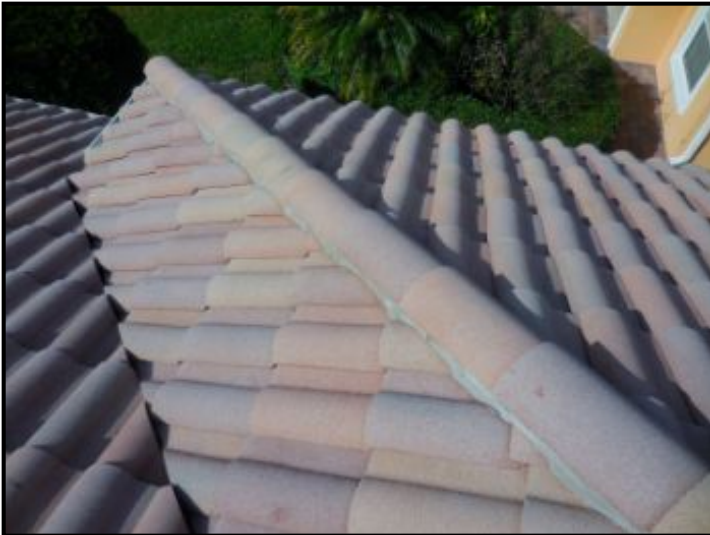
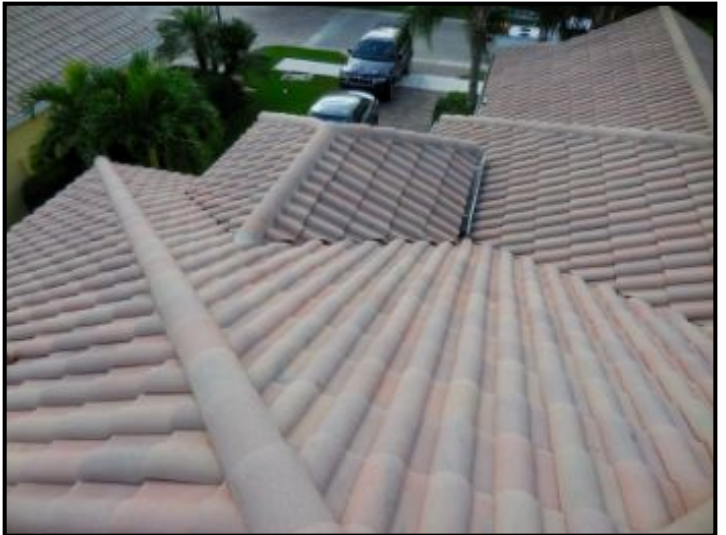
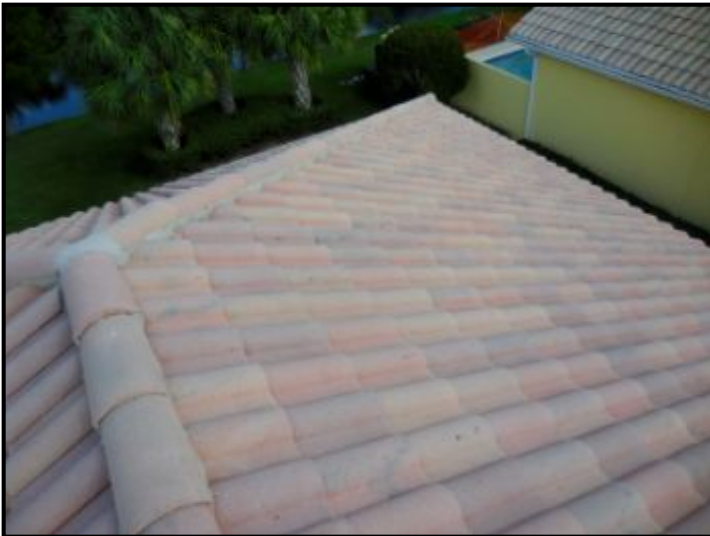
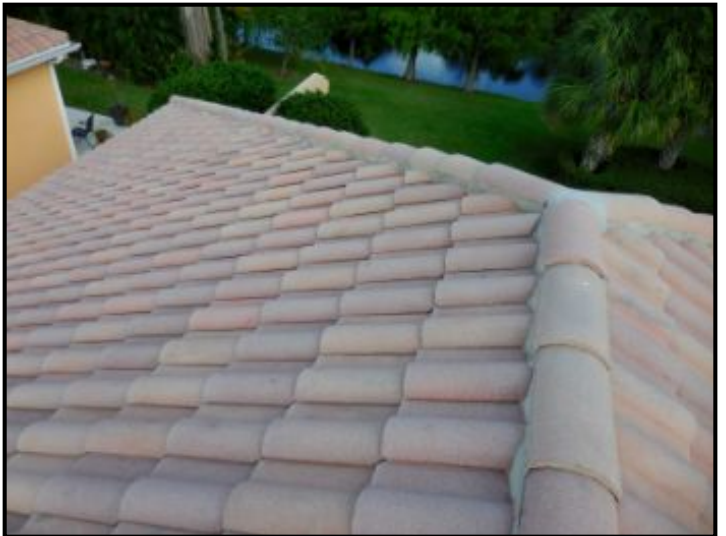
1. Roof Condition

Materials: Inspected from ladder.
 Materials: Concrete tiles noted.
 Observations:
 • Some minor shingles / tiles damaged.

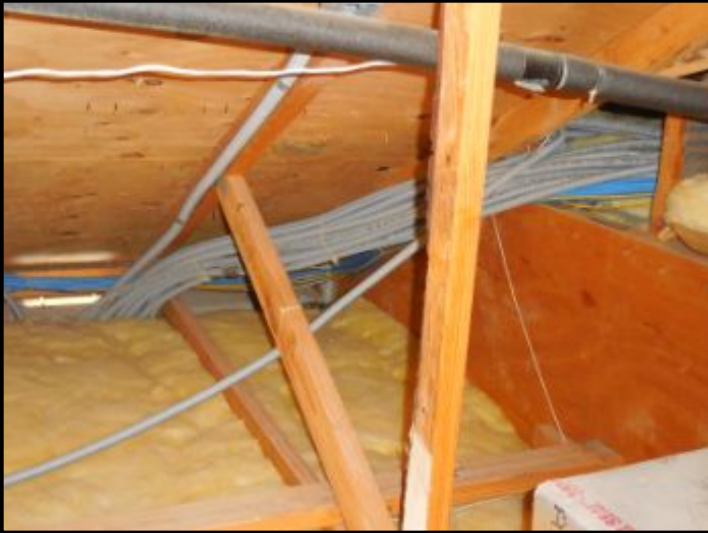
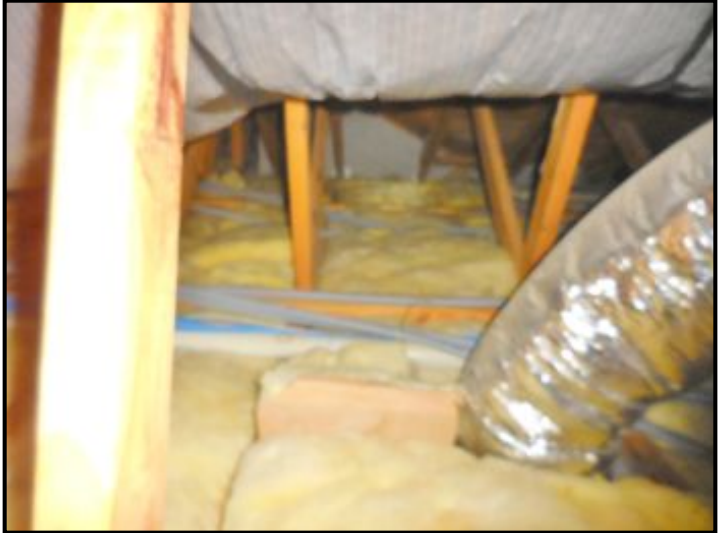
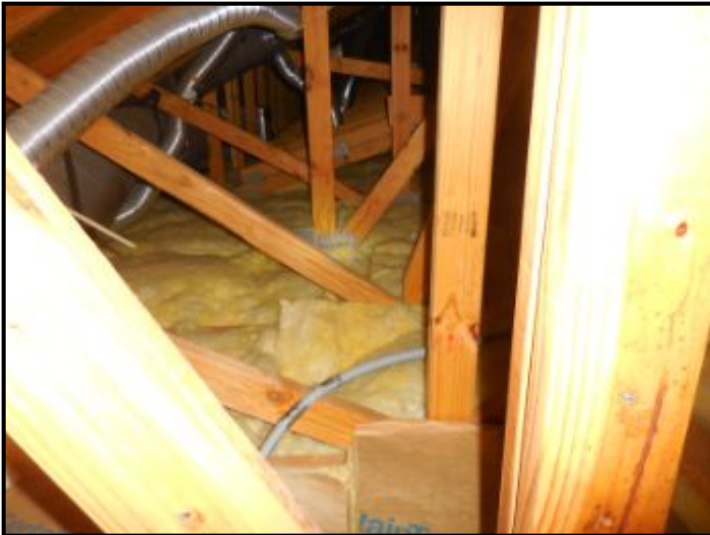
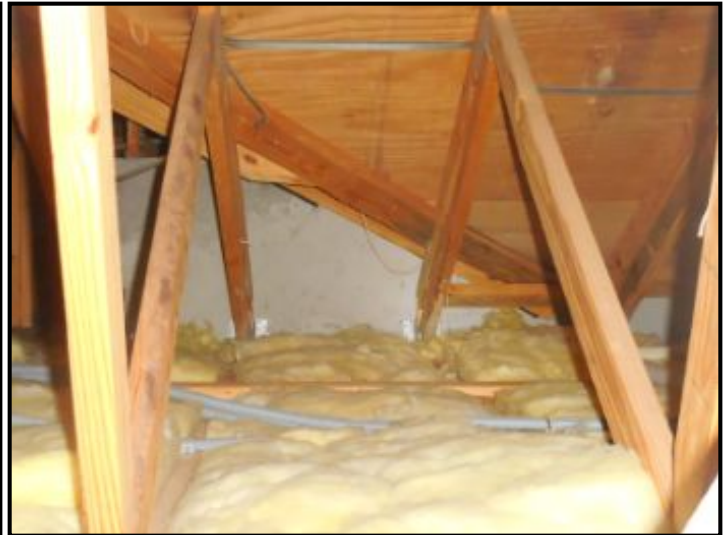
8. Insulation Condition

Materials: Fiberglass batts with kraft paper facing noted.
Depth: Insulation averages about 6-8 inches in depth
Observations:
• **Rodent and droppings are present.**

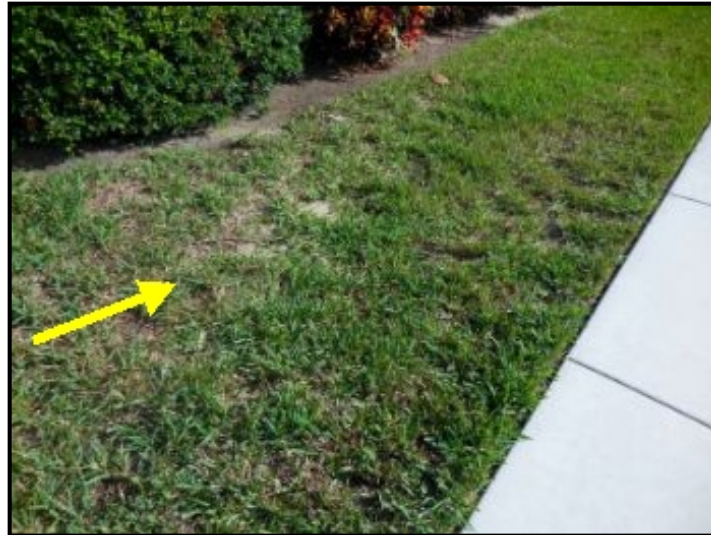
3. Vegetation Observations

- Sod areas in the front yard are thin.

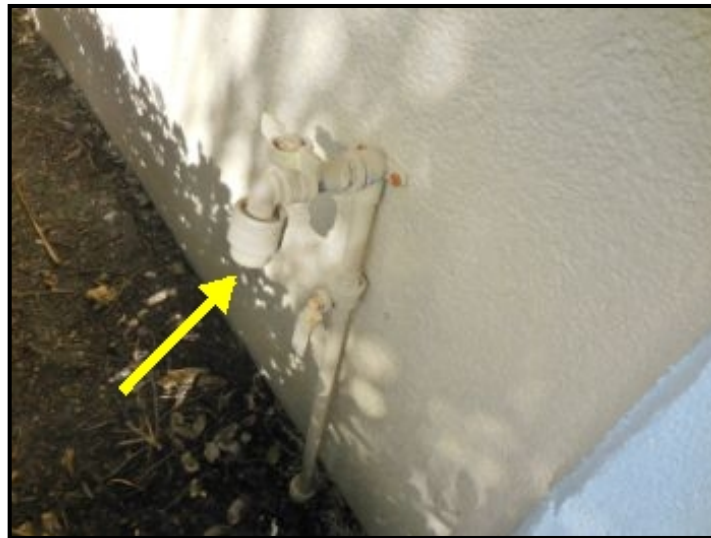
11. Exterior Faucet Condition

Location: West side of house.

- Hose bib at west side of house leaks.
