# *Inspection Xpress*

## Property Inspection Report

55 55th Sreet, Some Place, FL 33333  
Inspection prepared for: Alejandro and Alejandra Perez  
Date of Inspection: 10/14/2015 Time: 2PM  
Age of Home: 2006 Size: 6,994 SF  
Weather: Hot!  
Inspection performed by: Chet Peterman HI-8110

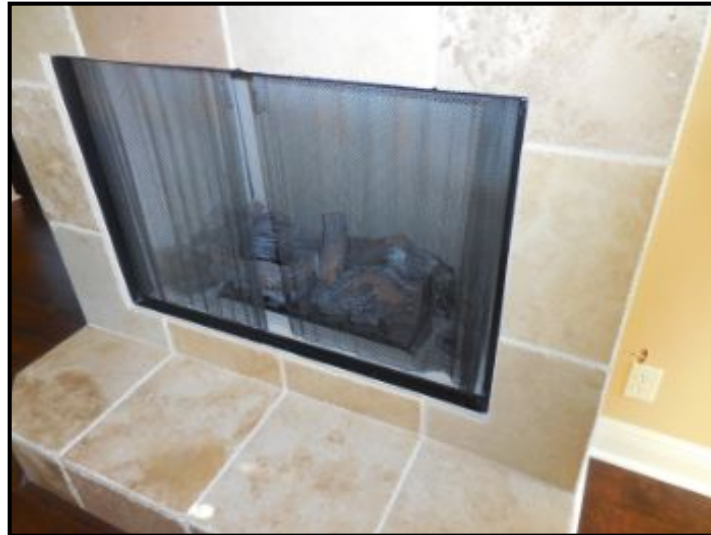
15. Fireplace

- Have a gas fireplace professional service/evaluate fireplace before operating.

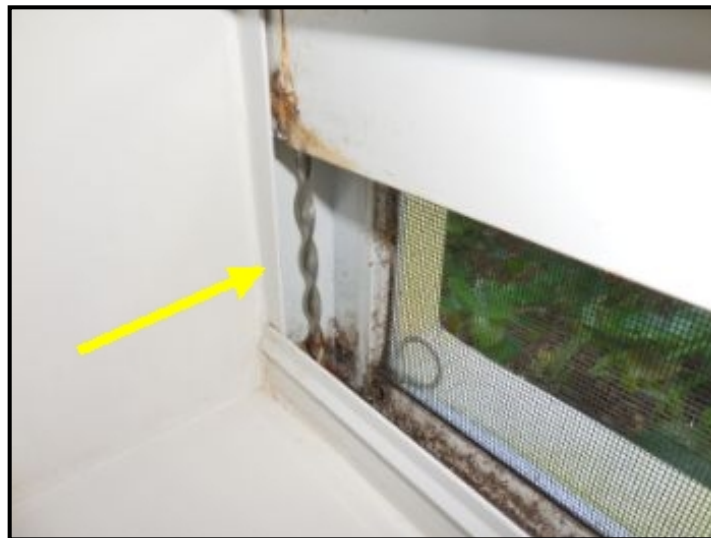
16. Window Condition

• One or more windows did not open/close/lock/latch properly, recommend repairs for enhanced security/safety to occupants. A spring kit is needed at the dining room window for proper operation.

Interior Areas		
Page 6 Item: 16	Window Condition	• One or more windows did not open/close/lock/latch properly, recommend repairs for enhanced security/safety to occupants. A spring kit is needed at the dining room window for proper operation.
Bathroom		
Page 10 Item: 13	Showers	• Missing grout noted at the tile near the drain in the master bath. Recommend maintenance of grout and caulking to prevent water seepage.
Page 11 Item: 17	Sinks	• Slow drain at sink. Recommend clearing. Some of the stoppers need to be adjusted for proper operation.
Page 11 Item: 18	Toilets	• Tank base in the 1/2 bath is cracked/broken. This does not affect operation of the fixture.
Kitchen		
Page 13 Item: 6	Microwave	• Inoperable at the time of inspection,
Heat/AC		
Page 18 Item: 6	Refrigerant Lines	• Missing insulation at A/C unit.
Garage		
Page 24 Item: 5	Rafters & Ceiling	• Garage drywall ceiling has minor cracking from drywall tape shrinkage and only needs to be monitored.

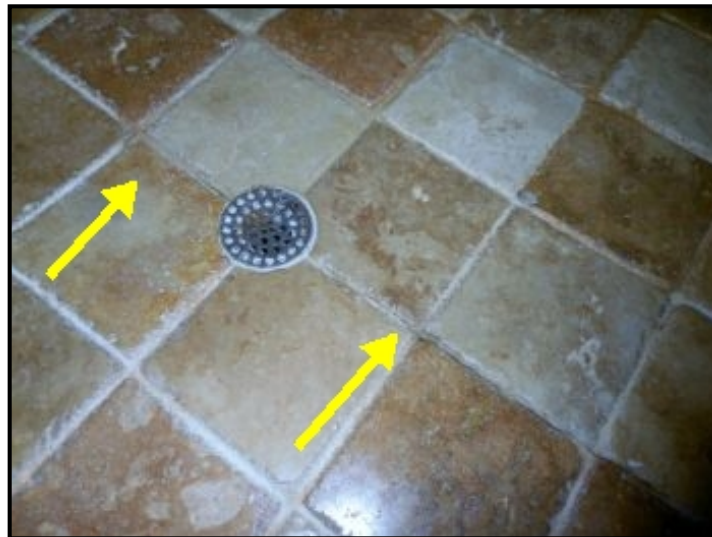
13. Showers

- Missing grout noted at the tile near the drain in the master bath.
- Recommend maintenance of grout and caulking to prevent water seepage.

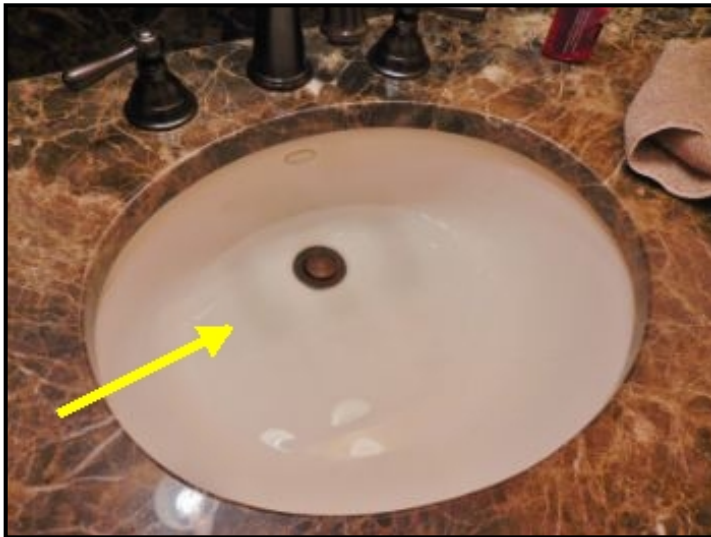
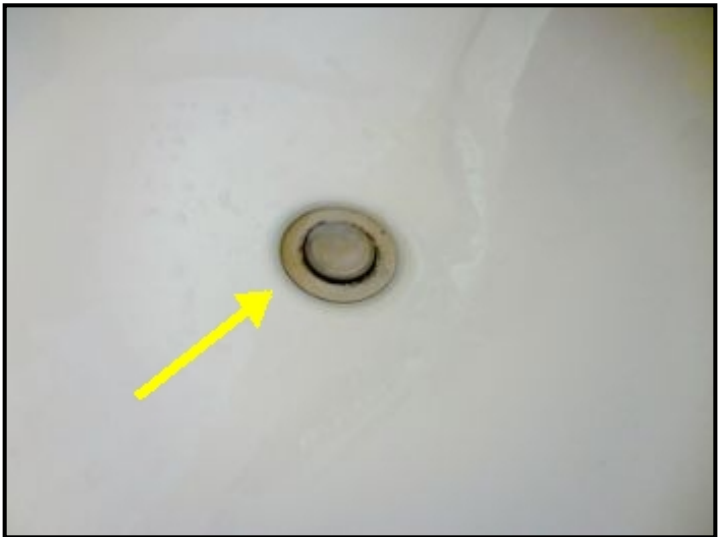
17. Sinks

• Slow drain at sink. Recommend clearing. Some of the stoppers need to be adjusted for proper operation.

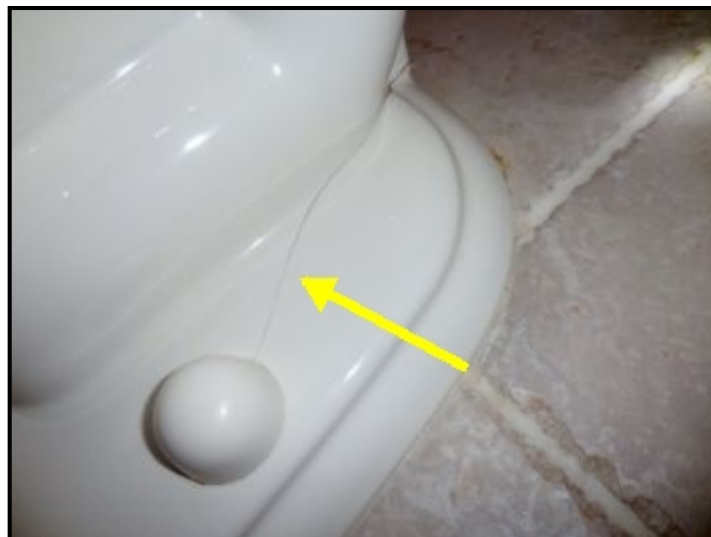
18. Toilets

• Tank base in the 1/2 bath is cracked/broken. This does not affect operation of the fixture.

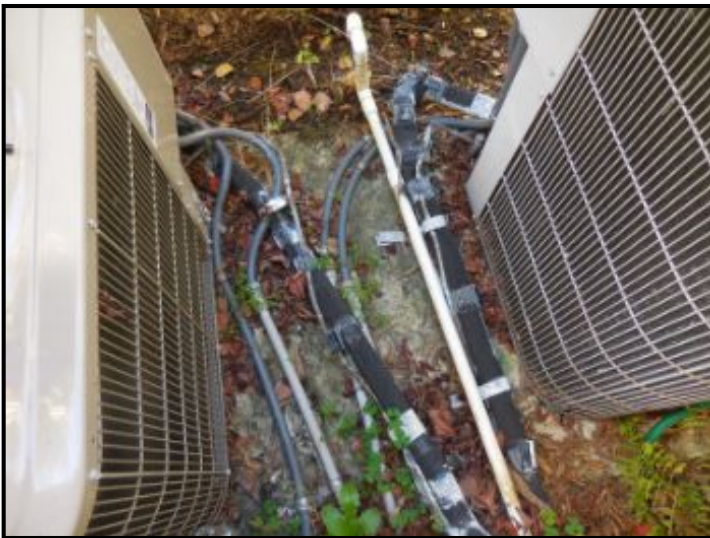
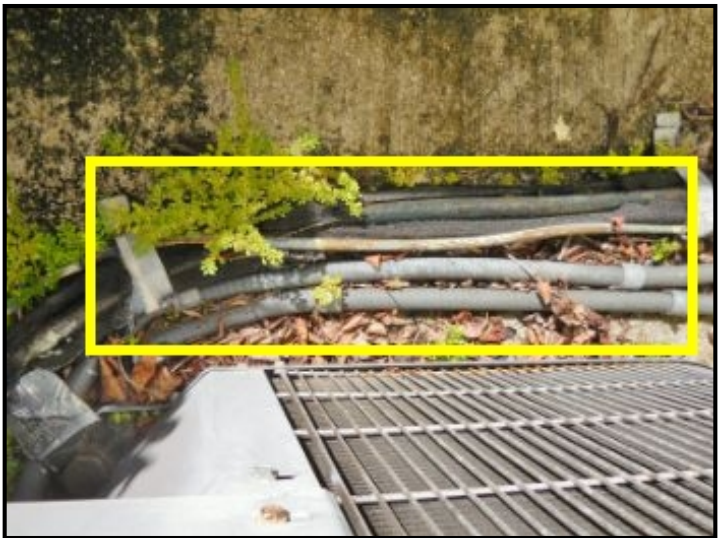
6. Refrigerant Lines

Observations:  
 • Missing insulation at A/C unit.

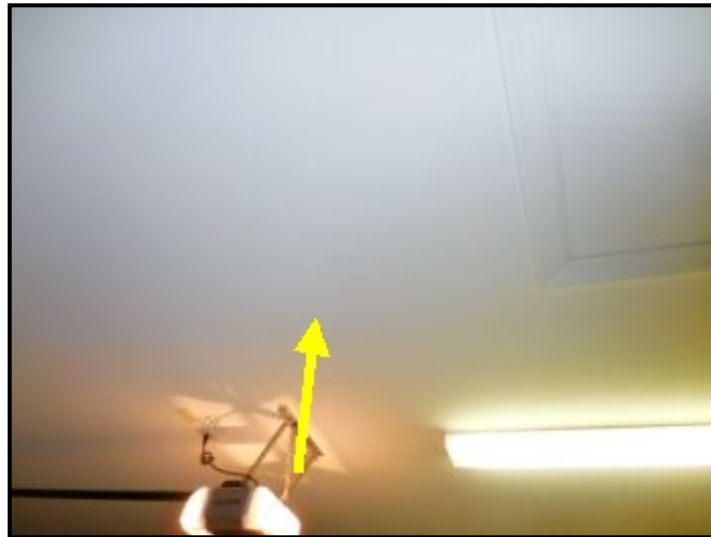
5. Rafters & Ceiling

- Garage drywall ceiling has minor cracking from drywall tape shrinkage and only needs to be monitored.

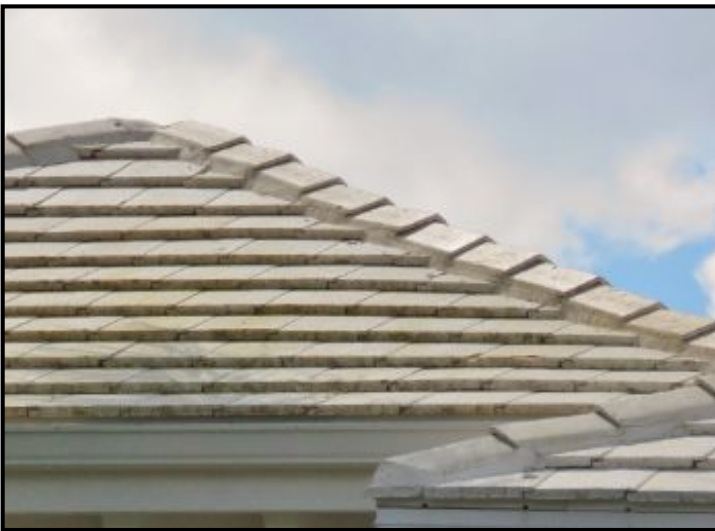
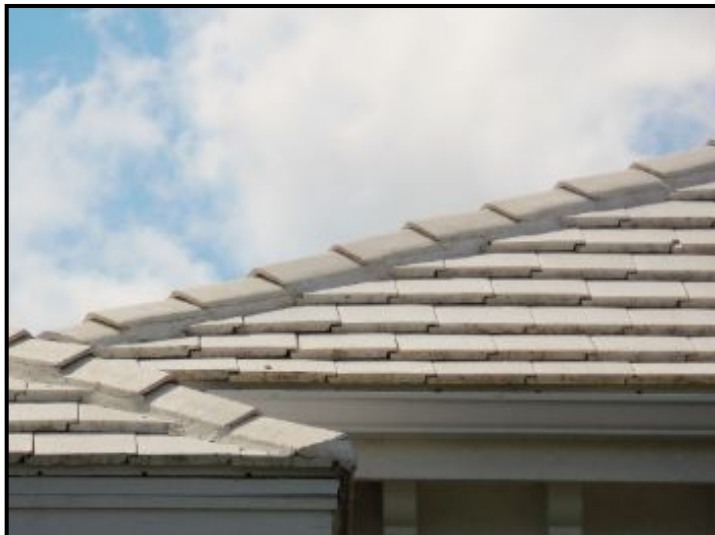
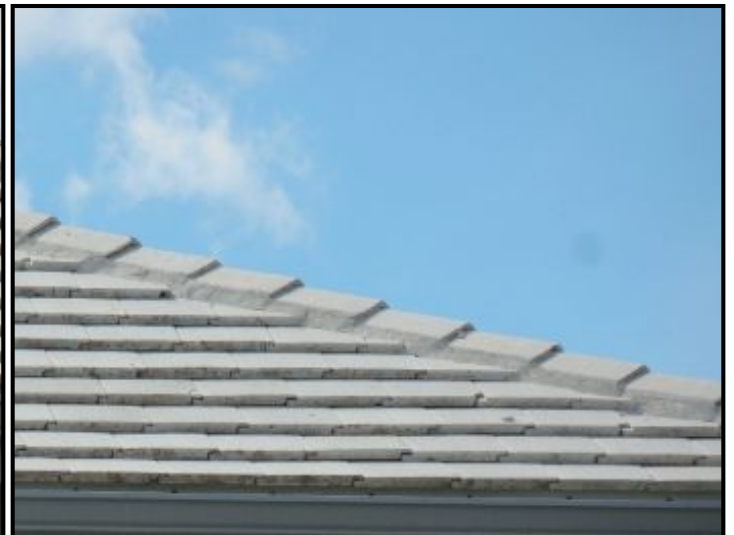
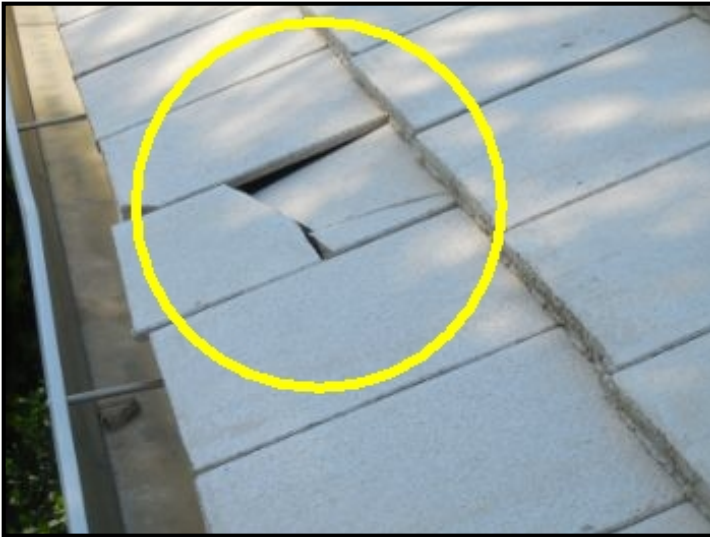
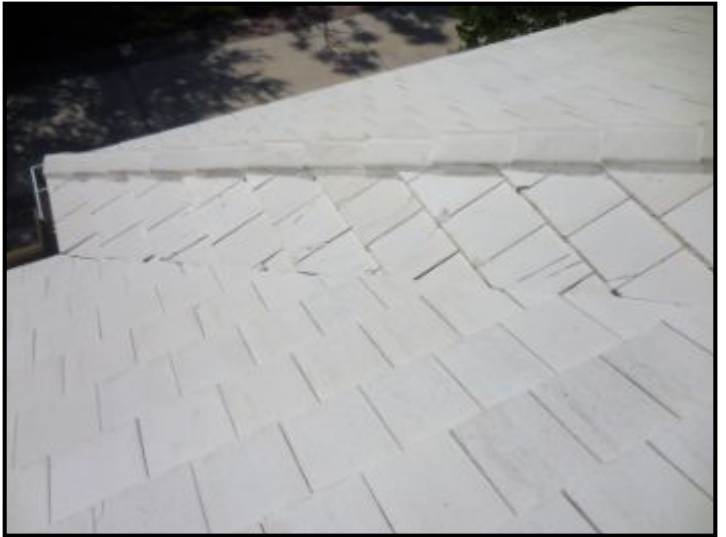
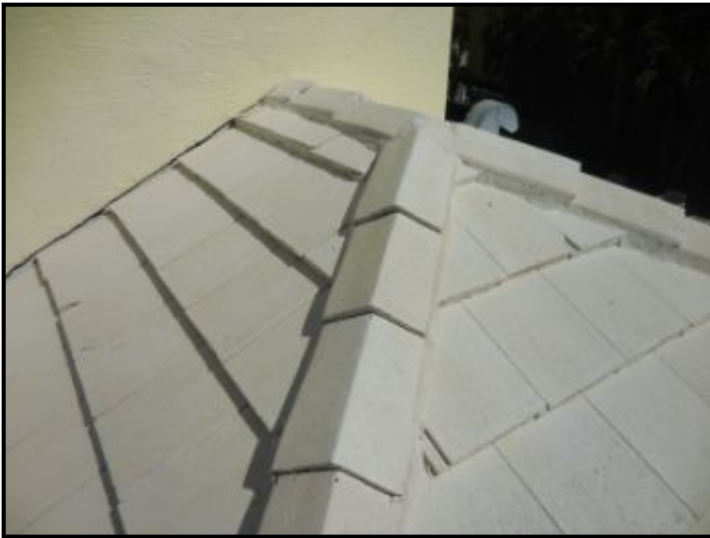
#### 1. Roof Condition

- Some shingles / tiles damaged and/or loose.
- Recommend roofing contractor to evaluate.

Page 25 Item: 14	Garage Door's Reverse Status	• The 1 car door requires a great deal of resistance to trigger the auto-reverse mechanism. We recommend adjusting the opener for proper reverse tension.
Roof		
Page 28 Item: 1	Roof Condition	• Some shingles / tiles damaged and/or loose. • Recommend roofing contractor to evaluate.
Page 32 Item: 7	Gutter	• One of the gutters needs to be inserted into the carry extension.
Attic		
Page 32 Item: 2	Structure	• Evidence of past or present leaks, dry at time of the inspection. Monitor for leaks &/or have roofing contractor evaluate.
Exterior Areas		
Page 37 Item: 2	Window Condition	• Some window screens damaged. 2. Some of the window areas need to be cleaned due to moisture based growth.
Page 38 Item: 4	Eaves & Facia	• There are areas where the facia needs to be painted due to peeling or missing paint. Some of the areas appear to be stained from previous rains etc. There are also other areas that appear to have been repaired which most likely dates back to the builder.

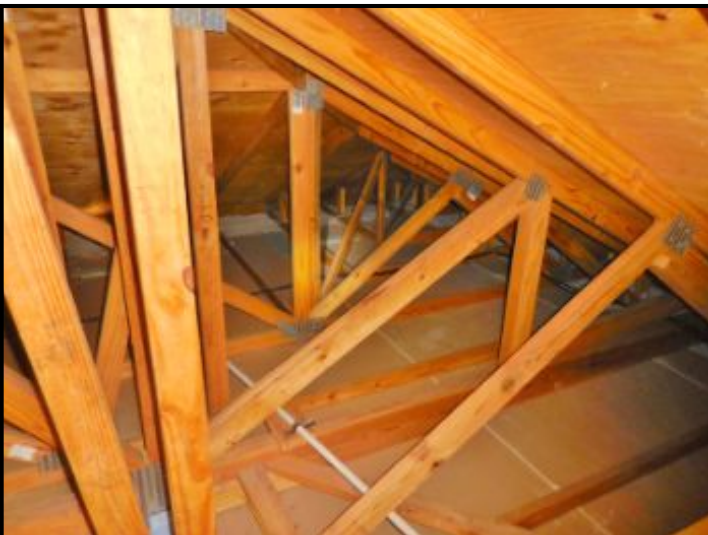
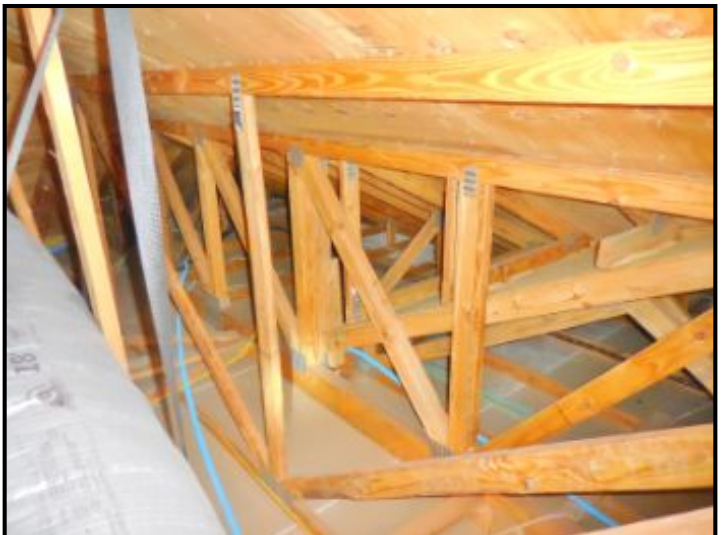
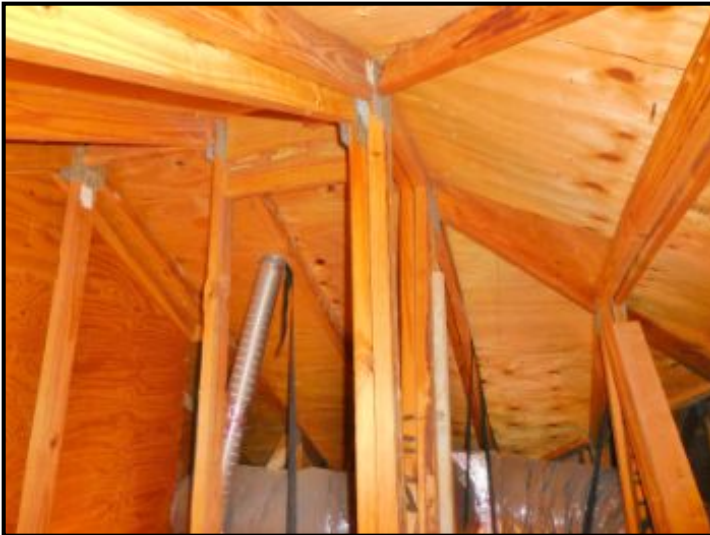
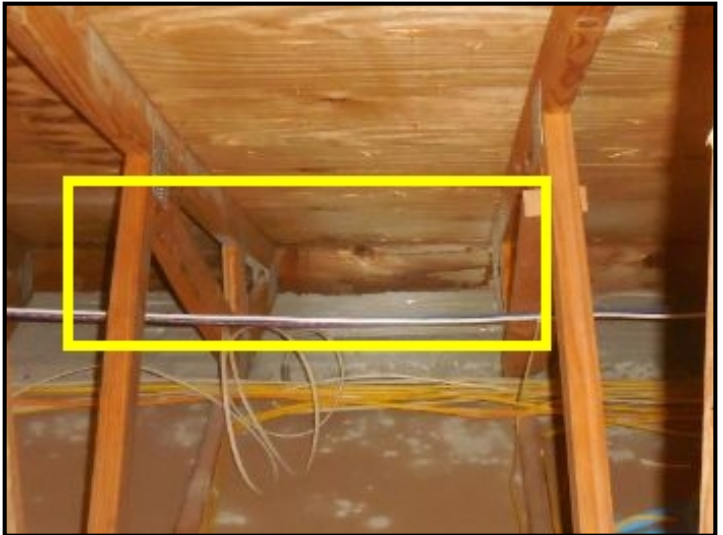
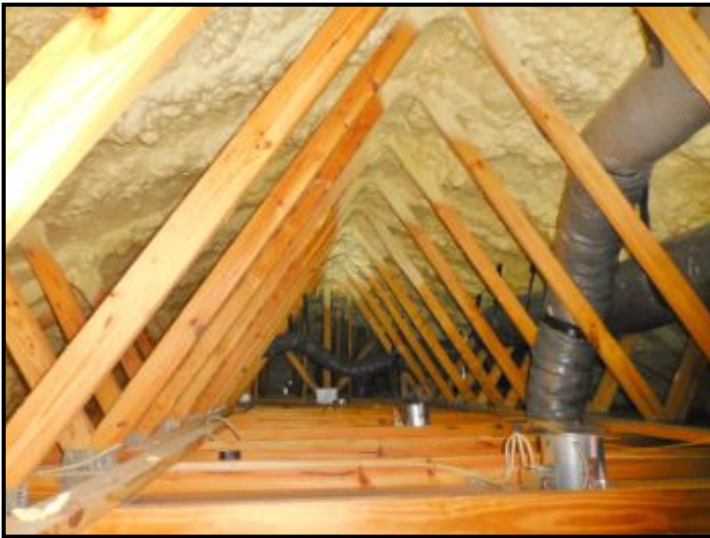
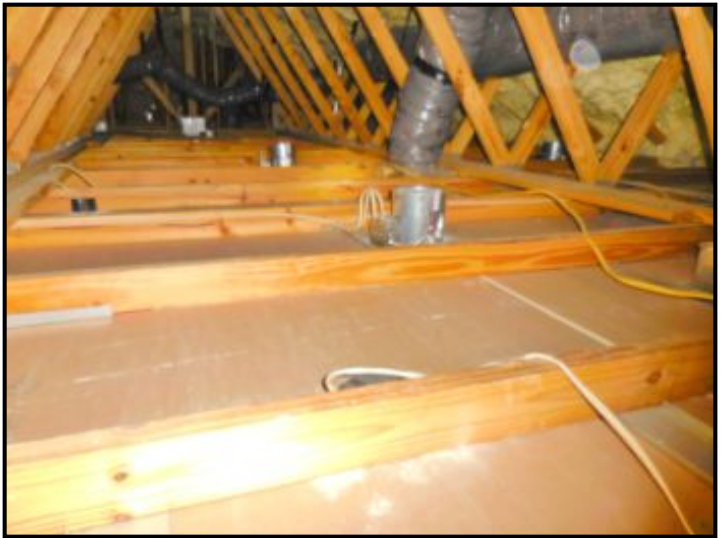
- Evidence of past or present leaks, dry at time of the inspection. Monitor for leaks &/or have roofing contractor evaluate.

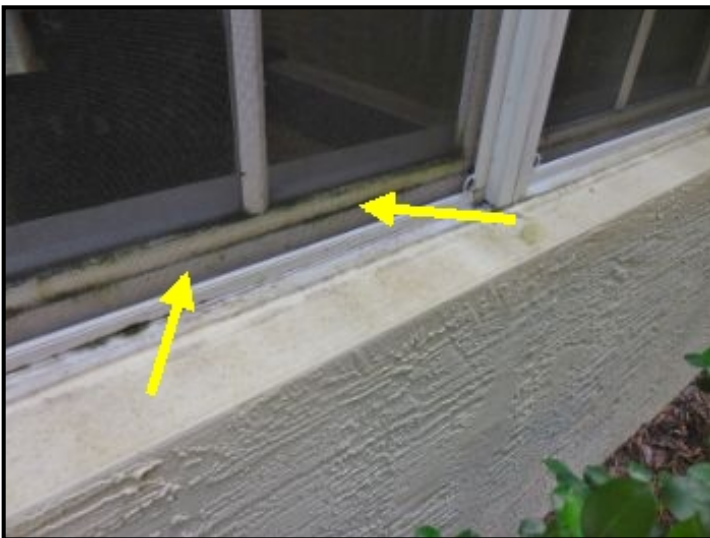
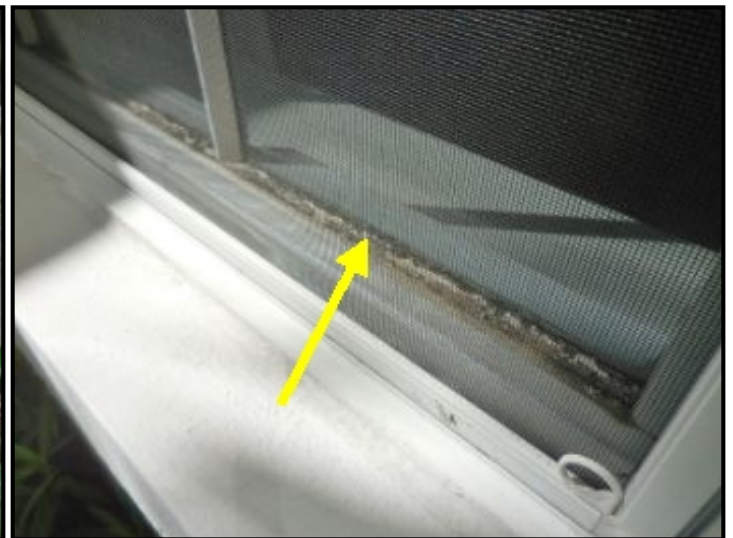
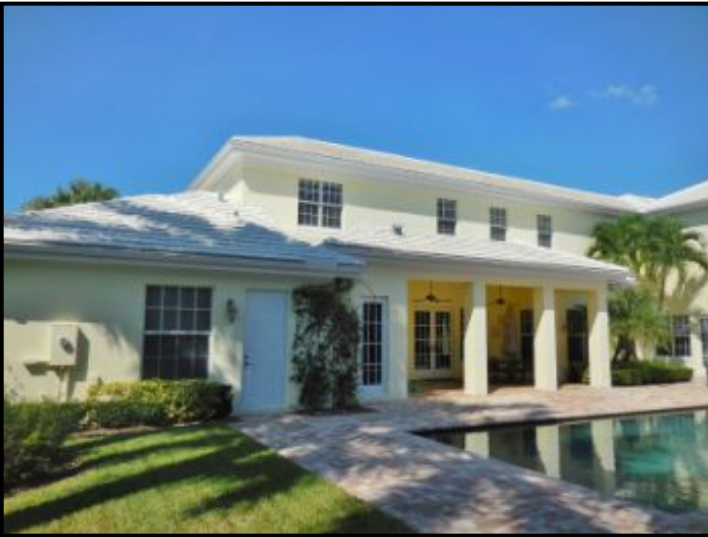
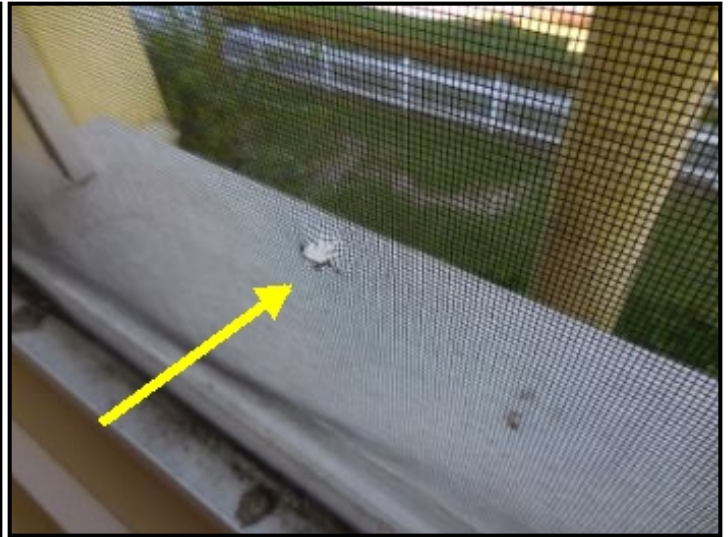
2. Window Condition

- Some window screens damaged. 2. Some of the window areas need to be cleaned due to moisture based growth.

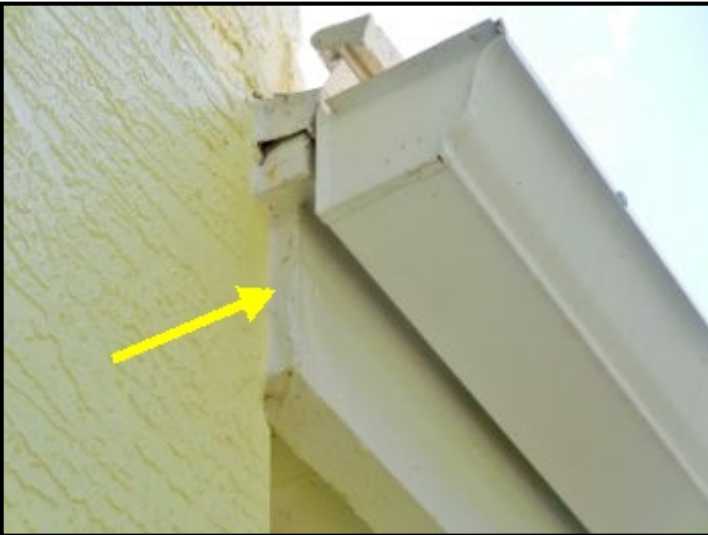
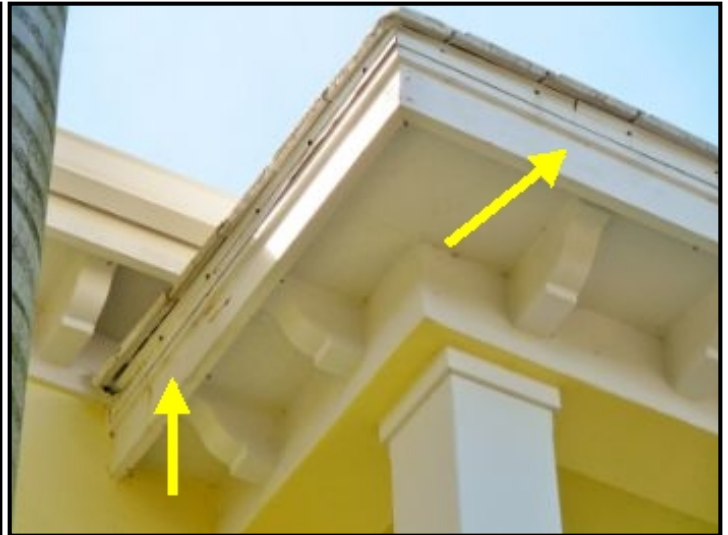
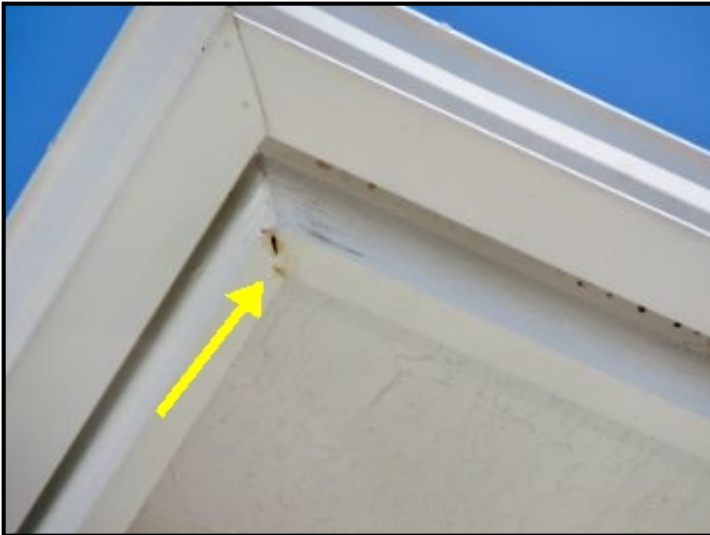
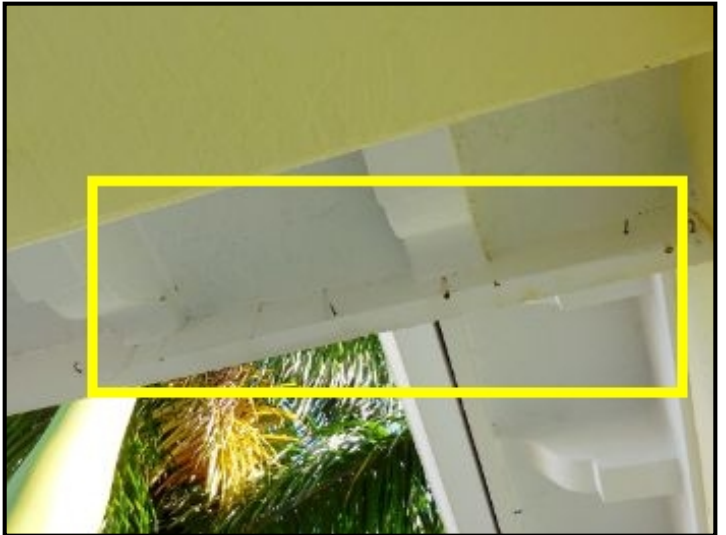
### 3. Siding Condition

• There are areas where the facia needs to be painted due to peeling or missing paint. Some of the areas appear to be stained from previous rains etc. There are also other areas that appear to have been repaired which most likely dates back to the builder.

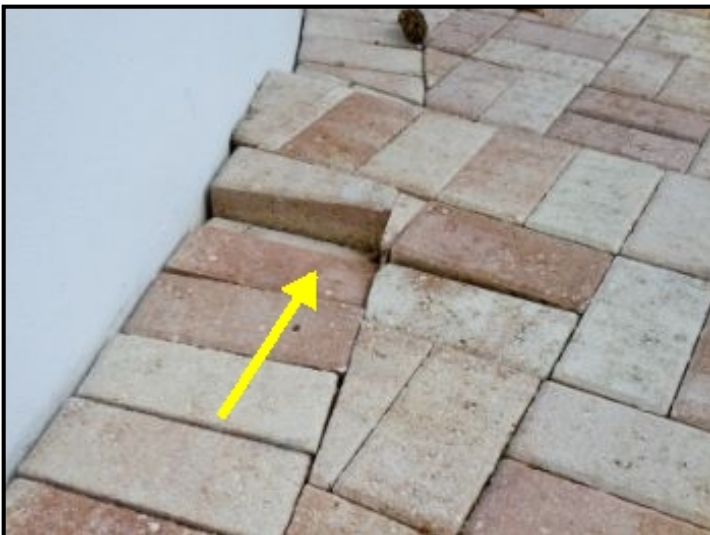
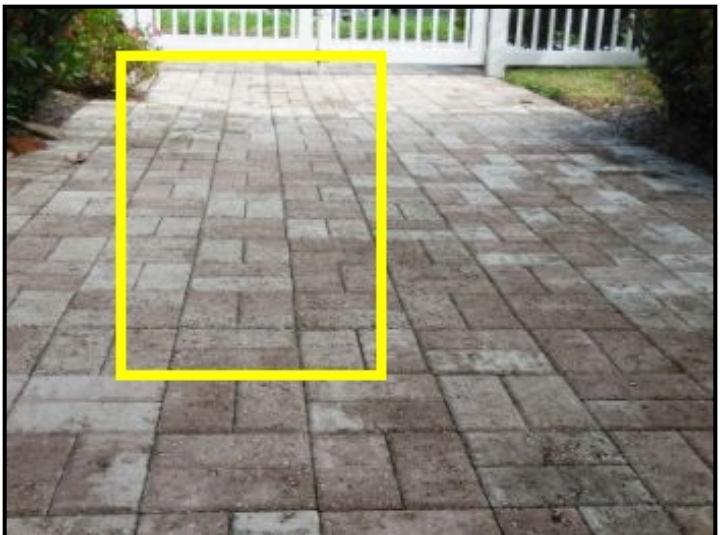
1. Driveway and Walkway Condition

- Potential Trip Hazard(s) at sidewalk; monitor / repair as necessary. 2. There is a low area of pavers at the front entry.

Page 39 Item: 1	Driveway and Walkway Condition	• Potential Trip Hazard(s) at sidewalk; monitor / repair as necessary. 2. There is a low area of pavers at the front entry.
Page 40 Item: 3	Vegetation Observations	• Prune or remove any plants that are in contact or proximity to home to eliminate pathways of wood destroying insects. 2. The sod at the front yard needs to be replaced.
Page 40 Item: 4	Gate Condition	• Gate is sagging - hinges appear to be corroded. 2. Some of the fence hardware is missing for appearance.
Pool		
Page 43 Item: 4	Filter	• Recommend pool contractor to evaluate. There is an accumulation of water at the filter on the pad possibly meaning there is a slight leak.
Page 44 Item: 6	Pool Heater Condition	• There is a pool heater that needs to be evaluated by a qualified tech during the pool service.
Page 45 Item: 13	Timer	• The salt system is not operating properly as stated and needs further evaluation / repair.

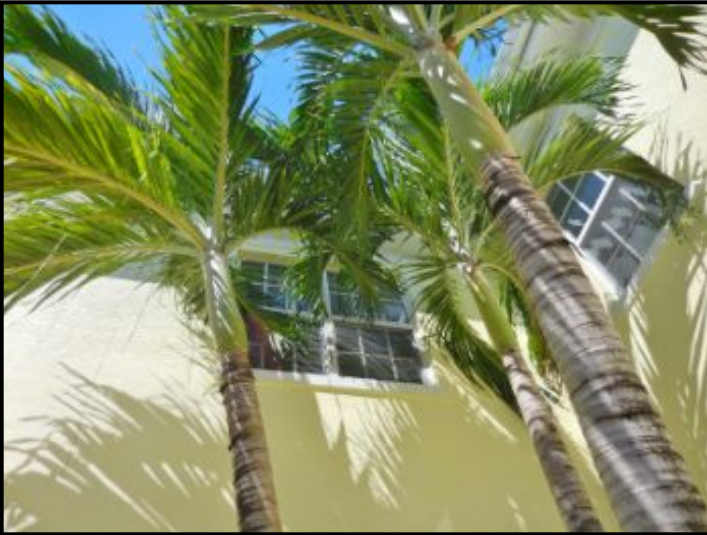
- Prune or remove any plants that are in contact or proximity to home to eliminate pathways of wood destroying insects. 2. The sod at the front yard needs to be replaced.

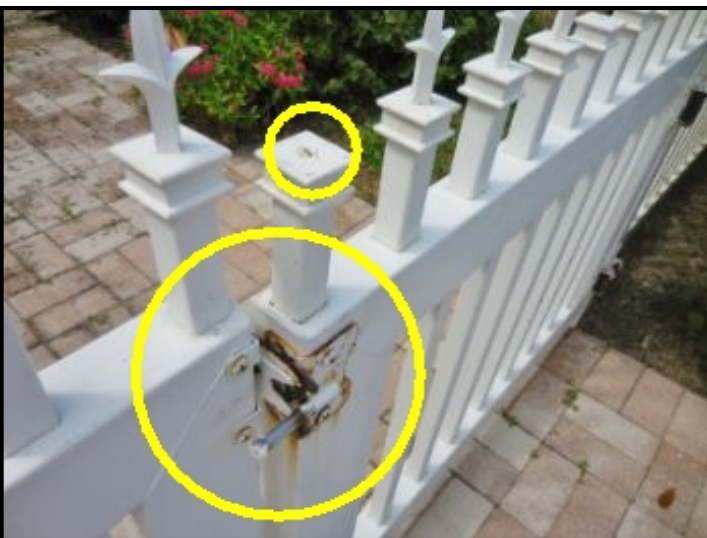
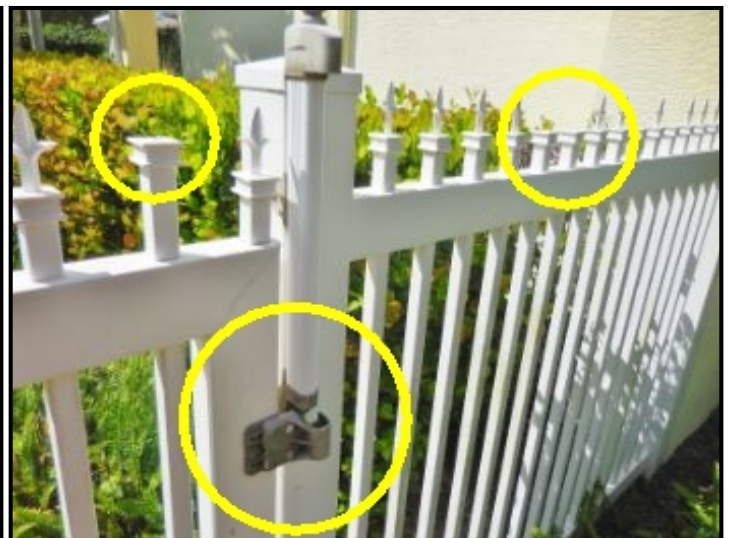
### 4. Gate Condition

- Fences and gates are NOT INCLUDED as part of a home inspection. Recommend confirming that all fences and gates are in serviceable condition before the close of escrow.
- Gate is sagging - hinges appear to be corroded. 2. Some of the fence hardware is missing for appearance.

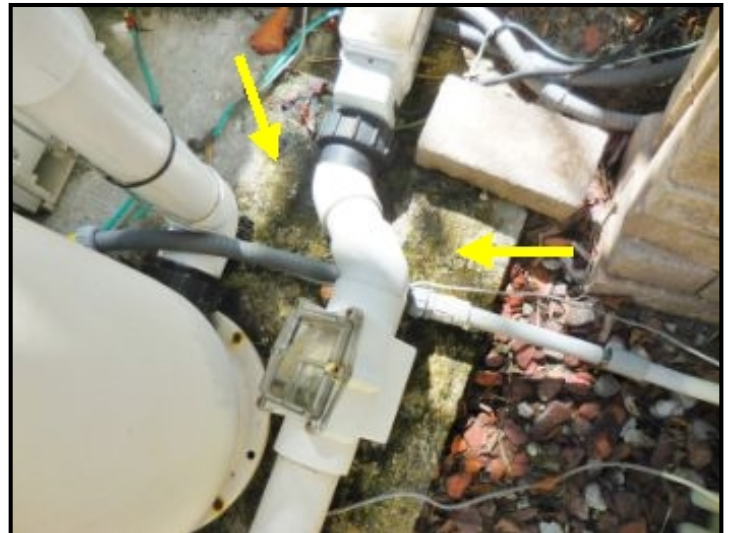
- Recommend pool contractor to evaluate. There is an accumulation of water at the filter on the pad possibly meaning there is a slight leak.

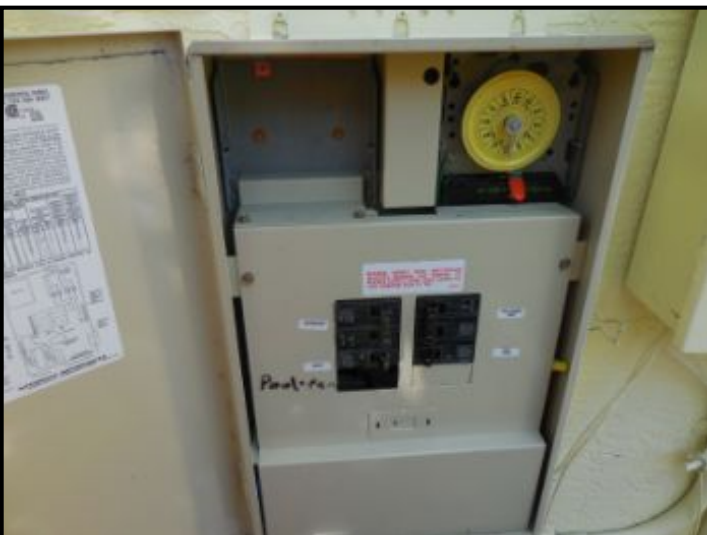
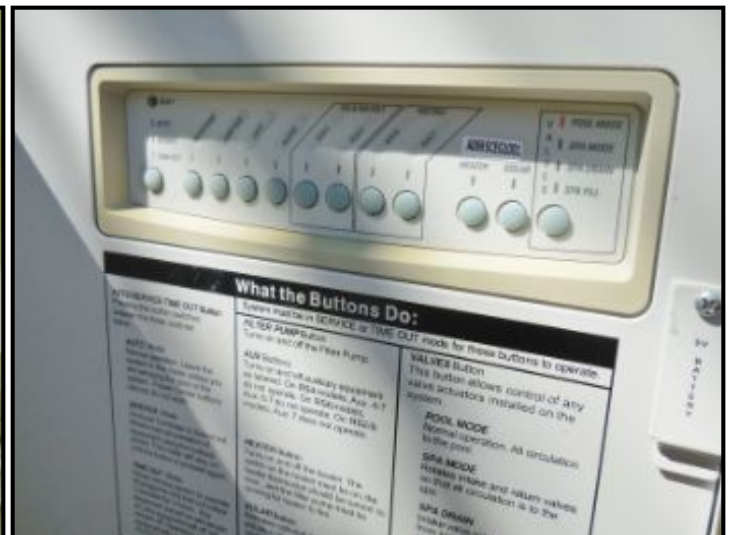
• The salt system is not operating properly as stated and needs further evaluation / repair.

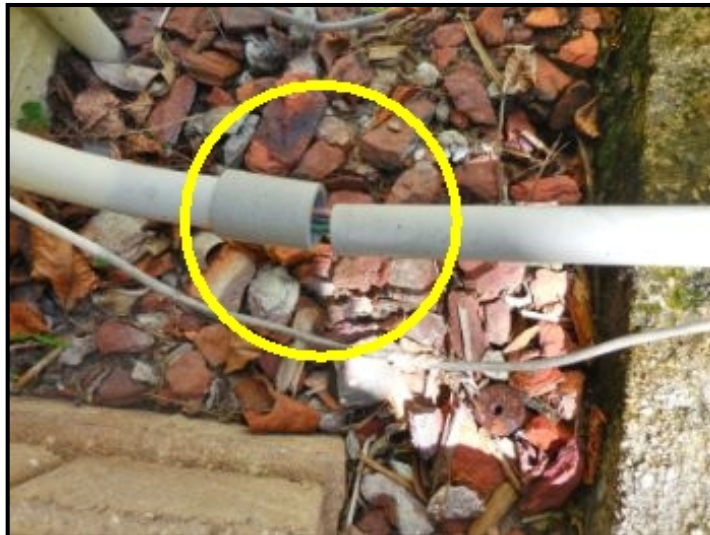
- There are wires loose / pulled at the conduit connection. This is a potential shock hazard.

Page 46 Item: 16	Electrical	• There are wires loose / pulled at the conduit connection. This is a potential shock hazard.
