## Inspection Report

**Property Address:**  
**555 Main St**  
**Unit A**  
**Charleston SC 29412**

## Gravity Home Inspections LLC

<b>Date:</b> 11/30/2016	<b>Time:</b> 10:00 AM	<b>Report ID:</b> 113016KF1
<b>Property:</b> 555 Main St Unit A Charleston SC 29412	<b>Customer:</b> Mike Smith	<b>Real Estate Professional:</b>

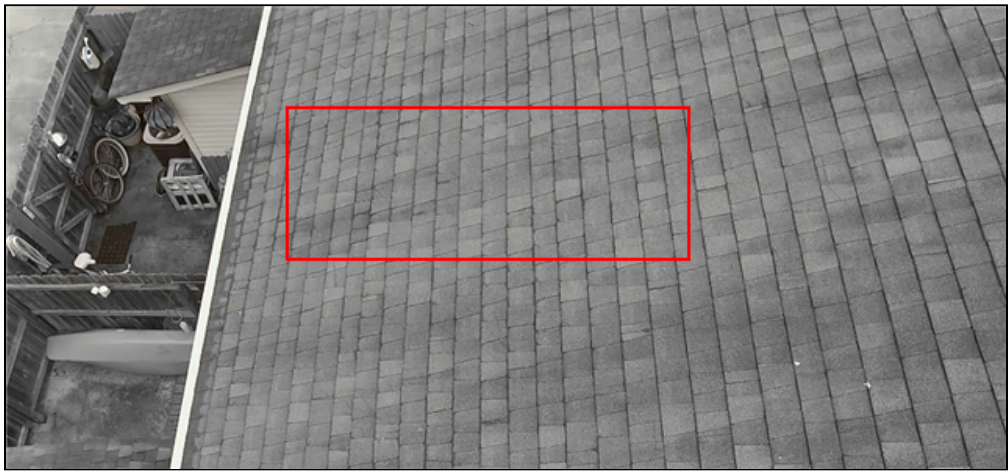
1.0 Item 1(Picture)

Roof is in average condition for it's age. There are some noticeable spots of wear/discoloration on some shingles as well as some cracking and granular loss which is normal. There was previous water rot found in the attic area, but all areas were very dry during the inspection which leads me to believe they existed before these shingles were installed. No other problems noticed. .

Roof is in average condition for it's age. There are some noticeable spots of wear/discoloration on some shingles as well as some cracking and granular loss which is normal. There was previous water rot found in the attic area, but all areas were very dry during the inspection which leads me to believe they existed before these shingles were installed. No other problems noticed. .

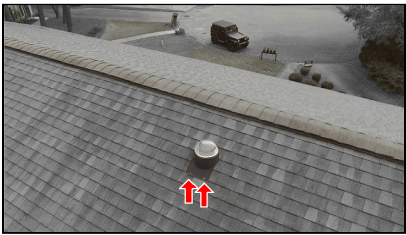
1.1 Item 1(Picture)

Flashings were in good condition. As a general maintenance tip, you should recaulk all exposed nails or other roof penetrations yearly to prevent moisture intrusion.

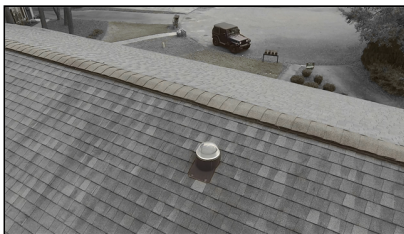
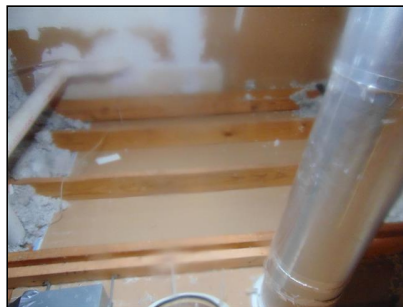
1.2 Item 1(Picture)

🏠 Skylight installed in attic over upstairs bathroom but is not connected to anything. The piping is there but was never completely installed. It does light up the attic nicely though.

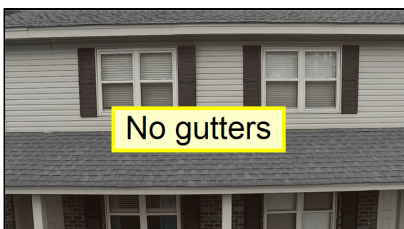
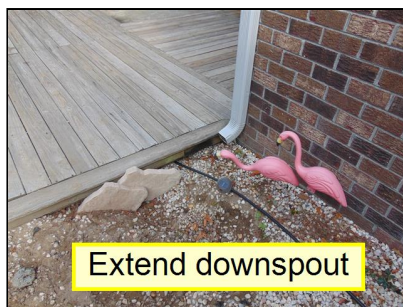
1.3 Item 1(Picture)

🏠 Recommend installing gutters over the front of the house as well as the rear laundry room area. The downspout on the rear gutters should be extended to drain water at least 6 feet from the foundation. This will prevent washout, erosion, and deterioration of the foundation.

Recommend installing gutters over the front of the house as well as the rear laundry room area. The downspout on the rear gutters should be extended to drain water at least 6 feet from the foundation. This will prevent washout, erosion, and deterioration of the foundation.

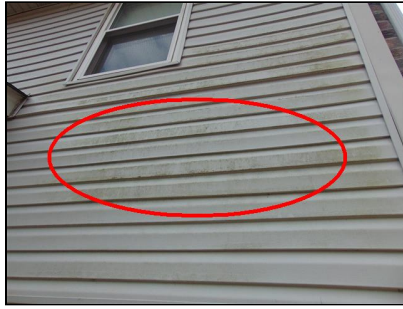
2.0 Item 1(Picture)

🏠 (1) Exterior siding shows signs of microbial growth. This should be cleaned/powerwashed to prevent damage to the siding and extend its service life.

(1) Exterior siding shows signs of microbial growth. This should be cleaned/powerwashed to prevent damage to the siding and extend its service life.

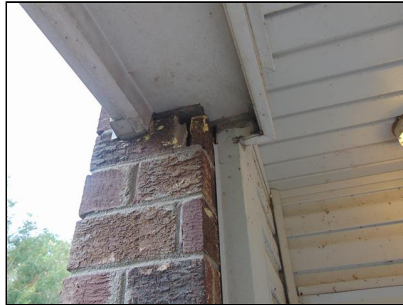
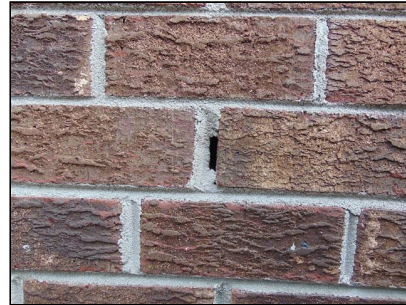
2.0 Item 2(Picture)

🏠 (2) Loose brick at left of front door at entry provides access for water and critter intrusion. There are also holes in the brick mortar in a few spots around the house. Recommend repairing these as well for the same reasons.

(2) Loose brick at left of front door at entry provides access for water and critter intrusion. There are also holes in the brick mortar in a few spots around the house. Recommend repairing these as well for the same reasons.

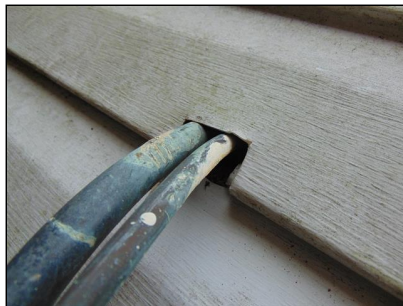
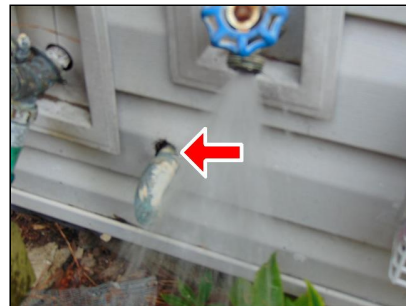
2.0 Item 4(Picture)

🏠 (3) Holes in the siding should be sealed with caulk to prevent water/pests from getting between the siding and the structural components of the home where they may cause damage and shorten the life span of the siding/structure.

(3) Holes in the siding should be sealed with caulk to prevent water/pests from getting between the siding and the structural components of the home where they may cause damage and shorten the life span of the siding/structure.

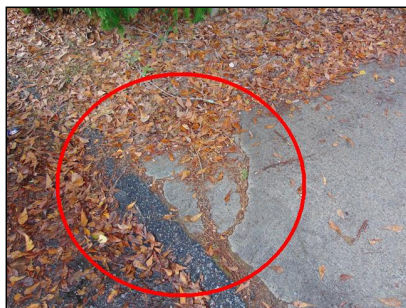
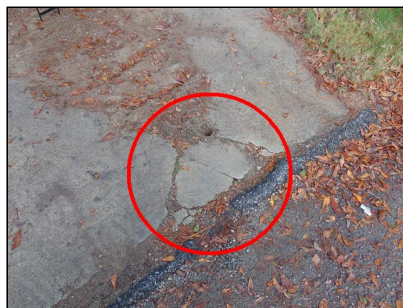
2.4 Item 1(Picture)

Driveway it cracked and sunken on both sides near the street. Water will pool here and continue to erode the driveway. This is also a trip hazard. Although the cracking is typical for its' age, I would recommend repair at some point to extend the life of the driveway.

Driveway it cracked and sunken on both sides near the street. Water will pool here and continue to erode the driveway. This is also a trip hazard. Although the cracking is typical for its' age, I would recommend repair at some point to extend the life of the driveway.

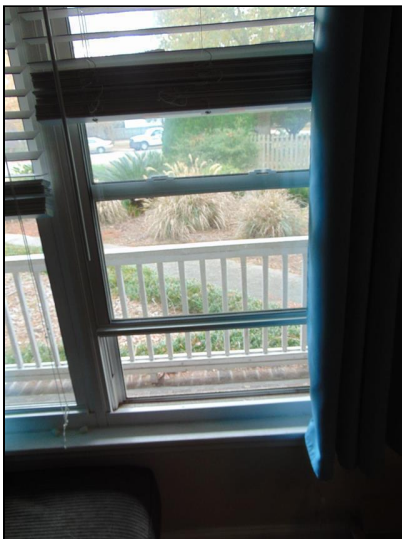
3.6 Item 1(Picture)

I could not check all windows due to owners belongings blocking access (beds). The window on the right side interior living room was hard to open and I couldn't get the tilt feature to work due to fear of breaking. Recommend adjustment.

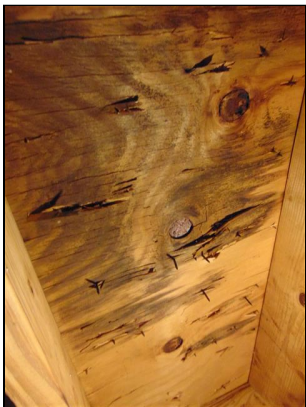
4.4 Item 1(Picture)

(1) Roof deck sheathing in attic does show signs of a prior roof leak, however, all areas checked were very dry at time of inspection. You will most likely have to replace a few of these areas during the next shingle

replacement. The insulation in the area also showed signs of clumping due to being wet previously. Again, everything was dry during my inspection.

(1) Roof deck sheathing in attic does show signs of a prior roof leak, however, all areas checked were very dry at time of inspection. You will most likely have to replace a few of these areas during the next shingle replacement. The insulation in the area also showed signs of clumping due to being wet previously. Again, everything was dry during my inspection.

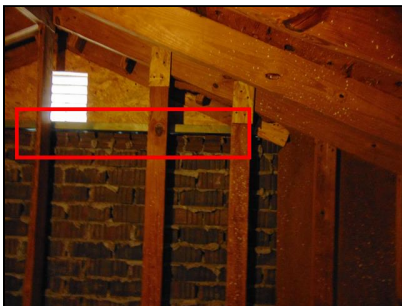
4.4 Item 2(Picture)

🏠 (2) Recommend caulking between the ledger board and first layer of brick as a preventative measure to prevent pest/water intrusion.

(2) Recommend caulking between the ledger board and first layer of brick as a preventative measure to prevent pest/water intrusion.

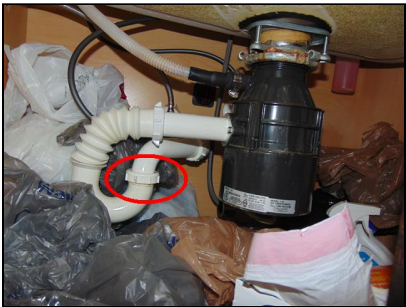
5.1 Item 1(Picture)

(1) Drain pipe from the disposal leaked during my inspection. The fitting was loose so I tightened it. I did not refill the sink and retest to verify. Recommend having it checked for leaks and/or replaced.

(1) Drain pipe from the disposal leaked during my inspection. The fitting was loose so I tightened it. I did not refill the sink and retest to verify. Recommend having it checked for leaks and/or replaced.

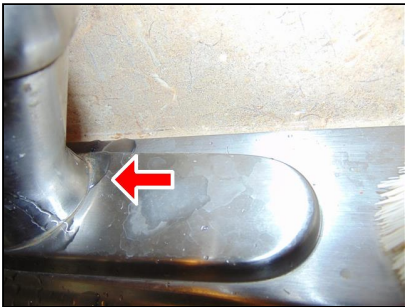
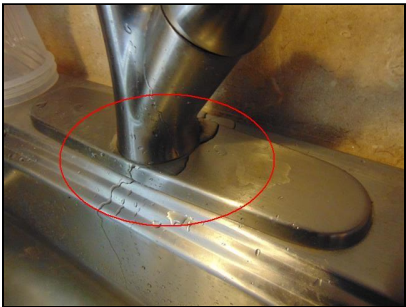
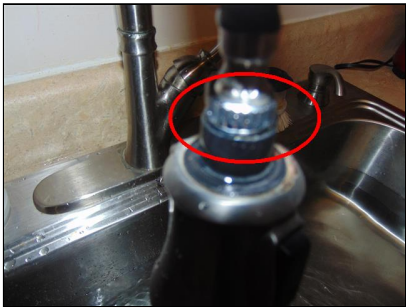
5.1 Item 2(Picture)

(2) Faucet for the kitchen sink leaks in several places. Recommend replacement.

(2) Faucet for the kitchen sink leaks in several places. Recommend replacement.

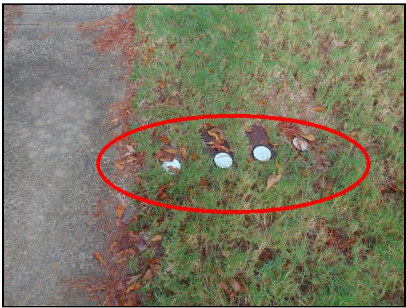
5.3 Item 1(Picture)

Front yard to right of walkway

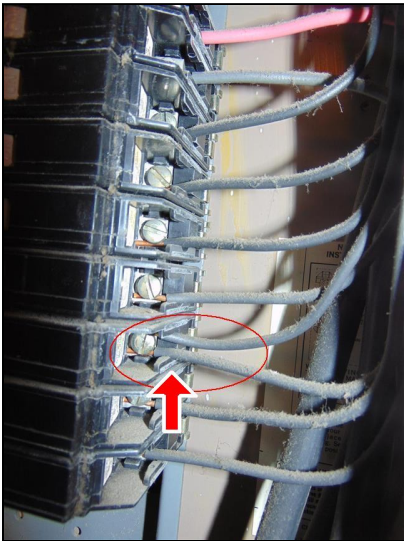
6.1 Item 1(Picture)

⚠ The electrical panel contains a double tapped breaker. This is when two wires connect to one breaker. The problem is that it can cause loose connections, arcing, and potentially a fire. Recommend having repaired by a licensed electrician.

The electrical panel contains a double tapped breaker. This is when two wires connect to one breaker. The problem is that it can cause loose connections, arcing, and potentially a fire. Recommend having repaired by a licensed electrician.

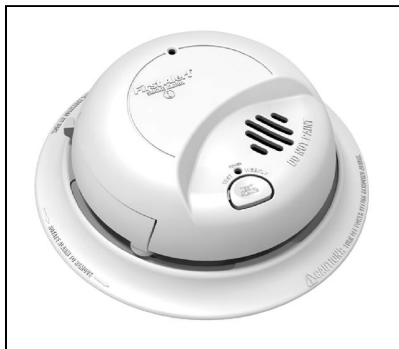
6.7 Item 1(Picture) Smoke Detector

Only one smoke detector was found in the home..

The National Fire Protection Association recommends homes should have smoke alarms installed inside every bedroom, outside each sleeping area and on every level of the home, including the basement. So that means a 2 story, 3 bedroom house needs a minimum of five smoke alarms.

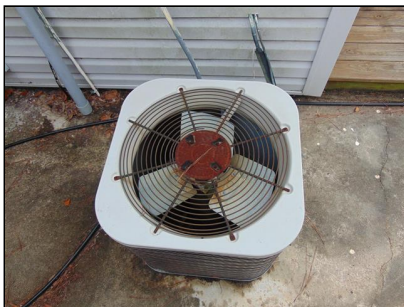
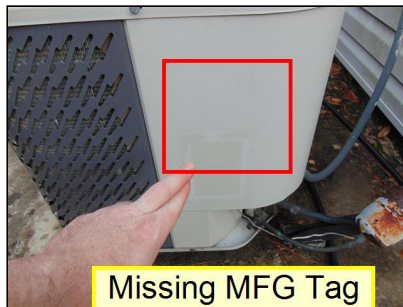
7.0 Item 1(Picture)

(1) HVAC heat pump (exterior unit) does not have a readable manufacturers tag. This provides information such as make/model, serial number, etc. I am unable to determine the age of this unit. While it did function properly during the inspection, the unit appears to be old.

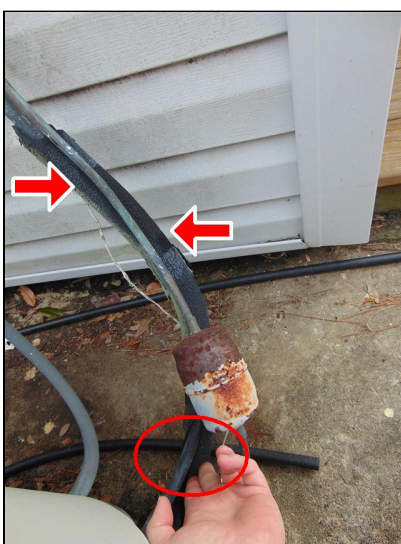
7.0 Item 3(Picture)

🏠 (2) Suction line insulation is deteriorated and should be replaced. This will help to reduce HVAC costs and extend the life of the system

(2) Suction line insulation is deteriorated and should be replaced. This will help to reduce HVAC costs and extend the life of the system

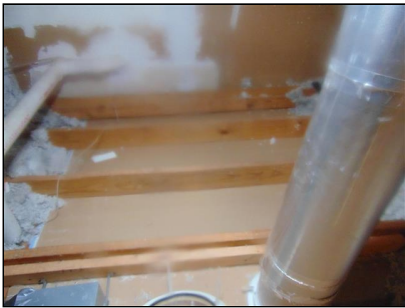
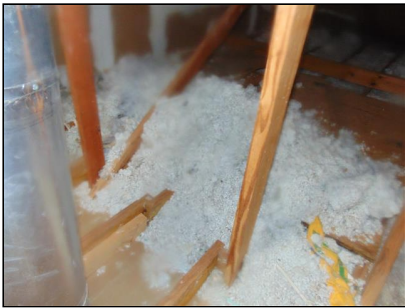
8.0 Item 1(Picture)

Insulation is missing/piled up in attic where skylight was being installed. Some spots have 4" of insulation and others, particularly near the soffits, barely have 2" of insulation. Recommend redistributing/adding insulation to reduce heating/cooling costs.

Insulation is missing/piled up in attic where skylight was being installed. Some spots have 4" of insulation and others, particularly near the soffits, barely have 2" of insulation. Recommend redistributing/adding insulation to reduce heating/cooling costs.

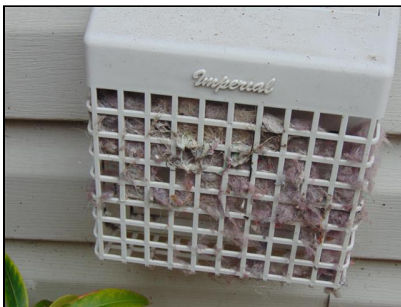
8.3 Item 1(Picture)

🏠 (1) Exterior dryer vent is full of lint. Recommend cleaning on a regular basis. Lint is highly flammable and could potentially cause a house fire. I would also recommend changing this "grate-type" exhaust port to a downspout with a flapper valve. This will allow lint to be expelled to the outside rather than getting trapped in the grate.

(1) Exterior dryer vent is full of lint. Recommend cleaning on a regular basis. Lint is highly flammable and could potentially cause a house fire. I would also recommend changing this "grate-type" exhaust port to a downspout with a flapper valve. This will allow lint to be expelled to the outside rather than getting trapped in the grate.

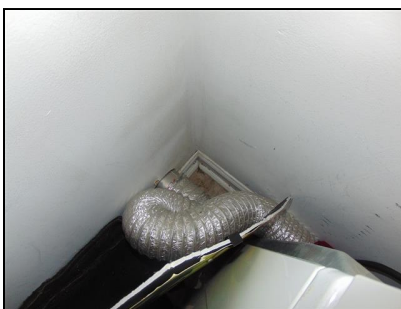
8.3 Item 2(Picture)

🚨 🏠 (2) Dryer vent is made of flexible metal and is coiled between the dryer and wall. This will reduce and inhibit the dryer exhaust, create possible lint blockages inside the pipe and potentially cause a fire. Vent should be straight without restrictions or bending as little as possible. Best practices would recommend a solid vent pipe made of sheet metal or galvanized steel constructed to replace the flexible metal..

(2) Dryer vent is made of flexible metal and is coiled between the dryer and wall. This will reduce and inhibit the dryer exhaust, create possible lint blockages inside the pipe and potentially cause a fire. Vent should be straight without restrictions or bending as little as possible. Best practices would recommend a solid vent pipe made of sheet metal or galvanized steel constructed to replace the flexible metal..
