Buckmaster Pond Natural Resource Inventory  
Westwood, Massachusetts

By Thomas Palmer  
Naturalist

For the Buckmaster Pond Association  
October, 2007

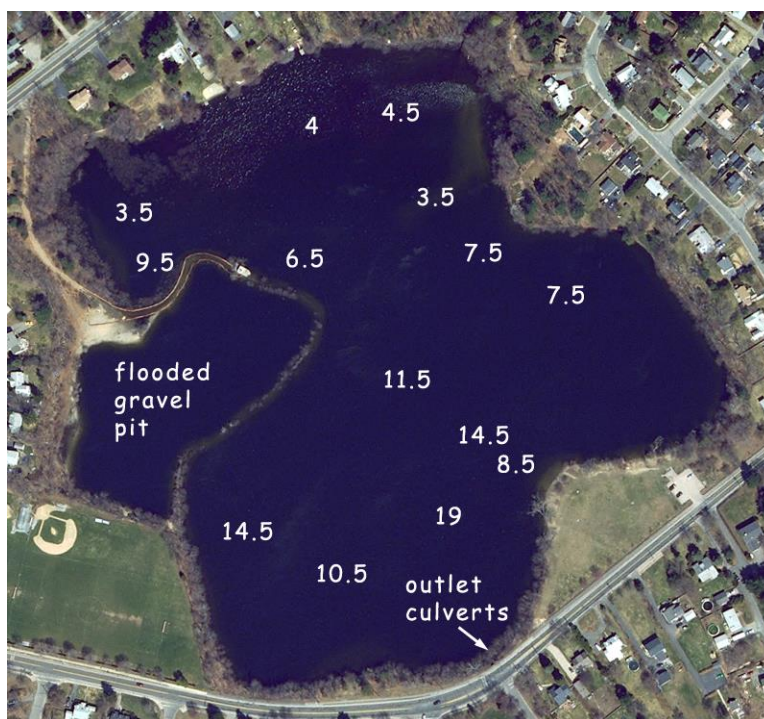
**Figure 1: Depths in feet below high water mark, 10/16/06  
Basemap: MassGIS April 2005 orthophoto**

Soundings taken by canoe on October 16 (fig. 1) suggest that Buckmaster has a maximum depth not much greater than 20 feet and an average depth of less than 10 feet.<sup>1</sup> Its northern third is shallow, mostly 5 feet or less, and supports extensive beds of water lilies, as well as 1-2 acres of shrubby buttonbush marsh.

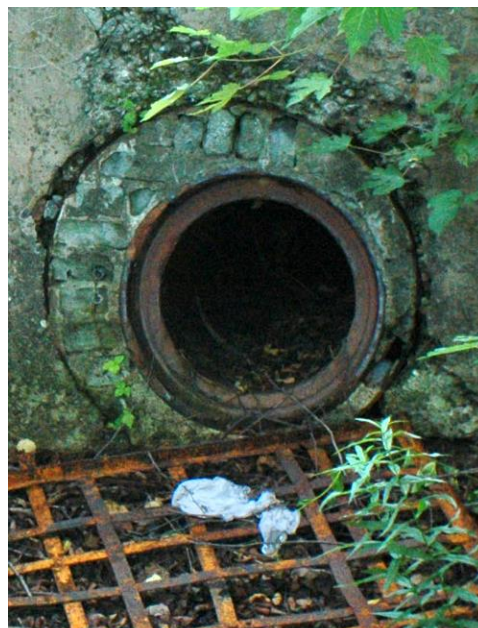
Figure 3: Westerly outfall 9/6/06

Although the mapping indicates that Buckmaster had a surface outlet flowing southeasterly from its south shore under Pond St. to Germany Brook as last as 1946, today no stream exits the pond, and high flows are discharged via a pair of twelve-inch outfall culverts set 15 feet apart in separate headwalls on the wooded bank opposite Arcadia St. The culverts are installed at the same height, with their upper edges about four inches below the high water mark. The westerly one is older and more deteriorated (Fig. 3). Both were high and dry from Sept. 6 onward.

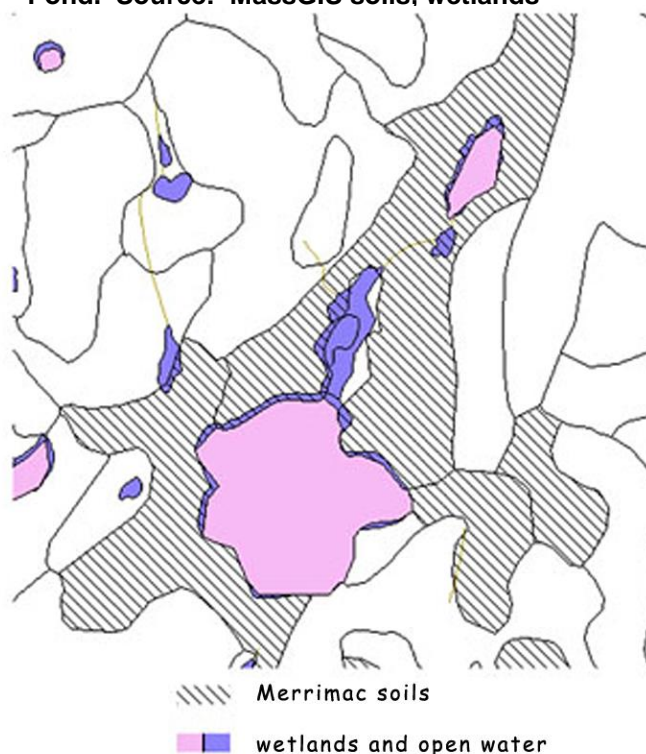
Figure 4: Sandy Merrimac soils near Buckmaster Pond. Source: MassGIS soils, wetlands

"The Merrimac series consists of a very deep, somewhat excessively drained soils on glacial outwash plains and glacial stream terraces" -- USDA, Soil Survey of Norfolk County (1984)

Fig. 4 illustrates the extent of deep sandy soils in the vicinity of Buckmaster. Ice-block ponds embedded in sand and gravel are known as kettles and occur

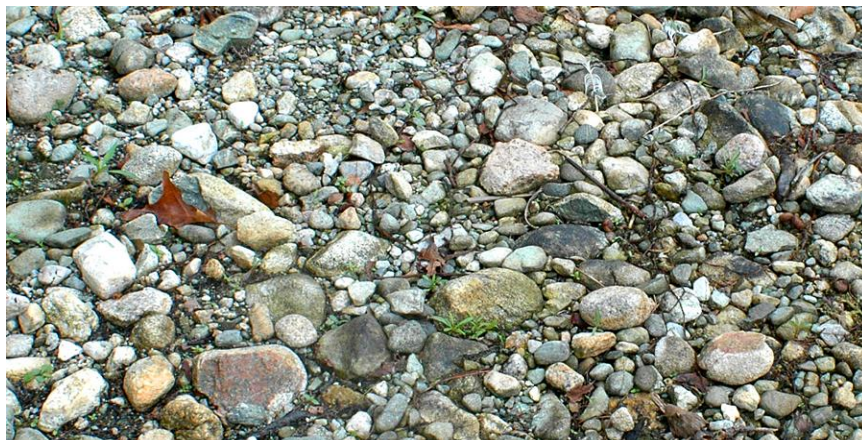
**Figure 5: rounded cobbles on south end east shore 9/6/06**

Further evidence of Buckmaster’s glacial origins is exposed along its north and east shores, where there are many beds of rounded stones, indicating that they were tumbled and smoothed in torrents that no longer exist (Fig. 5).

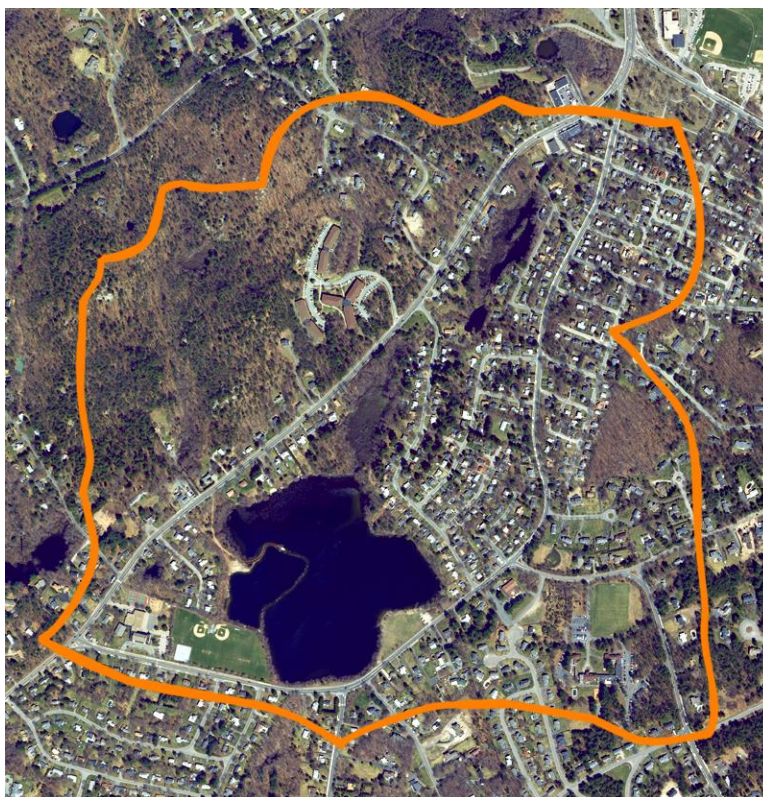
**Figure 8: Watershed associated with Buckmaster Pond. MassGIS sub-basin 19226 overlaid on April 2005 orthophoto**

Those authors also stated that Buckmaster's watershed "is mainly wood and pasture land, and contains a small population." This is no longer the case, as Fig. 8 demonstrates. There is no pasture remaining, and most of the woods have given way to suburban development. If Buckmaster's watershed is estimated at 300 acres, it contains at most about 100 undeveloped

acres, all woods and wetlands. There are 12 acres of wetlands exclusive of the pond proper, and the largest parcel of woods, about 60 acres, is centered north across Route 109 on the rugged cluster of bedrock knolls known as Satan's Kingdom.

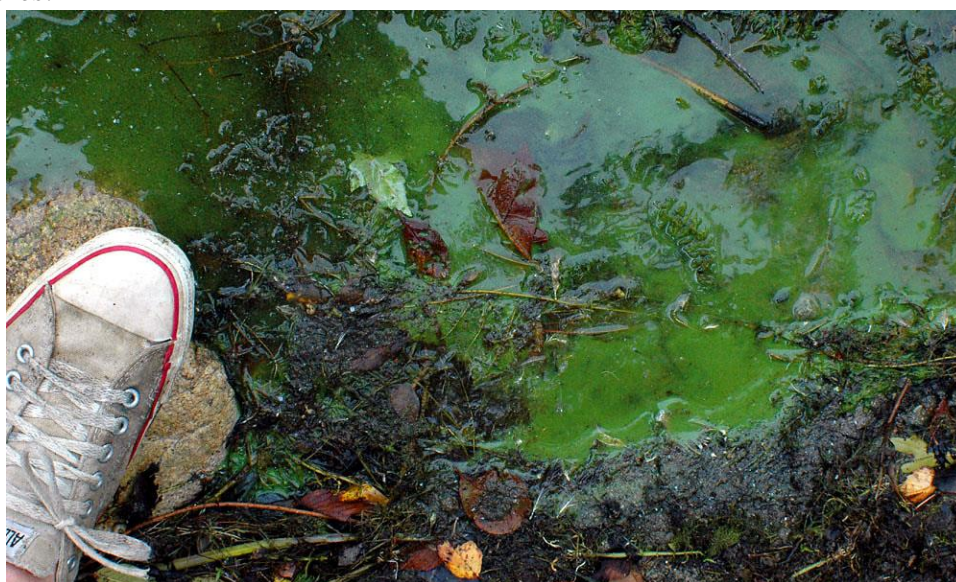
**Figure 10: Algal film on peaty sand near center of east shore 9/6/06**

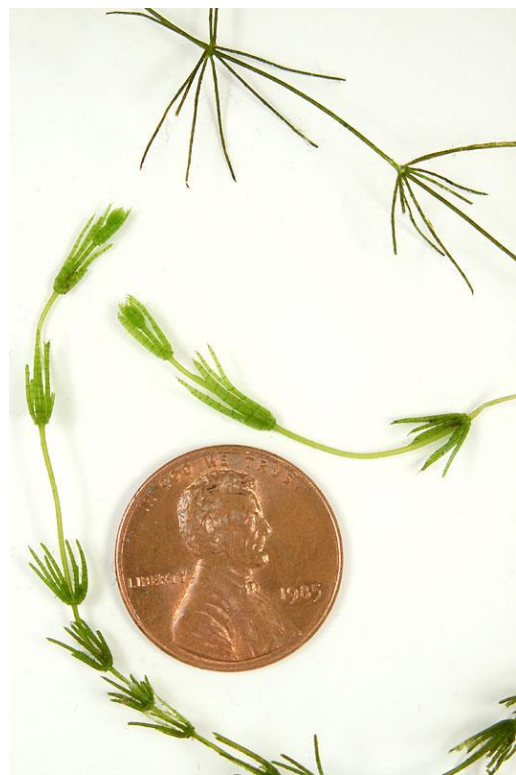
**Figure 11: Macroalga *Chara* sp. collected at 9 feet 10/16/06**

The greatest depth at which I observed plant growth was 9.5 feet (or 12 feet below the high water mark) near the middle of the pond, where rooted clumps of milfoil (*Myriophyllum heterophyllum*) rose several feet above the invisible bottom. Areas deeper than this may indeed be vegetated but were not sampled. In general, plants will grow as deep as light permits; the macroalga *Nitella*, for instance, which is present at Buckmaster, has been observed at 42 feet in Walden Pond.<sup>2</sup> Another deepwater macroalga, *Chara* (Fig. 11), was collected 9 feet below the surface in Buckmaster.

These plants typically form loose mats of prostrate stems up to several inches high on pond bottoms too dim for rooted plants, where they provide cover for fish and food for waterfowl. There are probably areas of Buckmaster where *Chara* and *Nitella* grow deeper than milfoil, and these may

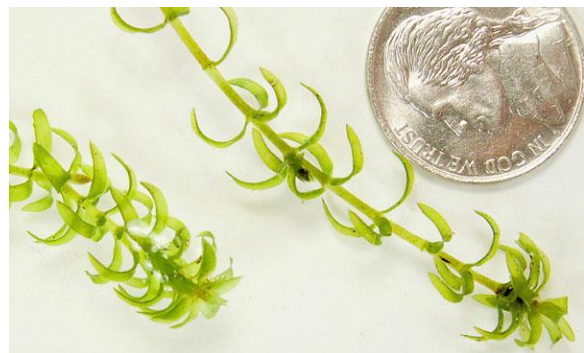
**Figure 12: Free-flowered waterweed (*Elodea nuttallii*) sampled 4.5 ft below high water mark, southeast shore 9/27/06**

Extensive meadows of these plants cover much of Buckmaster's firm bottom. The most typical association was a dense mat to several inches thick of free-flowered waterweed (*Elodea nuttallii*) partially shaded by many tall, bushy plumes of variable water milfoil (*Myriophyllum heterophyllum*). The milfoil plumes, although up to six feet high, topped out a foot or more below the surface and were usually well separated. In places the milfoil gave way to similarly open beds of grassleaf pondweed (*Potamogeton oakesianus*), also tall and erect but considerably less full, with dense tufts of short grasslike leaves dispersed along the stems.

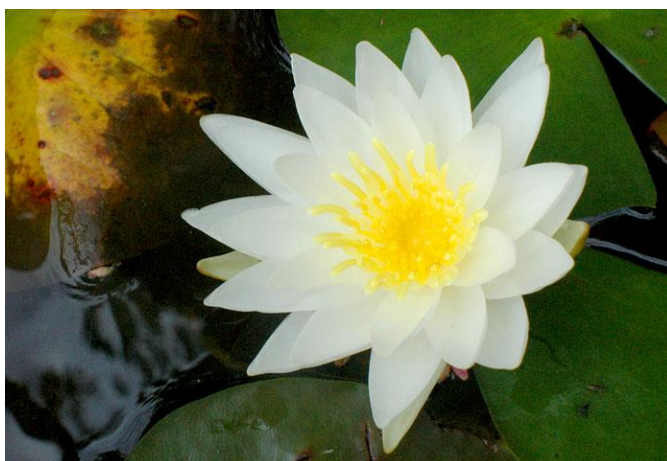
**Figure 14: White water lily (*Nymphaea odorata*)  
9/6/06**

These differences extend into the shallows 3 to 6 feet below the high water mark, which are flooded year-round in most years. In quiet areas with an inch or more of soft peat over the bottom, large colonies of floating-leaved perennials, primarily water lilies and spatterdock, cover fifty percent or more of the water surface by late summer, and exclude most other plants. These beds dominate the shallow northern third of the pond, and a large lilies-only patch has occupied part of the eastern cove as well. In contrast, where the peat thins out the lilies are less successful, and plants with mostly submersed leaves take over, including the widely distributed milfoil and *Elodea* but also a few shallow-water specialists like pickerelweed (*Pontederia cordata*), floating bladderwort (*Utricularia radiata*), and snailseed and ribbonleaf pondweed (*Potamogeton diversifolius* and *P. epihydrus*).

Based on the density of growth, it's likely that these shallow beds are the most productive habitat in the pond. The lilies, in particular, flower profusely and attract many beetles and flies, while their leaves roof over a dim tangle of spongy stems where the slow work of decay supports another suite of invertebrates, which in turn provide food for fish and turtles.

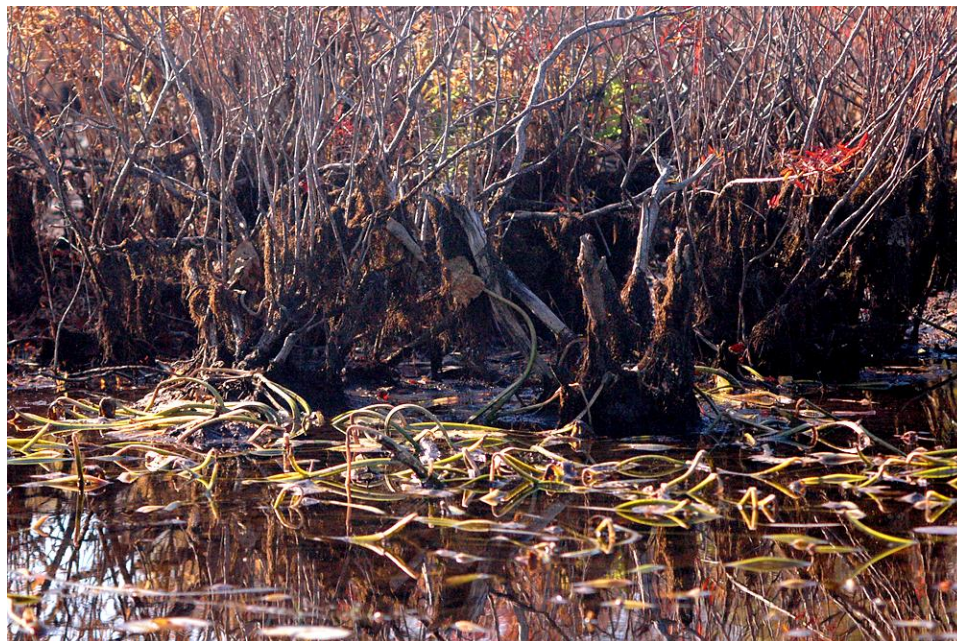
**Figure 15: Shrubby buttonbush (*Cephalanthus*, rear) and wilting spatterdock (*Nuphar*, foreground) with scattered stems red-orange loosestrife (*Lythrum*), 10/16/06. Water 30" below high water mark.**

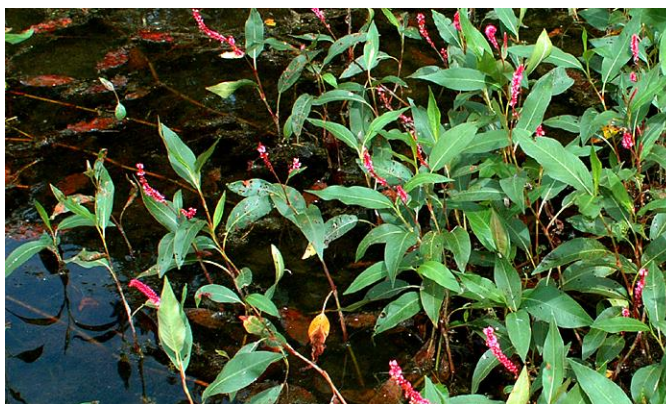
**Figure 16: Water Smartweed (*Polygonum amphibium*), 9/6/06**

But along most of the pond both the buttonbush and the loosestrife are limited to the upper portion of the littoral zone, and the interval that is exposed in late summer and fall is bare or dominated by perennial herbs. Amongst these, the showiest is water smartweed (*Polygonum amphibium*), a leggy, patch-forming native with large lanceolate leaves and long, deep-pink flower spikes that blooms while still inundated in August but is often exposed later (Fig. 16). Like the loosestrife and buttonbush, it prefers a peaty substrate and is most conspicuous along the north shore, where several large colonies paint a bright stripe above the waterline in early September, after the similarly-colored loosestrife has faded (Fig. 13).

Another uncommon native perennial herb that flourishes at Buckmaster is water smartweed, the showiest of several aquatic smartweeds that occur locally. It prefers shallow peat 3 to 6 feet below the high water mark, and often flowers while still partly submerged. A colonial plant, it spreads via freely branching rhizomes. In August and September the decumbent stems produce long erect terminal spikes of deep pink flowers (Fig. 16) that produce glossy lenticular seeds relished by waterfowl.

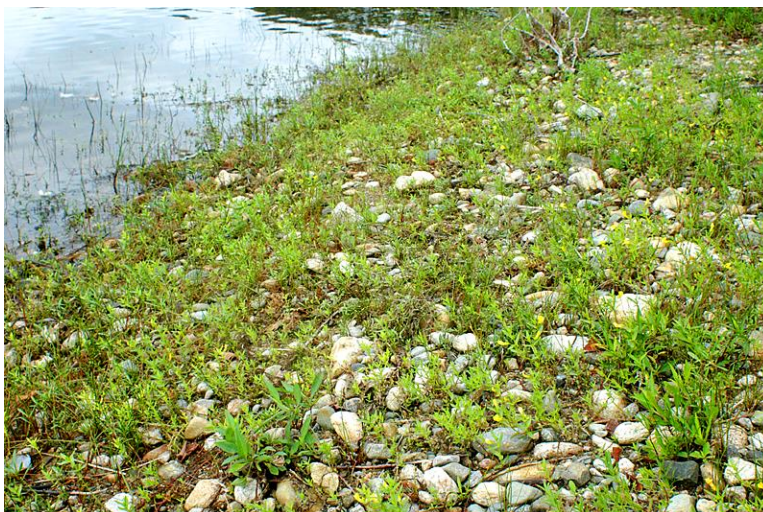
**Figure 17: Herbaceous cover on gravelly east shore about two feet below high water mark 9/6/06**

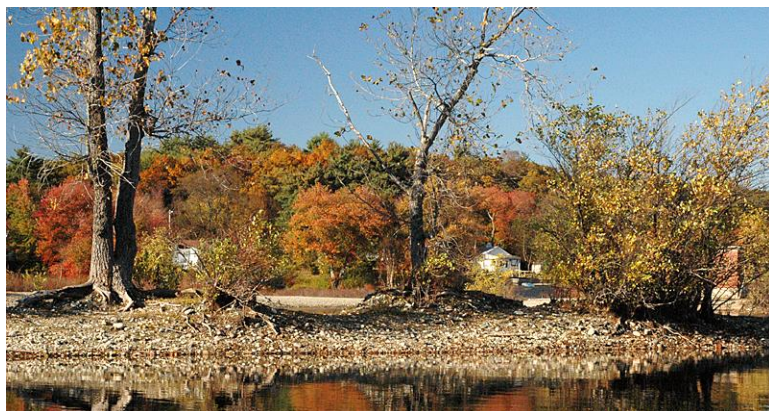
**Figure 19: Cottonwoods (left) and alder (right) atop eroding south end dike 10/16/06**

(*Asclepias incarnatum*), narrow-leaved loosestrife (*Lysimachia hybrida*), royal fern (*Osmunda regalis*), and others. Similarly, where the shore is particularly steep and exposed, as along much of the dike and the trampled area below the parking lot, ongoing erosion prevents any plant life from taking hold except near the high water mark, where scattered trees and shrubs cling tenaciously to whatever soil remains (Fig. 19).

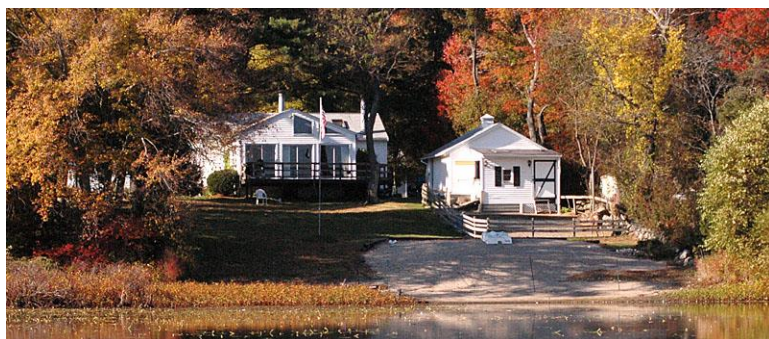
**Figure 20: Cleared shoreline at 1194 High St. 10/16/06**

vegetation has been entirely eliminated from about 75 ft of pondshore via placement of beach sand (Fig. 20).

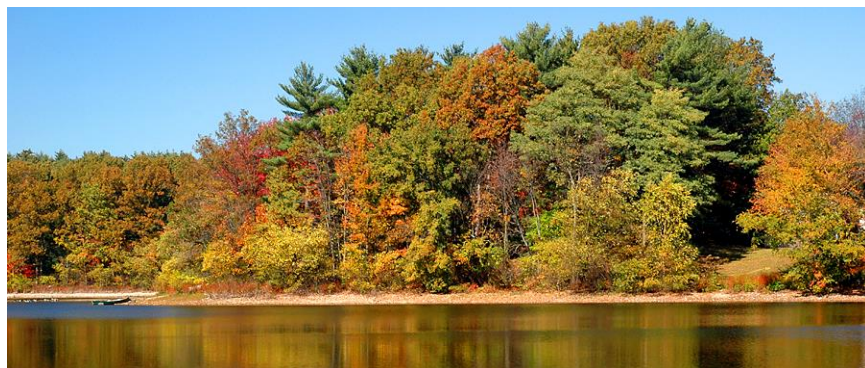
**Figure 21: Cobble-fringed knoll, north side east bank, 10/16/06**

The wooded fringe is dominated by mature native forest trees that appear to have seeded naturally, and include oaks, white and pitch pines, and black cherry. A particularly fine group of oaks and pines occurs on an elevated knoll at the north end of the east shore,

including portions of 111, 117, and 121 Lakeshore Drive (Figure 21). The fringe also expands significantly into a two-acre woodland on the east end of the north shore at 1142, 1148, 1154, and 1160 High St., where the houses and lawns are at the street edge

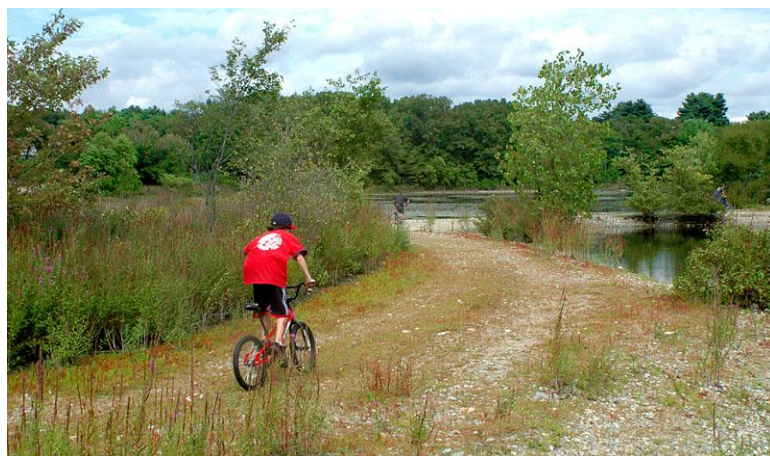
**Figure 22: Gravel road approaching north end dike, 9/6/06**

but the undeveloped back portions of the lots extend as much as 300 feet to the pond. Another two-acre woodland, this one much younger and scrubbier, occurs on an undeveloped lot fronting High St. at the pond's northwest corner, and is crossed by a gravel road leading from the street to the dike and the pumphouse. The south end of this mosaic of thickets and small openings is recent fill associated with the gravel pit, and is mostly too dry and sterile to support trees (Figure 22). The sunny, well-drained fill provides excellent nesting habitat for aquatic turtles, and a snapper hatchling was found here on September 9.

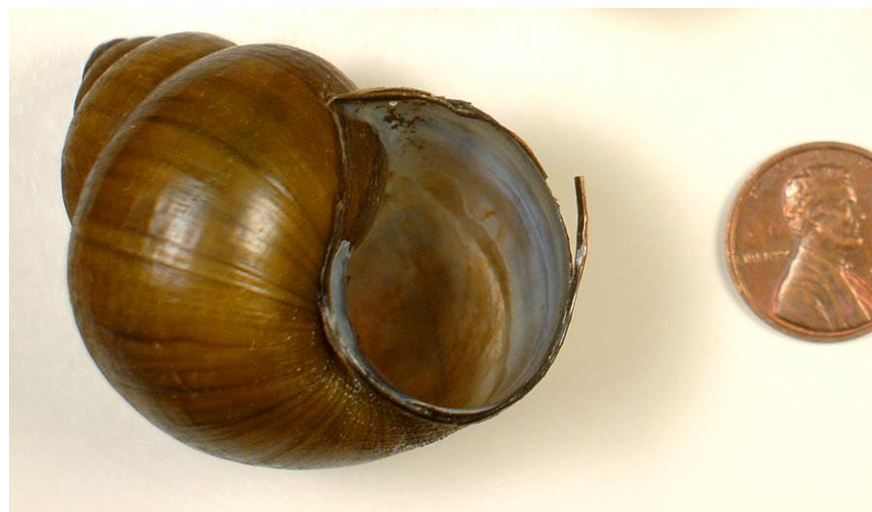
**Figure 23: Chinese Mystery Snail, *Cipangopaludina chinensis***

The snail is an exotic from east Asia, the Chinese mystery snail (*Cipangopaludina chinensis*). A livebearer, it was first recorded in Massachusetts in 1914, and is "established in scattered localities throughout eastern, central, and west central MA and is typically found in disturbed or artificially created lentic environments in urban areas" (Smith, 1995). Pond snails

feed by scraping algae from hard surfaces with their rasp-like tongues, and Buckmaster's gravel bottoms provides many such surfaces. It may be that flocks of grazing snails prevent algae from obscuring some of Buckmaster's stony shallows. It's likely that fish, birds, and turtles prey on the snails, thereby incorporating them in the pond's food chain.

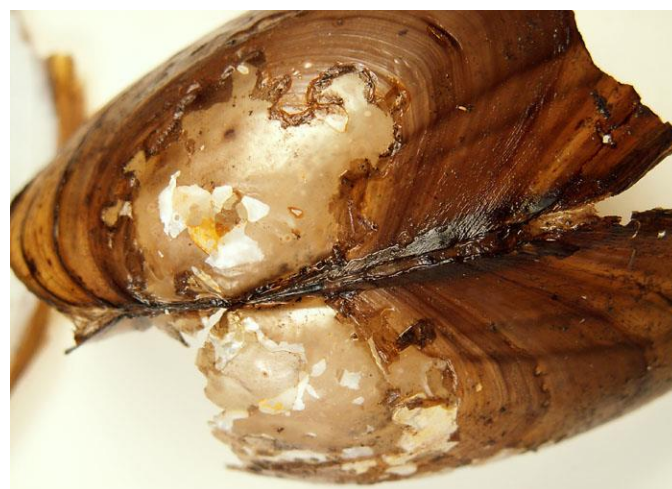
**Figure 24: Eastern Floater, *Pyganodon cataracta***

At least two freshwater mussels also inhabit Buckmaster, the eastern elliptio (*Elliptio complanata*) and the eastern floater (*Pyganodon cataracta*). Like saltwater clams, they lodge themselves head-down in the bottom and feed by filtering small organisms and other organic matter out of the ambient water. They are eaten by raccoons and the cleaned shells occurring along the shoreline may result from such meals. The elliptio occurs in many ponds and streams in the Neponset watershed; the floater is reportedly widespread also. The large populations of these native mussels at Buckmaster may play an important role in maintaining water clarity.

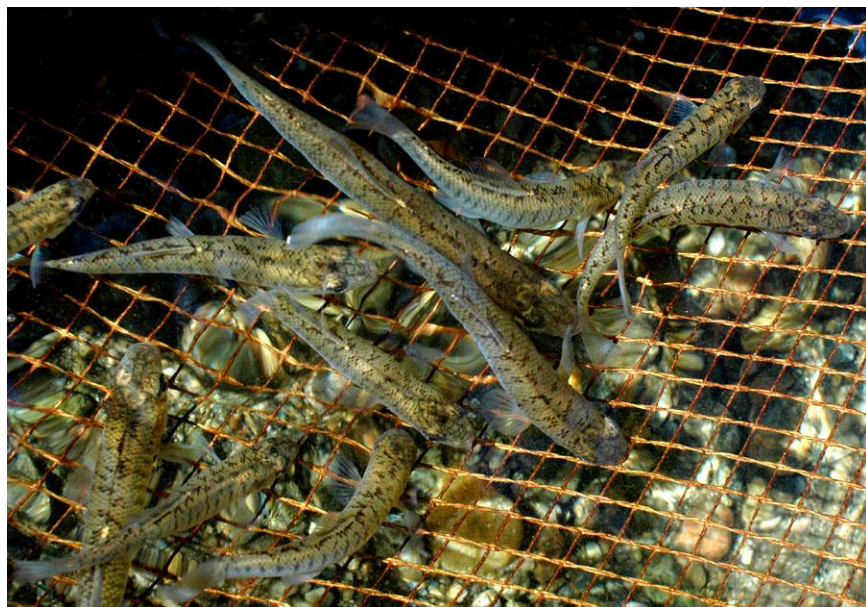
**Fig. 25: Banded Killfish (*Fundulus diaphanus*) in seine 9/27/06**

Juvenile bluegills (*Lepomis macrochirus*) and adult banded killifish (*Fundulus diaphanus*) dominated the seine hauls. The killifish could be seen schooling over open shallows; the bluegills also seemed to form age-specific groups but hung back near vegetated areas and moved less. Adult bluegills easily avoided the net.

All six fish species observed are frequent inhabitants of local fresh waters, but the killifish is somewhat less so, and has not previously been documented in the Neponset watershed (Hartel, 2002). Like its close salt water relative the mummichaug (*Fundulus heteroclitis*), its sides are vertically banded in black, but it is a bit narrower and sleeker.

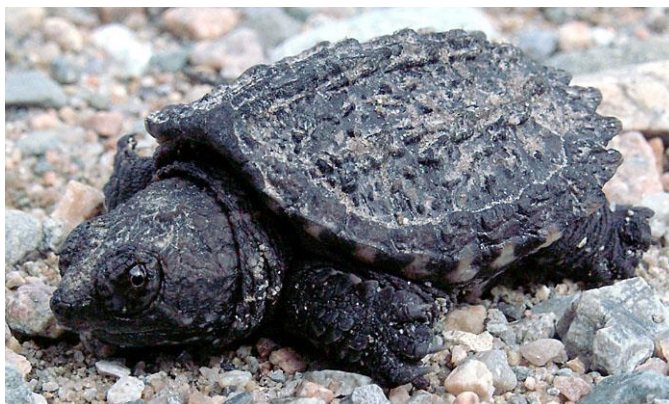
**Fig. 26: Snapping turtle (*Chelydra serpentina*) hatchling 9/6/06**

dwellers with the exception of the pickerel frog (*Rana palustris*), adults of which require moist grassy or shrubby thickets for foraging, and hence don't occur along manicured shorelines; at Buckmaster they exploit the less-developed east bank. Painted turtles (*Chrysemys picta*) are abundant, as is typical of ponds with extensive submerged vegetation; on September 6 at least a dozen adults and juveniles were sunning on exposed buttonbush root crowns near open water on the pond's north side. On that day a newly hatched snapping turtle (*Chelydra serpentina*) was found on the open gravel at the north end of the dike, still bearing the milky white egg tooth it used to open its shell.

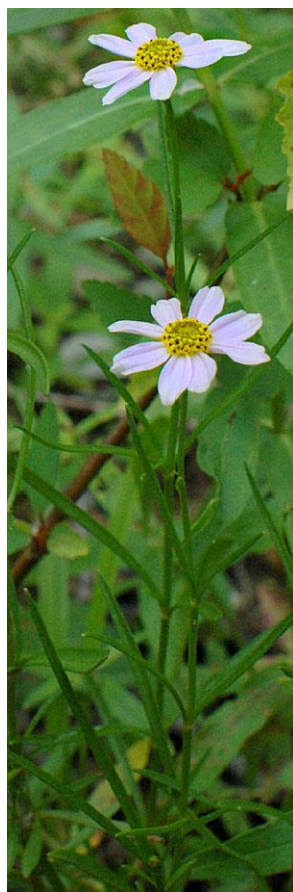
**Fig. 27: Pink Tickseed (*Coreopsis rosea*)**  
9/6/06

This pretty native wildflower, the ancestor of the pink coreopsis popular with gardeners, is a rare plant in the Neponset watershed due in part to its highly specific habitat requirements; it is found only in kettle ponds with sandy shorelines that are flooded in winter and bared in summer. The winter flooding prevents competing woody plants from establishing themselves, and the summer dry-out excludes strictly aquatic plants and provides an opportunity for it to sprout and flower.

A patch-forming knee-high herb with narrow opposite leaves and pink daisy-like flowers with yellow centers, tickseed is abundant on the south end of Buckmaster's east shore, as well as on the south end of the dike and the west bank of the gravel pit. All of these areas are fringed near the high water mark with tall thickets of purple loosestrife; the tickseed occurs on the bare sand and gravels immediately downslope.

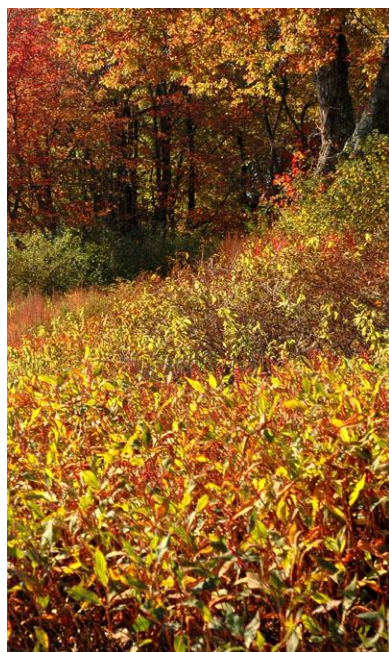
**Fig. 28: Water Smartweed (*Polygonum amphibium*) in foreground, 10/16/06**

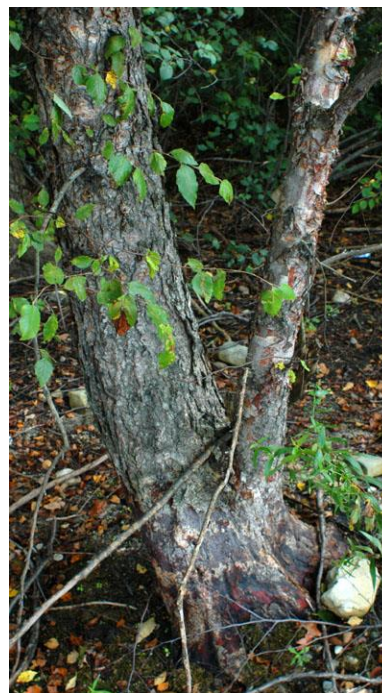
**Fig. 29: River Birch (*Betula nigra*) 9/6/06**

At many points along Buckmaster's shore, the tree that grows closest to the water's edge is a tall, often multi-trunked birch with peeling bark that is thin and salmon-colored on saplings but dark and rough on older trees. This is river birch, a Massachusetts native that is scarce in the wild but widely planted as an ornamental. Like cottonwood and silver maple, it prefers riverbanks, shorelines, and floodplains, and seldom if

There are dozens of river birches along Buckmaster's wooded shorelines, all growing in sands and gravels up to about eighteen inches below the high water mark. Reproduction occurs frequently, although seedlings are exposed to damage from waves and ice, and few survive more than a year or two. Because river birch occurs almost exclusively within the channel of larger streams elsewhere in Massachusetts, its presence at Buckmaster is a bit of a mystery. If the population originated with plantings performed long ago, it is now fully acclimated and self-sustaining. It may be that the pond's coarse gravel shores are particularly suited to a tree adapted to colonize similar substrates formed and deposited by fast-flowing water.

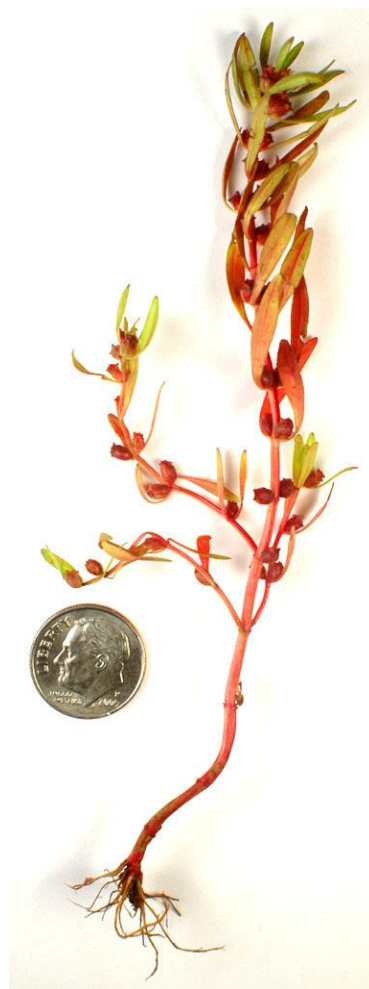
**Fig. 30: Annual Loosestrife (*Lythrum hyssopifolium*) 9/6/06**

Curiously, the pond also supports a close relative of purple loosestrife, *Lythrum hyssopifolium* or annual loosestrife, a much smaller plant no more than six inches high that is abundant on the sterile gravels of the north end of the dike just below the high water mark, and is very conspicuous in fall, when its stems, leaves, and fruits flush bright red. I haven't seen it anywhere but here, although it was noticed in the Blue Hills a century ago (Deane, 1896). Like its larger relative, annual loosestrife is also found in temperate Eurasia, and authorities differ on whether it is native to North America, some saying yea (Gleason and Cronquist, 1993) and some nay (Sorrie and Somers, 1999; USDA, 2007). In Massachusetts it has also been documented from Middlesex, Essex, Suffolk, Plymouth, and Barnstable counties. It is another indicator that Buckmaster, despite its robust suite of common plants, possesses a number of distinct features.

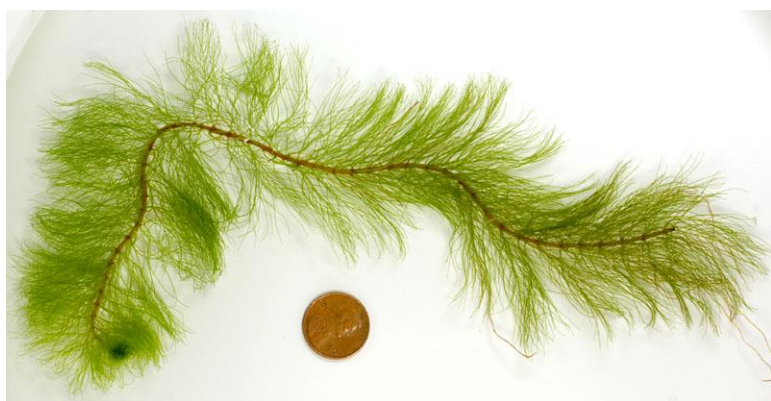
**Fig. 31: Variable-leaved Water Milfoil (*Myriophyllum heterophyllum* 9/6/06**

At Buckmaster it grows on hard bottoms throughout the pond from 4 to 12 feet below the high water mark and forms clumps of long, feathery erect stems bearing evenly-spaced whorls of pinnatisect leaves. In 2006 these stems rarely reached the surface and hence did not flower and

fruit. But milfoil does not depend on seeds for dispersal; any piece of the plant that breaks off and floats free can continue growing, and perhaps take root in a new location. This species is the most conspicuous and abundant submersed plant at Buckmaster, and formed the bulk of the wrack lines washed up here and there on the shore.
