Zinsco or GTE-Sylvania panels

Zinsco Panel Boxes Have 3 Reported Major Faults

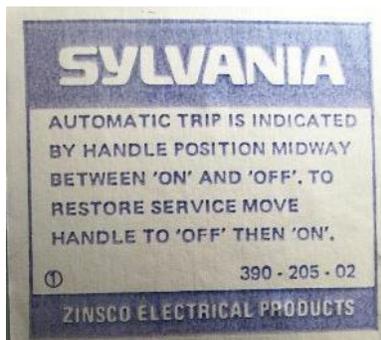
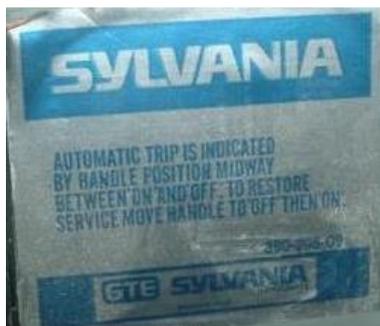
5/15/2003 - I was asked to look at this customer's home to give them an estimate to replace a Zinsco panel. The panel looked okay, but when I removed some of the breakers, I found signs of degradation on the buss. The breaker next to it also had started deteriorating. They had not failed yet or caused the customer any noticeable problems. I then tried to remove another breaker, and it would not come out. The breaker was welded onto the buss so bad that the buss started to come out with the breaker. I pushed the breaker and buss back into place and let the customer know that he had a serious problem that needed to be addressed as soon as possible.
