St Leonard's Church  
Newland

The Chapel of the Beauchamp Almshouses

*The restoration and re-instatement  
of the  
Clayton & Bell frescoes*

**Report written by C Raphael Brownlee**  
*Archivist*

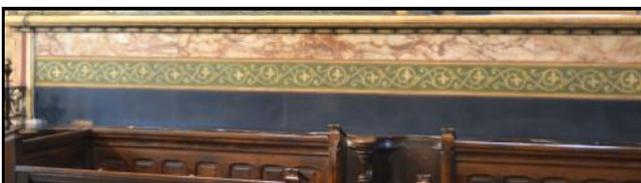
*The blue-green over painting which obliterated the designs under the decorative dado border and covered over the marble banding either side of the High Altar.*

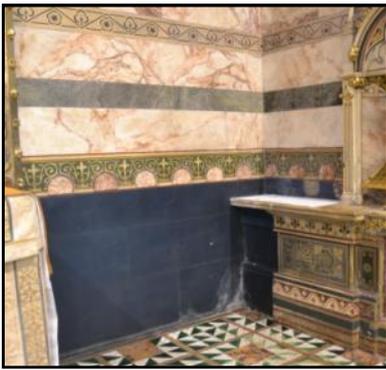
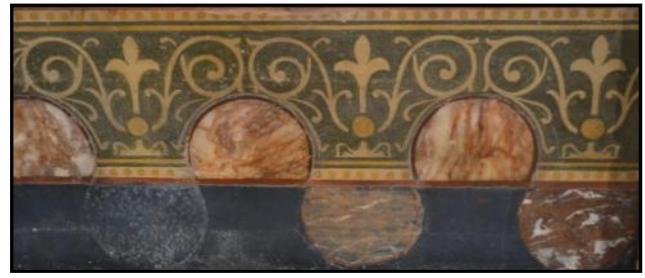
*The over painting of the marble sanctuary walls and the design of inlaid marble roundels. The outline can be seen beneath the overpainting and by the credence table the roundels have been at some point crudely uncovered but give a glimpse of how fine they once looked.*

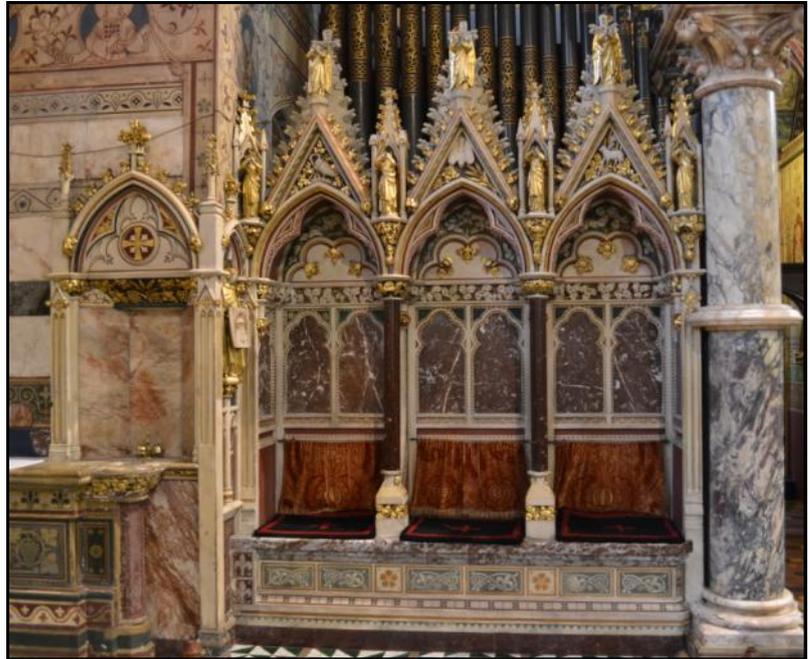
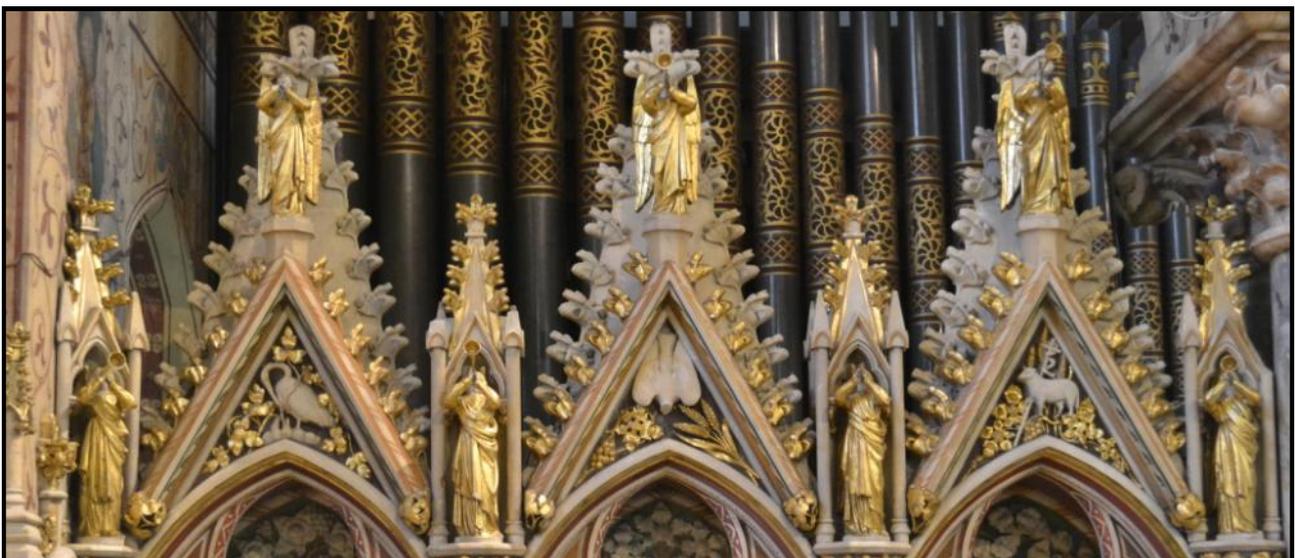
Over the years, various parts have become damaged, including pinnacles, trumpets and the doves head, all of which are safely stored in a box.

Overall the Sedilia is in good condition but there is a great amount of minor damage which requires painstaking restoration, particularly on the upper canopy.

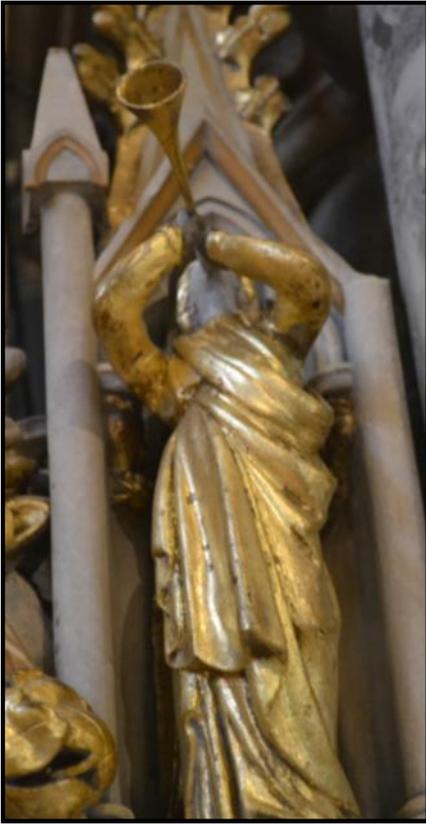
Missing columns and finials

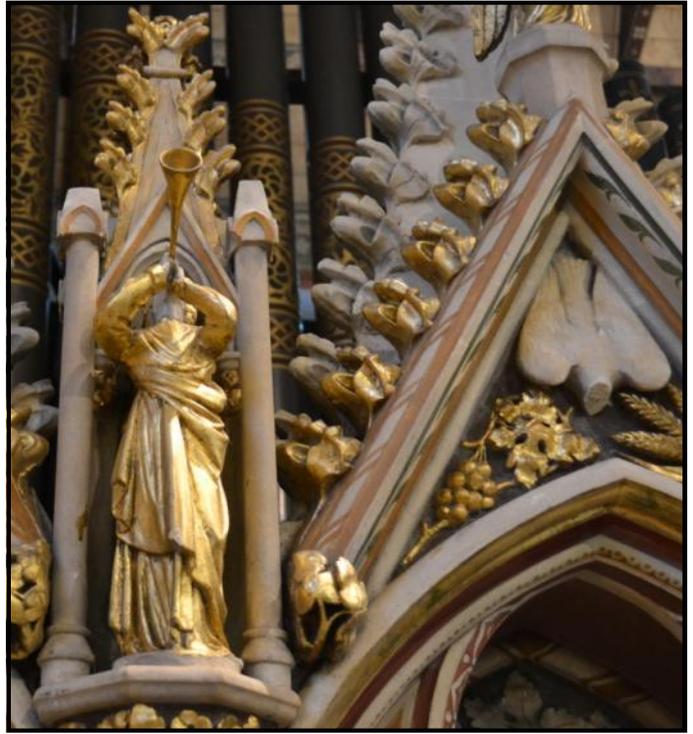
Missing finials and doves head

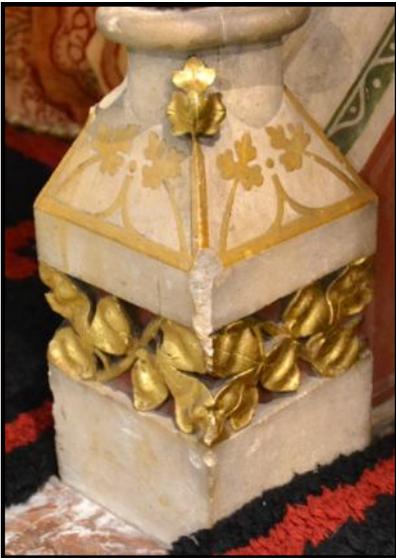
Missing numerous small parts of decoration

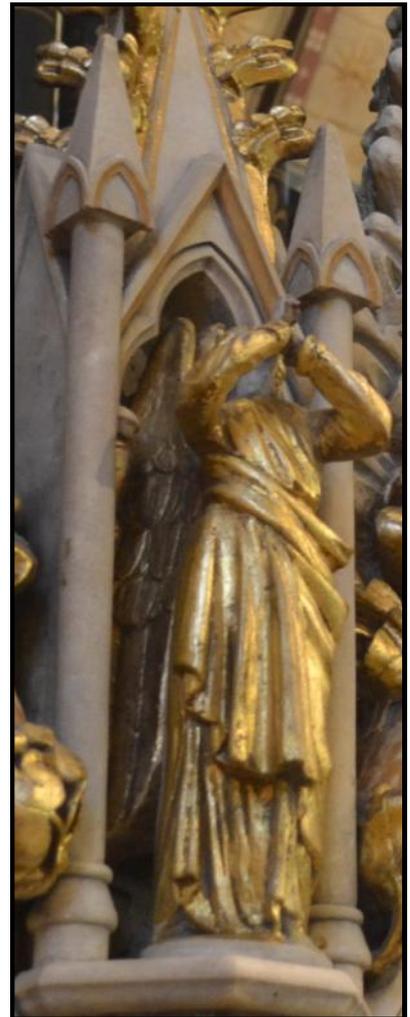
Missing trumpets

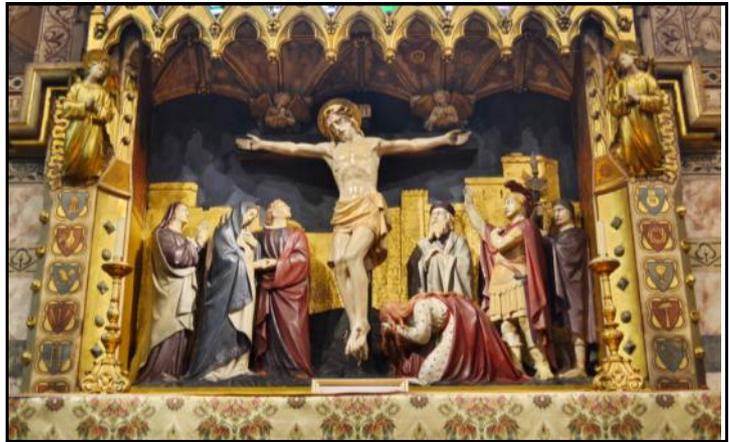
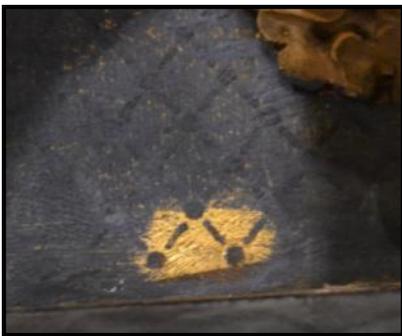
The Revd Bell, (no relation to Clayton & Bell) assisted by the then organist, decided that as a further part of his 're-brightening' of the chancel in 1928, the central part of the reredos now required their attentions. Fortunately, the canopy and passion emblems were spared the paint brush.

The appearance of the reredos was dramatically changed from something elegant and ethereal to something crude and ugly with the painting out of the original gold hatched background.

On the left can be seen part of the original gold background design with the outline of the pattern clearly showing through the blue overpainting.

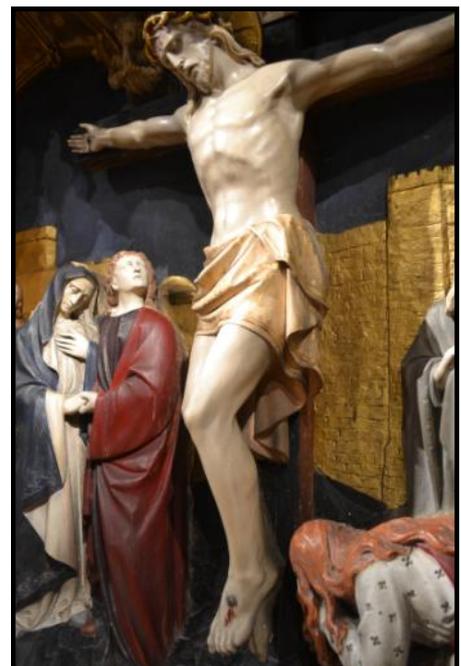
The figure of Christ is the only one to remain in original condition, showing the delicate colour and pattern of the loin cloth against the uncoloured stone.

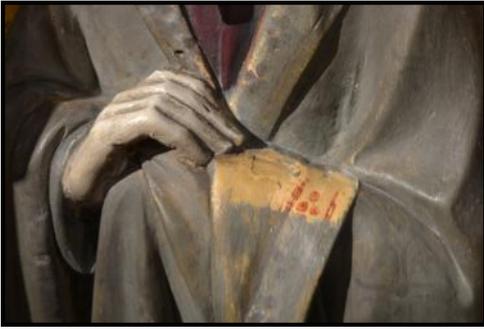
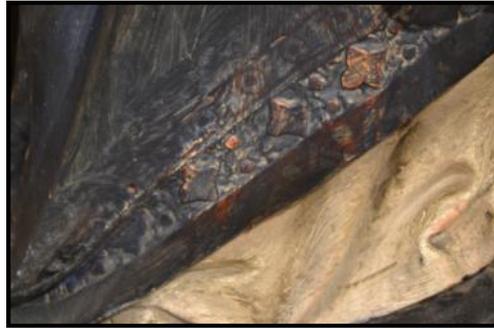
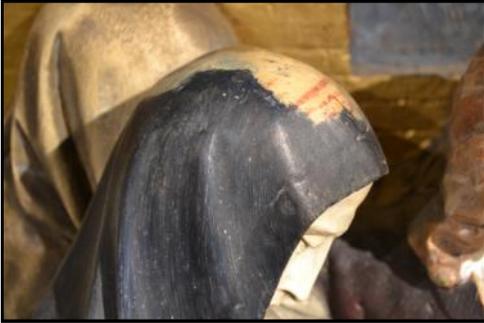
The heavy and crude painting of the figures is beginning to wear off in parts, revealing the original subtle colouring and design which you can see opposite.

You can also see above the intricate design on the hem of one of the robes which was painted out.

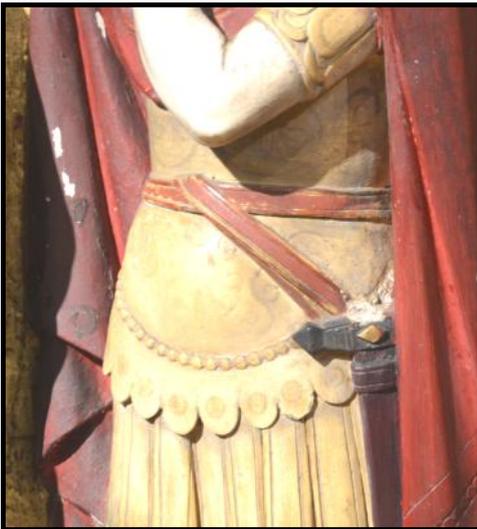
Handle of Centurions scabbard is missing.

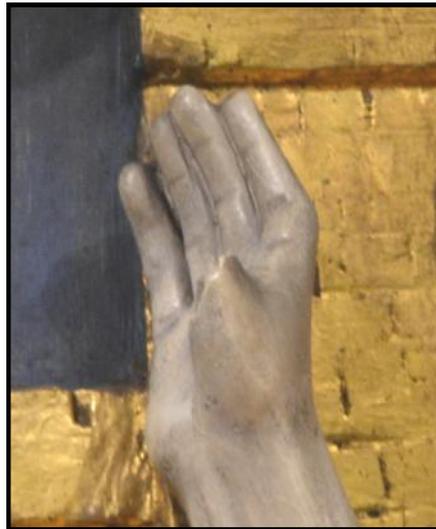
Thumb of Centurion is missing.

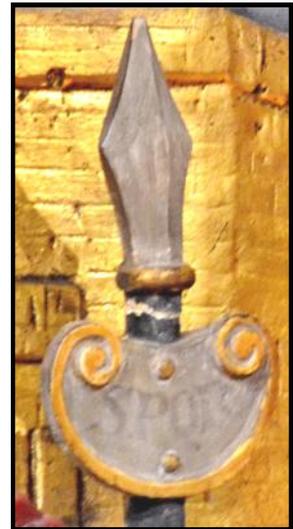
Top of the halberd is held in place with blu-tac.

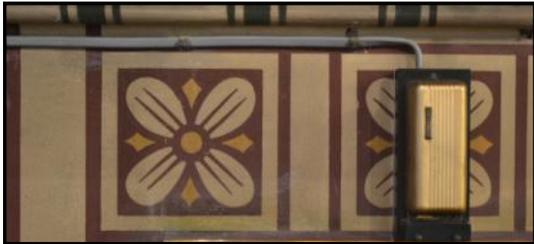
Defunct thermostat/wiring removed and damage repaired

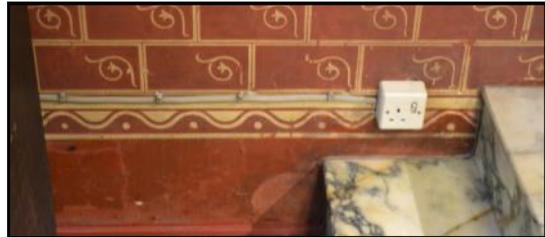
Electrical socket to be more discreetly located and damage repaired

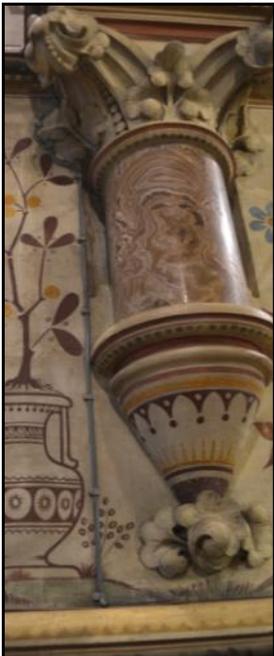
Defunct cabling removed; damage repaired

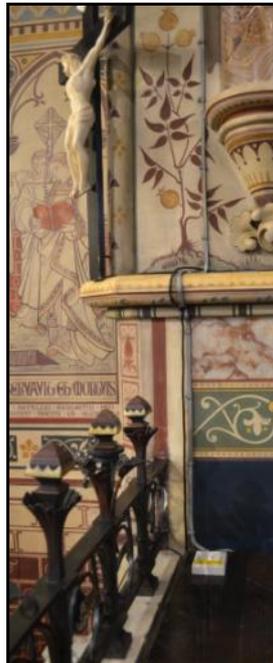
Defunct cable/switch removed; damage repaired

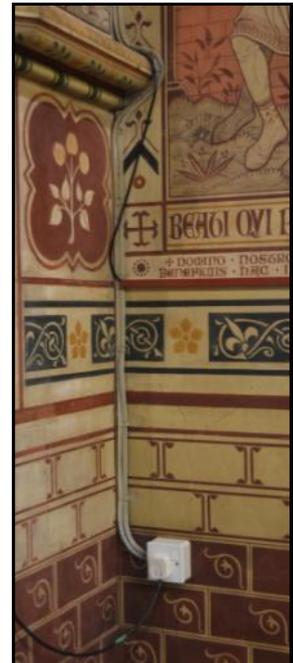
Electrical socket/cabling moved to more discreet location

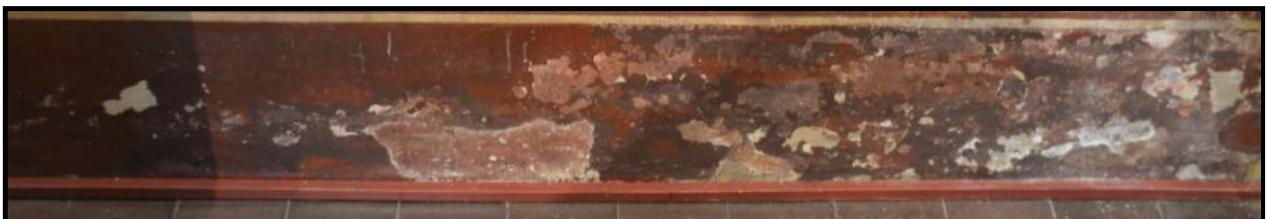
The nave skirting which is painted onto the walls is after a 150 years of being kicked and knocked about understandably in a poor state of decoration and required repainting.

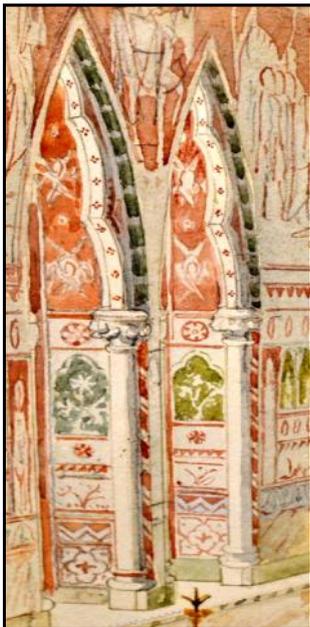
We are most fortunate to have a detailed watercolour of the interior of the church from 1876 which shows the original design of the chancel window jambs, which you can see on the left.

When the six female saints were added to the chancel soon after 1877 (see page 21) it is thought these window jambs may have been repainted to depict St Ambrose and the incarnational passages in the Te Deum.

As the Revd Bell kept no records of what he overpainted, further investigative work is required into the lost designs of the jambs.

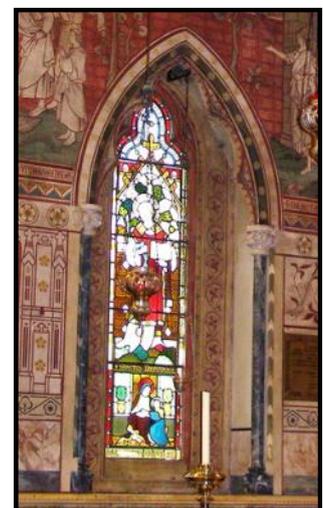
The main light is St Leonard in his chains and the bottom panel is St Anne teaching her daughter, the Blessed Virgin Mary, to read. The loss of the frescoes on this pair of jambs is particularly significant as they depicted two saints famous for the devotions, St Stephen and St Laurence.

These would have been painted in the same stylised manner as the angels in the East window jambs, which have survived intact.

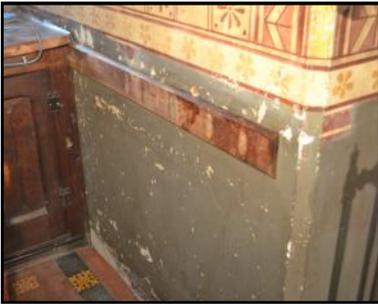
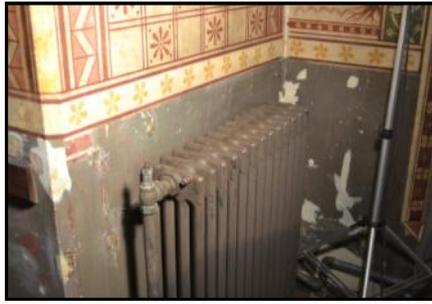
Situated between the cloisters and the church this was in poor state of repair, due to years of heavy footfall, neglect and water ingress.

Below the dado was particularly damaged and at some point had been over-painted with a cheap green paint, which was not the original colour.

By a stroke of good fortune, the original colour was discovered at the back the cupboard in the photograph. The double line decoration was re-instated and the woodwork repaired and polished.

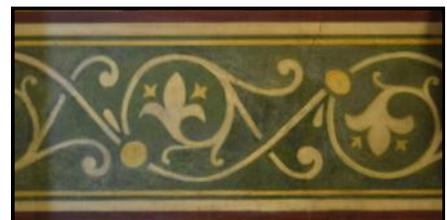
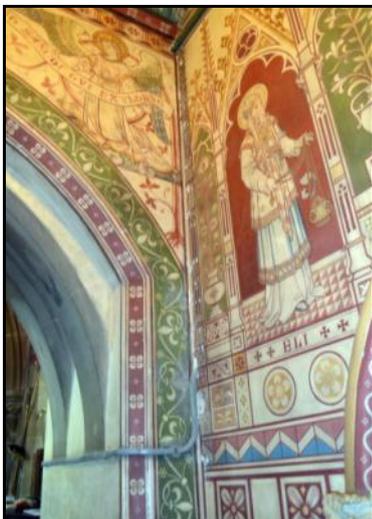
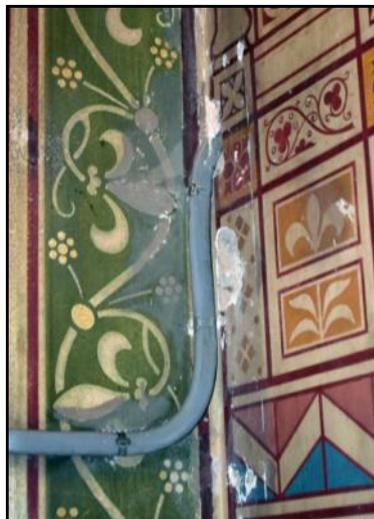
Botched earlier restoration had caused significant damage to the dado decoration, as seen on the left.

During previous rewiring of the church significant damage, together with further botched restoration, had left this corner of the vestibule in particularly poor condition with great chunks of plaster and decoration missing.

The same section after restoration, seen on the right.

The completed restoration of this very badly damaged area has been carried out with consummate skill.

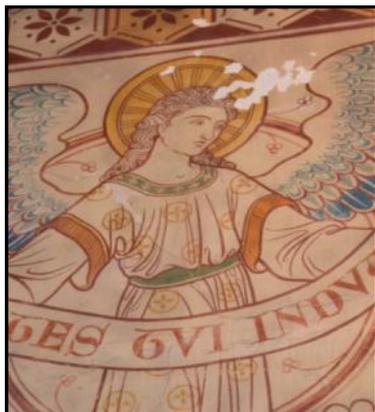
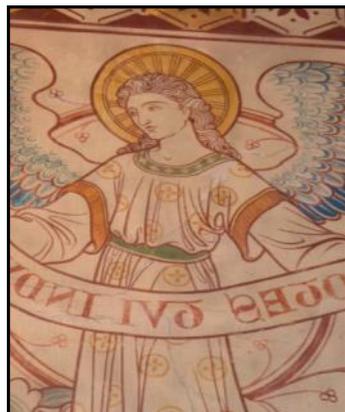
Water ingress through the Vestibule roof has caused considerable damage to the upper frescoes and painted woodwork.

Work on the Angel Gabriel is complete and major restoration of 'St Christopher with the Christ Child' will take place in September this year in conjunction with the repairs to the Chancel arch.

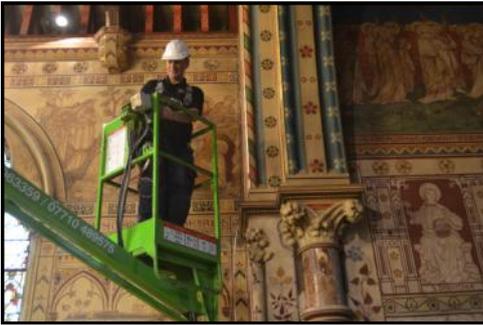
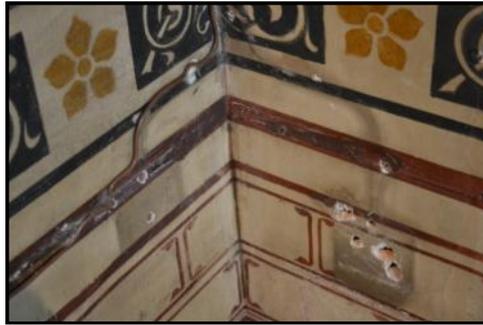
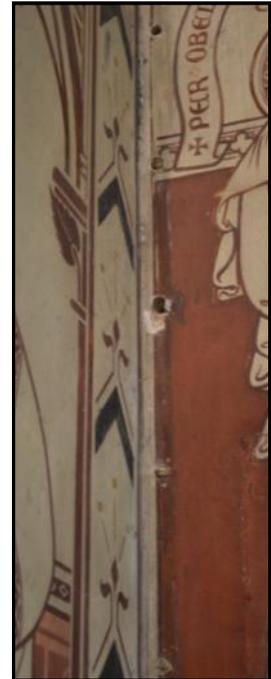
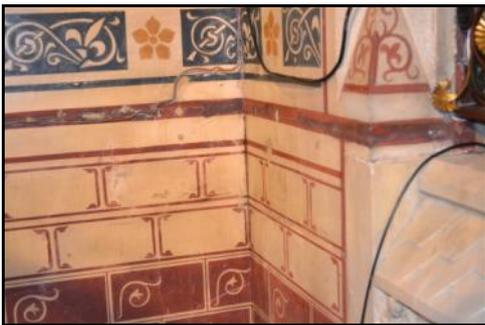
Considerable damage to the area beside the pulpit had been caused by old electrical wiring. This has been removed as has old and ugly defunct sockets.

Further defunct wiring around the church will be removed and made good as the restoration work progresses.

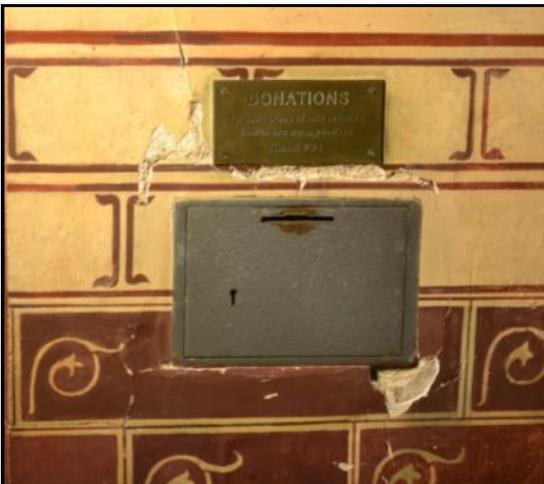
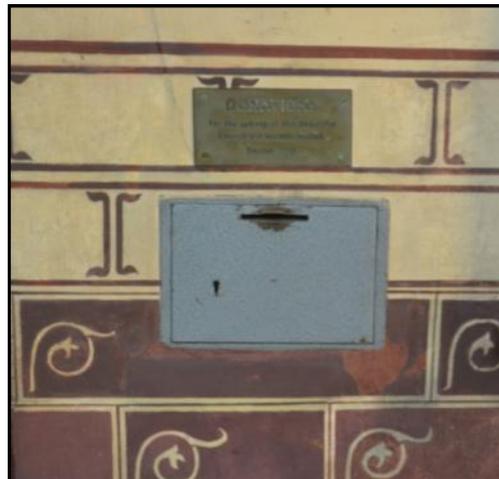
At some point in the past, an ill-advised 'Donations' box with descriptive plaque had been fitted into the wall, causing splitting of the stonework and damage to the frescoes.

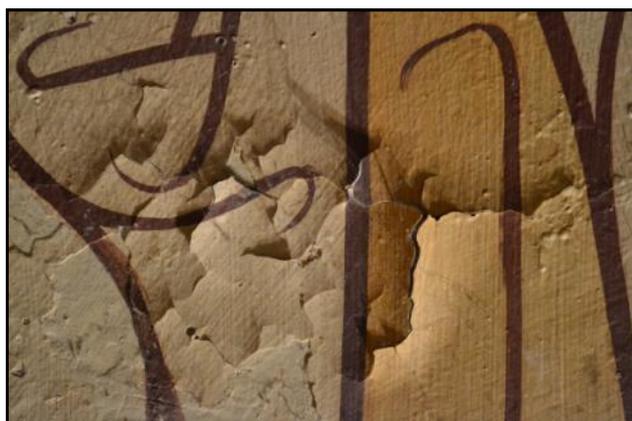
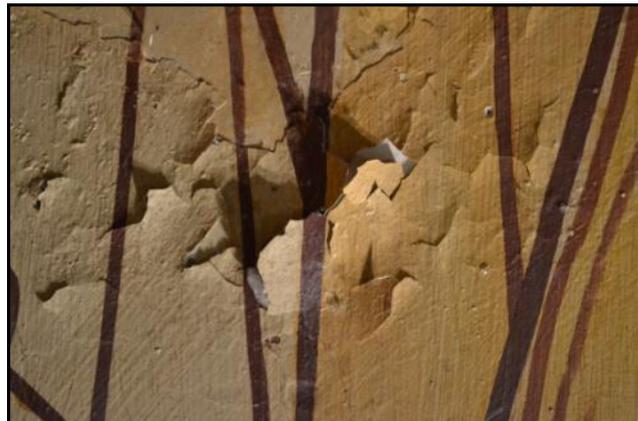
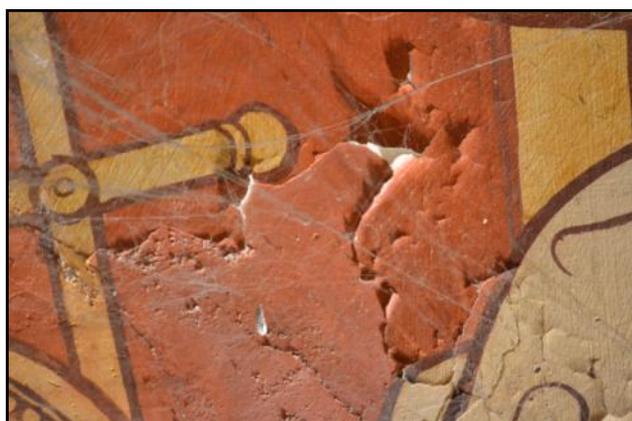
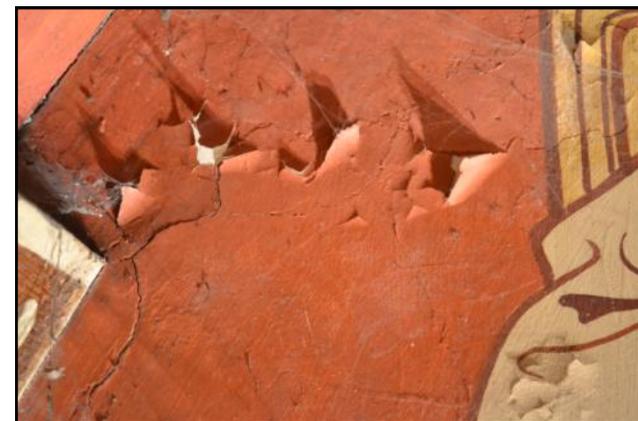
During a high level inspection of the chancel arch, serious damage was found due to the ingress of water. The underlying cause has now been rectified and major restoration work was required on sections of the chancel arch and upper section of the vestibule. An Archdeacons Licence has been granted and the work was completed in October 2015.

*Examples of the extensive damage to the Chancel arch*

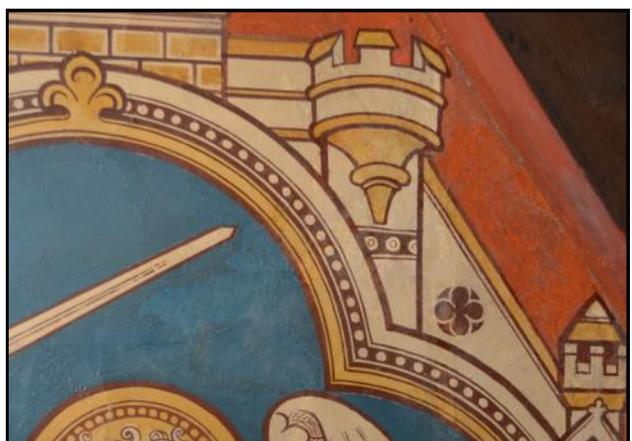
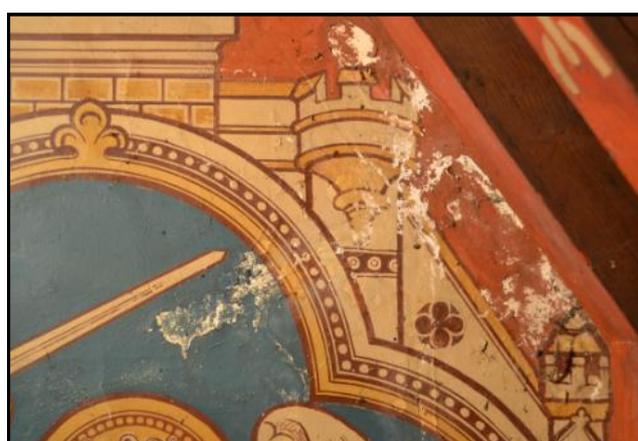
*An example of the 'before & after' on the chancel arch*

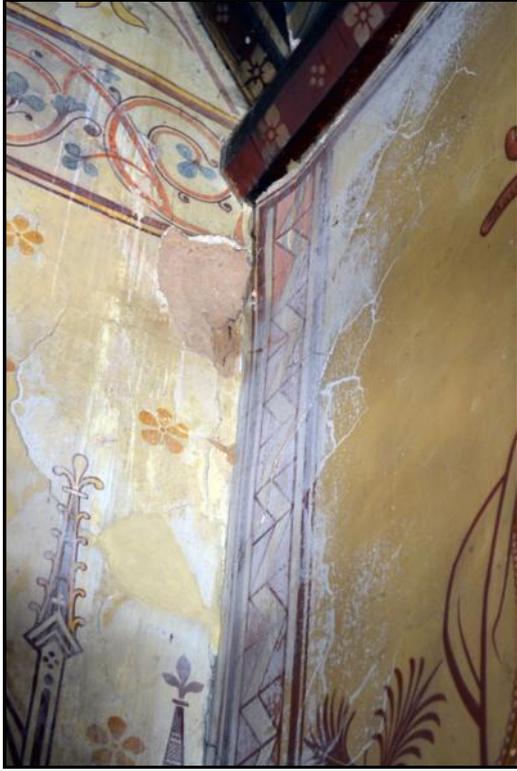
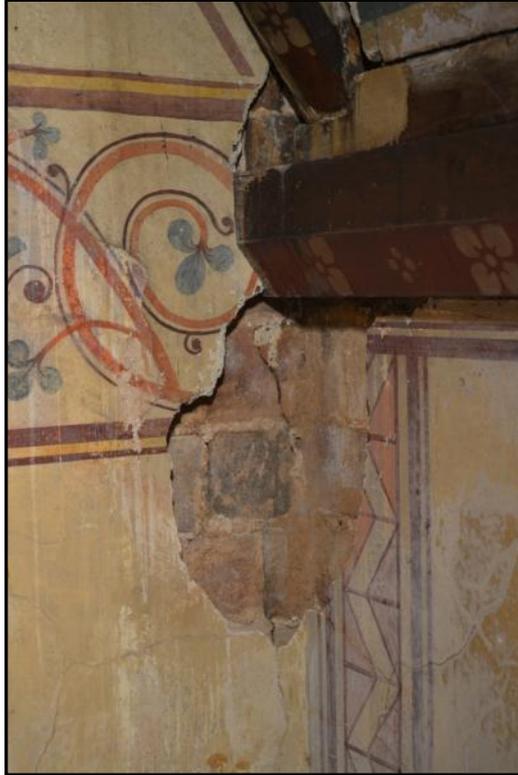
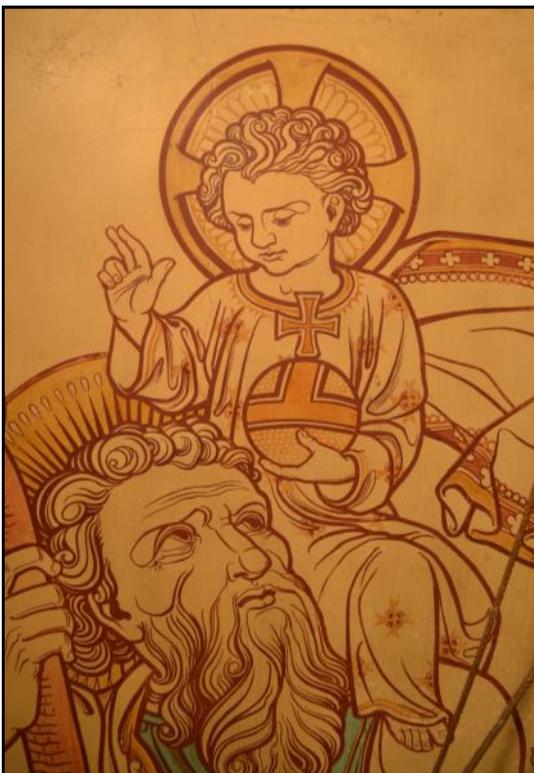
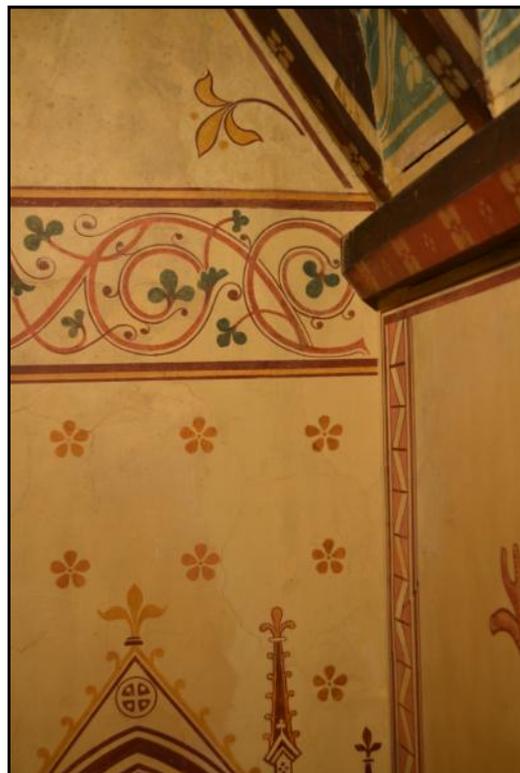
Although the lower levels of the vestibule were restored in 2014, there was serious and major damage to the two large upper frescoes behind the organ case.

This is due to water ingress, salt corrosion, cracking of the stonework and decorated plaster coming loose and disintegrating. The photos below show the 'before & after' restoration of St Christopher and the Christ Child.

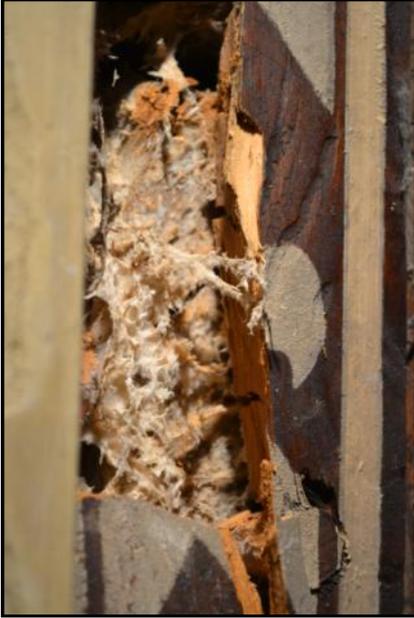
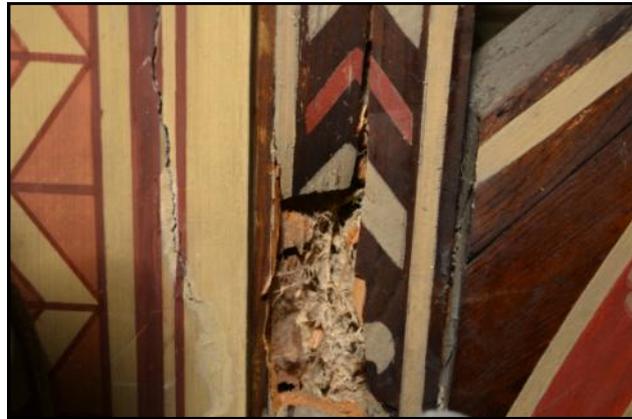
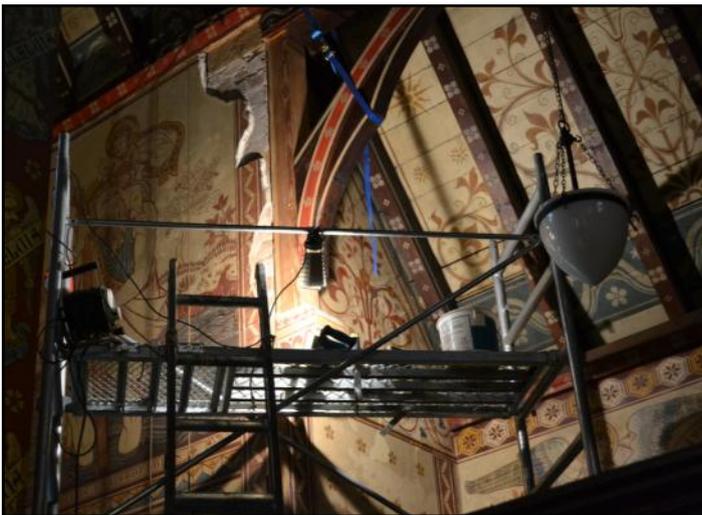
When the scaffolding reached the upper levels, dry rot was discovered in one of the main beams and in a decorative fascia beam.

The effected pitch-pine beams have been cut out and replaced with reclaimed beams of a similar age.

Some of the decorative plaster work has been cut out and taken back to the original brick work so the beam could be fitted.

The walls will be re-plastered with the decorative pattern re-instated and the new beams will be repainted in the original design.

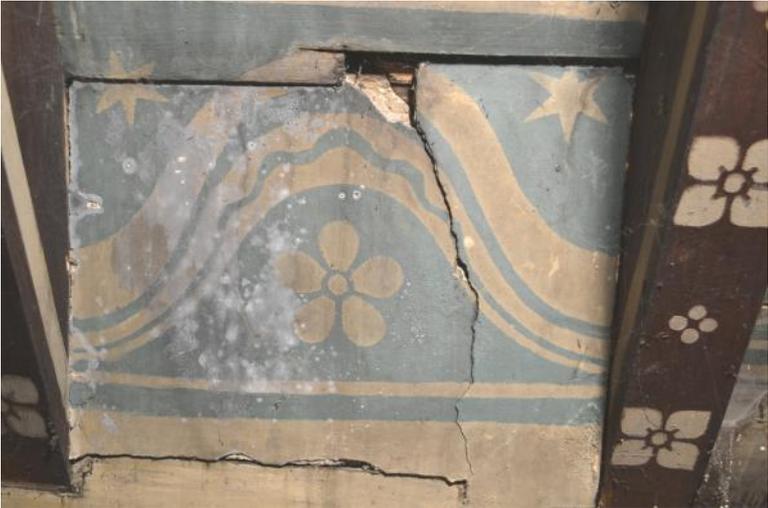
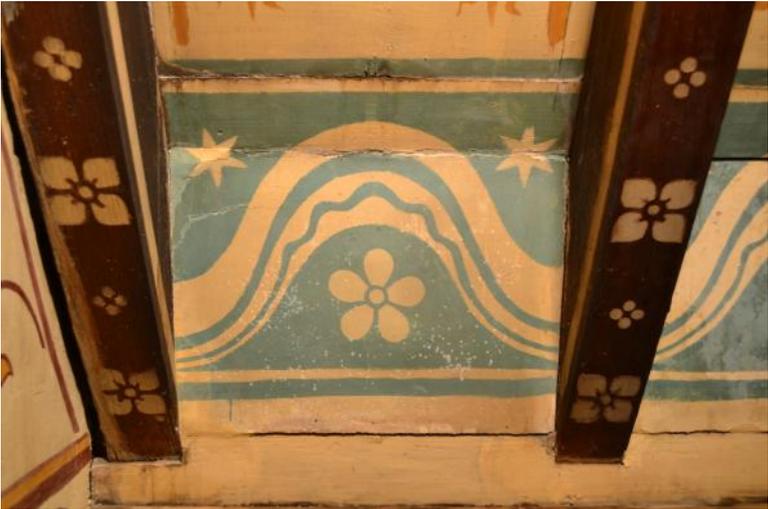
'Before & After' restoration above 'Ethan the Instrumentalist'

The restoration of Ethan the Instrumentalist has been delayed due to the dry rot but work should be completed on this fresco by April 2016

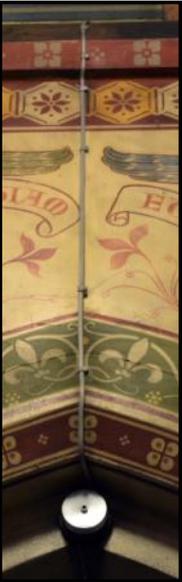
One final piece of restoration in the vestibule is the re-sighting of this ugly cable and junction box.
