Inspection Report

123 Any Town, FL
12345

Down Home Inspections

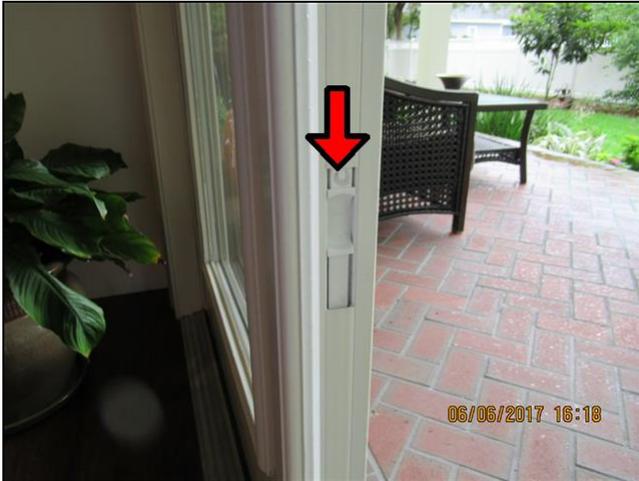
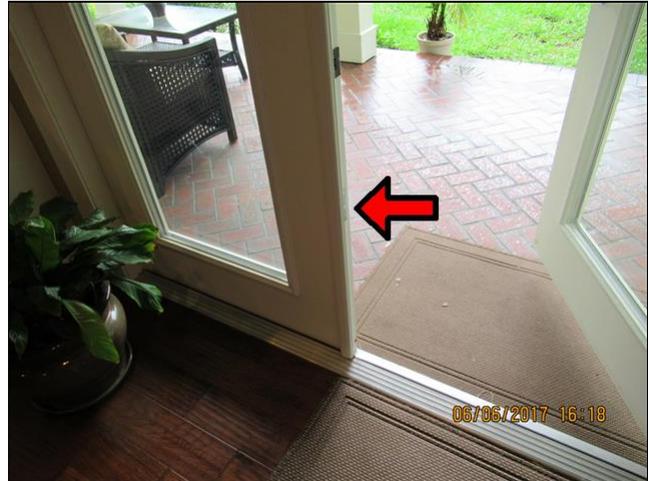
2.1 Item 1(Picture) Lock Binding

(1) At the time of the inspection, the bottom lock for the double doors leading from the kitchen to the covered porch is binding. The Inspector recommends repair. Item 1(Picture) Item 2(Picture)

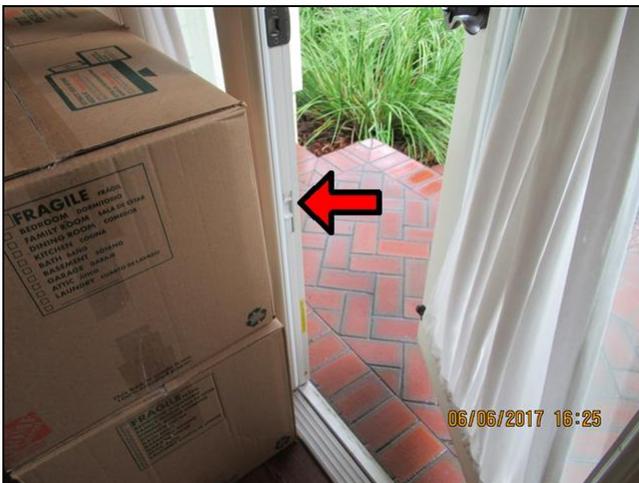
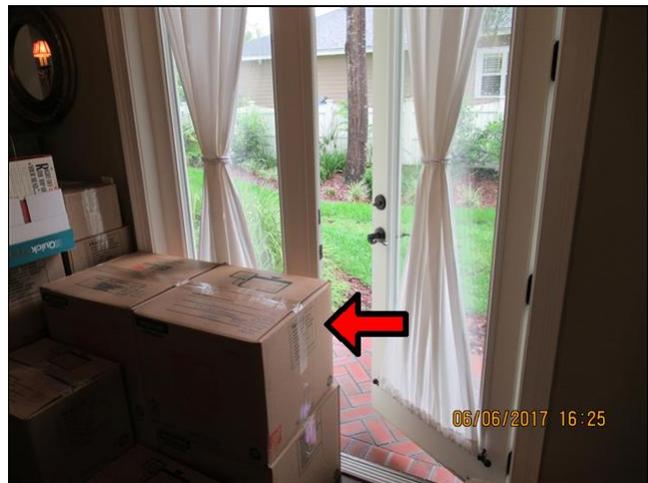
2.1 Item 3(Picture) Lock Binding

(2) At the time of the inspection, the bottom lock for the double doors leading from the entry area to the covered porch is binding. The Inspector recommends repair. Item 3(Picture) Item 4(Picture)

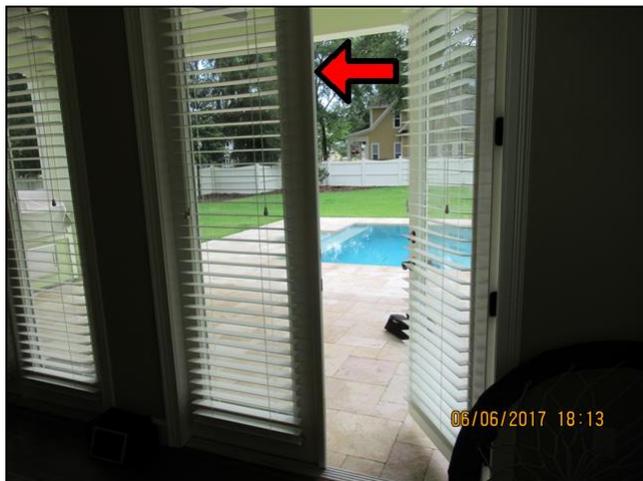
2.1 Item 5(Picture) Binding Lock

(3) At the time of the inspection, the top lock for the double doors on the right leading from the cabana to the pool area is binding. There is also some damage to the header board where the pin lock engages at the top. The Inspector recommends repair. Item 5(Picture) Item 6(Picture)

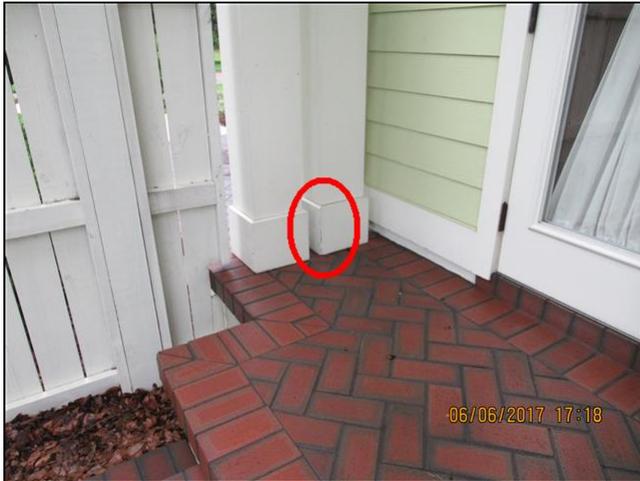
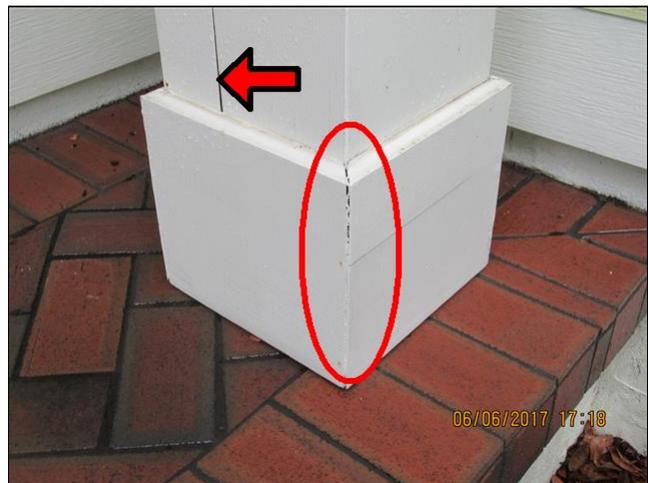
(1) At the time of the inspection, the base boards for the columns outside of the entryway double doors have some separation. The Inspector recommends an adding some sealant to help prevent moisture intrusion. Item 1(Picture) Item 2(Picture) Item 3(Picture) Item 4(Picture)

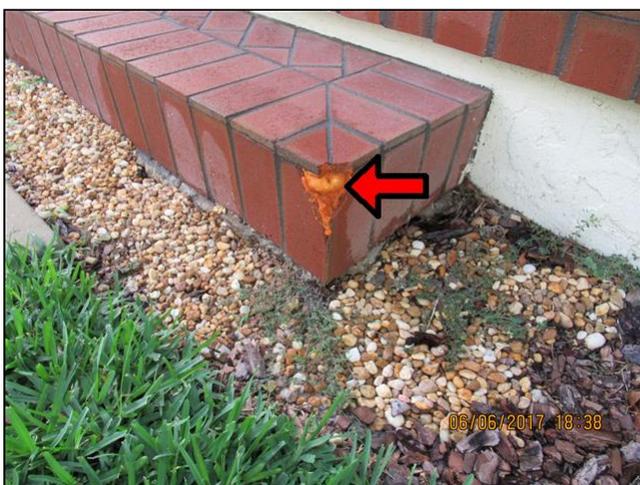
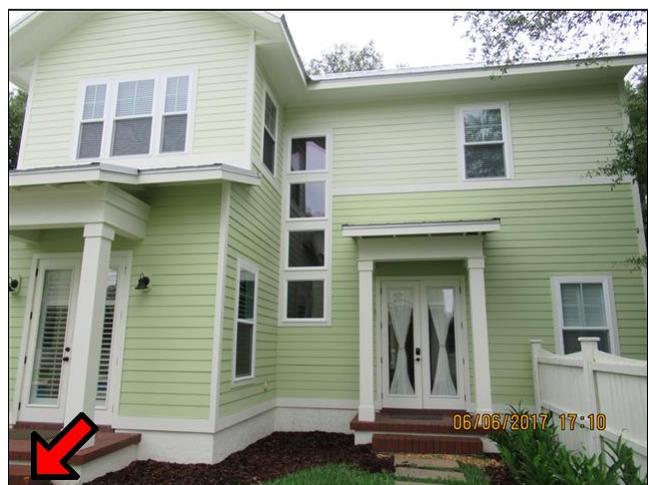
2.3 Item 5(Picture)

(2) At the time of the inspection, the corner of the steps that lead into the master suite is chipped off. The Inspector recommends repair. Item 5(Picture) Item 6(Picture)

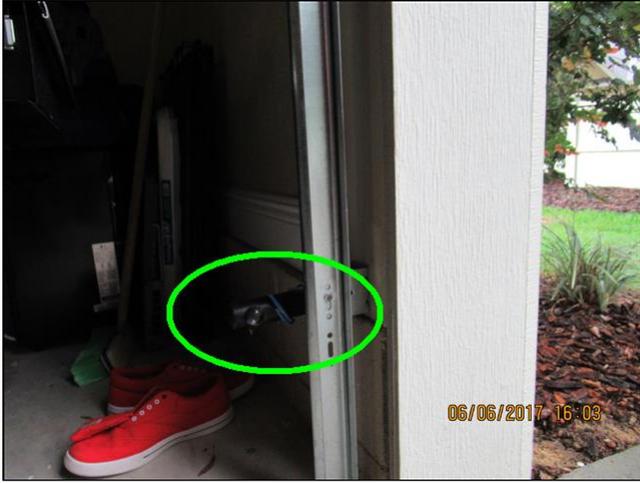
3.5 Item 1(Picture)

The sensors are in place for garage door and will reverse the door. Item 1(Picture) Item 2(Picture)

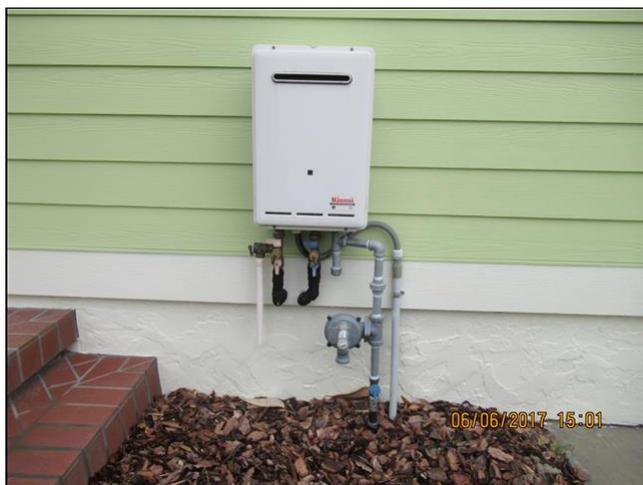
6.2 Item 1(Picture) Tankless Water Heater

The cabana has its own tankless water heater. The gas shut off valve for this component is located on the service line.

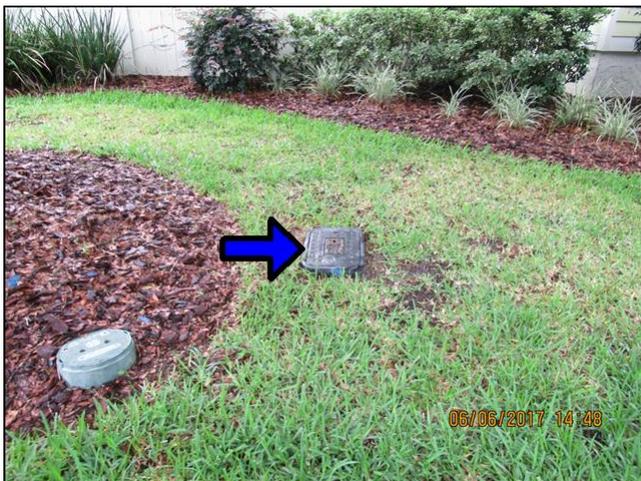
6.3 Item 1(Picture) Water Meter

The main water shut-off valve is located in the meter box out by the street. The Inspector recommends you become familiar with its location and operation in the event of an emergency. You can purchase a "water key" at any of the home improvement stores. This tool is the quickest and easiest way to turn the water on and off. Item 1(Picture)

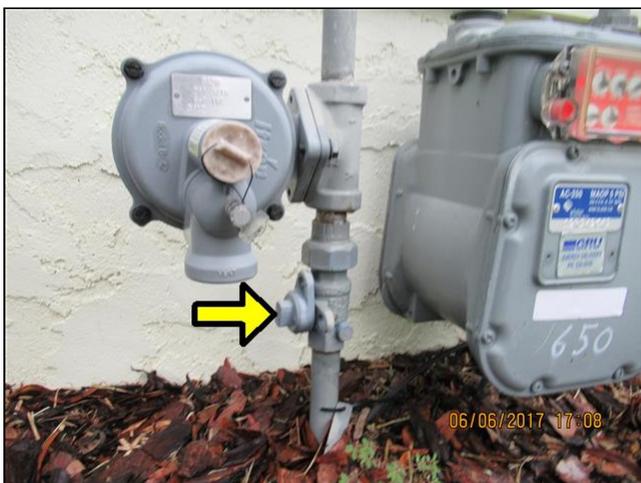
6.5 Item 1(Picture)

The main fuel shut off is at gas meter outside. Item 1(Picture) Item 2(Picture)

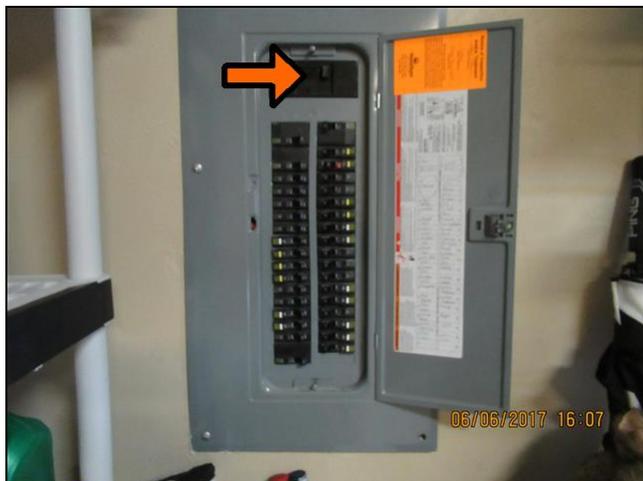
7.1 Item 1(Picture) Main Disconnect

(1) Power company service cables fed a load center service panel containing the main disconnect and breakers that protect and control power to branch circuits. The service panel is located in the garage. The service disconnect is rated at 200 amps. Item 1(Picture)

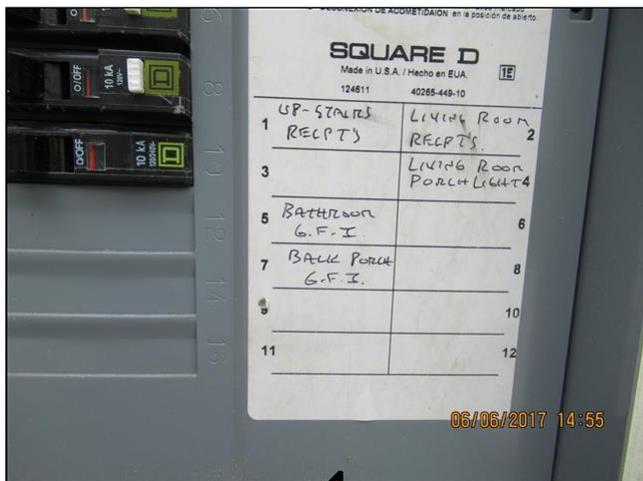
7.1 Item 2(Picture)

(2) The Inspector recommends that all the circuits for the cabana be added to the label. Item 2(Picture)

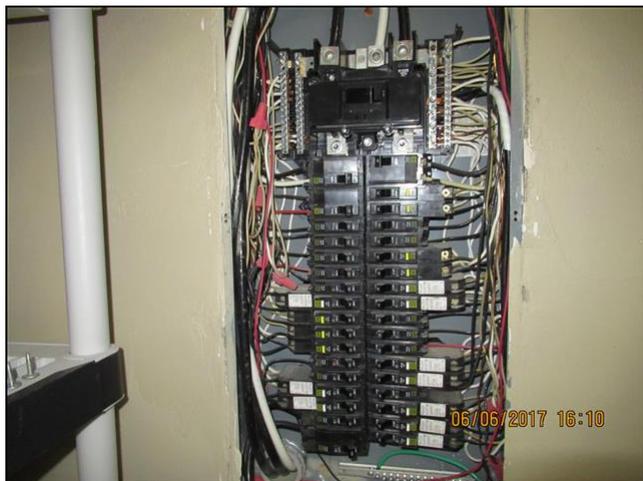
7.2 Item 1(Picture) Circuit Breakers

(1) At the time of the inspection, the Inspector observed no deficiencies in the condition of circuit breakers in the electrical service panel. Item 2(Picture)

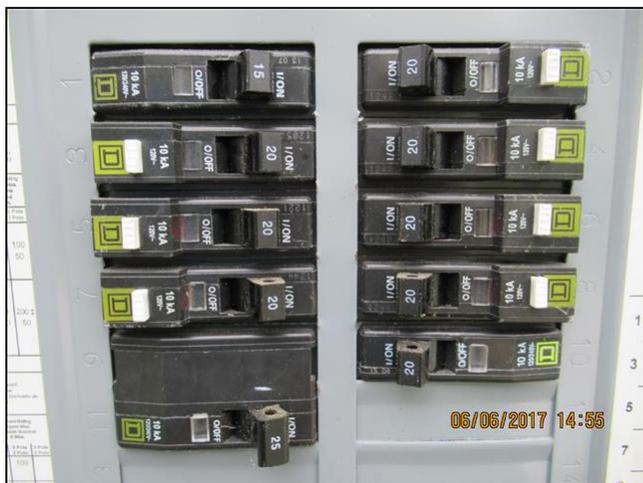
7.2 Item 2(Picture) Cabana Service Panel

(2) At the time of the inspection, the Inspector observed no deficiencies in the condition of circuit breakers in the electrical service panel for the Cabana. Item 1(Picture)

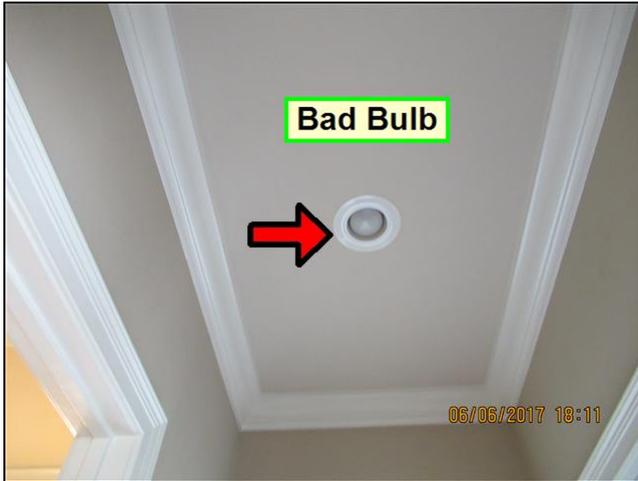
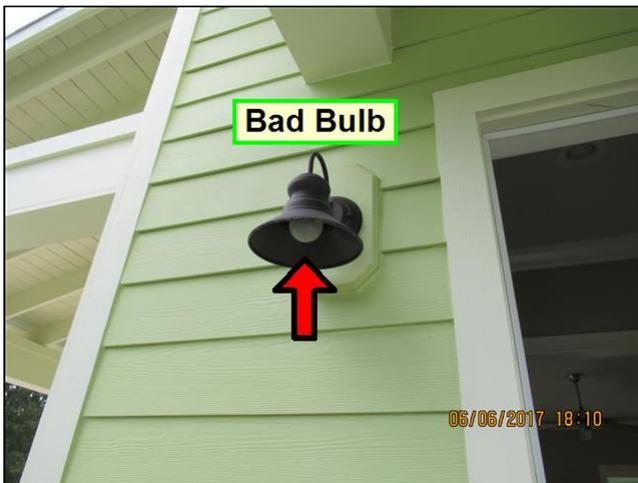
(1) The light bulb above the hallway in the cabana needs to be replaced. Also, the light bulbs on the exterior on both sides of the back door of the cabana need to be replaced. Electrical current was detected going to these fixtures. Item 1(Picture) Item 2(Picture) Item 3(Picture)

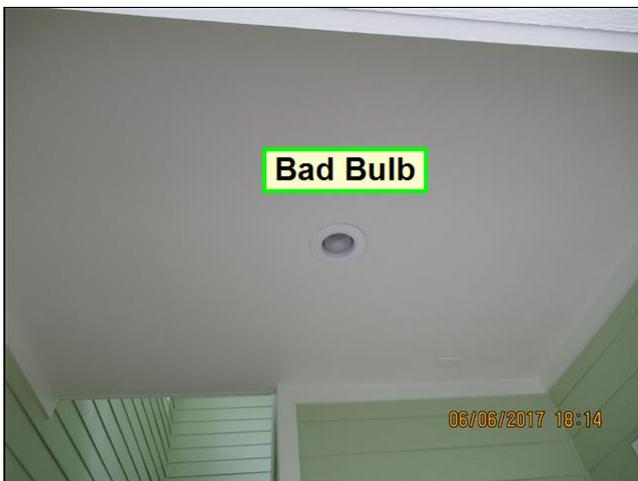
7.3 Item 4(Picture)

(2) The light bulb above the stair way area for the cabana needs to be replaced. Item 4(Picture)

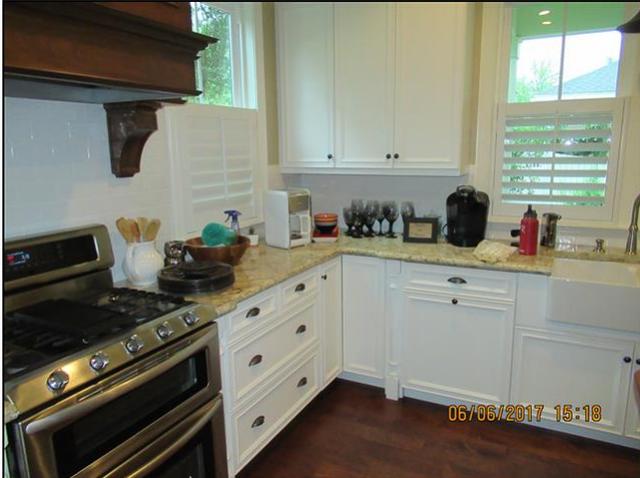
7.4 Item 1(Picture)

(1) The GFCI reset for the kitchen counter receptacles to the right of the range is located in the electrical service panel in the garage. Item 1(Picture)

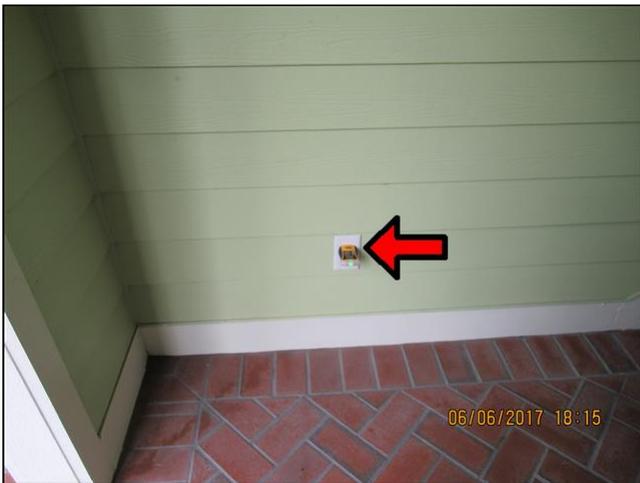
7.4 Item 2(Picture) Not GFCI Protected

(2) At the time of the inspection, the wall receptacle at the base of the stairs of the cabana is not GFCI protected. The receptacle did not respond to testers. The Inspector recommends an evaluation by a licensed electrical contractor to determine the cost of repair. Item 2(Picture)

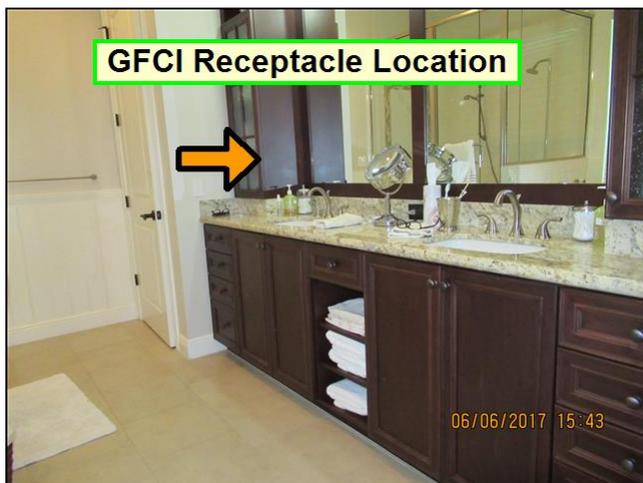
7.5 Item 1(Picture)

The GFCI receptacle with the reset switch on it is located in the cabinet to the left of the dual sinks in the master bath. Item 1(Picture)

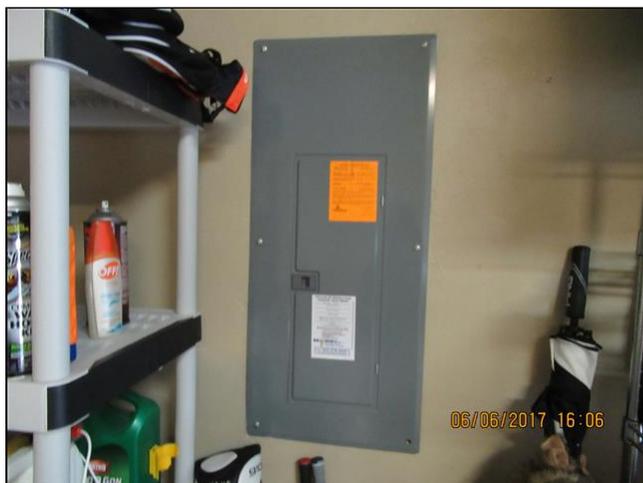
7.6 Item 1(Picture)

(1) The main electrical panel is located on the wall in the garage. Item 1(Picture)

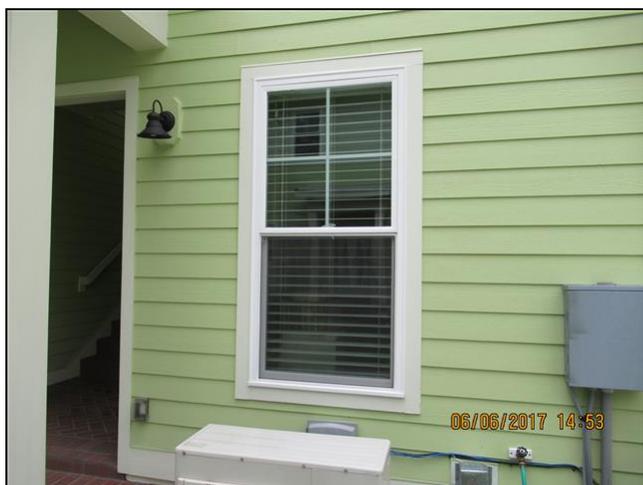
7.6 Item 2(Picture)

(2) The sub panel for the cabana is located on the exterior wall. Item 2(Picture)

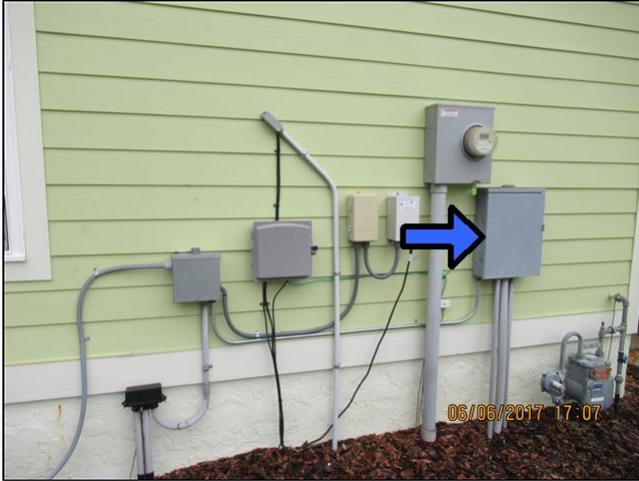
7.6 Item 3(Picture)

(3) The sub panel for the pool equipment is located on the exterior wall. Item 3(Picture)

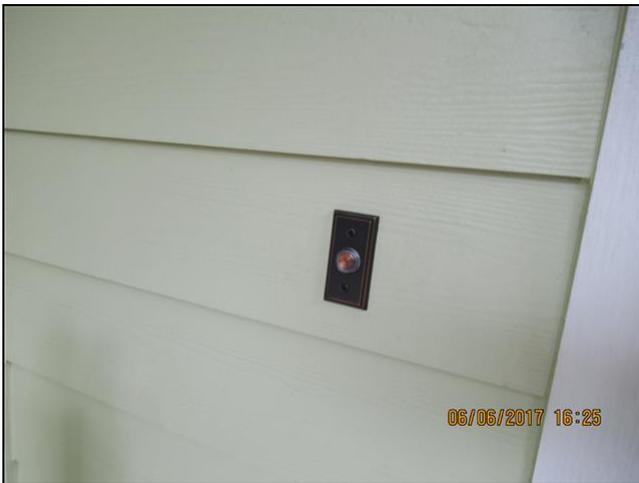
7.9 Item 1(Picture) Door Bell Switch

The doorbell responded to the switch at the time of the inspection. Item 1(Picture)

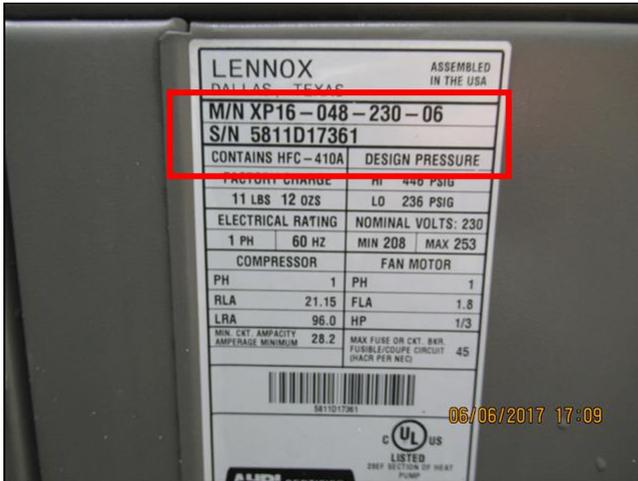
8.0 Item 1(Picture)

The condenser part of the heat pump system was manufactured in 2011. Item 1(Picture)

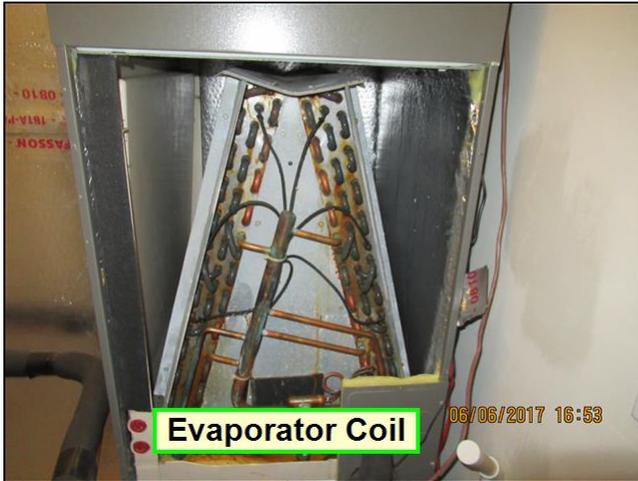
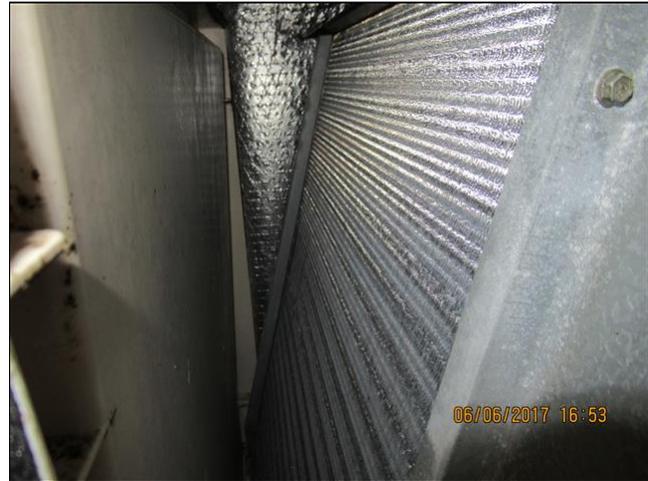
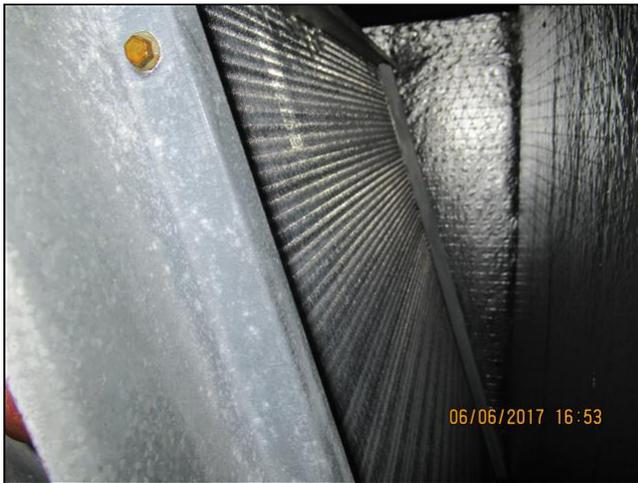
(1) [The evaporator coil is clean and undamaged.](#) Item 1(Picture) Item 2(Picture) Item 3(Picture)

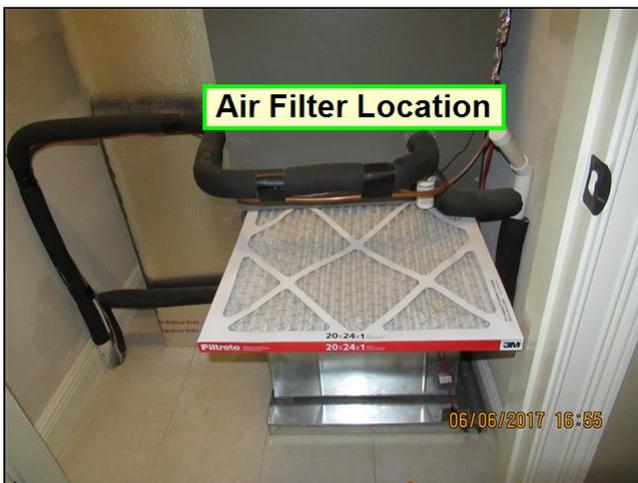
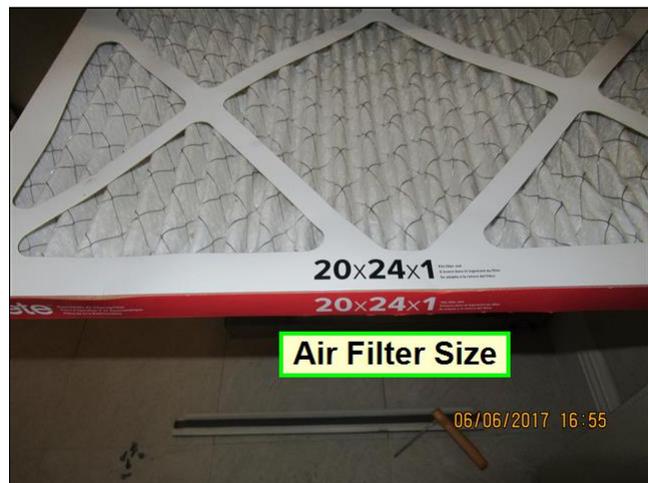
(2) The air filter is clean. It is very important that the filter be changed at least every 30 days. Make sure the arrow on the filter is pointing in the direction the air flow is going. Item 4(Picture) Item 5(Picture)

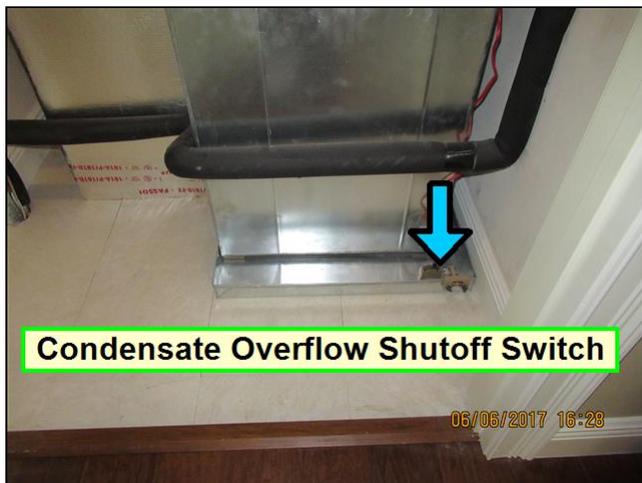
8.8 Item 1(Picture)

(1) A condensate overflow warning/shutoff device is installed under the air handler equipment in the attic. If this device is activated the unit will stop working to prevent a water overflow incident. Item 8(Picture)

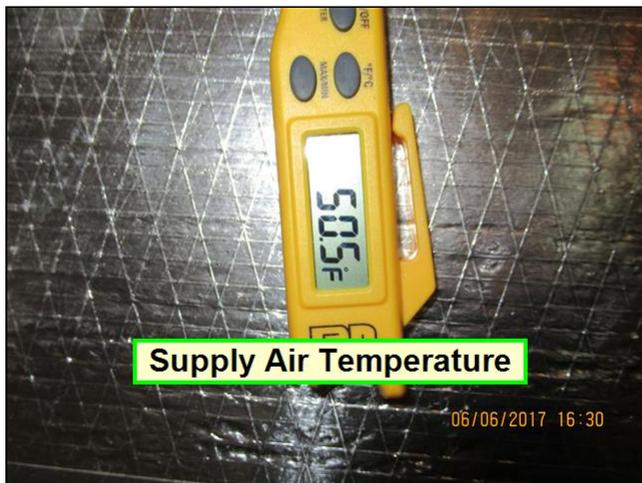
(2) The ambient air test was performed by using thermometers on the air handler of Heat pump in cool mode to determine if the difference in temperatures of the supply and return air are between 14 degrees and 22 degrees which indicates that the unit is cooling as intended. The supply air temperature on your system read 51 degrees, and the return air temperature was 71 degrees. This indicates the range in temperature drop is normal. Item 9(Picture) Item 10(Picture)

8.8 Item 2(Picture) Supply Air

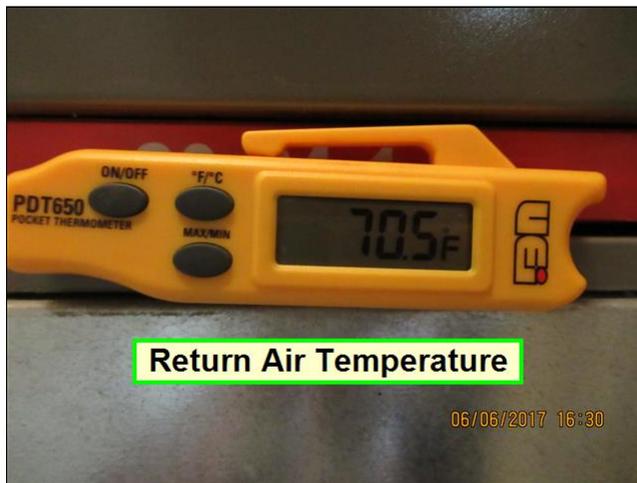
8.8 Item 3(Picture) Return Air

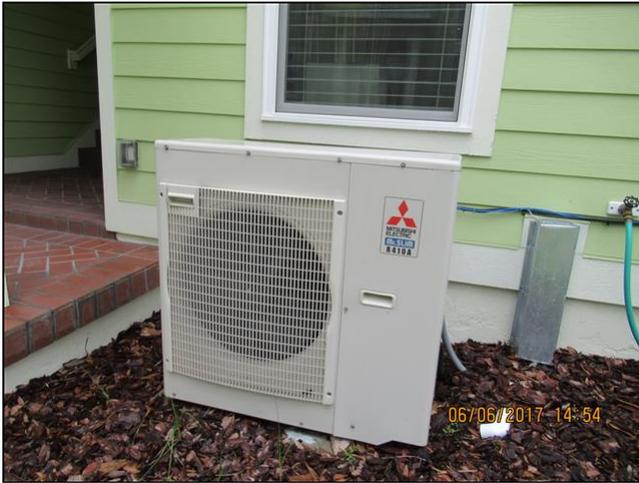
(3) The HVAC system for the cabana is a 3 ton unit that is capable of operating up to eight zones. It controls two zones in the cabana. It is split up simply by lower and upper floors. There are two ceiling recessed air handlers. One in the downstairs cabana room and the other in the upstairs bedroom. The thermostat is located near the door to that opens near the stairs. Item 1(Picture) Item 2(Picture) Item 3(Picture)

8.8 Item 4(Picture) Condenser

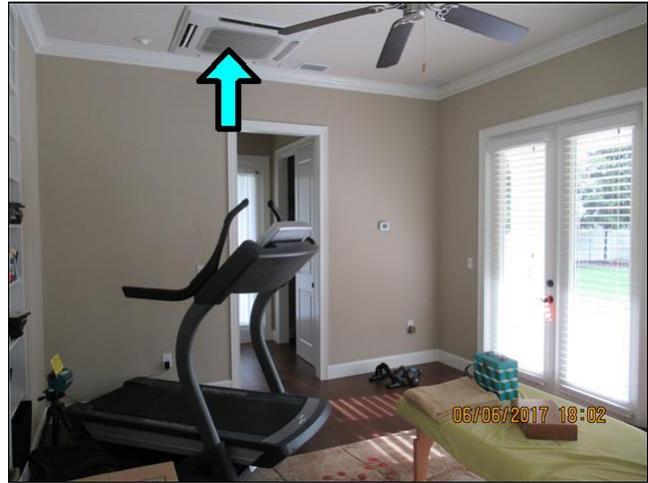
8.8 Item 5(Picture) Air Handler

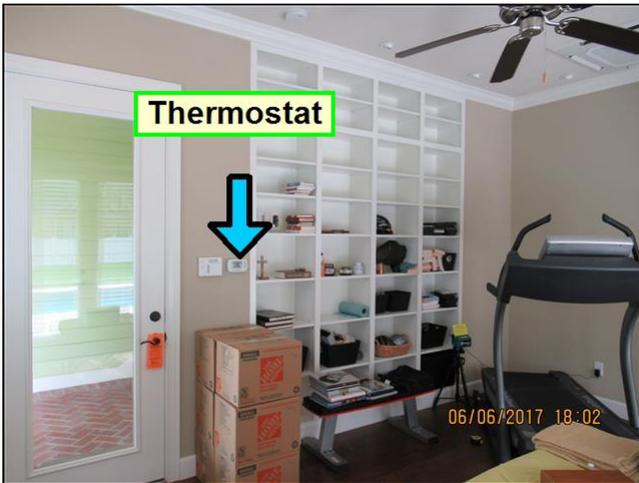
8.8 Item 6(Picture) Thermostat

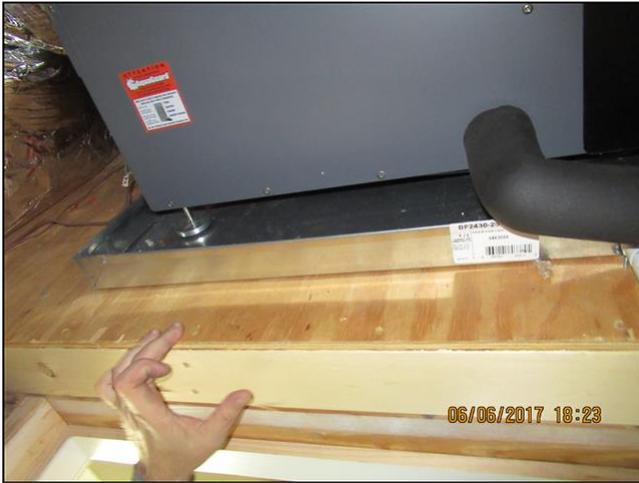
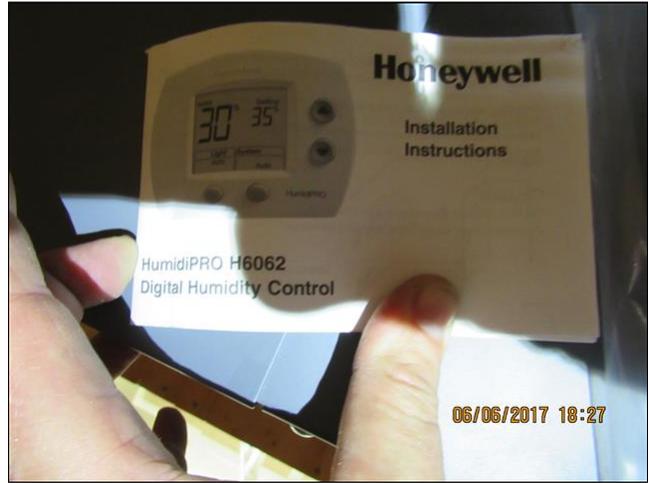
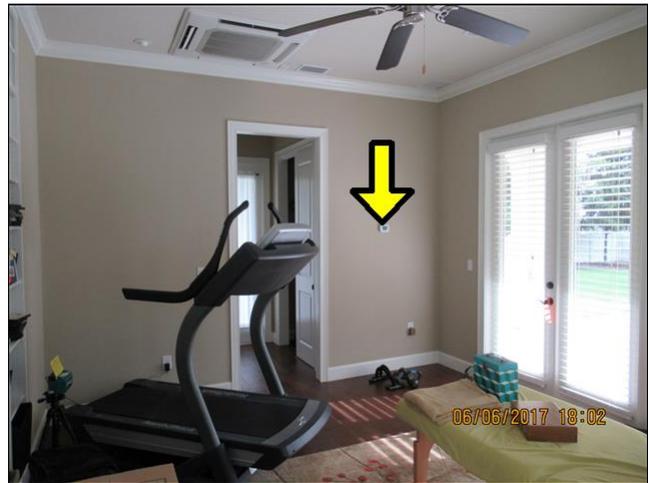
(4) There is a whole house dehumidifier installed in the cabana. This system is located in the attic above the cabana bedroom upstairs. The controls for it are on the wall of the cabana room near the entrance to the bathroom. Item 4(Picture) Item 5(Picture) Item 6(Picture) Item 7(Picture)

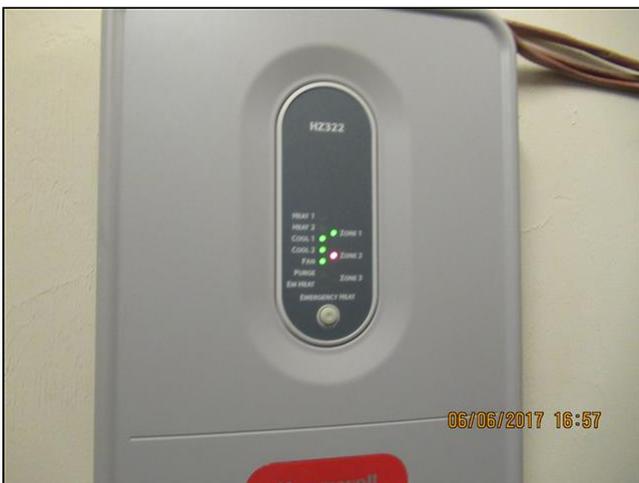
8.8 Item 11(Picture) Zone Monitor

(5) There is a zone monitor on the wall in the closet with the air handler. You can monitor which zone is currently being conditioned with this. Item 11(Picture)

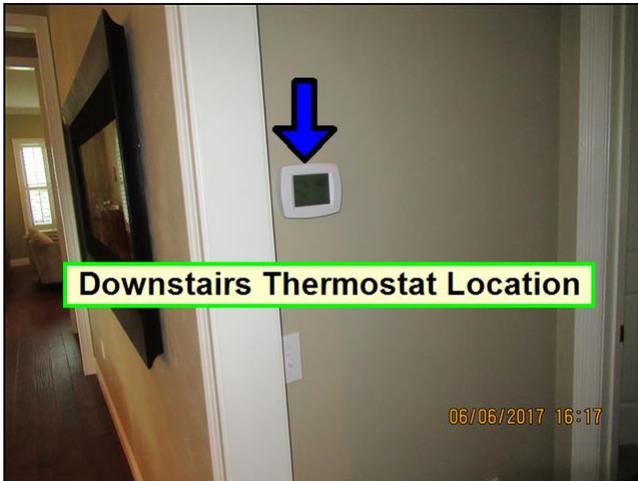
- (1) The thermostat for the downstairs zone is located on the wall in the hallway that leads to the master suite. Item 1(Picture)

8.9 Item 1(Picture) Thermostat

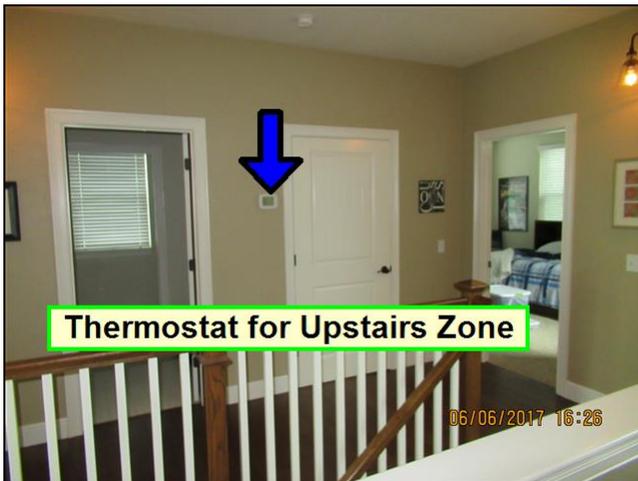
8.9 Item 2(Picture)

- (2) The thermostat for the upstairs zone is located on the wall between the hall bath and air handler closet. Item 2(Picture)

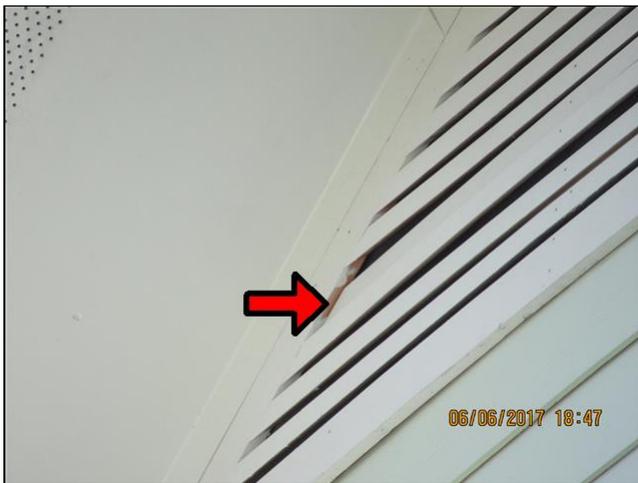
9.3 Item 1(Picture)

One of the boards for the gable ventilation of the attic on the cabana has become displaced. The Inspector recommends repair. Item 1(Picture) Item 2(Picture)

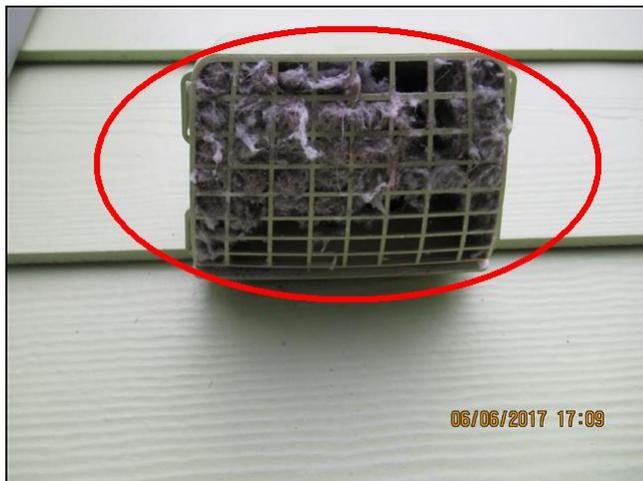
9.4 Item 1(Picture)

(1) The exterior dryer vent guard needs to be cleaned for proper operation. Item 1(Picture)

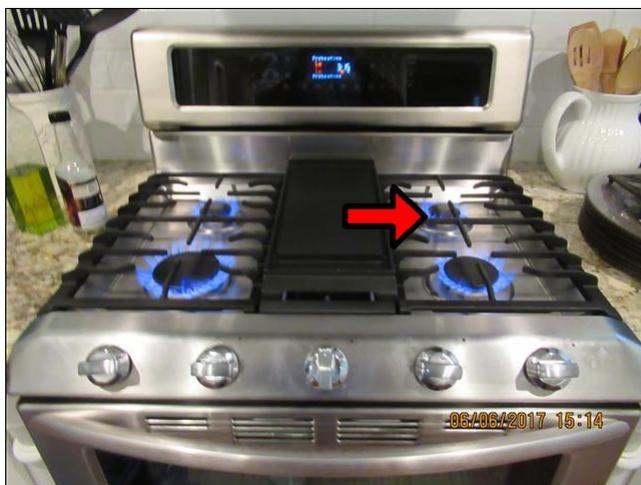
10.1 Item 1(Picture)

At the time of the inspection, the right rear burner goes out when the knob is turned to its lowest setting. The Inspector recommends an evaluation by a licensed contractor to determine the cost of repair. Item 1(Picture) Item 2(Picture)

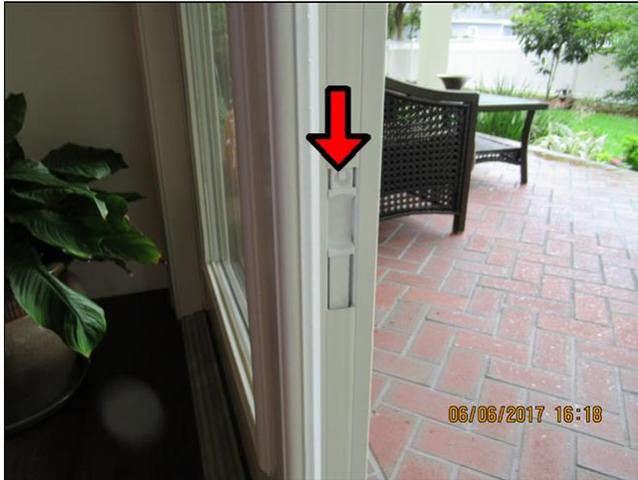
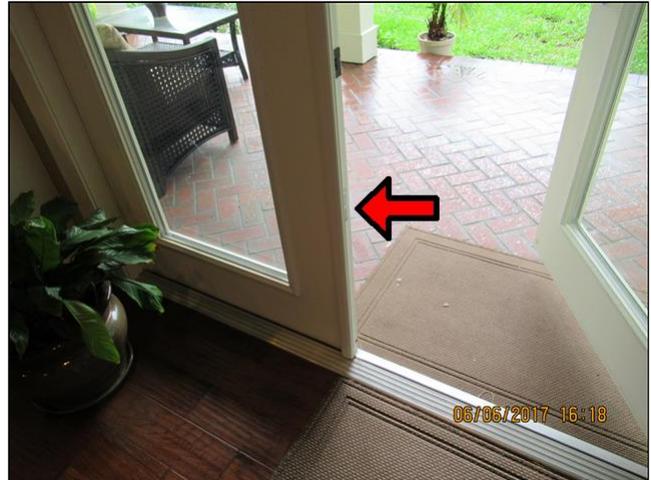
2.1 Item 1(Picture) Lock Binding

(1) **At the time of the inspection, the bottom lock for the double doors leading from the kitchen to the covered porch is binding. The Inspector recommends repair.** Item 1(Picture) Item 2(Picture)

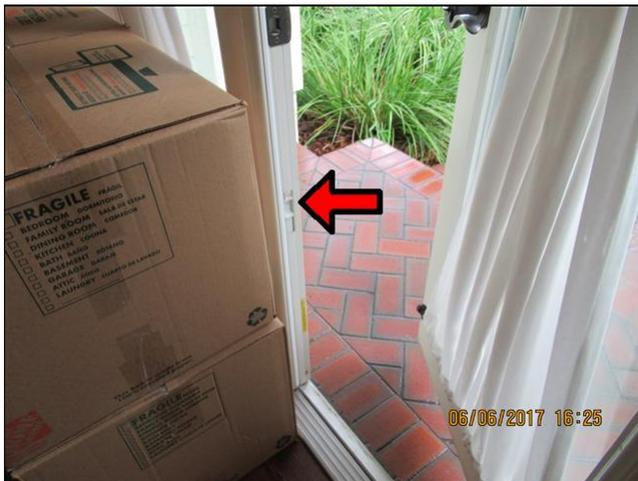
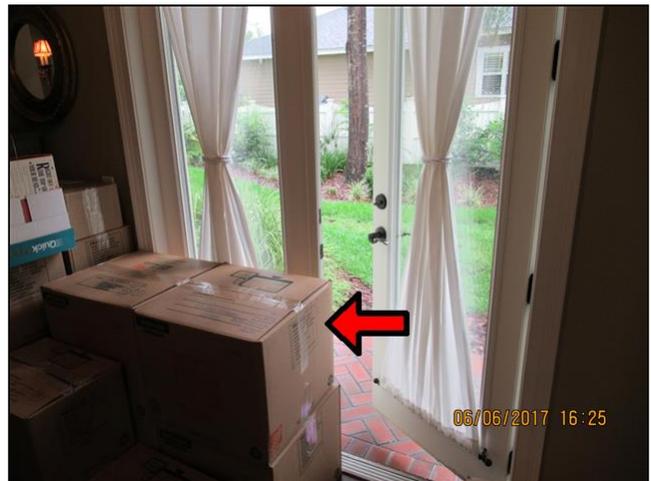
2.1 Item 3(Picture) Lock Binding

(2) At the time of the inspection, the bottom lock for the double doors leading from the entry area to the covered porch is binding. The Inspector recommends repair. Item 3(Picture) Item 4(Picture)

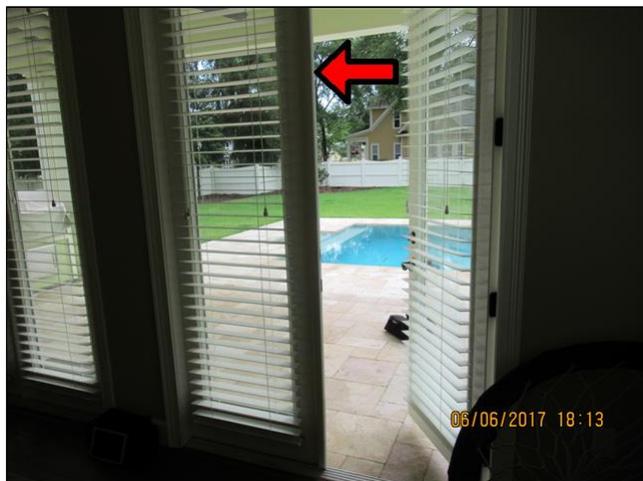
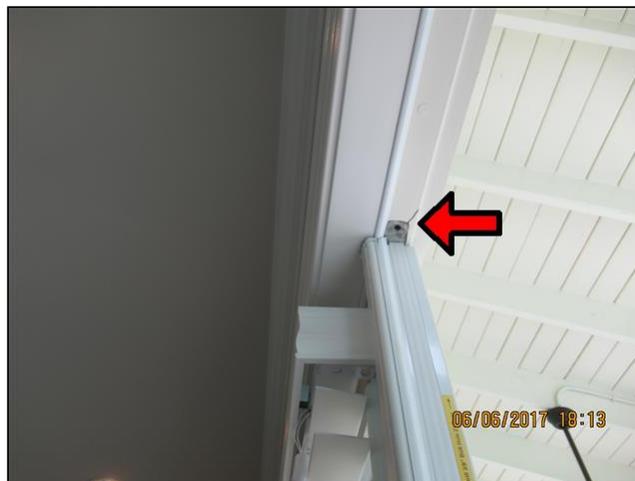
(3) At the time of the inspection, the top lock for the double doors on the right leading from the cabana to the pool area is binding. There is also some damage to the header board where the pin lock engages at the top. The Inspector recommends repair. Item 5(Picture) Item 6(Picture)

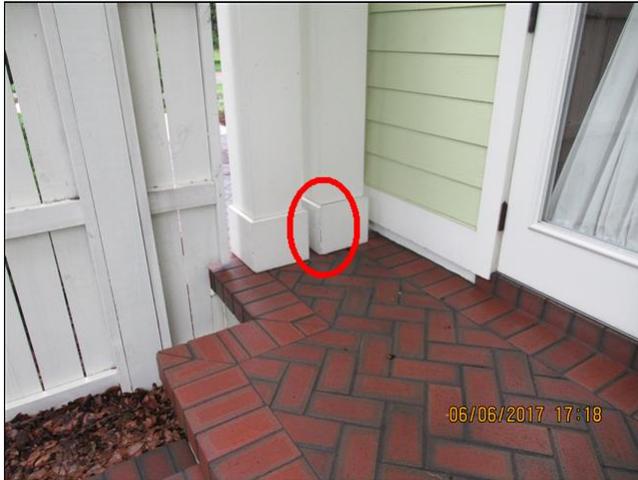
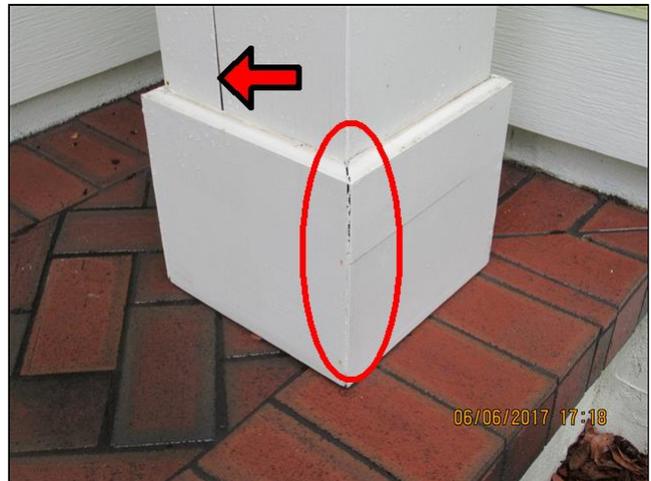
(1) At the time of the inspection, the base boards for the columns outside of the entryway double doors have some separation. The Inspector recommends an adding some sealant to help prevent moisture intrusion. Item 1(Picture) Item 2(Picture) Item 3(Picture) Item 4(Picture)

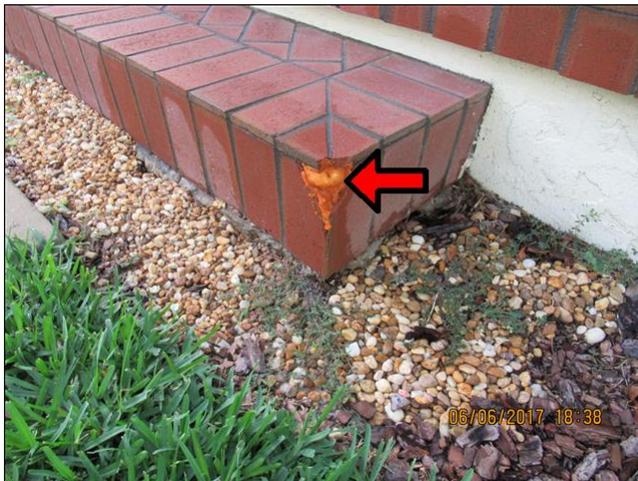
2.3 Item 5(Picture)

(2) At the time of the inspection, the corner of the steps that lead into the master suite is chipped off. The Inspector recommends repair. Item 5(Picture) Item 6(Picture)

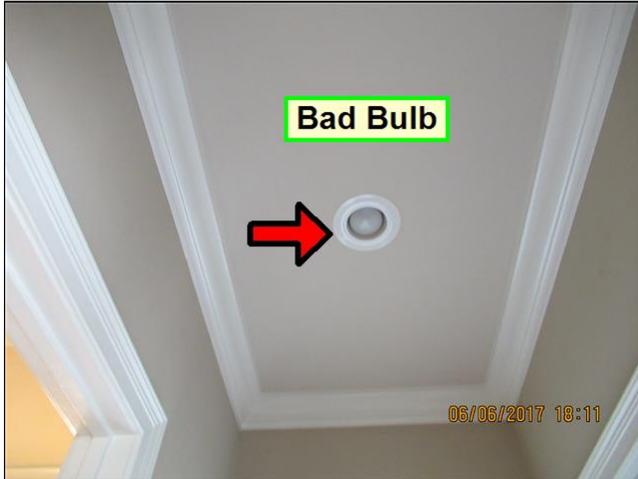
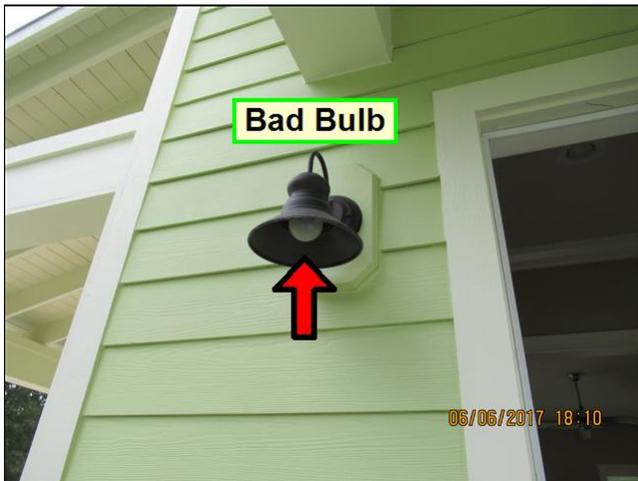
(1) The light bulb above the hallway in the cabana needs to be replaced. Also, the light bulbs on the exterior on both sides of the back door of the cabana need to be replaced. Electrical current was detected going to these fixtures. Item 1(Picture) Item 2(Picture) Item 3(Picture)

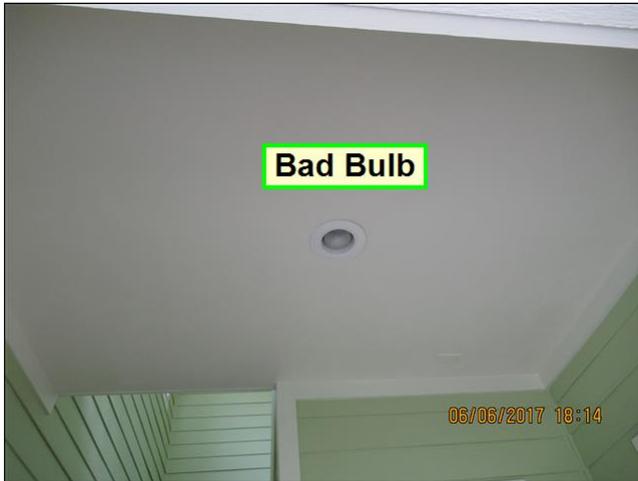
7.3 Item 4(Picture)

(2) The light bulb above the stair way area for the cabana needs to be replaced. Item 4(Picture)

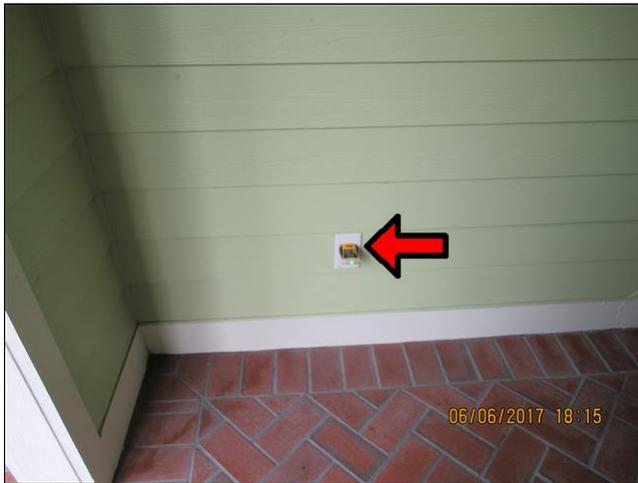
7.4 Item 2(Picture) Not GFCI Protected

(2) At the time of the inspection, the wall receptacle at the base of the stairs of the cabana is not GFCI protected. The receptacle did not respond to testers. The Inspector recommends an evaluation by a licensed electrical contractor to determine the cost of repair. Item 2(Picture)

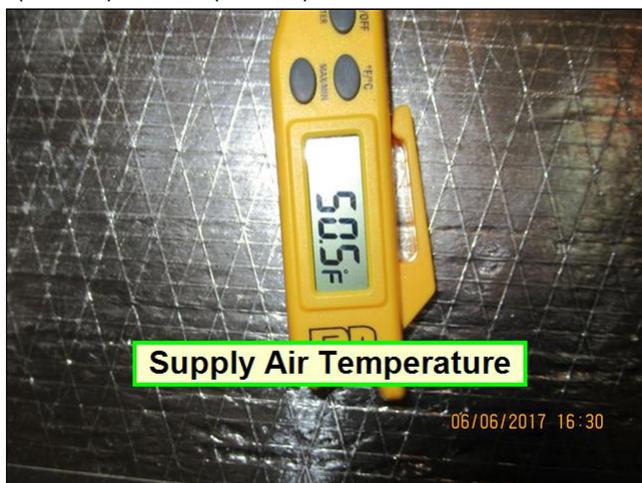
(2) The ambient air test was performed by using thermometers on the air handler of Heat pump in cool mode to determine if the difference in temperatures of the supply and return air are between 14 degrees and 22 degrees which indicates that the unit is cooling as intended. The supply air temperature on your system read 51 degrees, and the return air temperature was 71 degrees. This indicates the range in temperature drop is normal. Item 9(Picture) Item 10(Picture)

8.8 Item 2(Picture) Supply Air

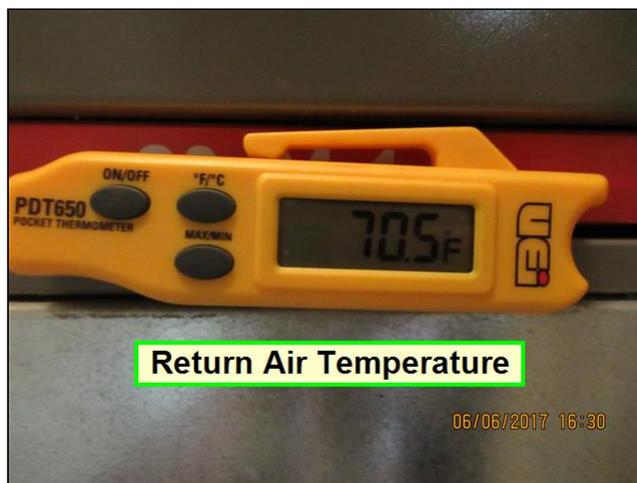
8.8 Item 3(Picture) Return Air

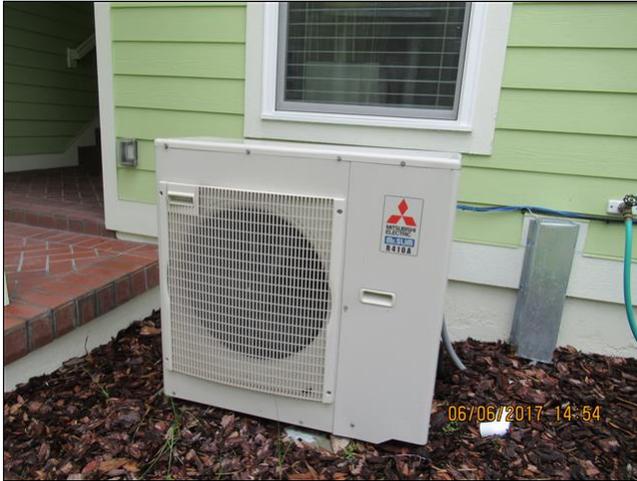
(3) The HVAC system for the cabana is a 3 ton unit that is capable of operating up to eight zones. It controls two zones in the cabana. It is split up simply by lower and upper floors. There are two ceiling recessed air handlers. One in the downstairs cabana room and the other in the upstairs bedroom. The thermostat is located near the door to that opens near the stairs. Item 1(Picture) Item 2(Picture) Item 3(Picture)

8.8 Item 4(Picture) Condenser
