Inspection Report

123 Any Town, FL
12345

Down Home Inspections

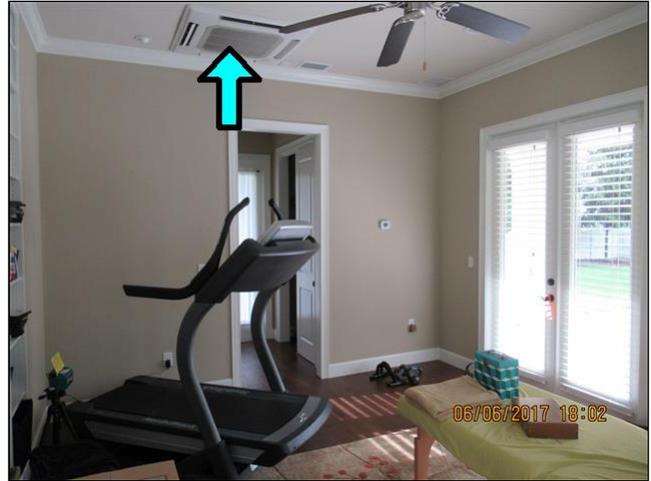
(3) The HVAC system for the cabana is a 3 ton unit that is capable of operating up to eight zones. It controls two zones in the cabana. It is split up simply by lower and upper floors. There are two ceiling recessed air handlers. One in the downstairs cabana room and the other in the upstairs bedroom. The thermostat is located near the door to that opens near the stairs. Item 1(Picture) Item 2(Picture) Item 3(Picture)

8.8 Item 5(Picture) Air Handler

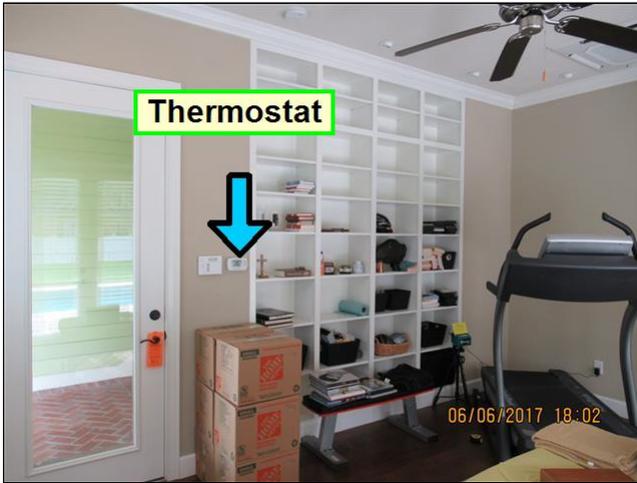
8.8 Item 6(Picture) Thermostat

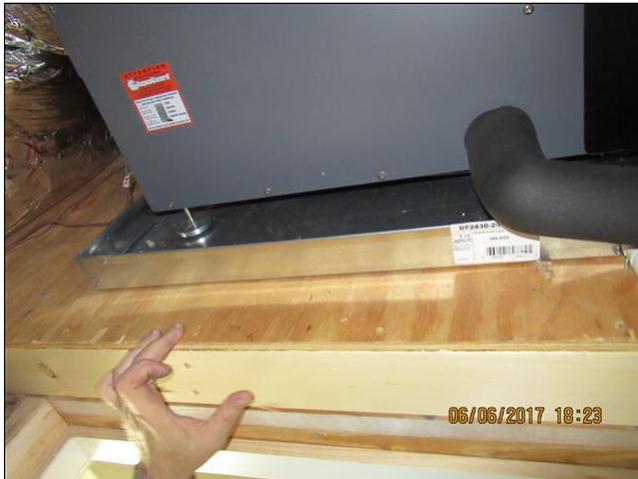
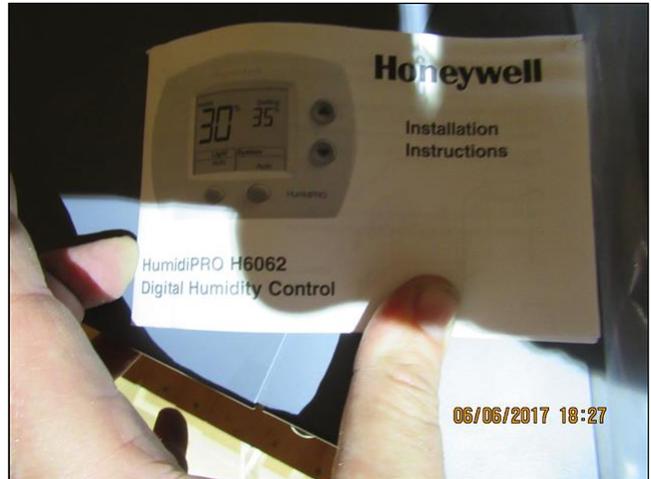
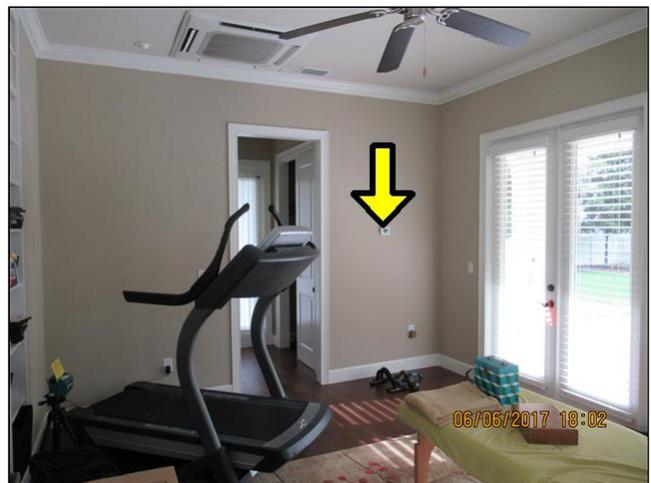
(4) There is a whole house dehumidifier installed in the cabana. This system is located in the attic above the cabana bedroom upstairs. The controls for it are on the wall of the cabana room near the entrance to the bathroom.
Item 4(Picture) Item 5(Picture) Item 6(Picture) Item 7(Picture)

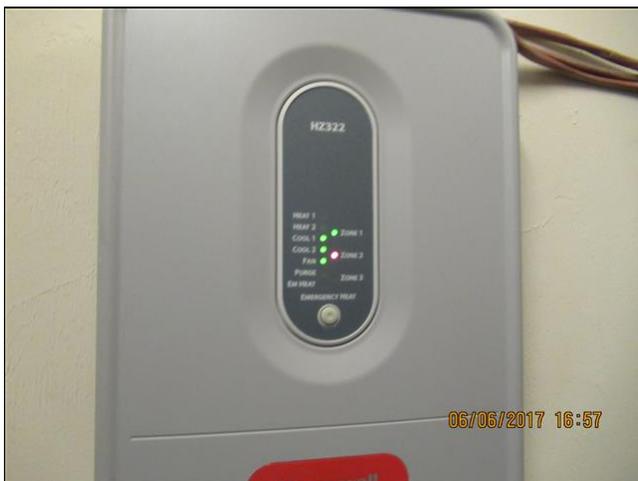
8.8 Item 11(Picture) Zone Monitor

(5) There is a zone monitor on the wall in the closet with the air handler. You can monitor which zone is currently being conditioned with this. Item 11(Picture)

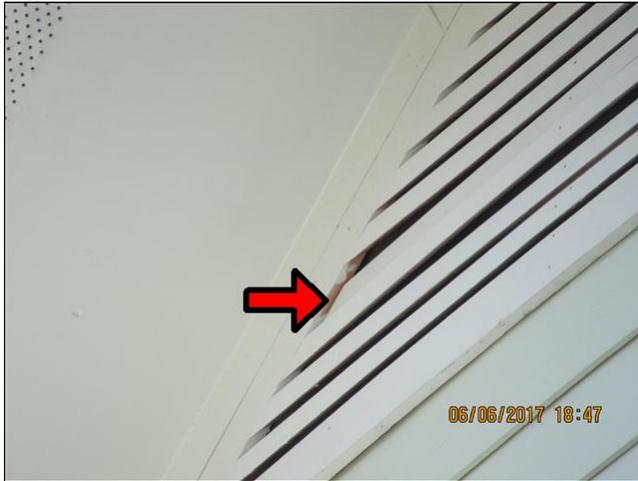
9.3 Item 1(Picture)

One of the boards for the gable ventilation of the attic on the cabana has become displaced. The Inspector recommends repair. Item 1(Picture) Item 2(Picture)

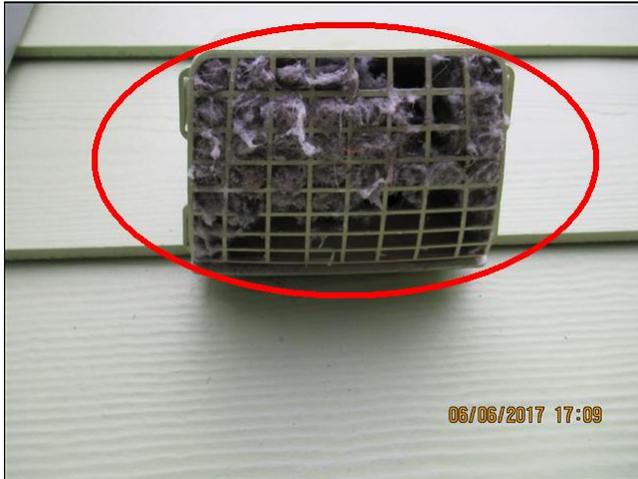
9.4 Item 1(Picture)

(1) The exterior dryer vent guard needs to be cleaned for proper operation. Item 1(Picture)

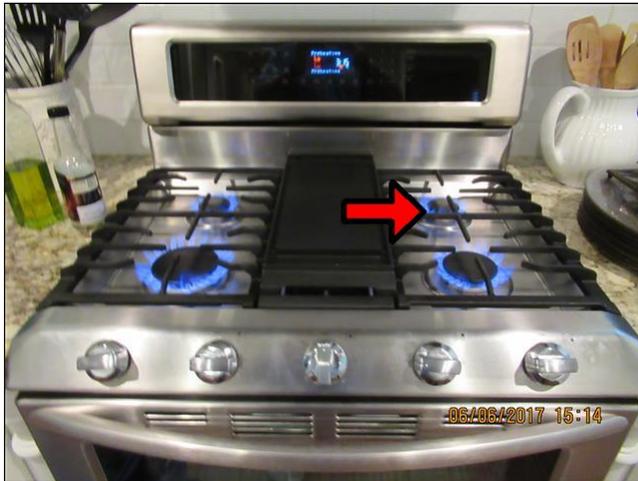
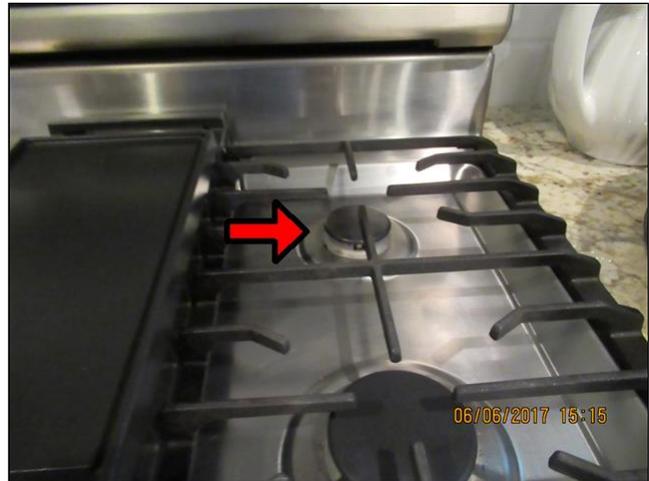
At the time of the inspection, the right rear burner goes out when the knob is turned to its lowest setting. The Inspector recommends an evaluation by a licensed contractor to determine the cost of repair. Item 1(Picture) Item 2(Picture)
