INTRODUCTION

13TH PIPELINE TECHNOLOGY CONFERENCE

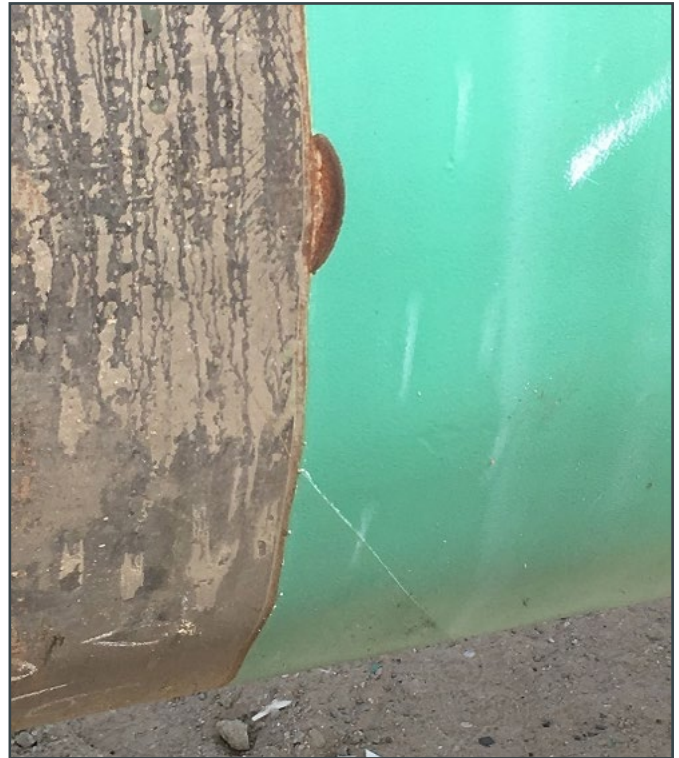
In a pipeline project in South East Asia, pipe end disbondment occurred with well-applied single layer FBE coated pipes after a 6-month storage in an open environment (Figure 1). In an Australian offshore pipeline project, the coating end disbondment issue occurred, after 8 months of exposure to an open environment, on a few MLPP coat-

Figure 1: End Disbondment of a FBE pipe coating

begins and creates the disbondment (Figure 1). Multiple initiation sites can later result in multiple disbondments growing together and a loss of adhesion around the circumference of the pipe.

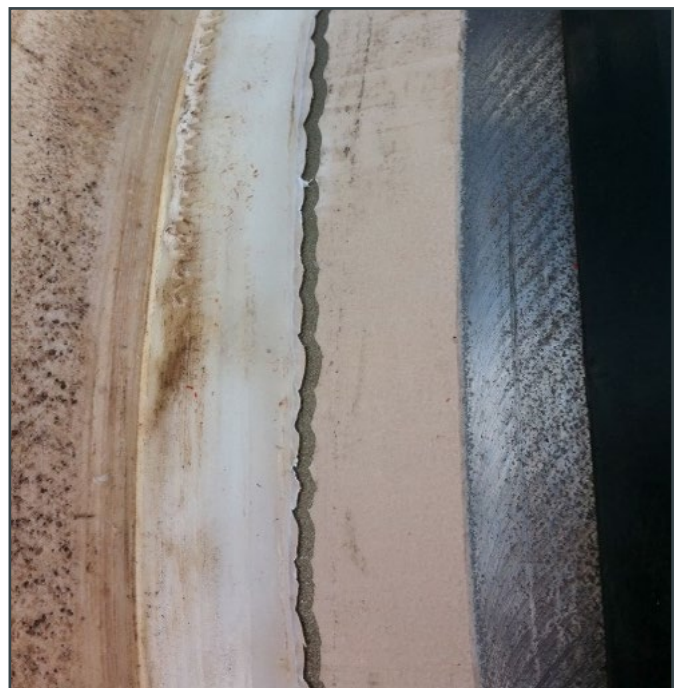
ed pipes with a FBE toe of >20 mm in length which was significantly longer than the typical 3-5 mm, intending to significantly reduce the SCF (Figure 2).

Figure 2: End Disbondment of a MLPP coating with a FBE toe (of >20 mm length vs. typically 3-5 mm)

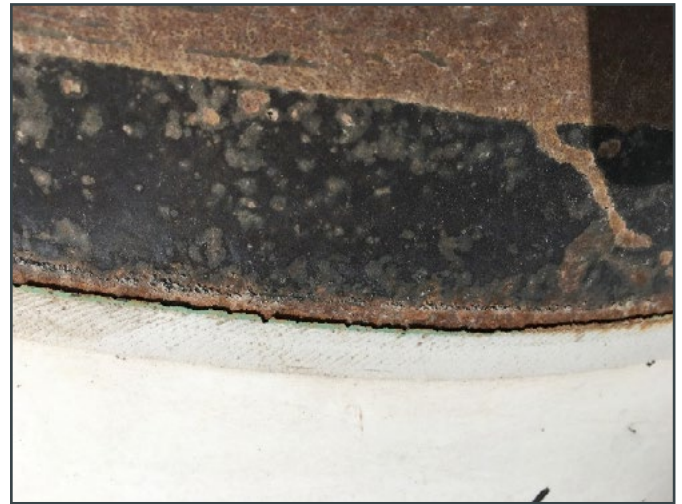
Figure 3b: End disbondment on a pipe with the FBE toe disappeared

In a 3LPP pipeline project in the Middle East, pipe end coating disbondment occurred when the cutback bevel angle was well below $<30^\circ$ (Figure 3a and Figure 3b) and with a 3-5 mm FBE toe. The first pipe (shown in Figure 3a) had some areas showing a 2-5 mm FBE toe remained but coating disbondment still occurred in some areas around the circumference of the pipe, delaminating between the FBE and the steel, after over 1 year exposure in an open environment. The second pipe (shown in Figure 3b) had most FBE toe disappeared, with some traces of FBE left in the toe area. Like the first pipe, the cutback bevel angle of the second pipe was less than 30° , complying with the project specification requirement. Some gouge damage on the cutback and the FBE toe were found from the investigated pipe ends of the first and the second pipe. However, localized end disbondment spots between good FBE toe and rust steel were also evident, suggesting that the use of FBE toes did not provide a sufficient protection to the pipe end from end disbondment when exposed to an open environment, and that the gouge damage on the FBE toes was not the key root-cause of the issue.
