# Inspection Report

1000 Sample, Perkins, Oklahoma 74059

**Inspection Date** November 7, 2016  
**Inspector** Bill Darbe #70001625  
(405) 697-4607  
[onpointpropertyservices@yahoo.com](mailto:onpointpropertyservices@yahoo.com)

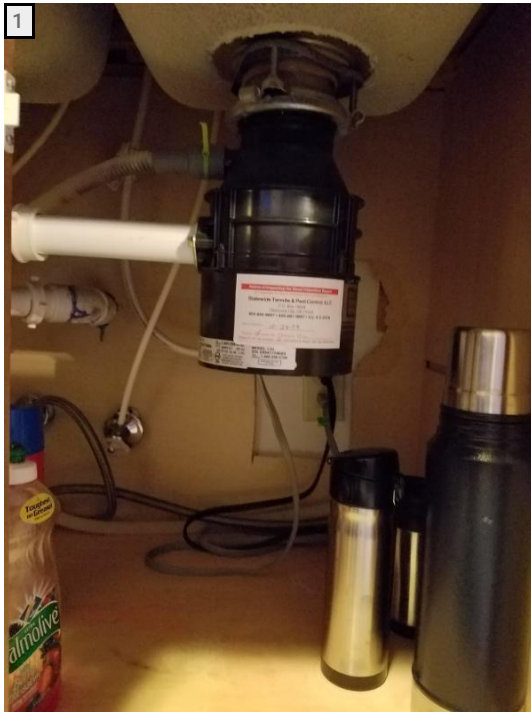
**In Working Order**

**Unit is in good condition**

Location Kitchen

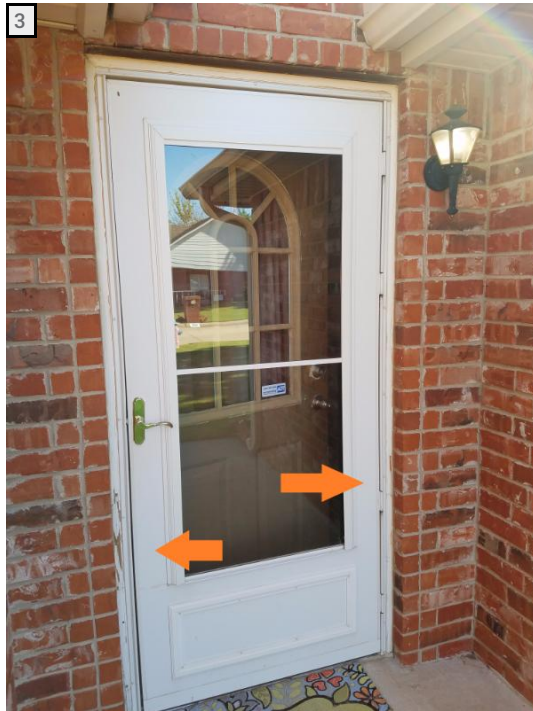
**Moderate Concern****Stain, paint or sealer has peeled, faded or bleached out**

<b>Location</b>	Exterior: Ground View
<b>Impact</b>	Without sealer, the wood is not protected from the elements
<b>Suggested Action</b>	Restain and/or reseal with a weather resistant sealer

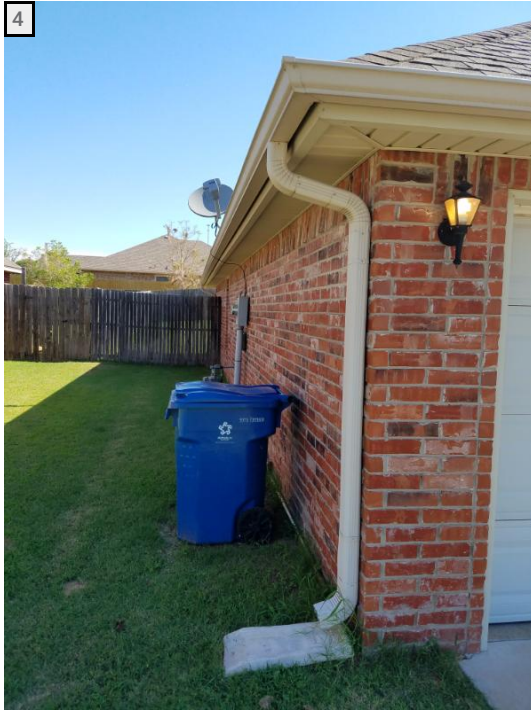
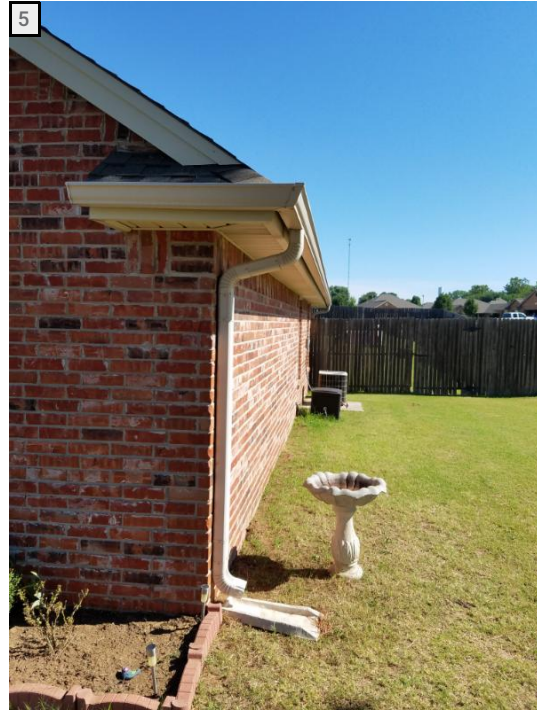
**In Working Order**

**Appears serviceable**

Location Exterior: Ground View

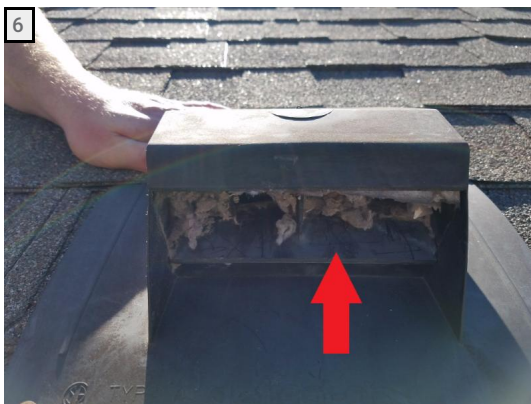
**Not Working**

**Obstructed preventing moisture elimination**

Location Exterior: Ground View  
 Impact If the exhaust fan is still working, the odor and smoke has no escape  
 Suggested Action If the vent is being used, clear the vent passage and install a bird cage style vent cover. If the vent is not in use then eliminate the exhaust passage and block off and seal the opening

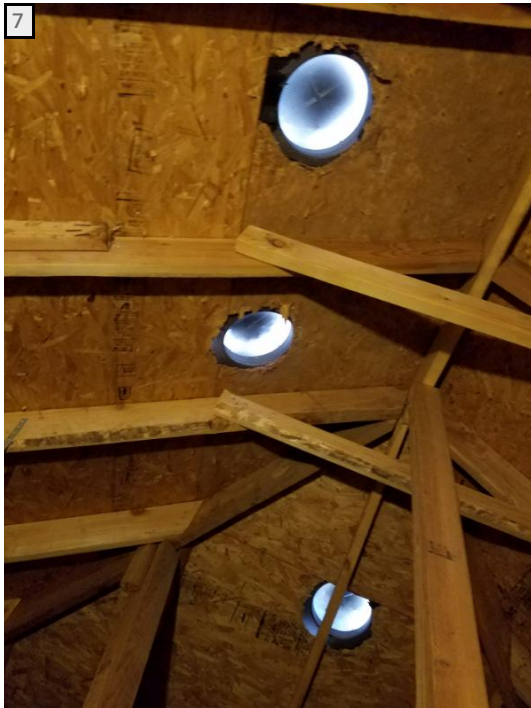
In Working Order

Satisfactory

Location Attic

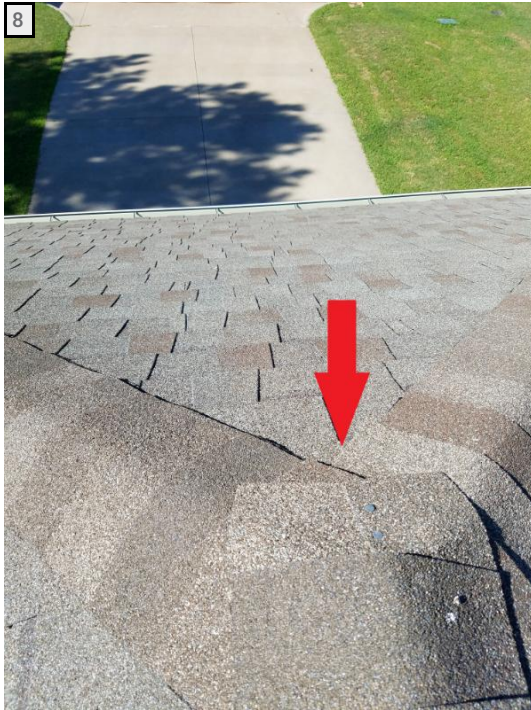
**Moderate Concern****Missing Ridge Shingles**

<b>Location</b>	Exterior: Roof View
<b>Suggested Action</b>	Replace missing shingles

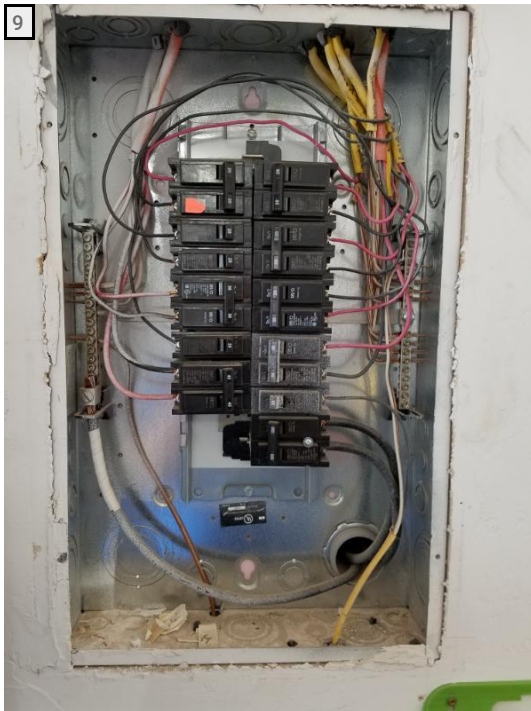
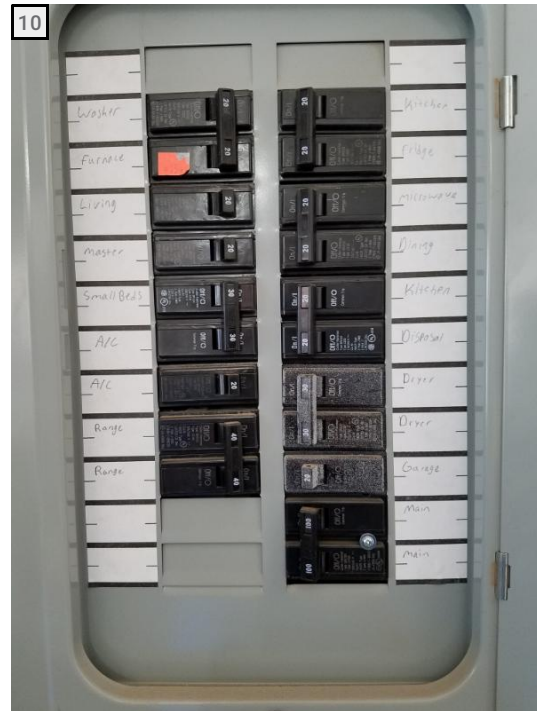
In Working Order

Satisfactory

Location Exterior: Ground View

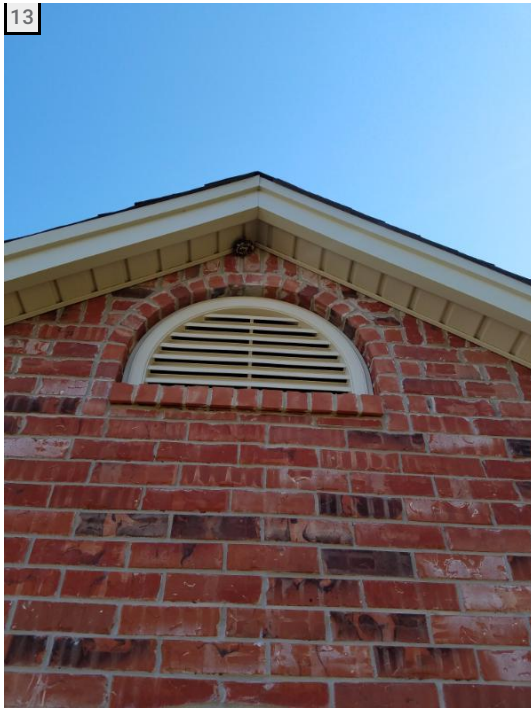
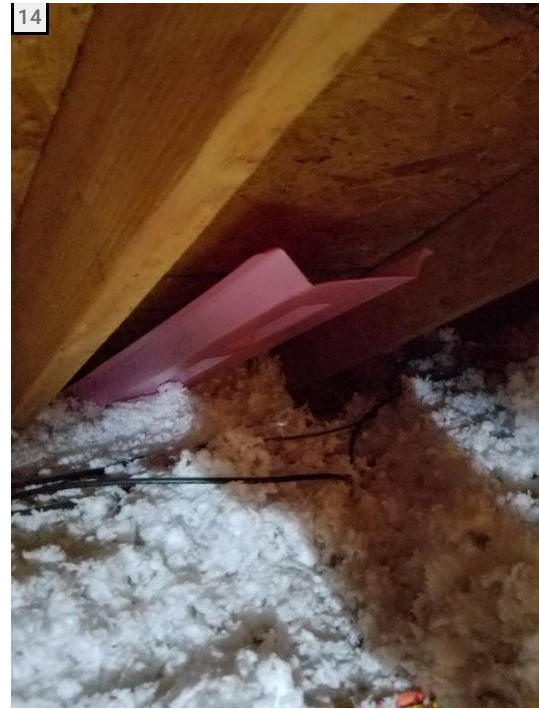
**In Working Order**

**Satisfactory**

<b>Location</b>	Exterior: Ground View
-----------------	-----------------------

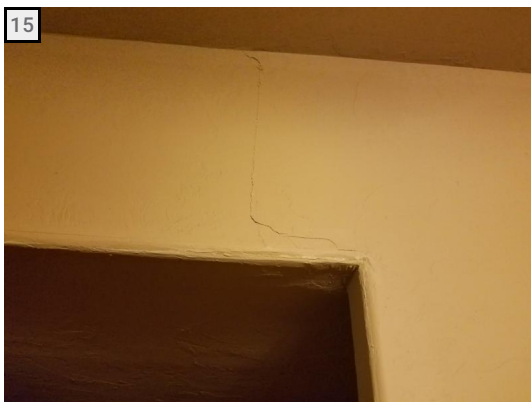
#### Drywall has settling cracks

Location	Living Room
Suggested Action	Repair with drywall tape and drywall compund and repaint

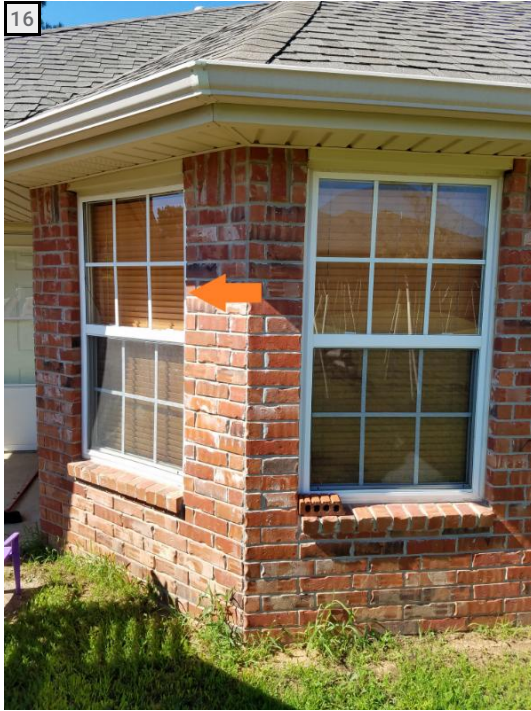
### Window

**Moderate Concern**

**Glass pane is cracked**

<b>Location</b>	Exterior: Ground View
<b>Impact</b>	The cracks expose sharp edges and reduce protection from the elements
<b>Suggested Action</b>	Replace the glass
