Comprehensive Lake Management Planning

Pioneer Lake

Vilas County, WI

Created By: Many Waters, LLC
2527 Lake Ottawa Road
Iron River, MI 49935

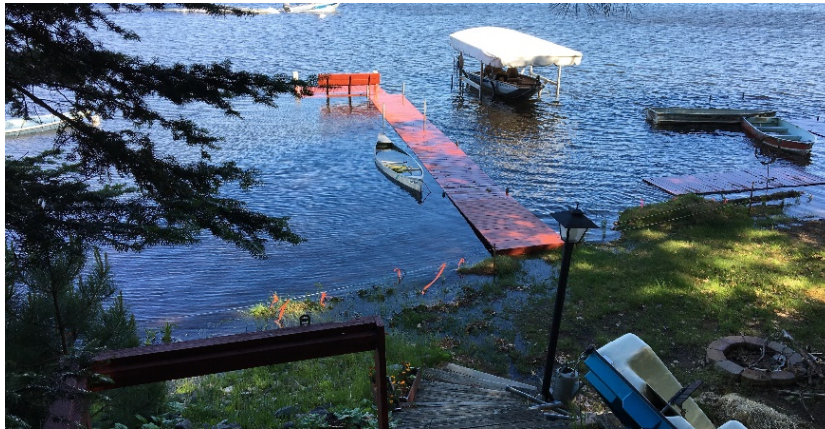
Photo 3: Flooding damage on one Pioneer Lake Property (2017). Mary Finlay.

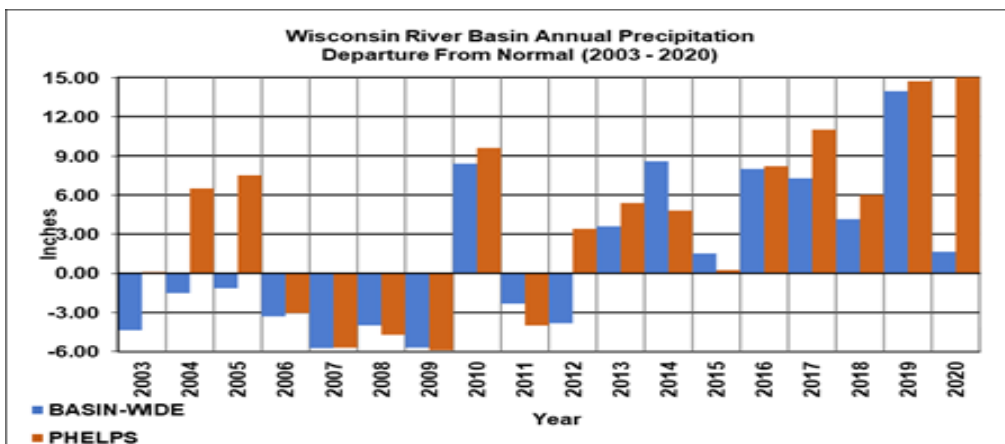
Figure 1.1: Wisconsin River Basin Annual Precipitation Departure from Normal (2003-2020) (WVIC).

regulate the flow from the much larger volume of the Twin Lakes reservoir. WVIC states that operations of Twin Lakes Dam have reflected the hydrologic conditions of the watershed. In the corresponding report (Article 421- Operating Plan Status Report and Review) referencing this response, WVIC details that the last 8 years have been the wettest on record since data was kept starting in 1890. The report states that the 8-year (2013-2020) cumulative departure above normal precipitation within the entire operating system of WVIC is 50 inches. It is important to note that precipitation at Phelps, Wisconsin, where much of the subject drainage basin is located is more than 65 inches above normal during this same 8-year period and adding 2012 amounts into the data, the sub-basin is nearly 70 inches above normal. The following graphic shows the comparison.

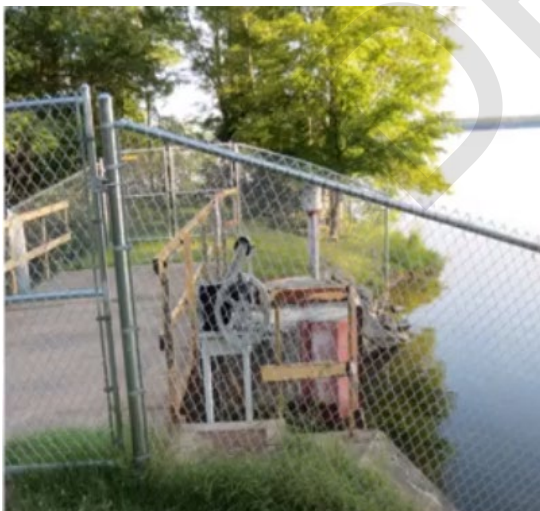
Photo 4 : Twin Falls Dam, 2017. PLA.

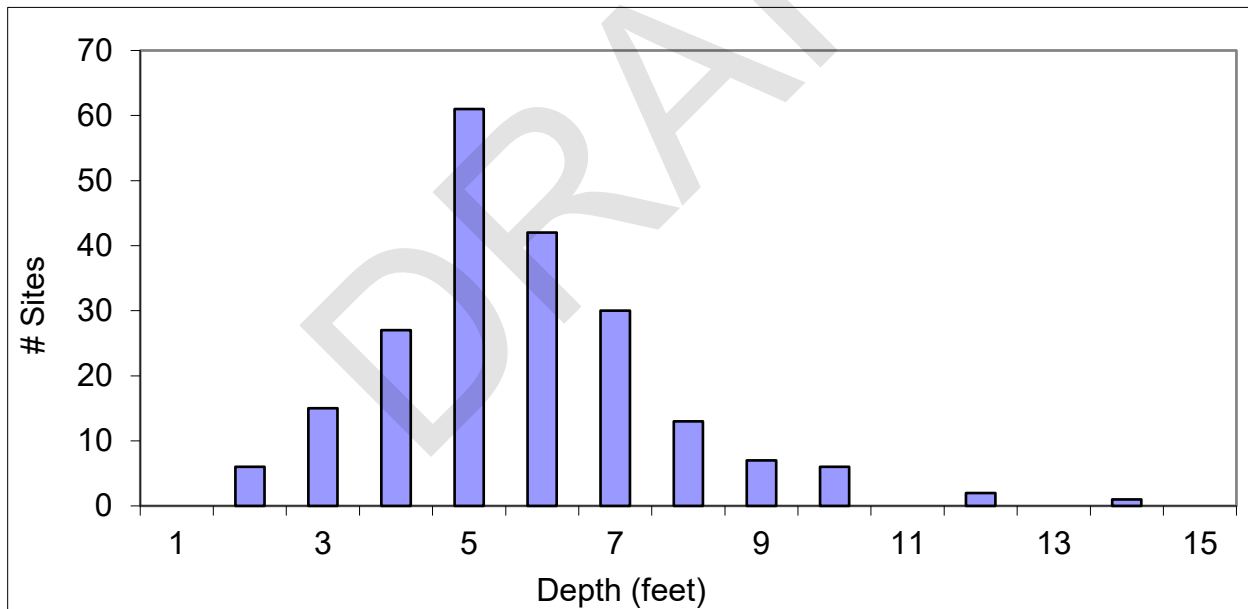
Figure 2.3: Depth of aquatic plant colonization – Pioneer Lake, 2019.

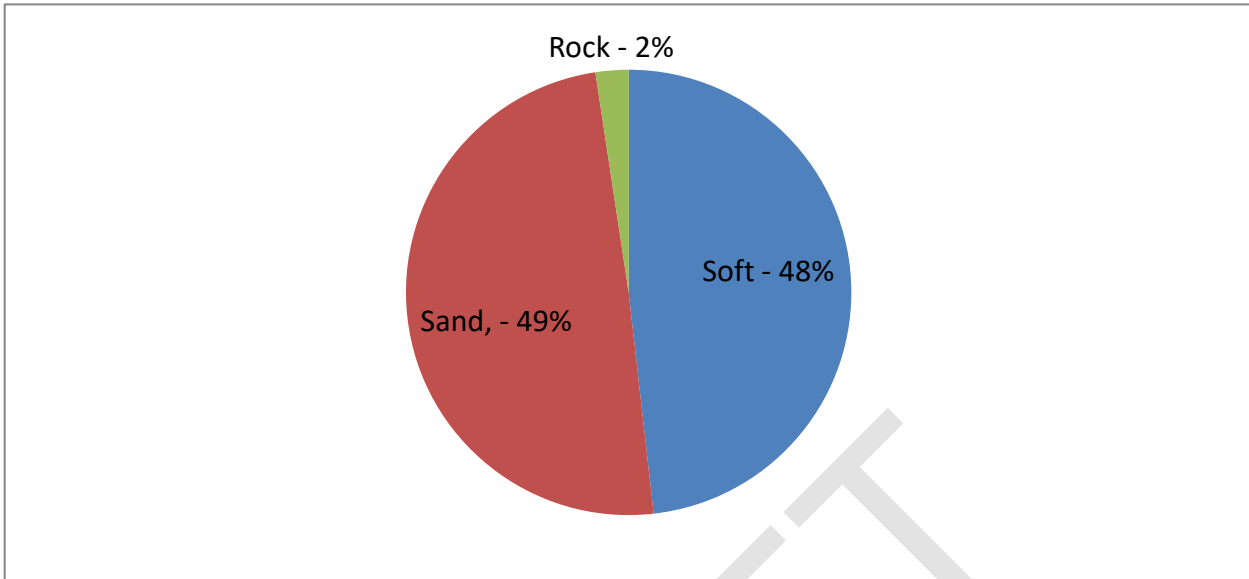
Figure 2.4: Bottom substrate consistency – Pioneer Lake, 2019.

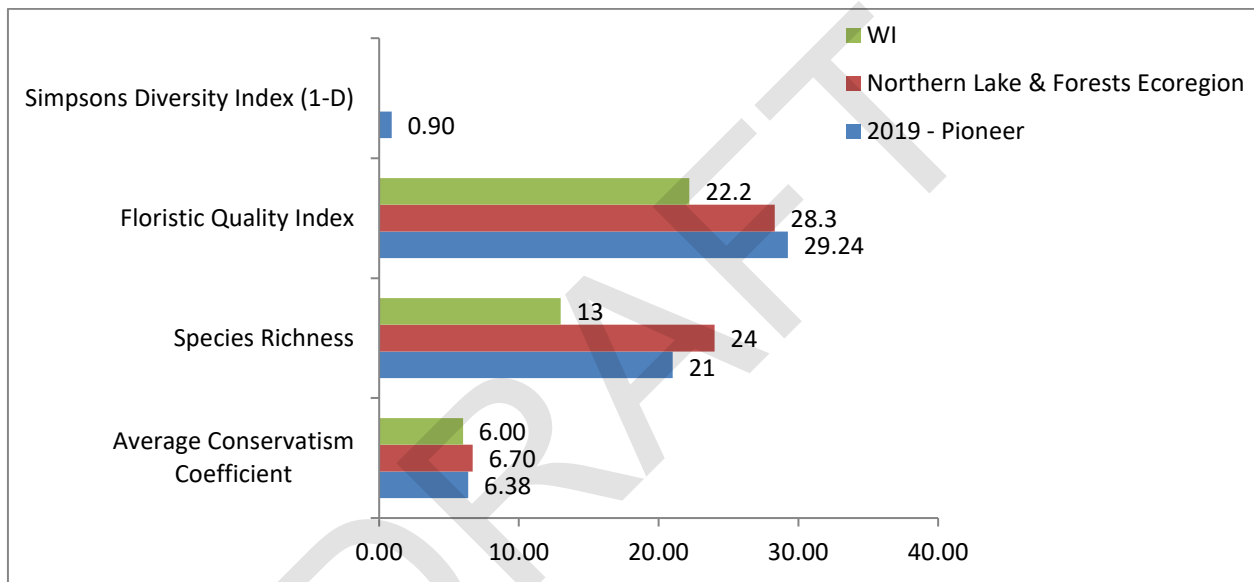
Figure 2.6: Summary of Pioneer Lake’s floristic quality and diversity, 2019.

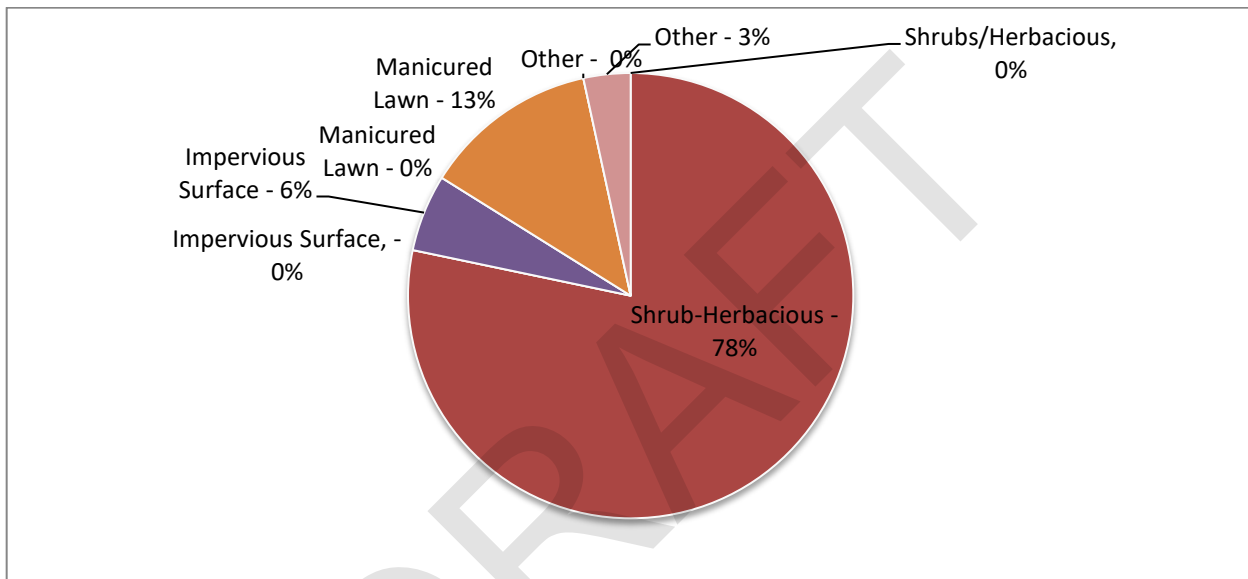
Figure 4.2: Breakdown of total “ground-layer” riparian buffer by riparian coverage type, Pioneer Lake – 2019. Note: This breakdown does not include canopy- total canopy cover for Pioneer Lake buffer zone was 61%.

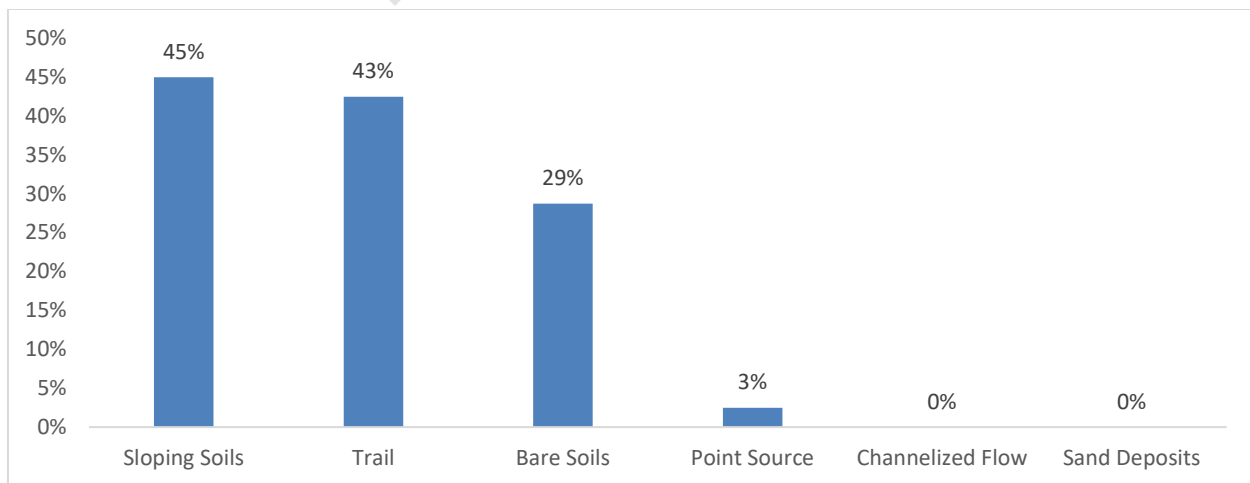
Figure 4.3: Percent of total properties contributing potential runoff to the lake by runoff type, Pioneer Lake – 2019.

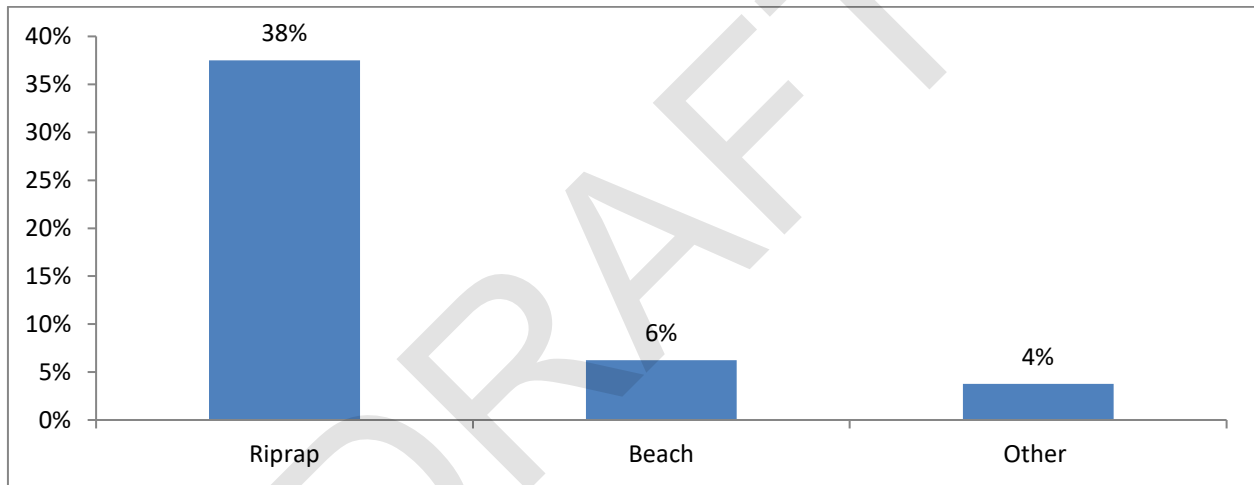
Figure 4.4: Percent of properties with observed bank zone modifications by type – Pioneer Lake, 2019.

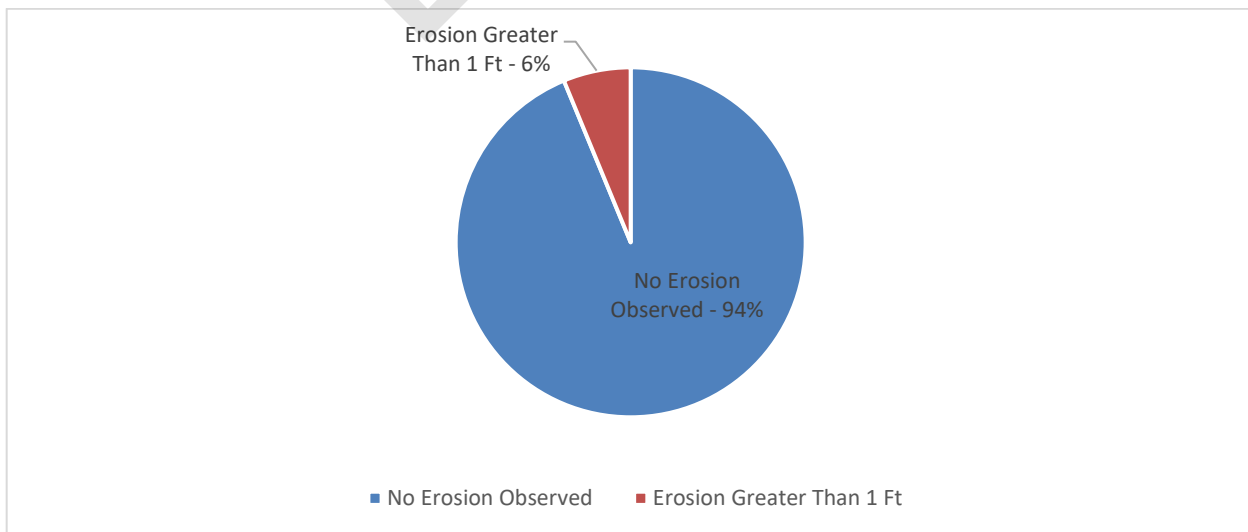
Figure 4.5: Percent of parcels with observed erosion – Pioneer Lake, 2019.

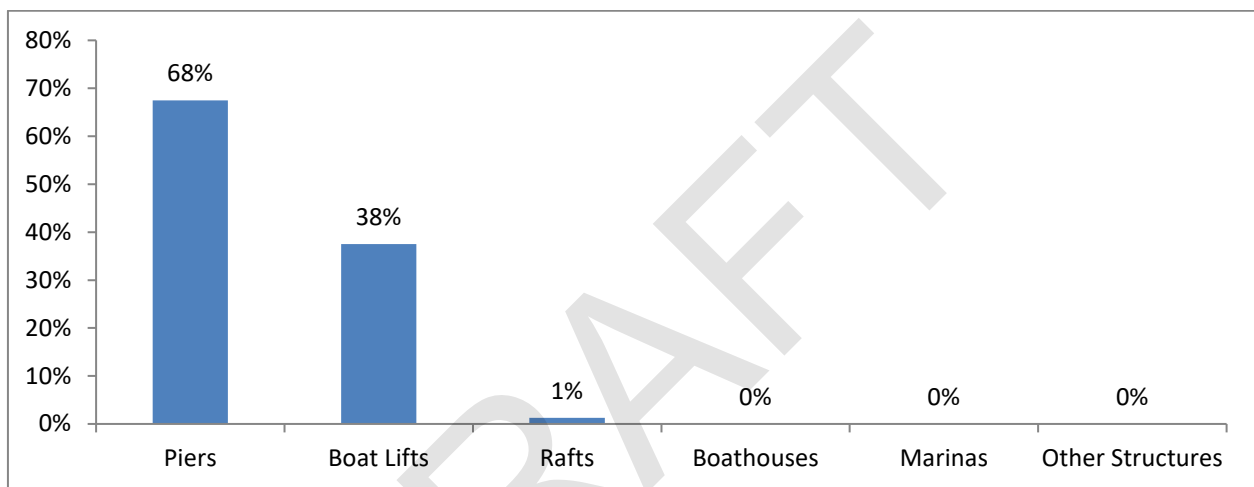
Figure 4.6: Percent of properties with observed littoral zone features – Pioneer Lake, 2019.

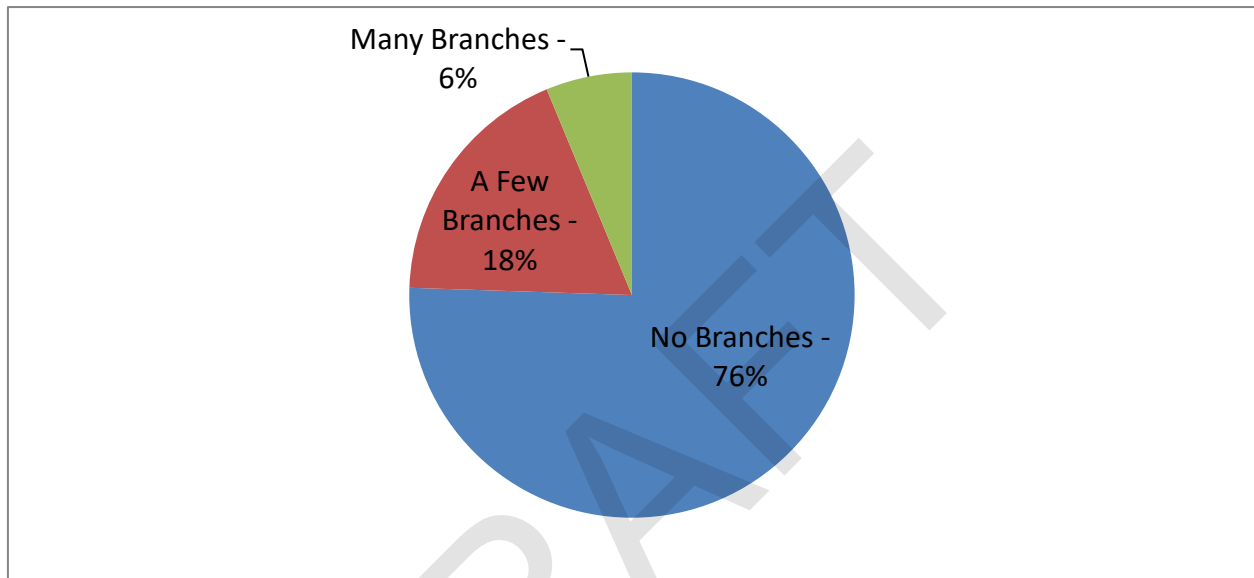
Figure 4.8: Percent of coarse wood debris by branching type – Pioneer Lake, 2019.

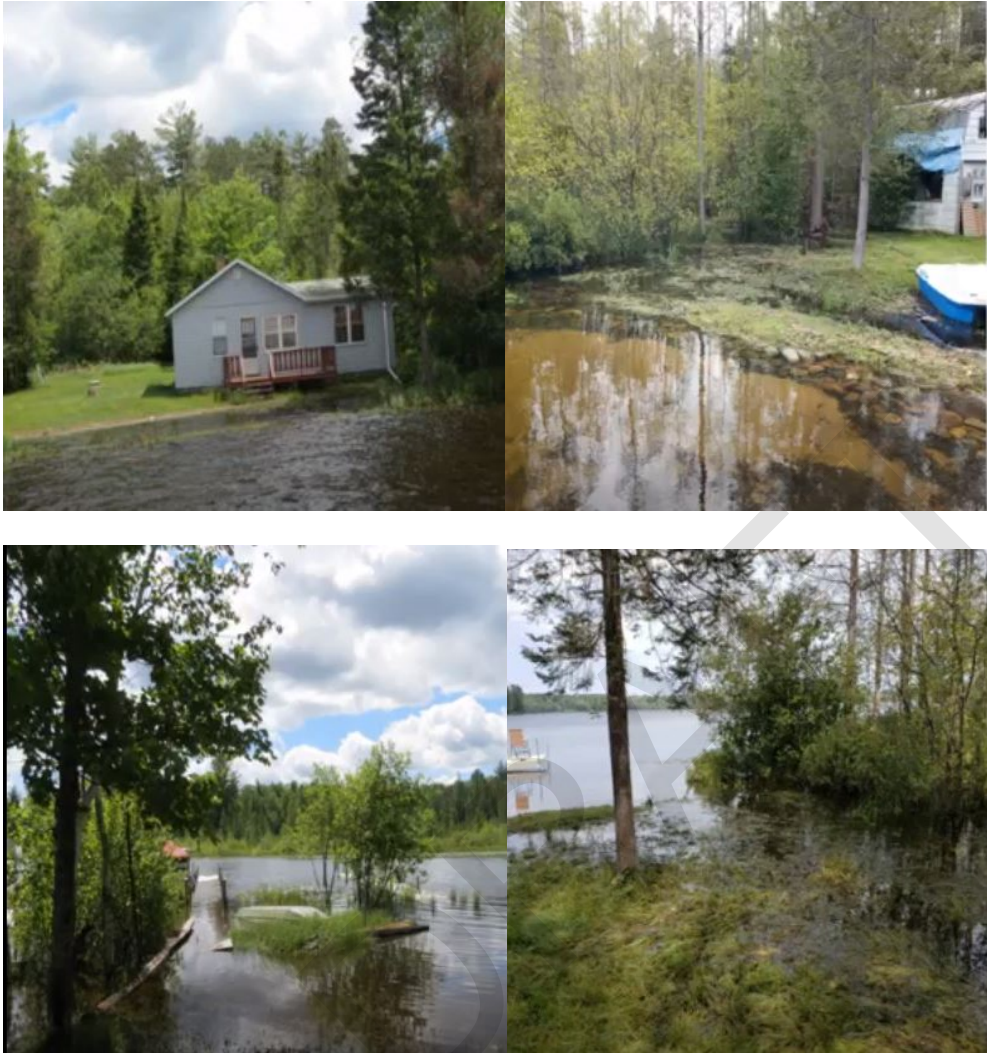
Photo 6: A sampling of shoreland flooding on Pioneer Lake following 2017 extreme rain events. M. Finlay.

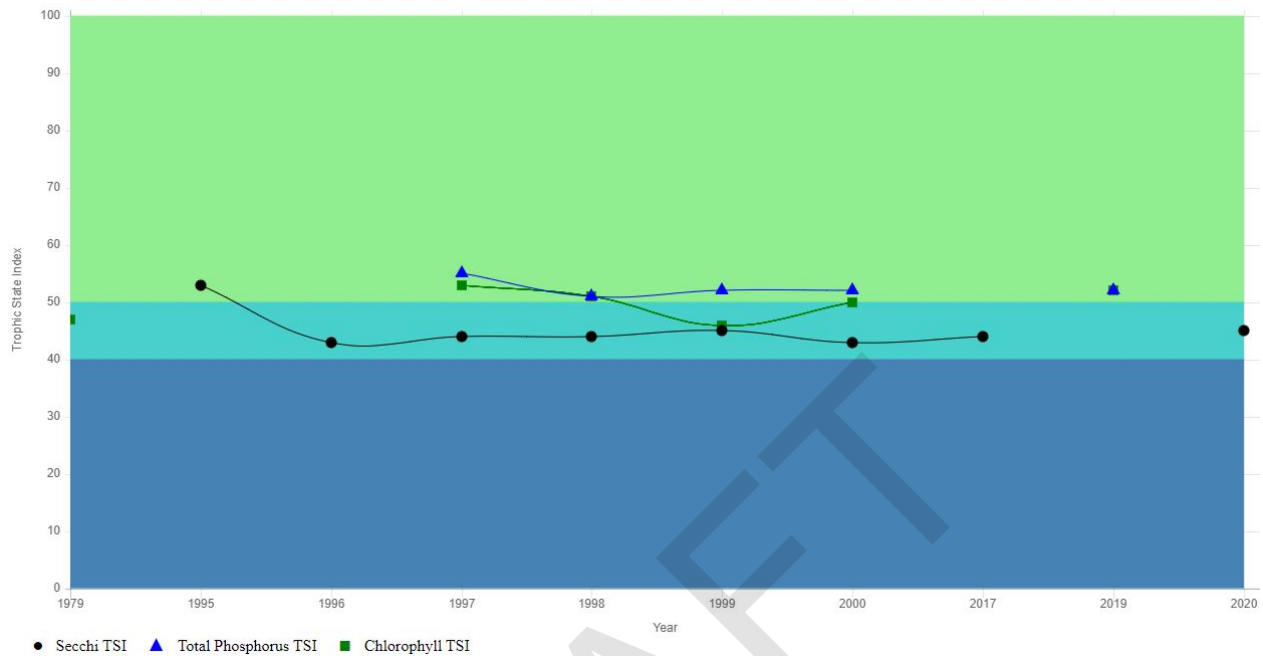
Figure 5.1: Pioneer Lake’s trophic status based on water transparency, total phosphorous, and chlorophyll *a*.¹⁶

Comparing TSI values to Pioneer Lake’s natural community type, Pioneer Lake’s general condition is considered good, meaning water quality parameters are at or below designated thresholds assigned to that lake for fish and aquatic life and fish consumption (Figure 5.2). General condition assessment for recreational use is currently unknown. Pioneer Lake had been listed as impaired for fish consumption due to mercury contaminated fish tissue. This impairment listing has since been removed during the 2020 assessment process due to changes in the State assessment process.

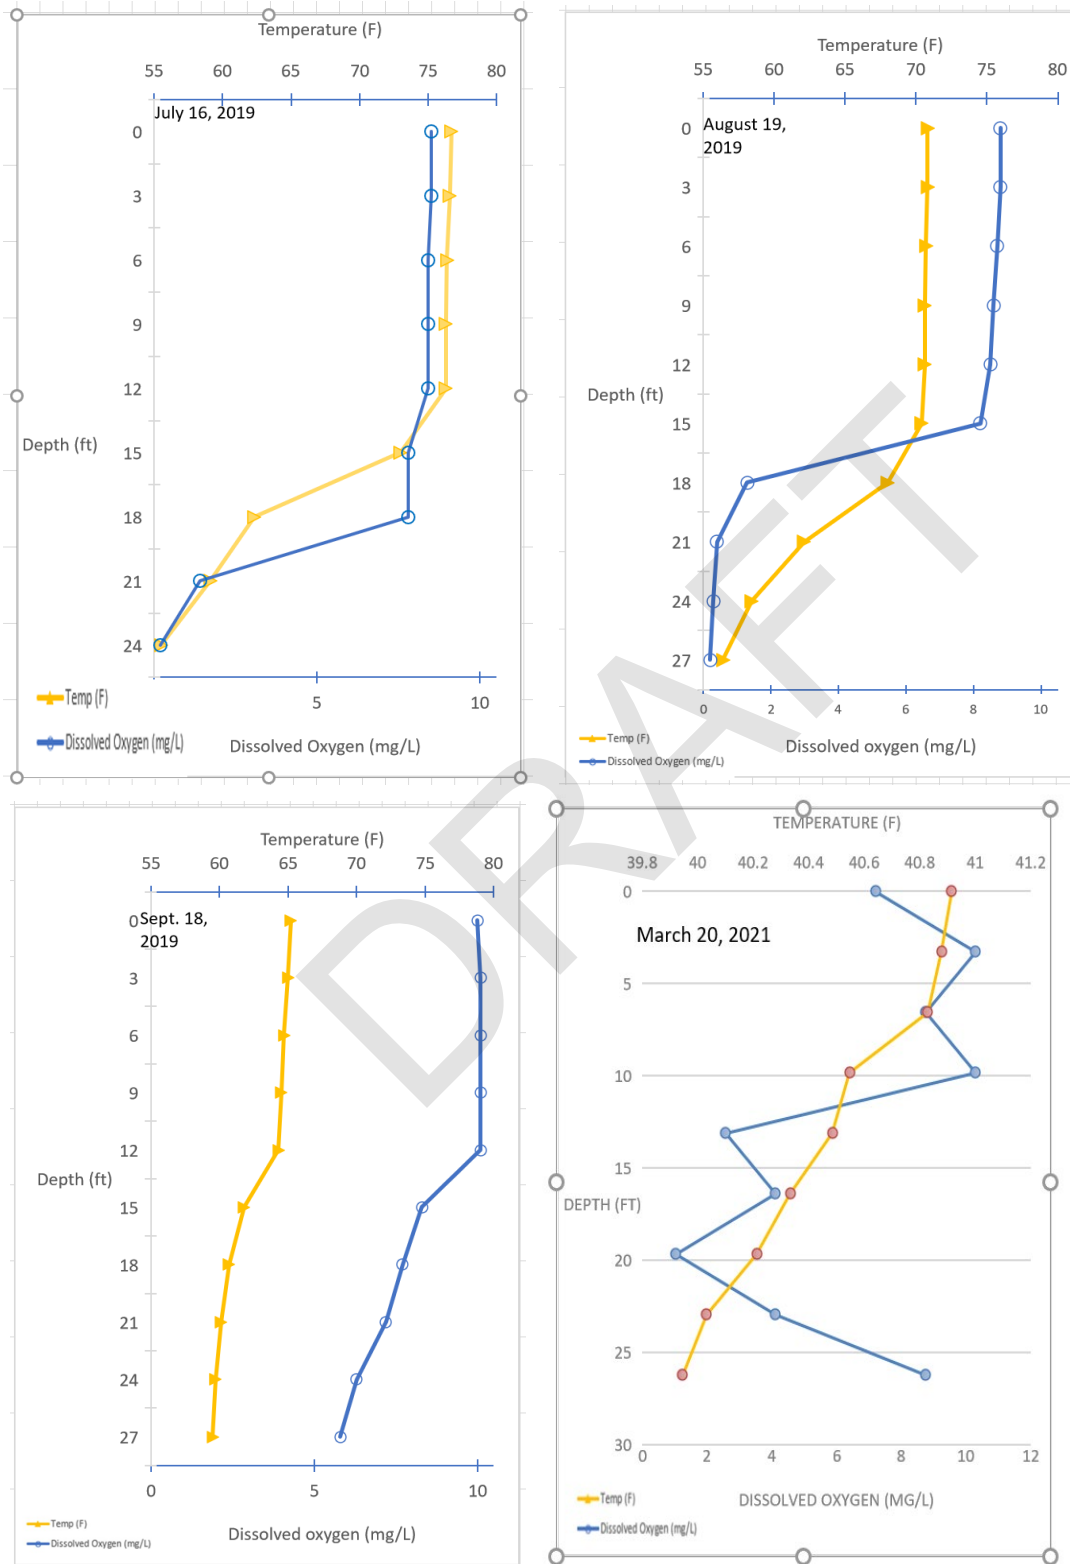
Figures 5.6-5.9: Dissolved oxygen and temperature profiles July, August & September 2019, and March 2021 –Pioneer Lake. 2019 data collected by VCLWCD, 2021 data collected by Many Waters.

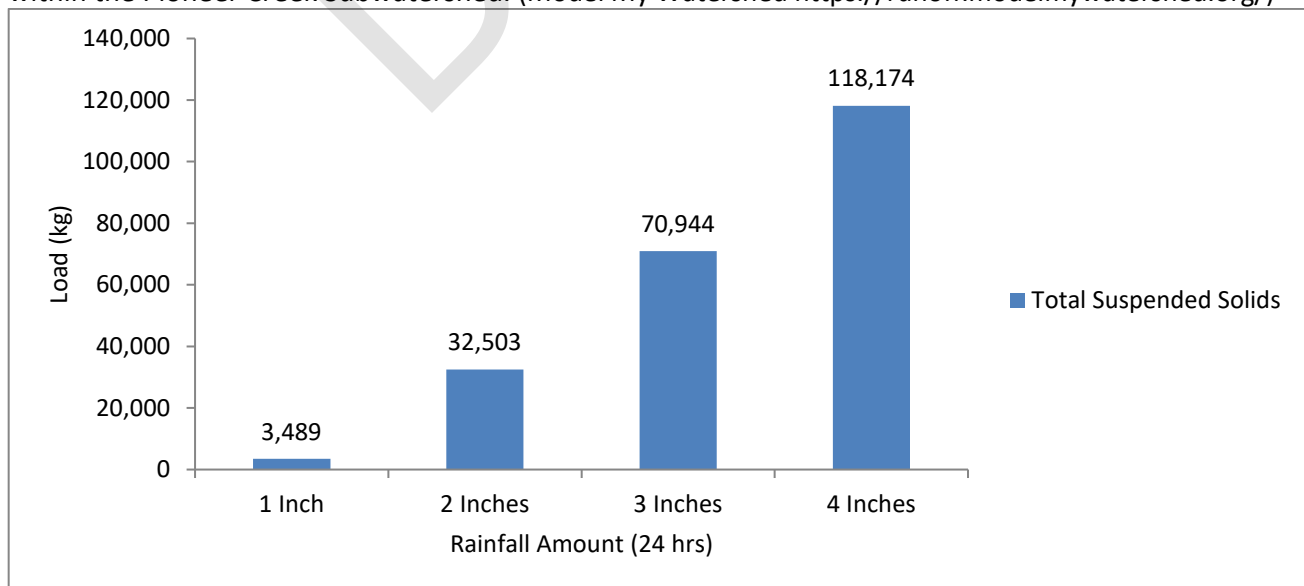
Figure 6.2: Comparing potential amount of total suspended solids loaded to different rainfall events within the Pioneer Creek Subwatershed. (Model My Watershed <https://runoff.modelmywatershed.org/>)

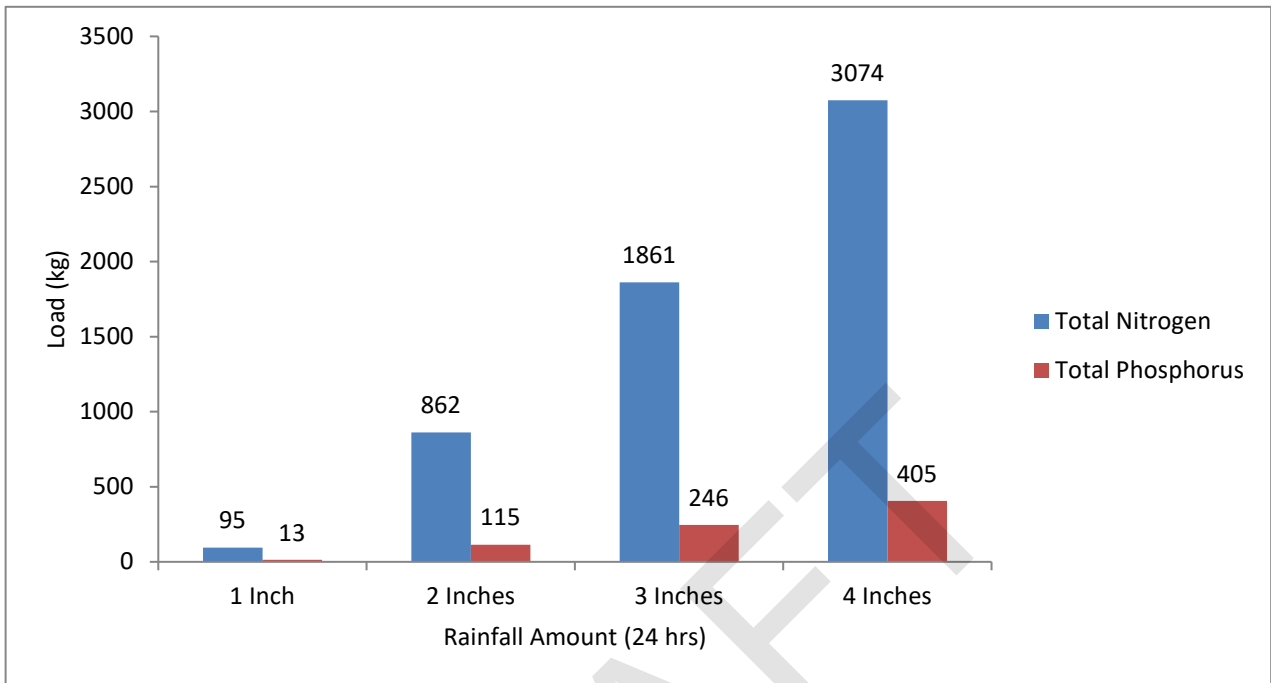
Figure 6.3: Comparing potential amount of nitrogen and phosphorous loads to different rainfall events within the Pioneer Creek Subwatershed. (Model My Watershed-<https://runoff.modelmywatershed.org/>)
