Inspection Issues Report

Fair Home Inspections Inc.

123 main street
Chicago, IL 60542

Date: May 12, 2018

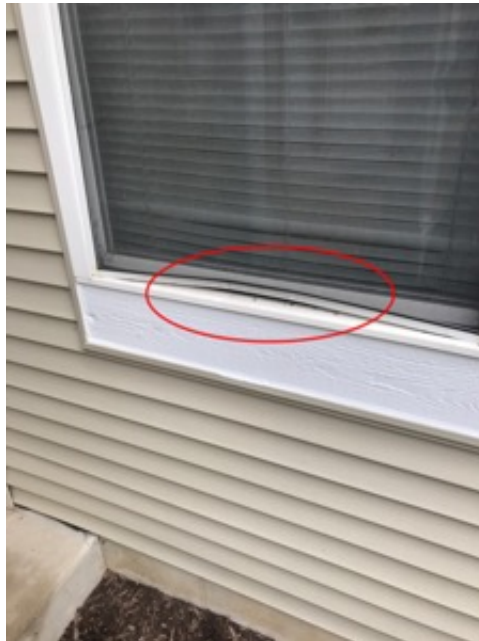
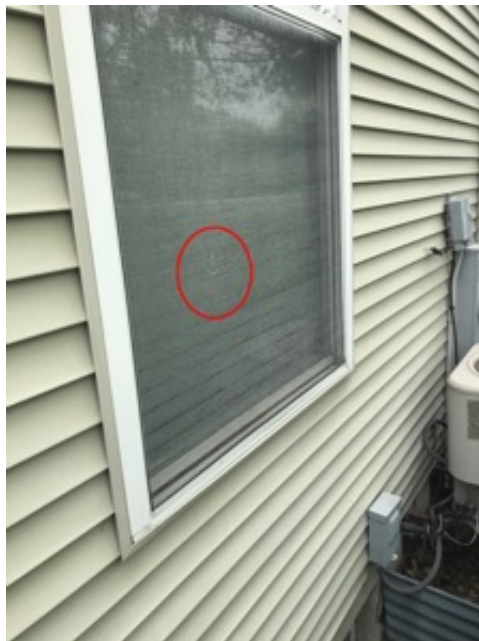
Location : Front

Condition: Damaged screen - Screening is damaged in multiple areas and in need of repair.

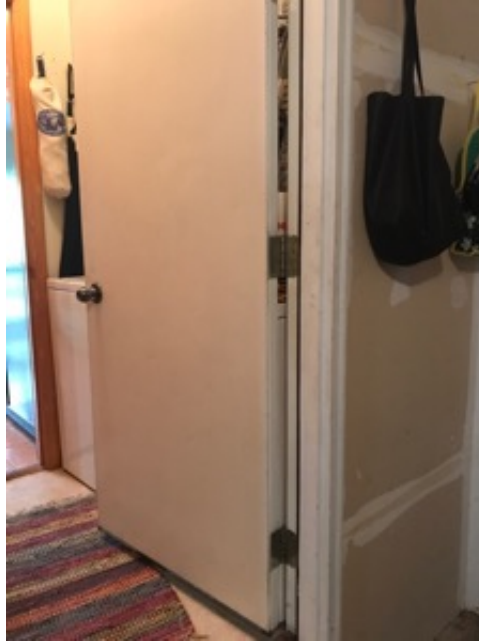
Condition: **No fire door** - self-closing hinges on fire rated doors and jambs are missing between attached garage and living space.

Ratings : Hazardous

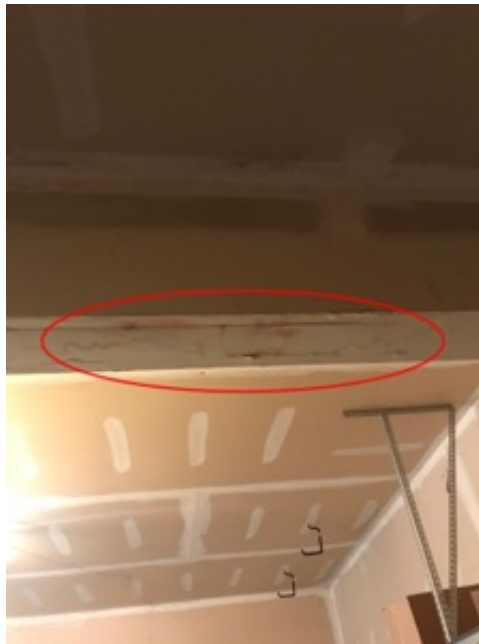
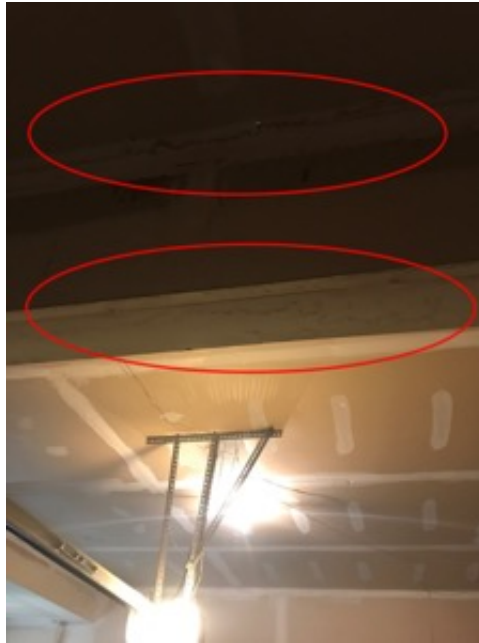
Water stains - Water stains were noted. Stains are evidence of prior water penetrations. Monitor and repair if needed.

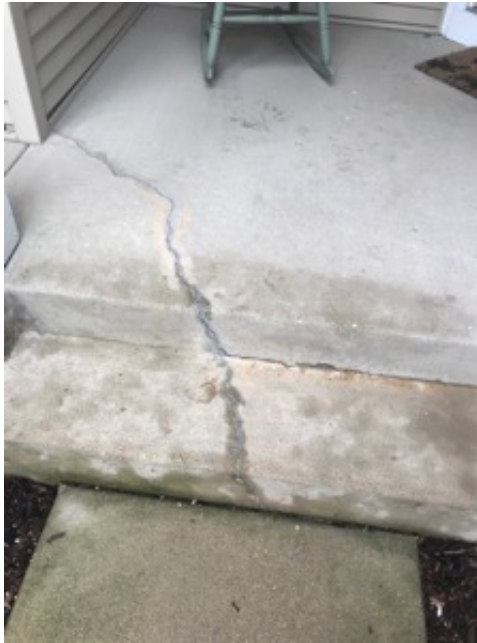
Condition: Cracks (minor) - Some cracks were noted that are minor in nature. Small expansion or settlement cracks are a common occurrence and if need be repaired, providing that the settling has stopped.

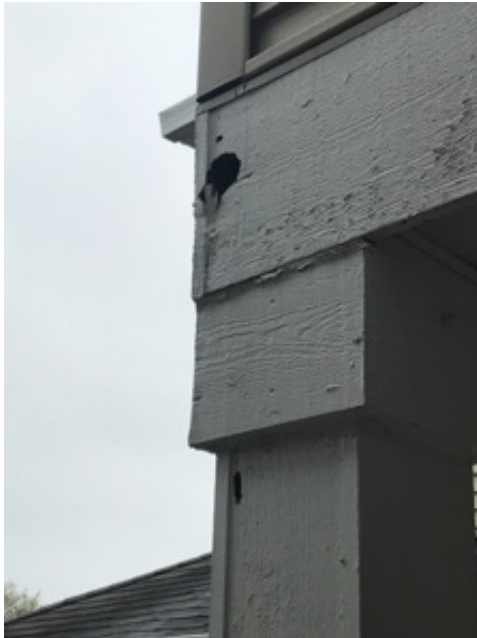
Physical damage - Physical damage was noted and should be repaired.

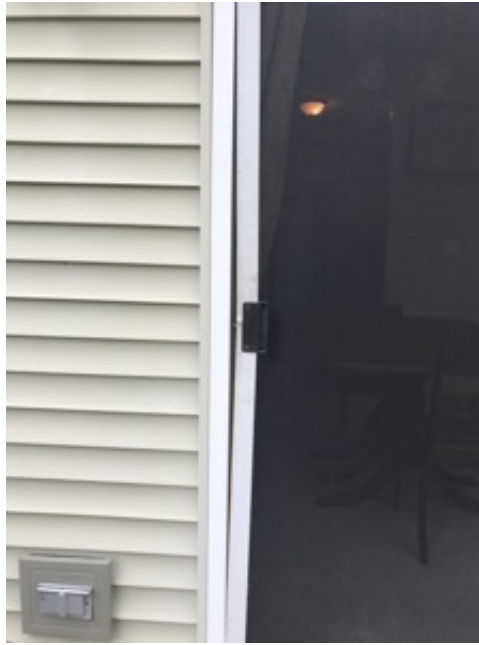
Damaged screen - Screening is damaged and in need of repair. Door does not close fully.

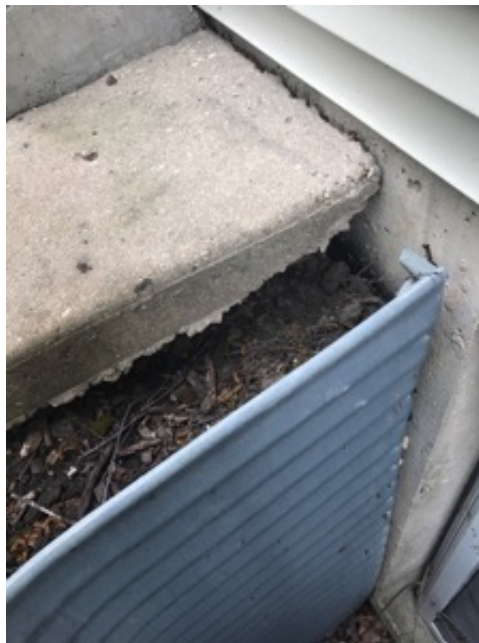
Location : Rear, Patio

Condition: Undermining of slab - Dirt under slab is being washed away. It is my opinion that this can lead to settling and should be evaluated further by a certified professional.

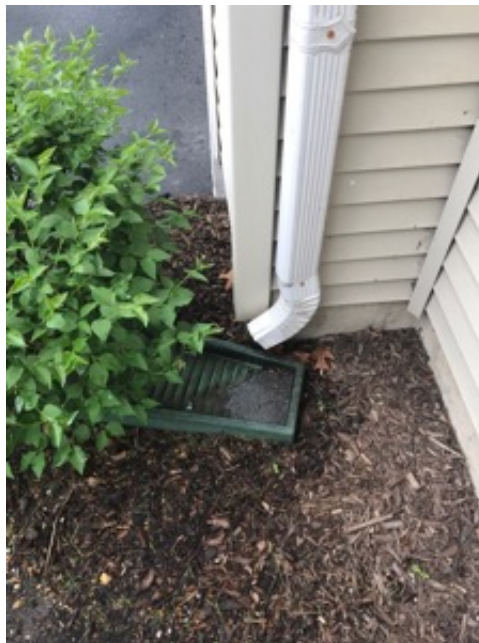
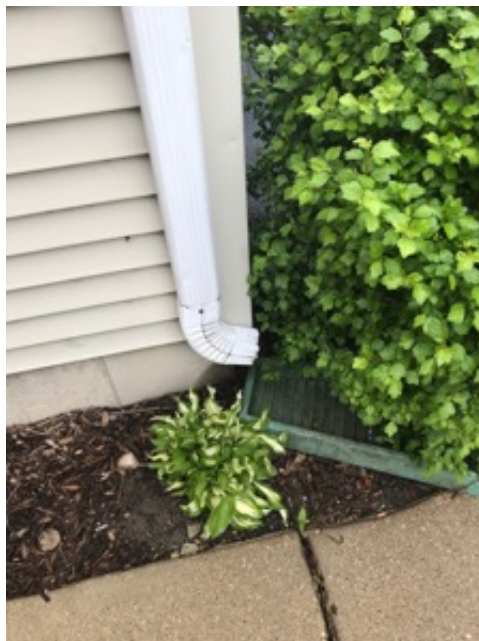
Condition: Discharge near foundation - Downspout is discharging close to the foundation. This may cause water to enter the building. It is recommended that all downspouts be extended 3 to 4 feet from the foundation.

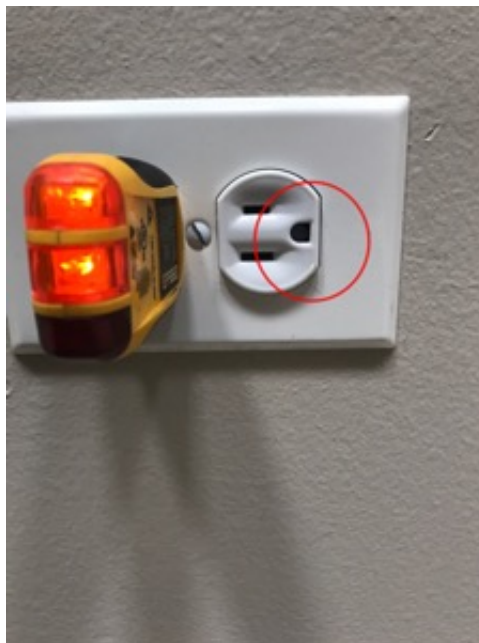
Location : Lower Level

Three-prong - Ground plug is broken off in receptacle therefore not allowing a grounded plug to be plugged in. I suggest a certified electrician evaluate further.

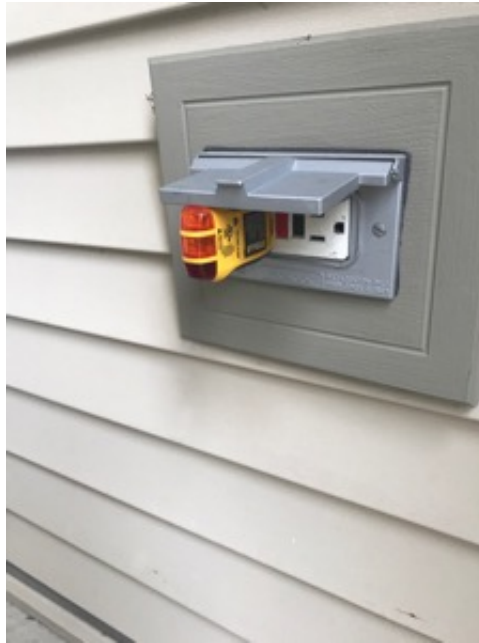
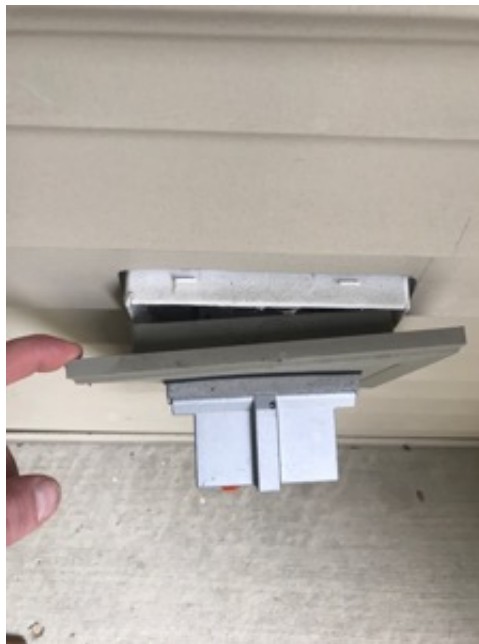
Location : Front, Porch

Condition: GFCI broke - The Ground Fault Current Interrupter is broken. Its safety capabilities are therefore eliminated. Replacement is needed.

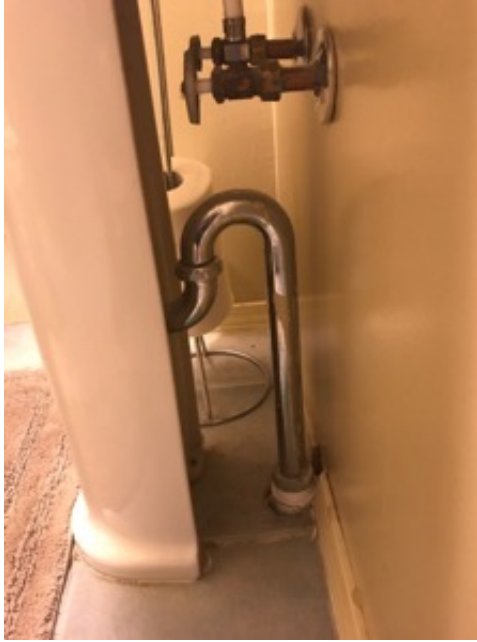
Condition: **Improper trap** - The waste piping does not contain a proper trap. This should be corrected.

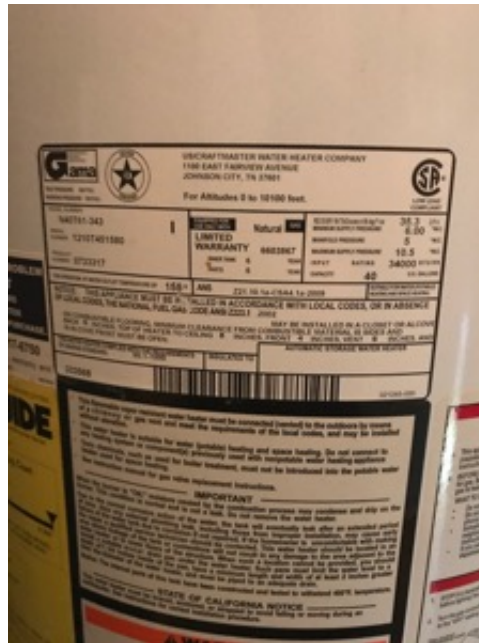
Size: 40 - The typical life expectancy of a water heater is 8-12 years. This water heater was manufactured in 2009, putting it at the end of its expected life.

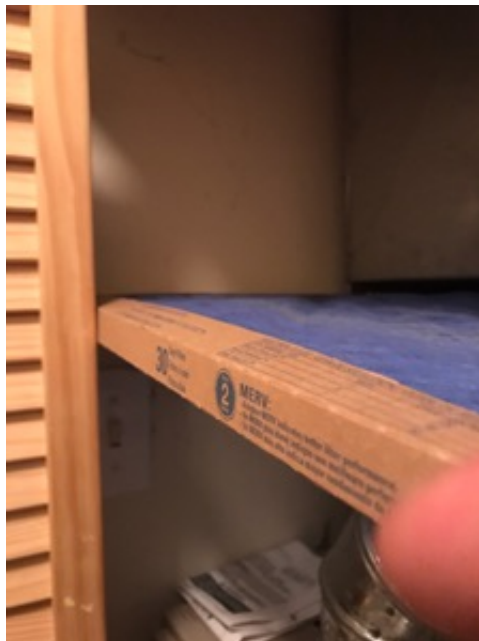
Location : Utility room

Condition: **Filter cannot be removed easily** - The door for the utility closet blocks the filter so it cannot be removed freely.

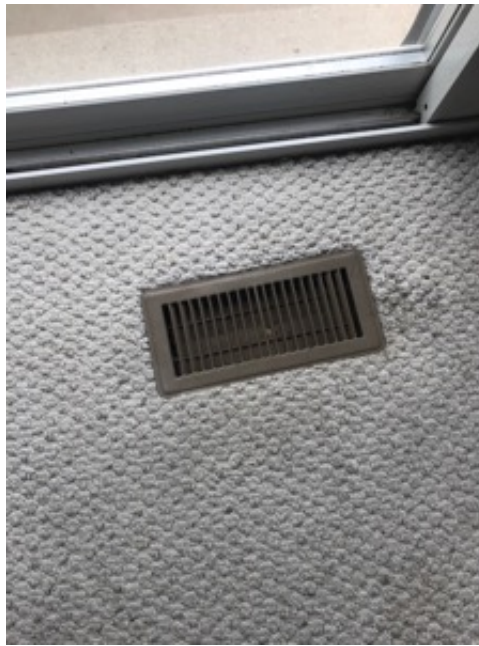
Location : First Floor

Type: Vent cover - Vent cover does not open or close properly

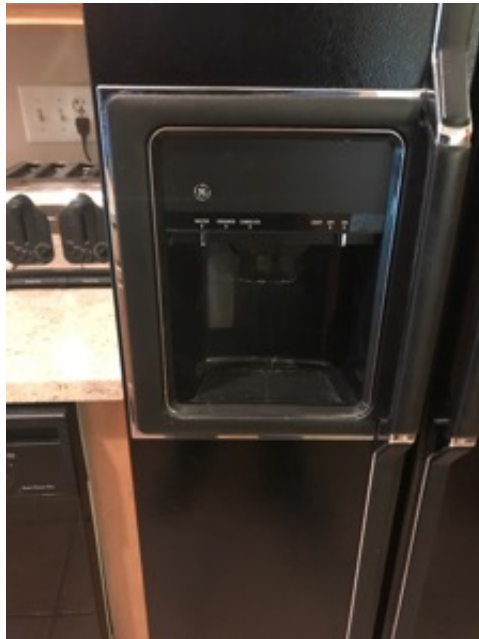
Location : Kitchen

Condition: **Not operational** - Water dispenser did not work when switch was turned on. Check and repair as needed.

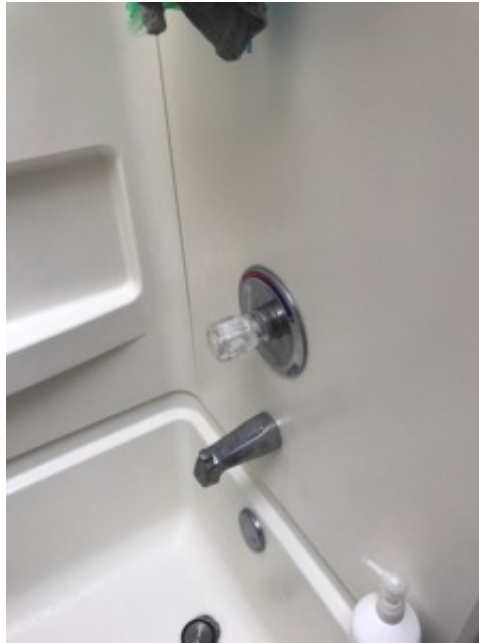
Type: Shower - Shower valve appears to be broken. Handle turns 360 degrees, which in my professional opinion is not correct. This can lead to scalding. I, Ryan Fair, am a licensed plumber.

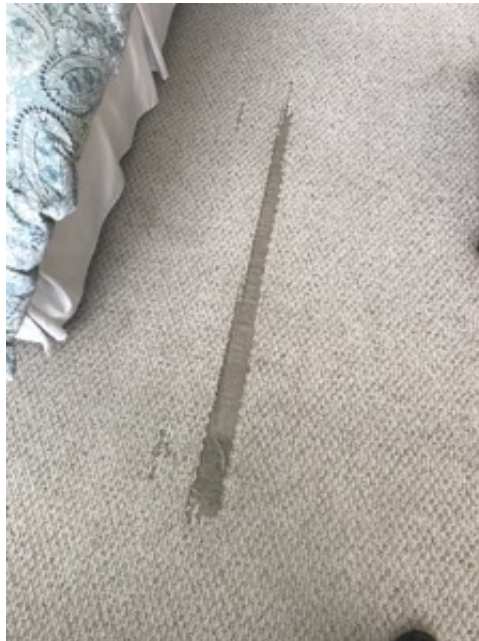
Location : bedroom

Condition: Physical damage - Physical damage was noted and should be repaired.

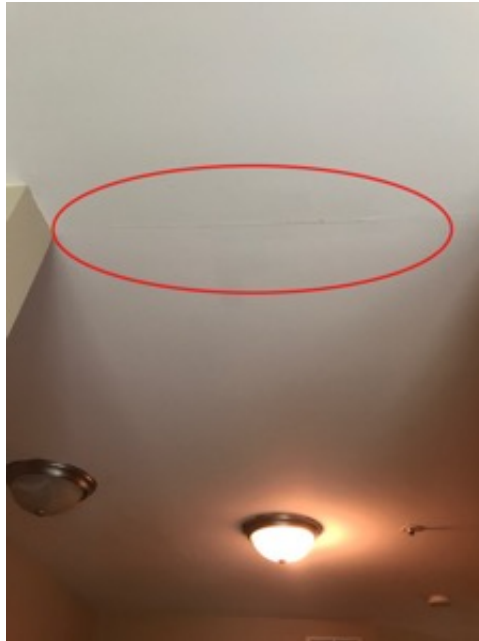
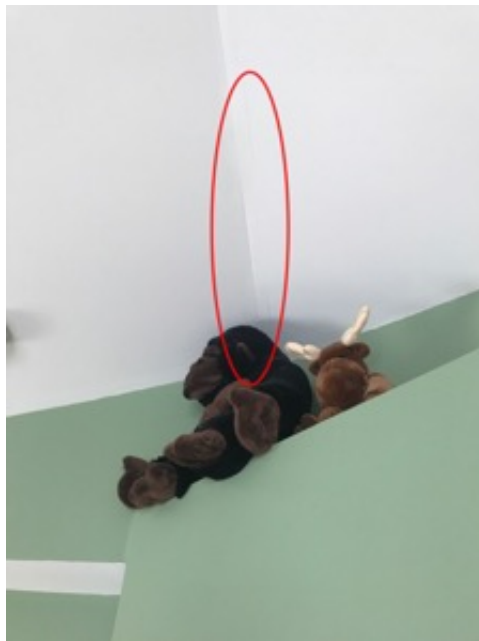
Location : Second Floor

Condition: Cracks (minor) - Some cracks were noted that are minor in nature. Small expansion or settlement cracks are a common occurrence and if need be repaired, providing that the settling has stopped.

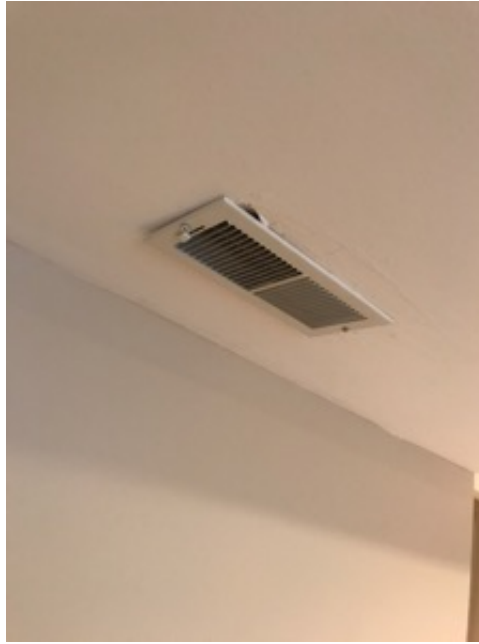
Location : Basement

Poor workmanship - The quality of work does not appear to be what is generally considered acceptable from a professional. Repair as needed.

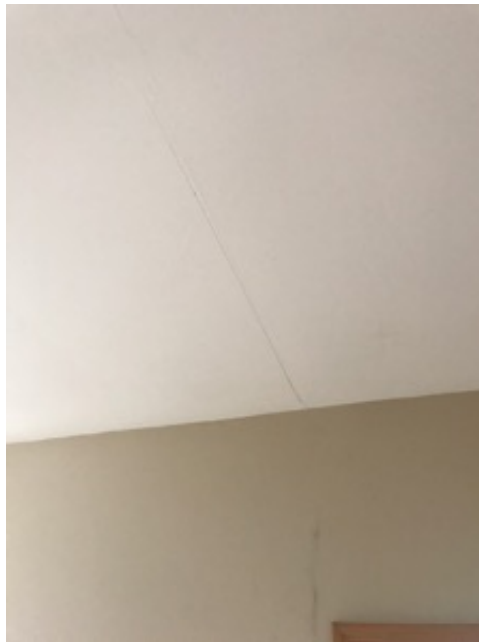
Location : Second Floor

Cracks (minor) - Some cracks were noted that are minor in nature. Small expansion or settlement cracks are a common occurrence and if need be repaired, providing that the settling has stopped.

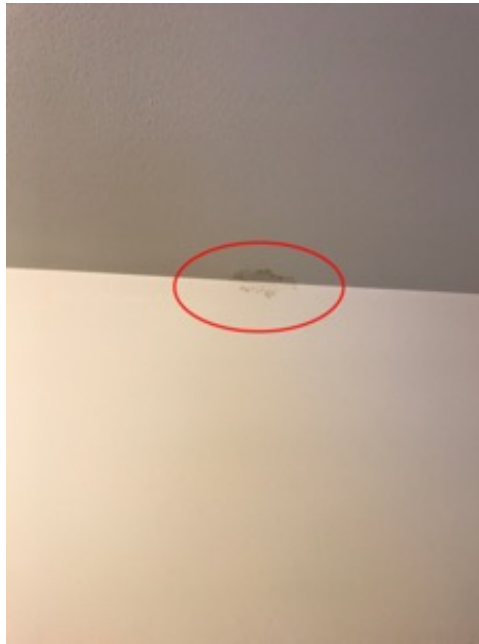
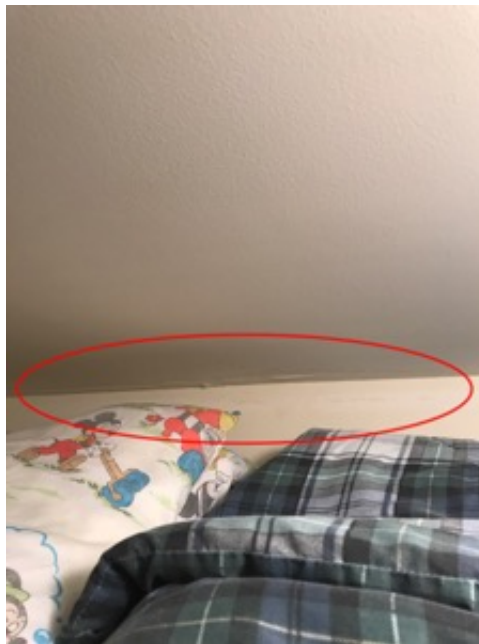
Location : bedroom, closet

Stained - The material is stained. Some stains may be very difficult to remove. Before repairing, be sure the source of the stain has been located and cured.

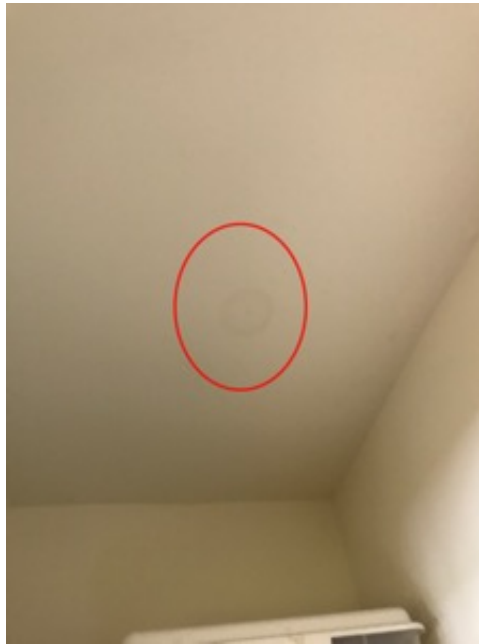
Location : bedroom, closet

Stained - The material is stained. Some stains may be very difficult to remove. Before repairing, be sure the source of the stain has been located and cured.

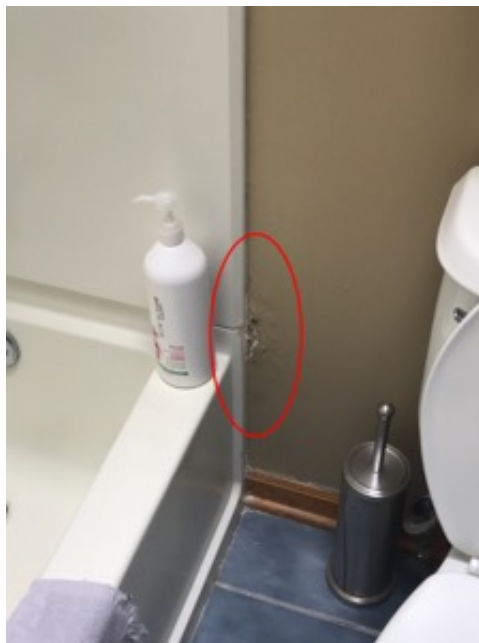
Condition: Peeling paper - Peeling wallpaper was noted, which could be a sign of excessive moisture or poor installation. Repair as needed.

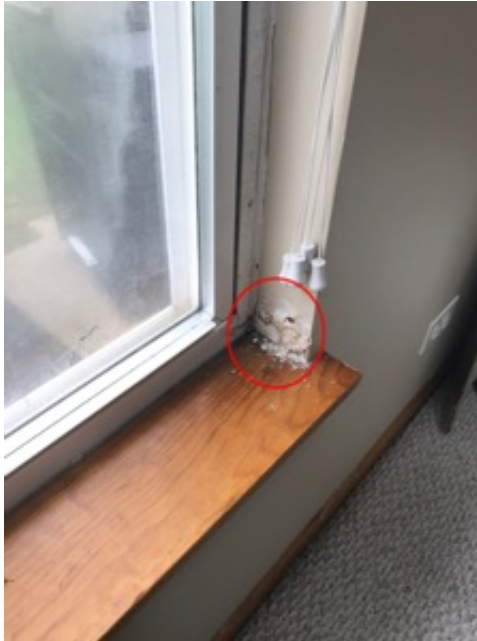
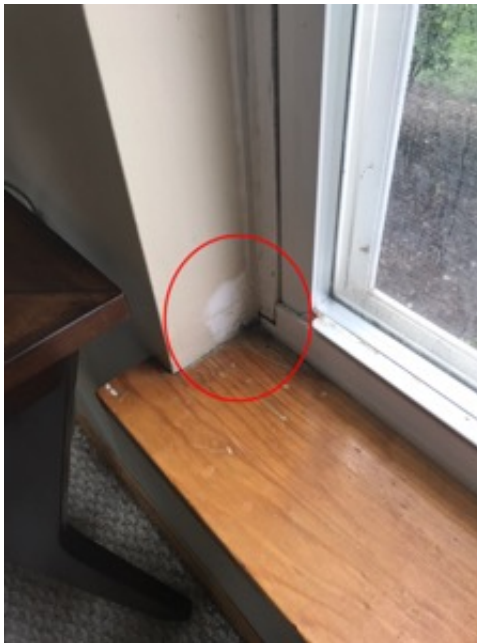
Condition: Water stains - Water stains were noted. Stains are evidence of prior water penetrations. Monitor and repair if needed.

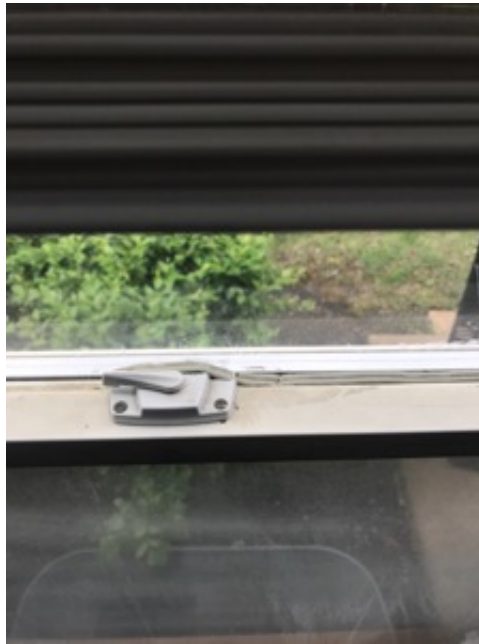
Location : Lower Level

Poor workmanship - The quality of work does not appear to be what is generally considered acceptable from a professional. Repair as needed.

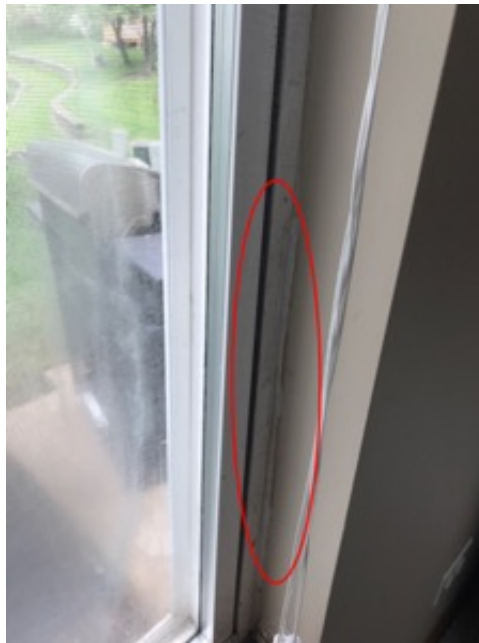
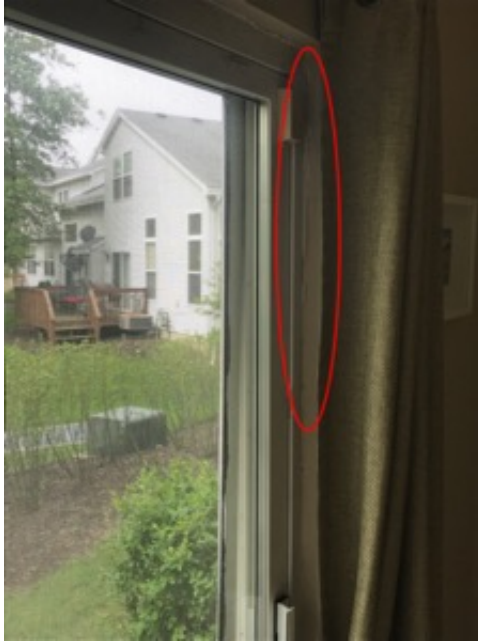
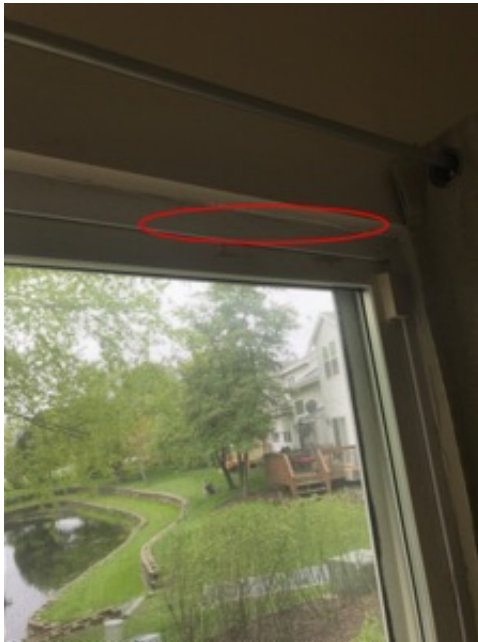
Peeling Caulk

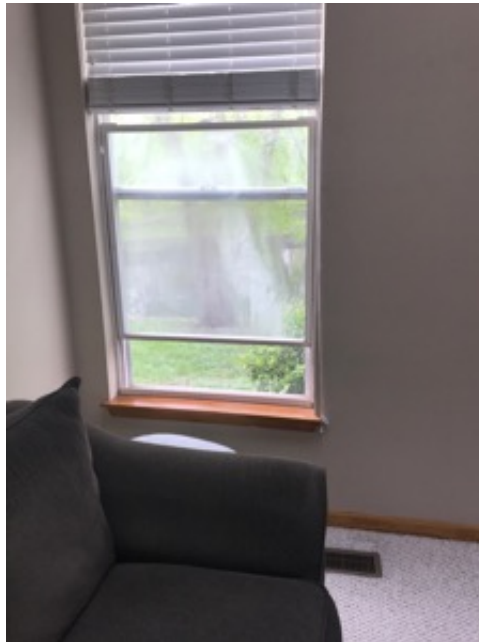
Window stuck - Window does not open and close properly and should be repaired.

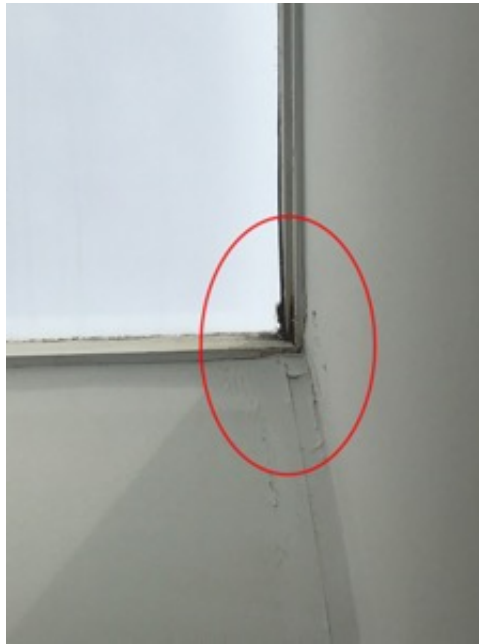
Location : bathroom, Second Floor

Water stains - Water stains were noted. Stains are evidence of prior water penetrations. Monitor and repair if needed. Drywall tape also appears to have had moisture issues as well.

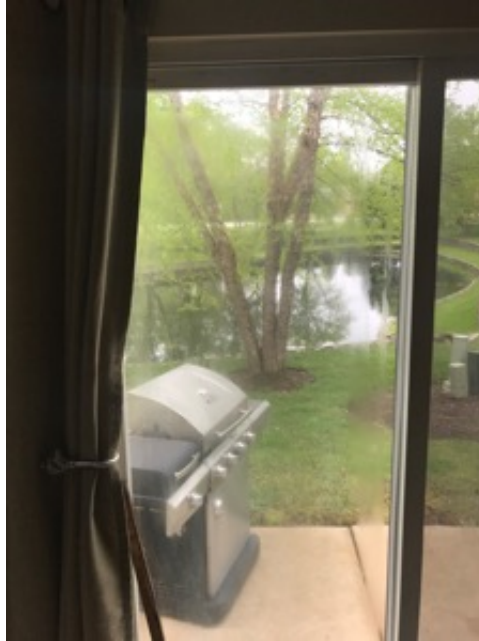
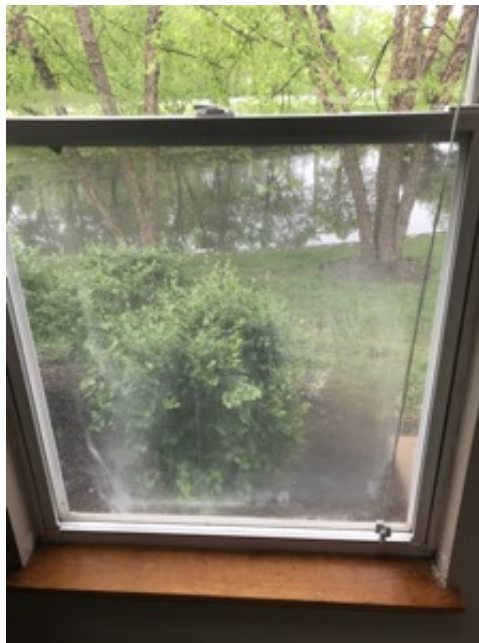
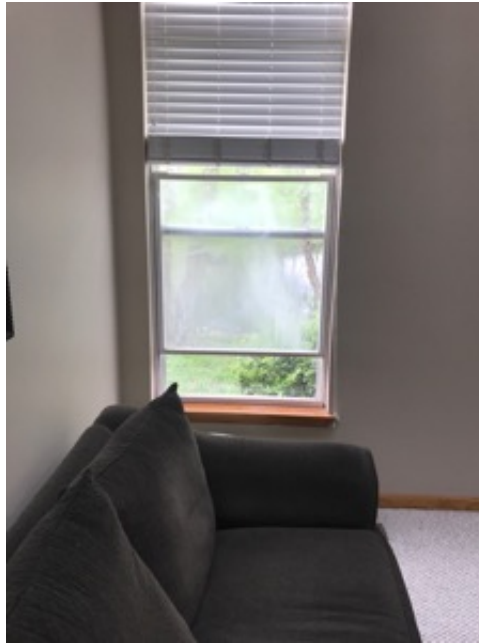
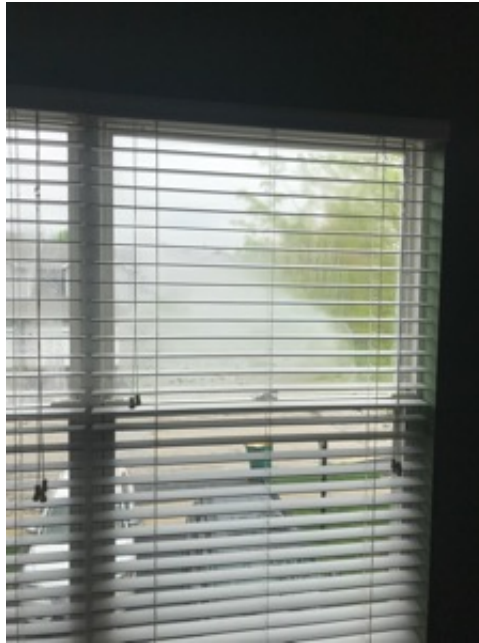
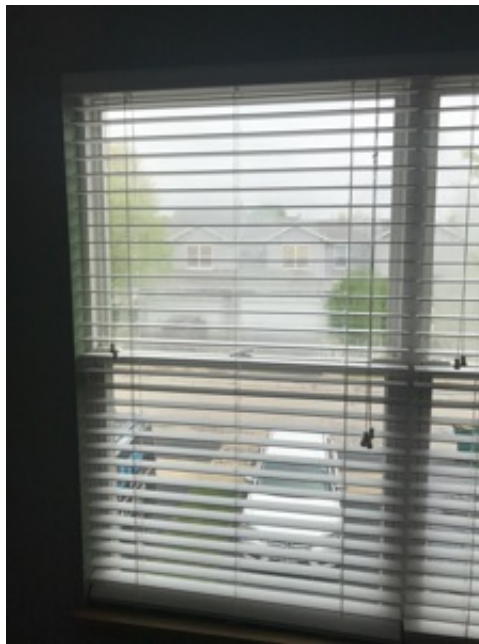
Location : Throughout, Second Floor, First Floor

Condition: Fogged - Fogging was observed. This indicates failure of the seal between layers of glass. Replacement is the only method to cure this problem.

Ratings : Defective

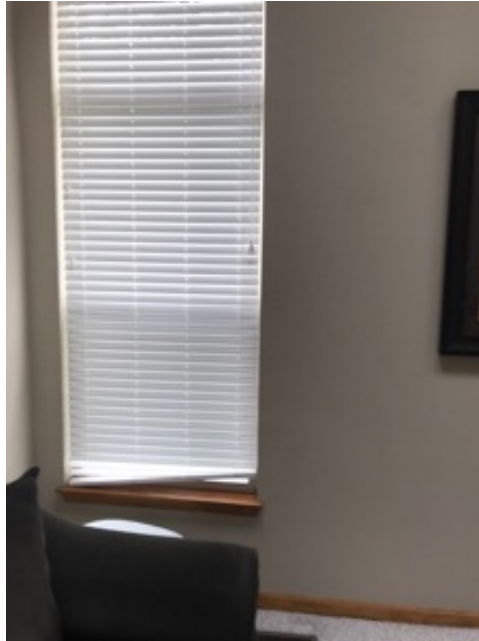
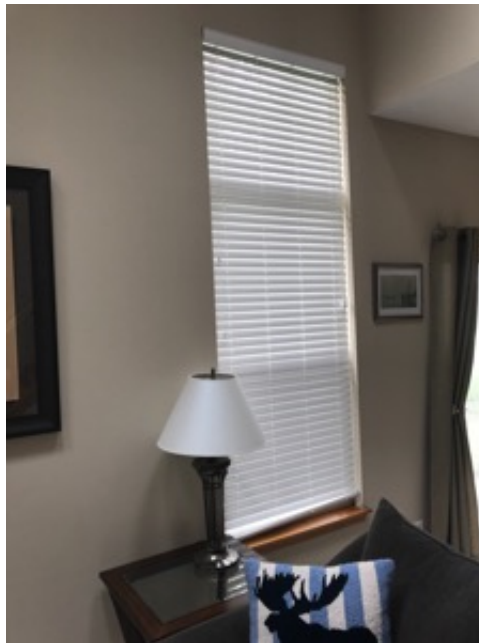
Type: Blinds - Blinds throughout the property do not seem to work as they should. They do not move freely when cord is pulled to lower.
