# DBB Home, LLC

## Summary

Property address: **Rochester, NY Area**

Inspection date: **Monday, October 23, 2017**

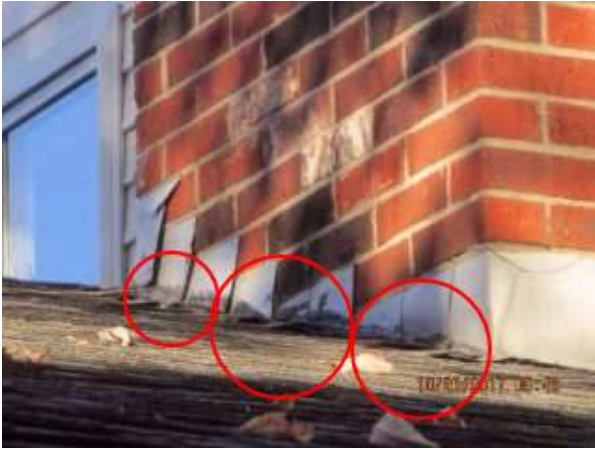
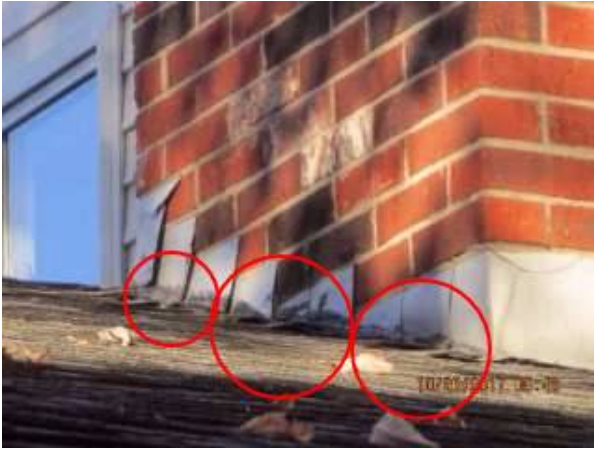
Photo 6-1  
Lower roof chimney flashing is heavily caulked. No leaks at time of inspection, but visible signs of water damage from inside the garage. Check with the home owner prior to taking possession to see if the water marks were from a previous leak or repair.

Lower roof chimney flashing is heavily caulked. No leaks at time of inspection, but visible signs of water damage from inside the garage. Check with the home owner prior to taking possession to see if the water marks were from a previous leak or repair.

6) 🧑🔧 Flashings at the base of one or more chimneys were deteriorated and/or missing counter flashing. Leaks can occur as a result. This is a conducive condition for wood-destroying organisms. Recommend that a qualified contractor evaluate and repair as necessary.

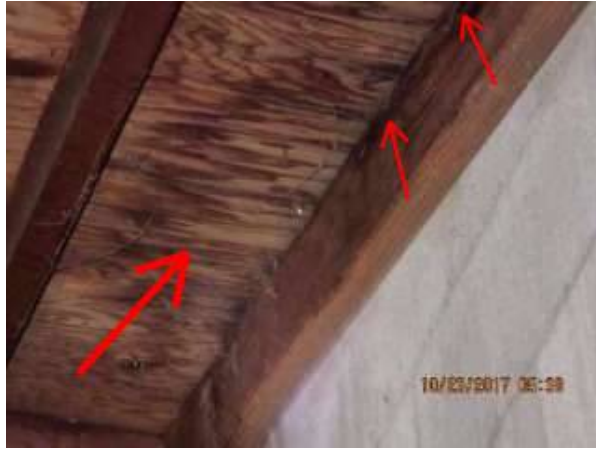
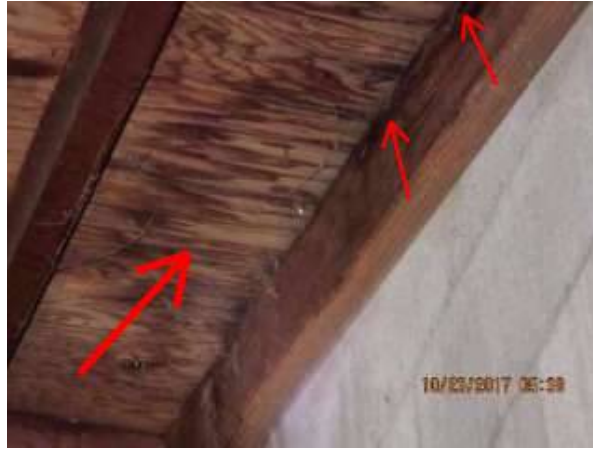
Photo 6-2  
Below the chimney flashing previously pictured. Picture taken from inside the garage looking up.

Below the chimney flashing previously pictured. Picture taken from inside the garage looking up.

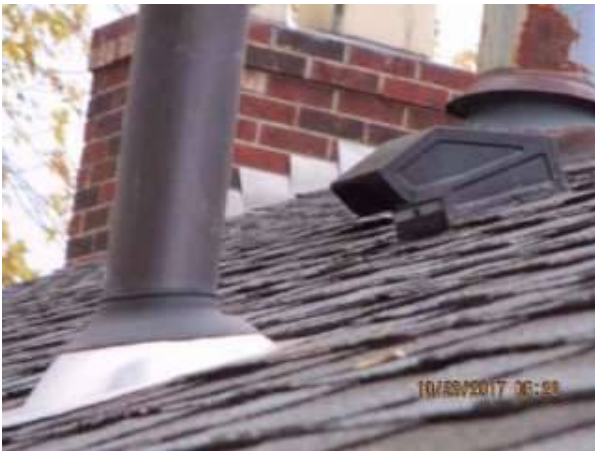
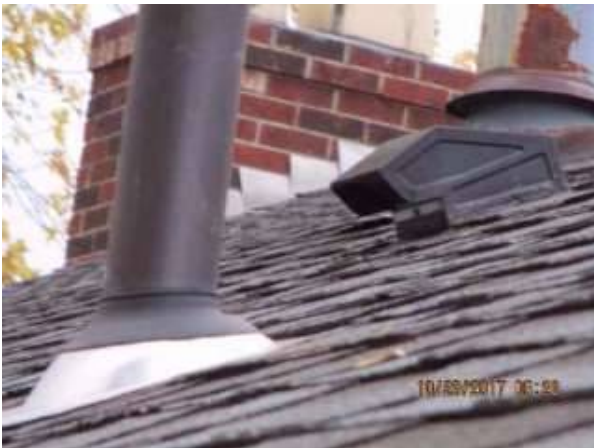
Photo 6-3  
Roof penetrations appear dry at the time of inspection both inside the attic and out.

Roof penetrations appear dry at the time of inspection both inside the attic and out.

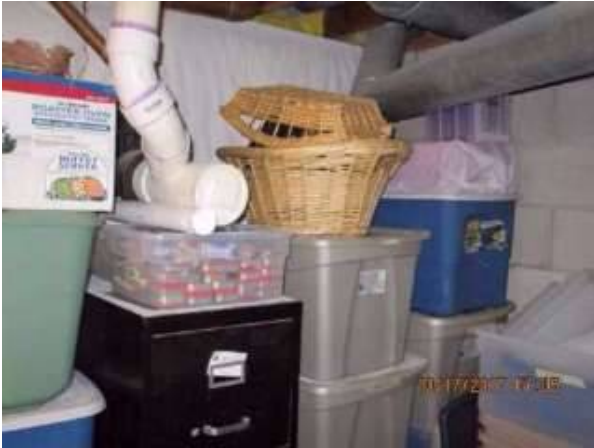
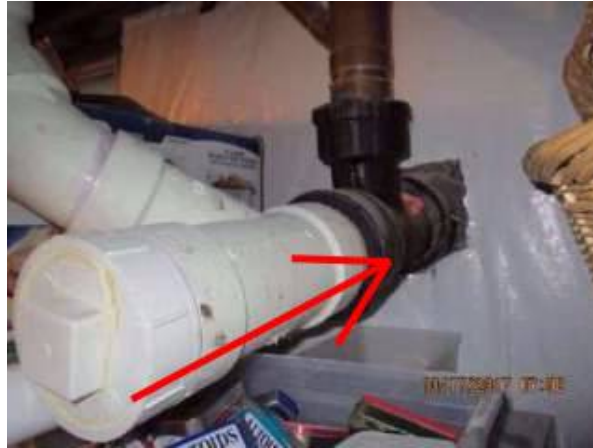
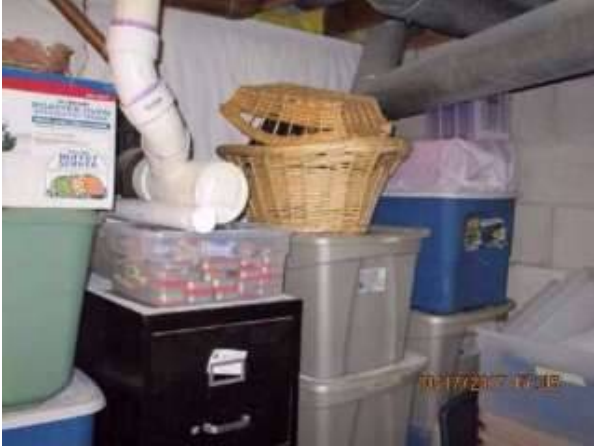
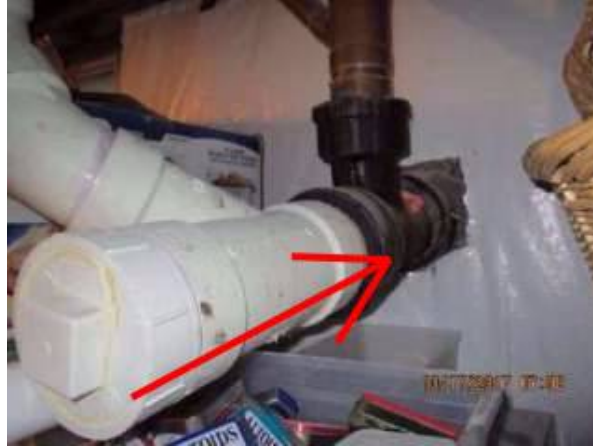
Main waste stack to septic system slopes upward. It should slope down toward the septic (wall).

16) 🚧🔧 The waste stack slope needs to be corrected. The stack should flow down from the waste lines into the septic system. The upward slope could cause clogs and repairs in the future. Have a qualified plumber correct this issue.

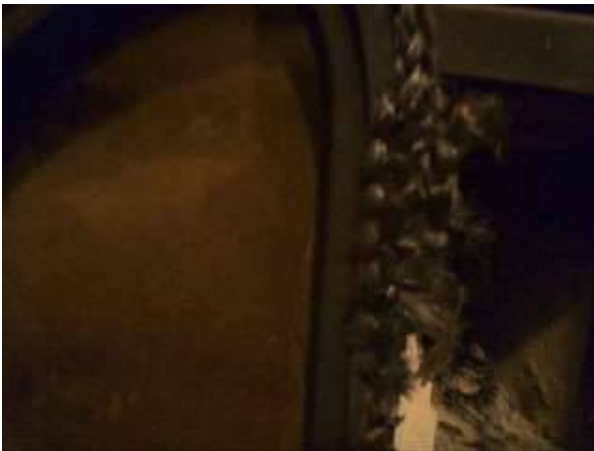
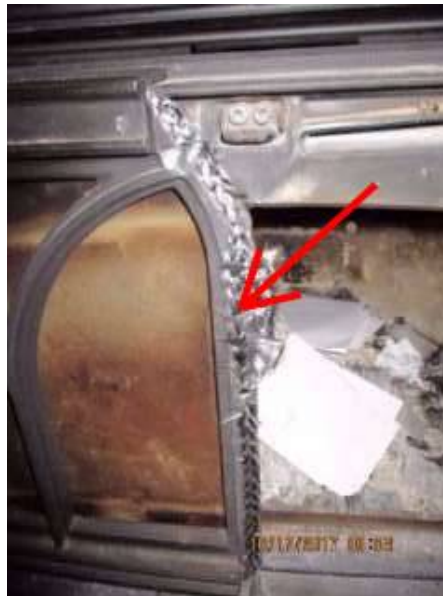
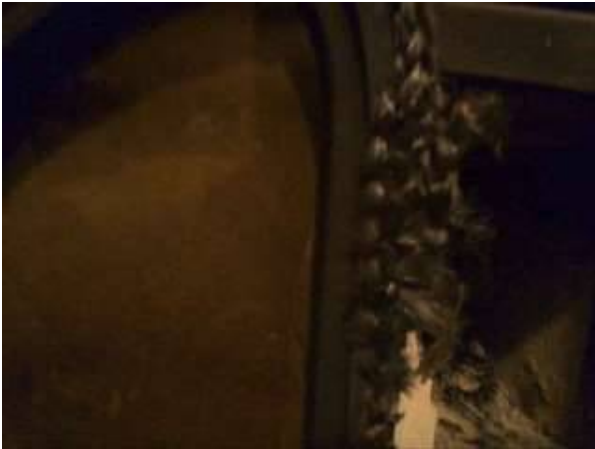
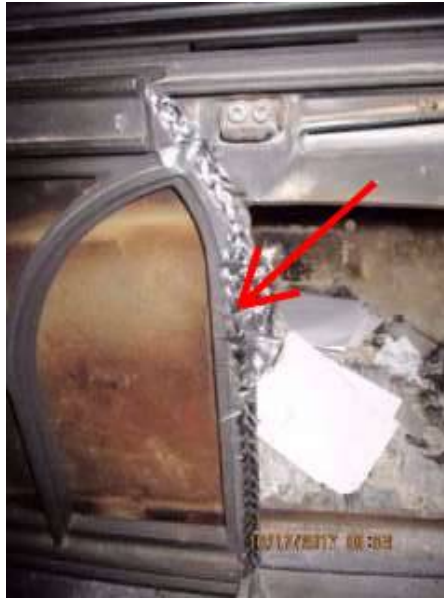
Seal needs repair/replacement in order to keep air tight combustion of solid fuel stove insert.

18) 🛠️ 📦 Door gasket needs repair.

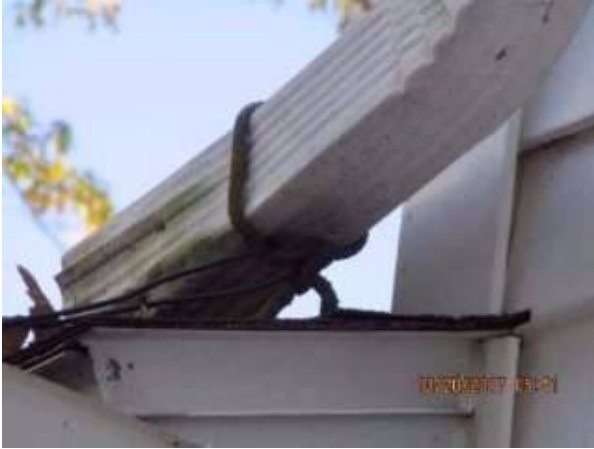
Photo 7-1

See downspout over the patio that feeds the south roof gutter from the upper roof. Recommend securing the downspout so that water and ice flow where they should especially during periods of heavy precipitation. Recommend a qualified person re attach the downspout with proper strapping for the type of siding.

South side gutter not properly fastened to the house. Have a qualified person reinstall it with the upper gutters. You may want to consider sloping it toward the other side so that it does not feed into the lower gutter.

One or more downspouts were loose. Rainwater can come in contact with the building exterior or accumulate around the building foundation as a result. This is a conducive condition for wood-destroying organisms. Recommend that a qualified person repair as necessary.

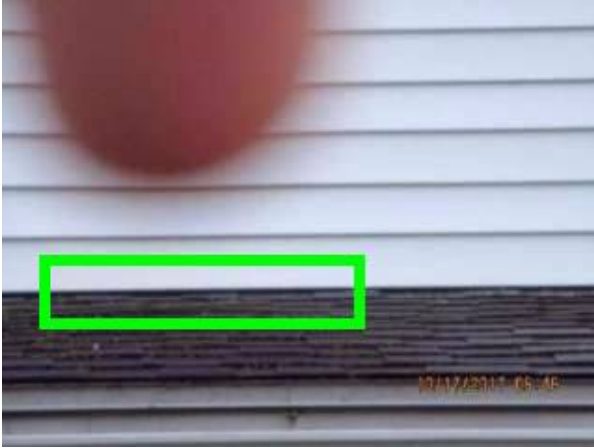
Photo 8-1

Some moss growth on the lower front roof from a leaky gutter above

8) 🧑🔧 Stains were found on one or more gutters that indicate past leaks have occurred. However, the inspector was unable to verify that the gutters do or don't leak because of lack of recent rainfall. Monitor the gutters in the future while it's raining to determine if gutters leak. If they do, then recommend that a qualified person repair as necessary to prevent water from coming in contact with the building or accumulating around the building foundation.

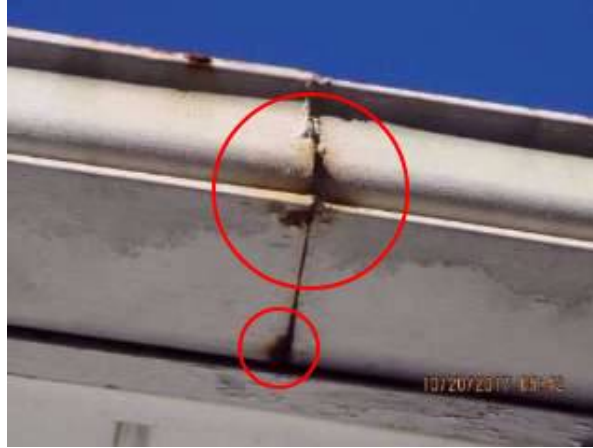
Photo 8-2

Leaky gutter join on the south upper roof. Steel gutters appear to be near or at the end of their useful lifespan. Consider budgeting to replace them. The front and lower gutters have been replaced with aluminum.

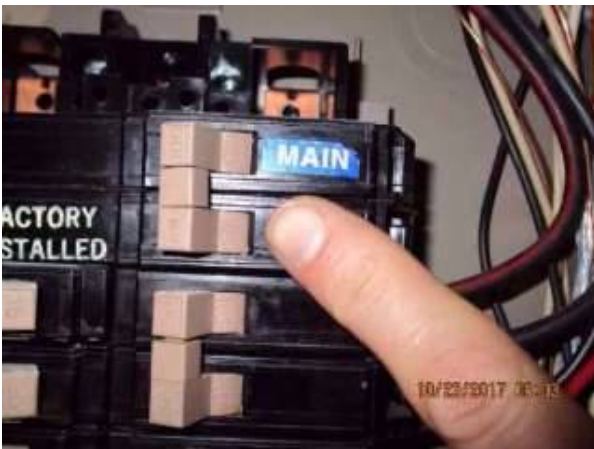
Photo 14-1  
100 Amp Main Disconnect for Cutler and Hammer Principal Electric Panel

14) 🚧 The electric service to this property appeared to be rated at substantially less than 200 amps and may be inadequate. Depending on the client's needs, recommend consulting with a qualified electrician about upgrading to a 200 amp service. Note that the electric service's rating is based on the lowest rating for the meter base, the service conductors, the main service panel and the main disconnect switch. One or more of these components may need replacing to upgrade.

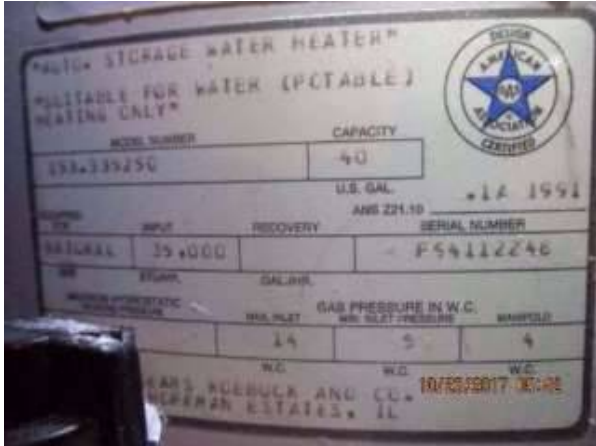
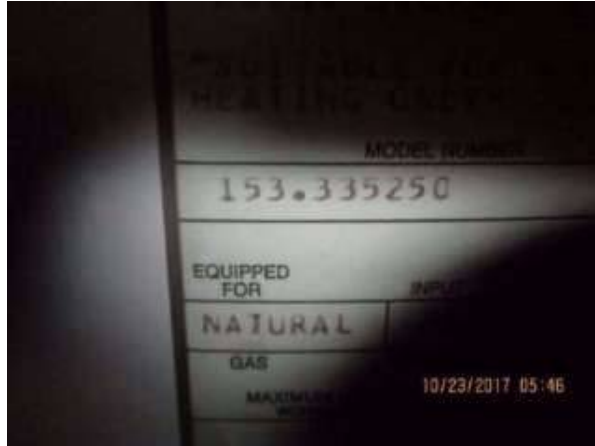
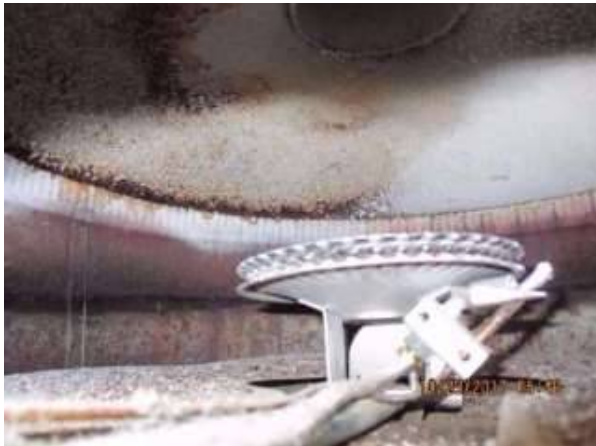
17) ⓘ The estimated useful life for most water heaters is 8-12 years. This water heater appeared to be beyond this age and/or its useful lifespan and may need replacing at any time. Recommend budgeting for a replacement in the near future, or considering replacement now before any leaks occur. The client should be aware that significant flooding can occur if the water heater fails. If not replaced now, consider having a qualified person install a catch pan and drain or a water alarm to help prevent damage if water does leak.

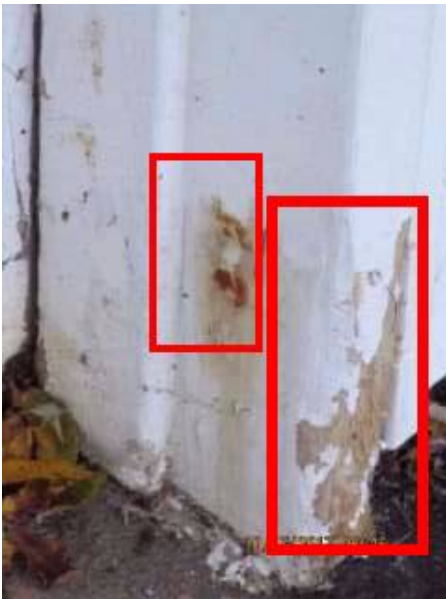
Photo X-1

Maintenance needed to preserve garage door trim. Might want to consider having a qualified contractor wrap the wood with aluminum or replace the wood with low maintenance PVC trim.

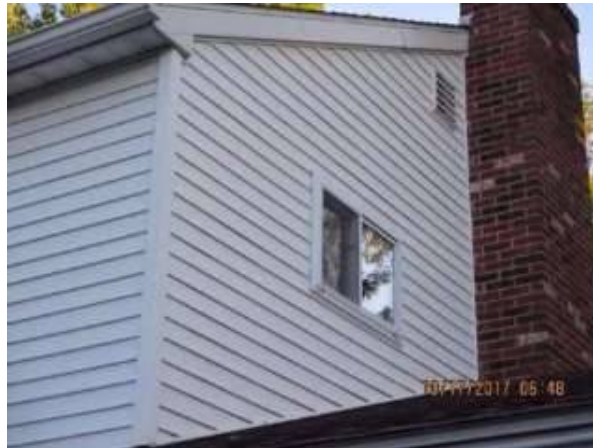
Photo X-2

Gable vent on both gables, plus roof box vents.

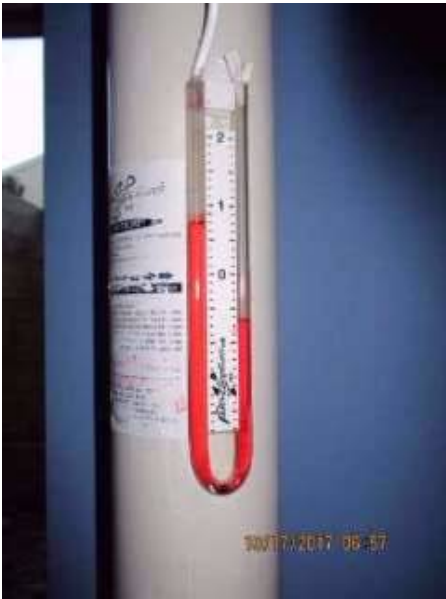
Photo X-3  
Radon Mitigation system gauge in operation.

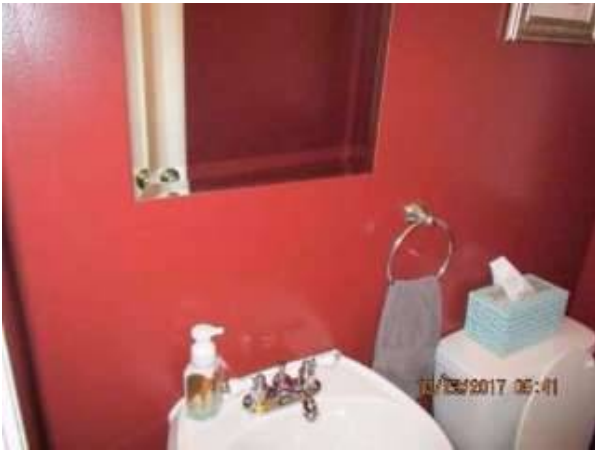
Photo X-7  
No GFCI outlet in the 1/2 bath downstairs, this is an inconvenience, but could be a safety concern if someone uses an extension cord around water.

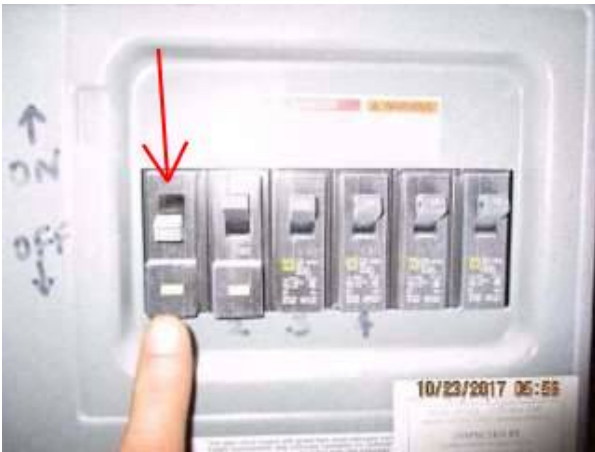
Photo X-9  
This breaker was off at time of inspection and remained off during the inspection.

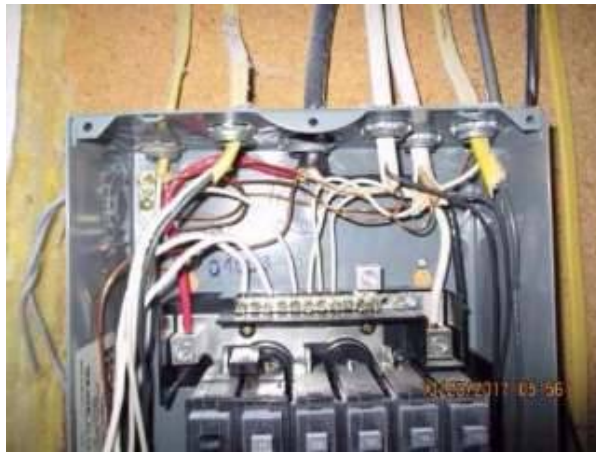
Photo X-10  
Sub Panel with neutral and ground bus bars separated. GFCI's were operated except for the one breaker that was off. Breaker operates the pool and it was closed for the season. Make sure the breaker operates before you take possession of the house - talk to your realtor about the final walk through.

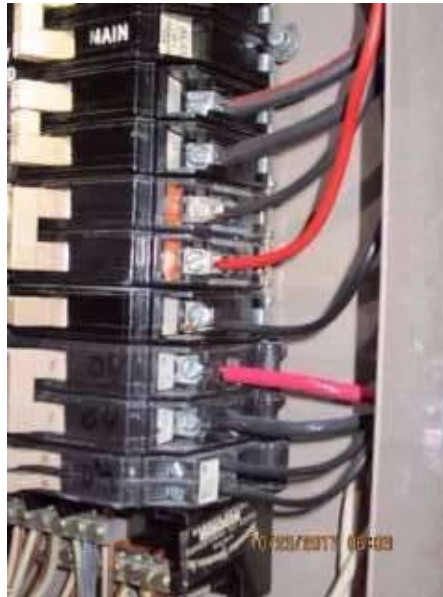
Photo X-16

This side of the panel is properly wired at the time of inspection.

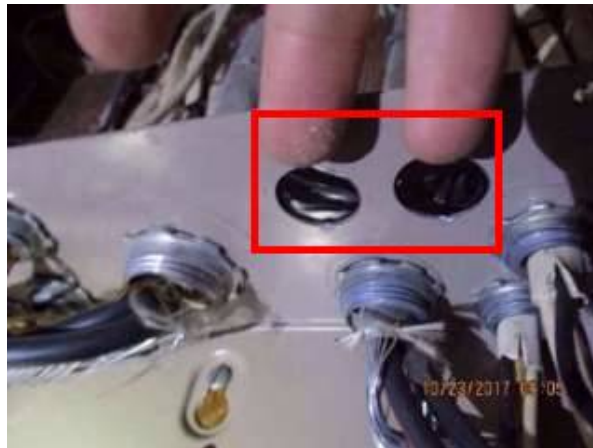
Photo X-18

These two knock-outs have only electrical tape covering. This is a safety hazard as someone could get a shock if they stuck their fingers or dropped something inside the panel box. Have an electrician install approved covers.

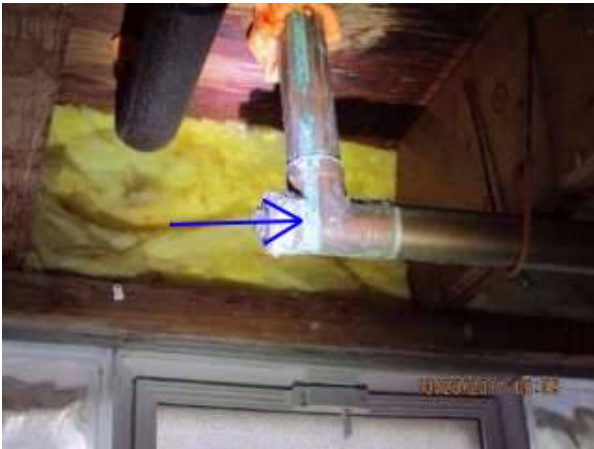
Photo X-19  
 Dry at the time of inspection there are signs of a long term water leak under the kitchen sink. Monitor for future leaks and any wetness.

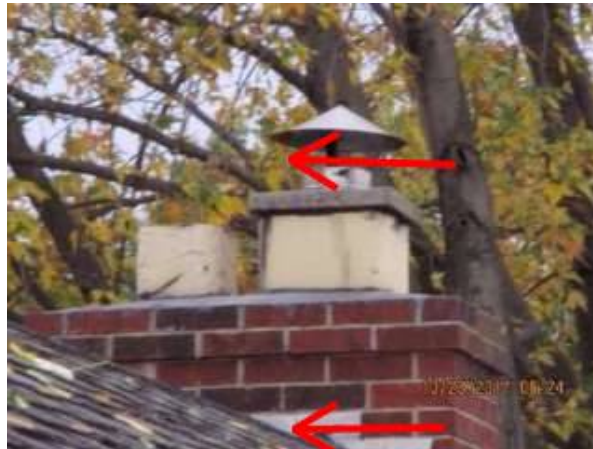
Photo X-20  
 Chimney height less than 3 feet above the height of the roof. At the time the chimney was made the height was probably fine. New standards today recommend 3 feet.

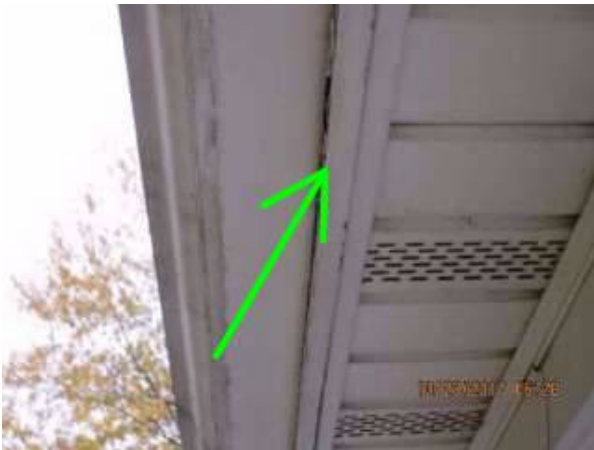
Photo X-21  
 Vented soffit allows for continuous airflow to the attic. Some maintenance will be needed to maintain the integrity of the fascia.

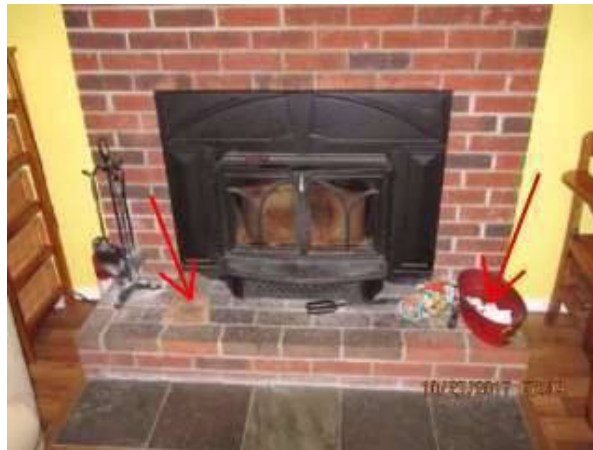
Photo X-22  
 With the exception of the fire glove and paper box the clearance to combustible materials is acceptable.

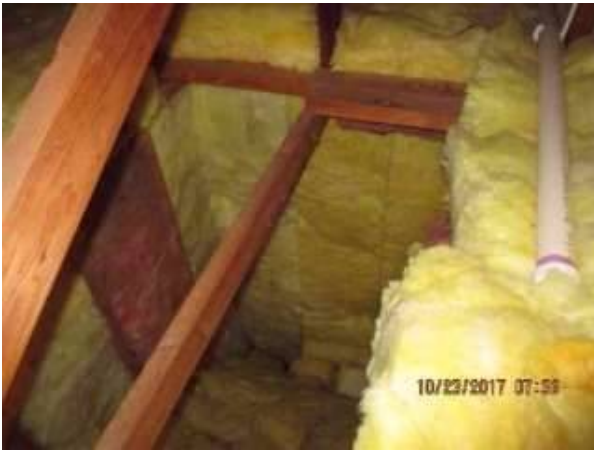
Photo X-23  
Attic insulation around the stairwell has a vapor barrier and is in place.

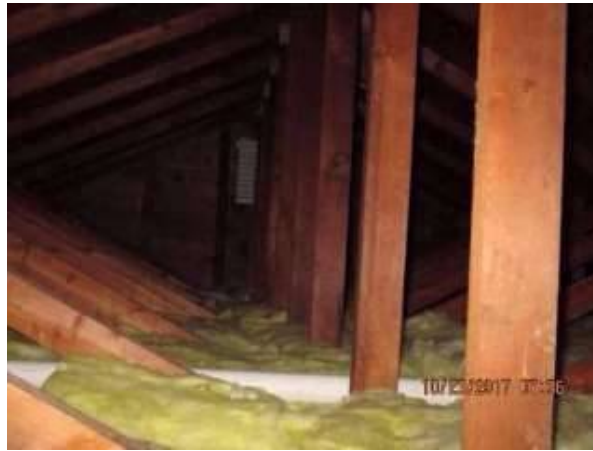
Photo X-24  
Attic has batt insulation and is approximately R48
