*** Residential Inspection Report ***

Inspection Address
455 Sycamore St
St George, Utah 84770

Date Of Inspection: October 1, 2015
Inspection Address: 455 Sycamore St , St George, Utah 84770

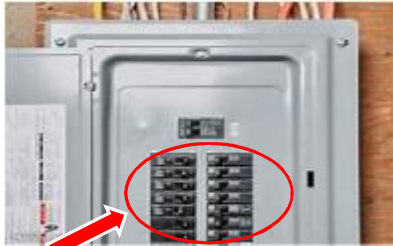
Sub-panel in basement did not have labeling of the circuit breakers. Recommend proper labeling.

Basement auxilliary panel needs proper labeling.

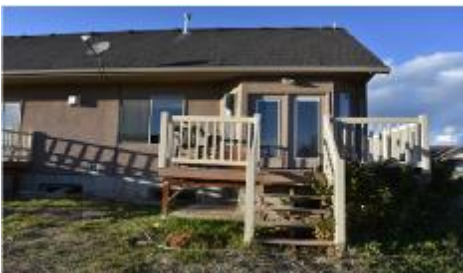
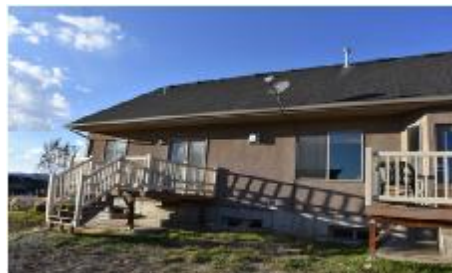
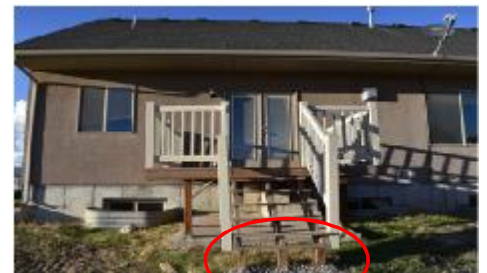
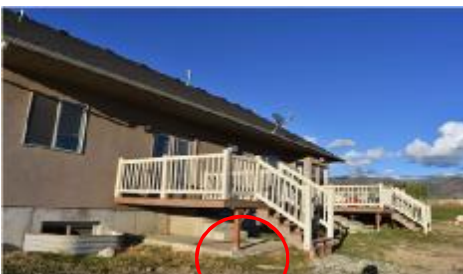
Further Comments: Wood supports under steps come in direct contact with the soil. This could provide termites and other pests with access to the wood structure. Additionally, this could cause moisture and rot issues to form. Recommend treated supports be used. Should be reexamined by proper repair personel.

- Wood supports under steps come in direct contact with the soil. This could provide termites and other pests with access to the wood structure. Additionally, this could cause moisture and rot issues to form. Recommend treated supports be used. Should be reexamined by proper repair personnel.

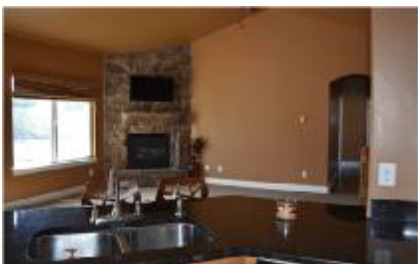
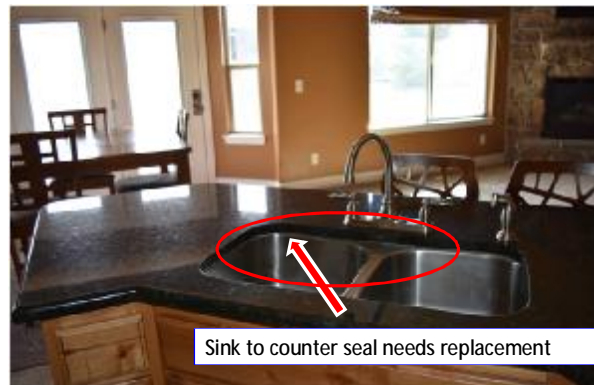
Further Comments: Sink Seal Needs re-sealing

- Sink Seal Needs re-sealing
