Is my roof damaged by hail?

The information in this guide covers some of the more common types of damage to composition roofs. It shows what hail damage typically looks like, and also what other types of damage look like.

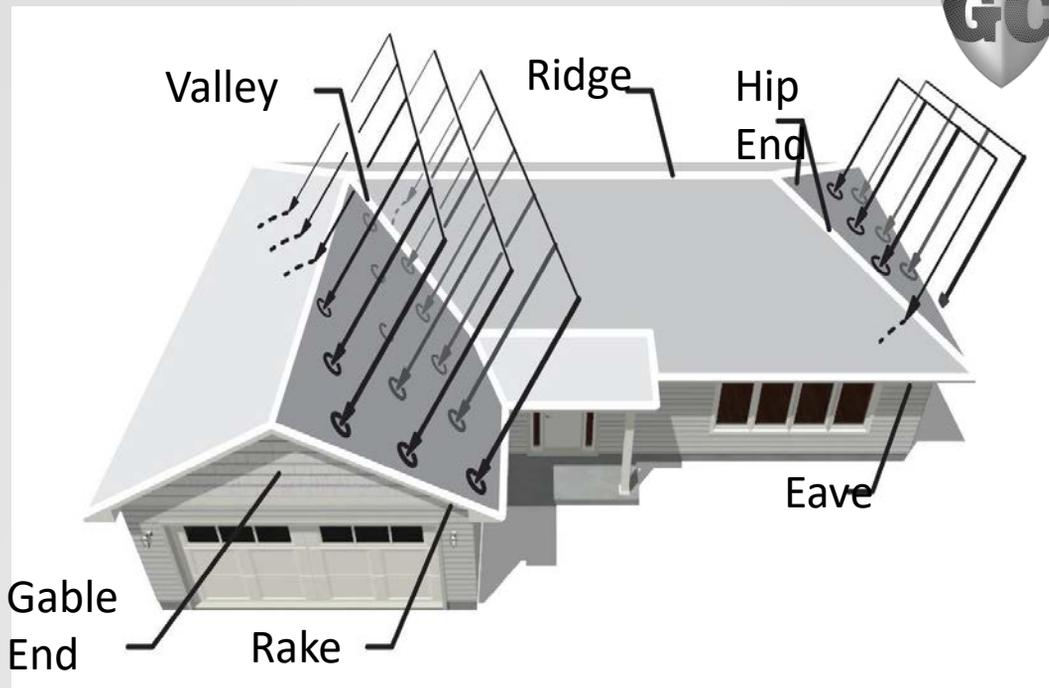
Directionality of Hail

During a hail storm, depending on the direction and velocity of the wind, some slopes may be more susceptible to hail damage while other slopes may have minimal or no damage.

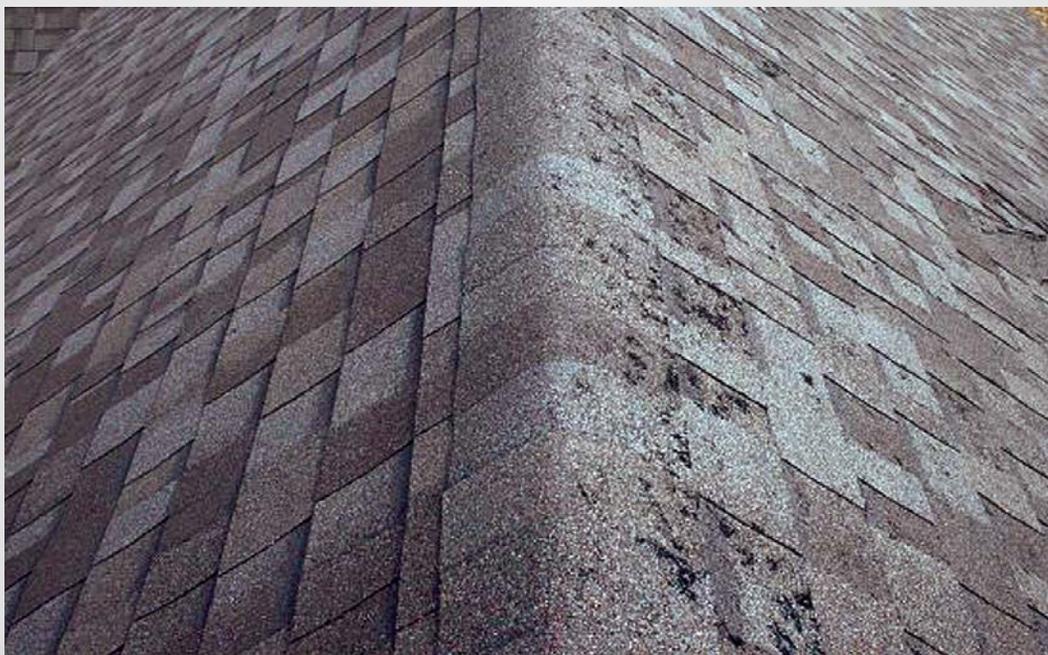
Hail – The number, size and hardness of the hailstones can vary tremendously within a small locality. Velocity and direction of the wind are also factors.

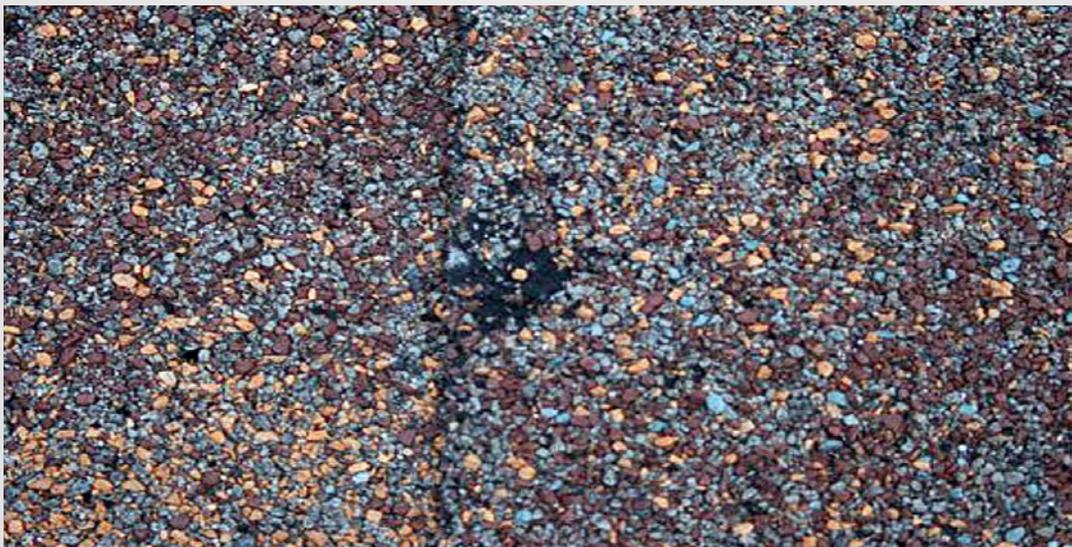
Bruise – Created when a hailstone crushes the mat material and can displace granules. Bruises may cause premature deterioration and weathering, eventually resulting in a hole in the shingle.

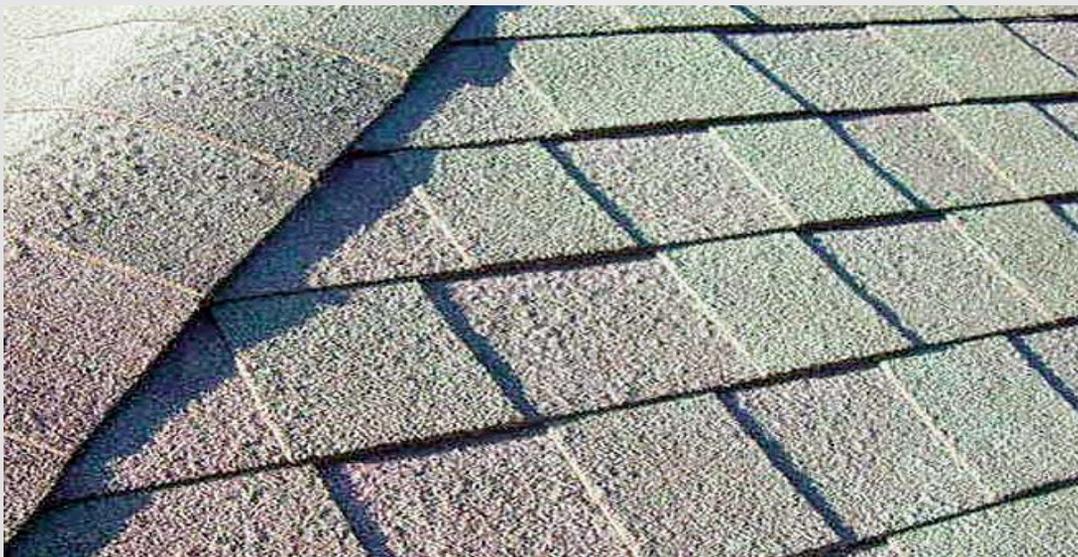
Blisters – Small bubbles or crater-like holes generally. Blistering can result from the manufacturing process or from roof ventilation issues and are not caused by hail. Blisters can eventually cause granule displacement.

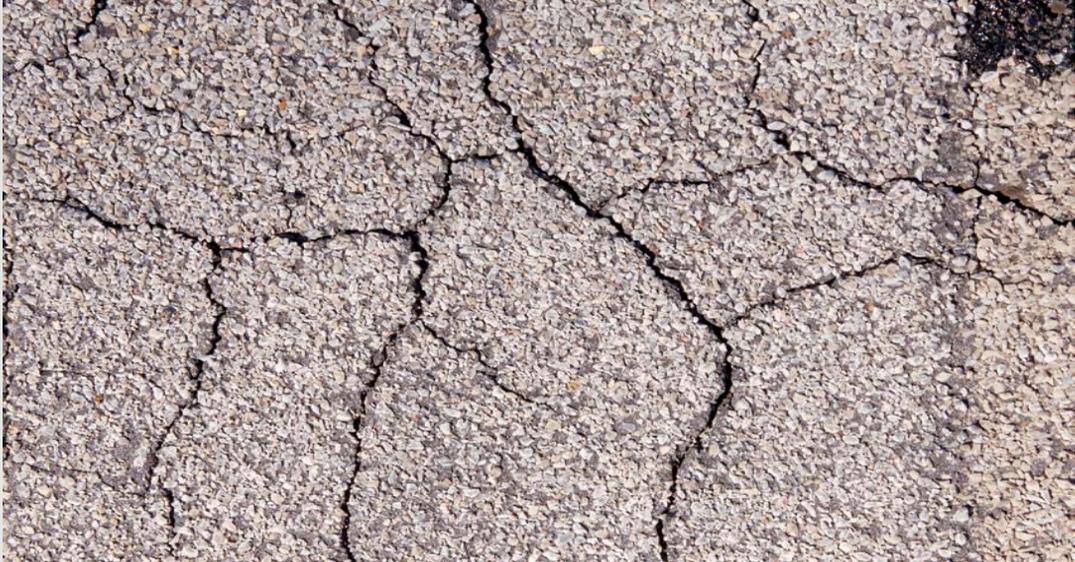
Cracking – Web-like pattern of cracks in surface of shingles due to natural weathering.

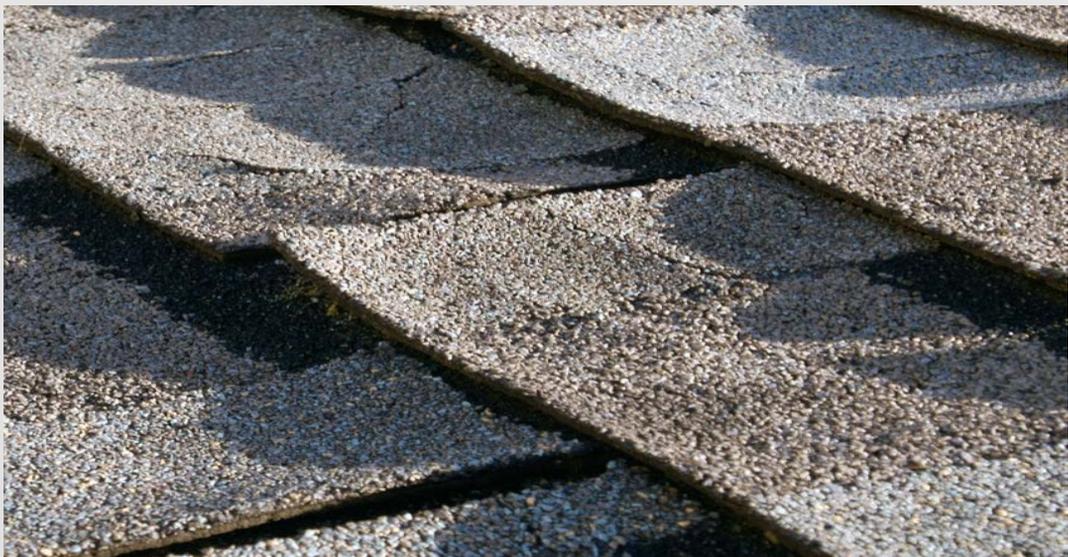
Curling/Cupping – This is the result of normal weathering of the asphalt shingle.

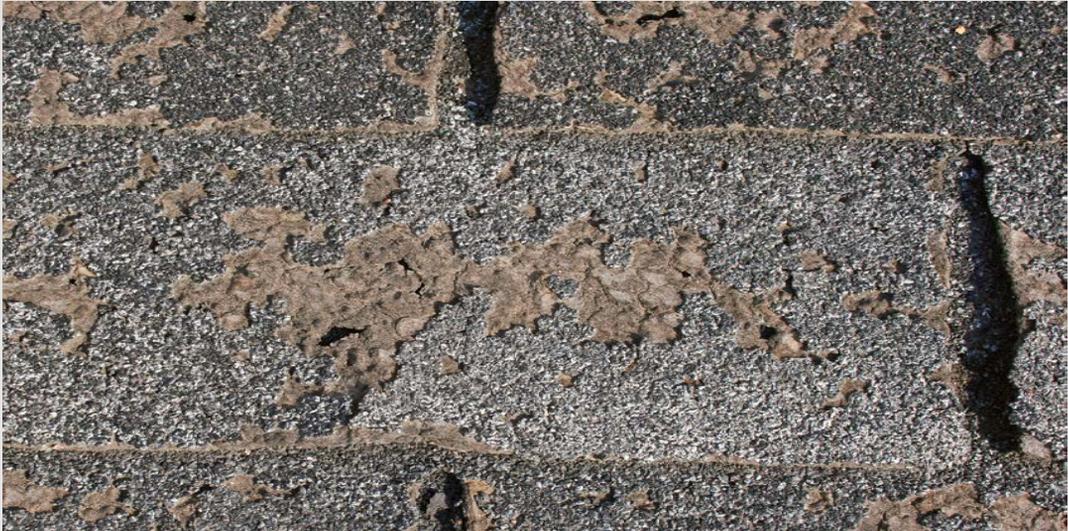
Flaking – As the natural weathering of shingles continues, small chunks of the granules coating begin to delaminate from the mat.

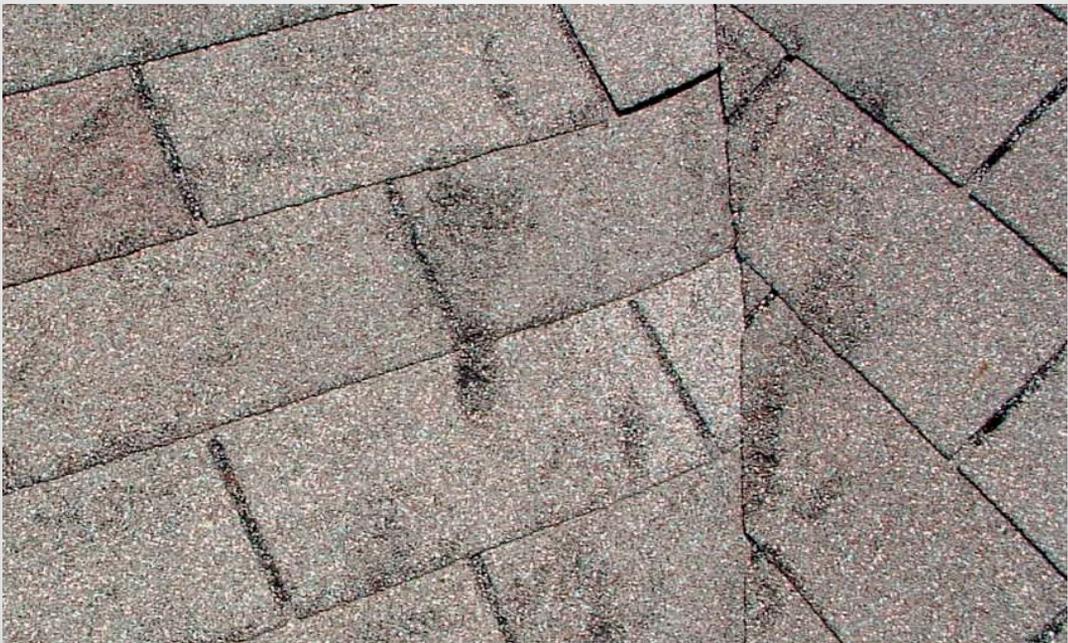
Foot Traffic – Potential loss of granules caused by walking on a roof.

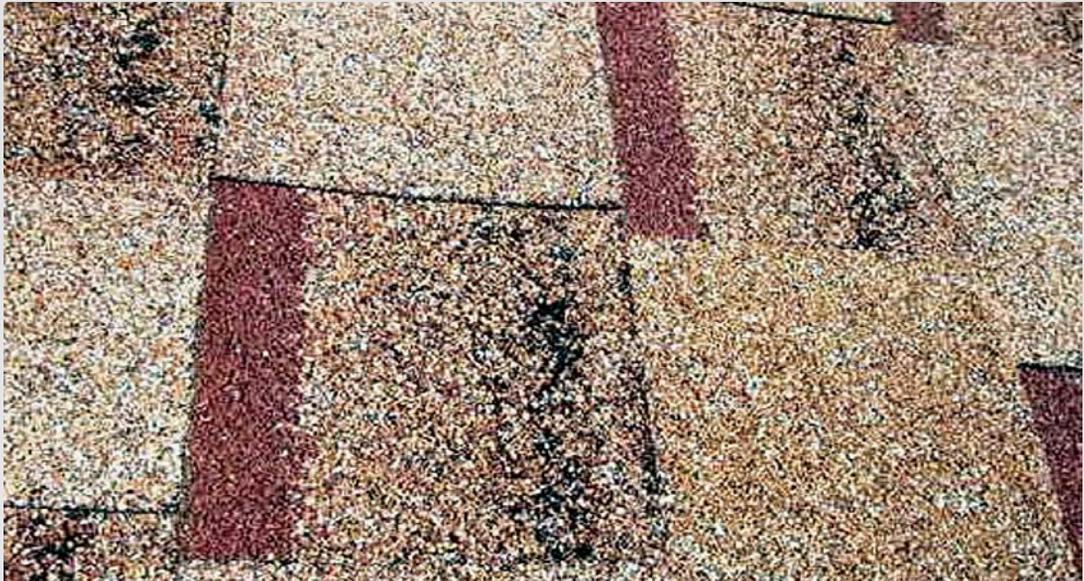
Manufacturing Defects – This may occur during the manufacturing of shingles.

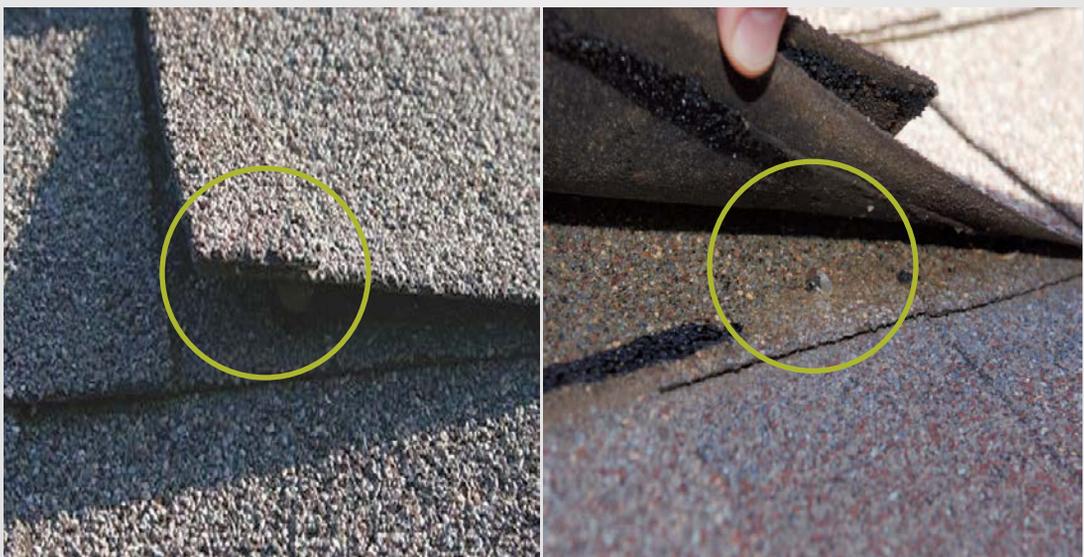
Nail Pop – An Elevated nail that can push a portion of the shingle off the roof plane. Over time, this pop can cause a hole in the shingle.
