Twin Oak Home Inspections

Home Inspection Report

Xxxxx Rd

Inspected on Sun, Jan 7 2018 at 8:30 AM

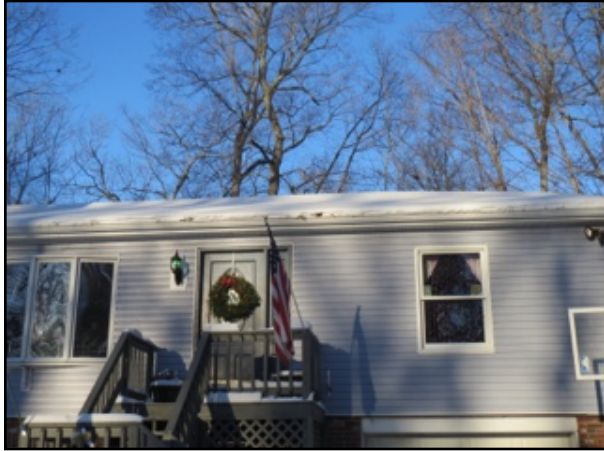
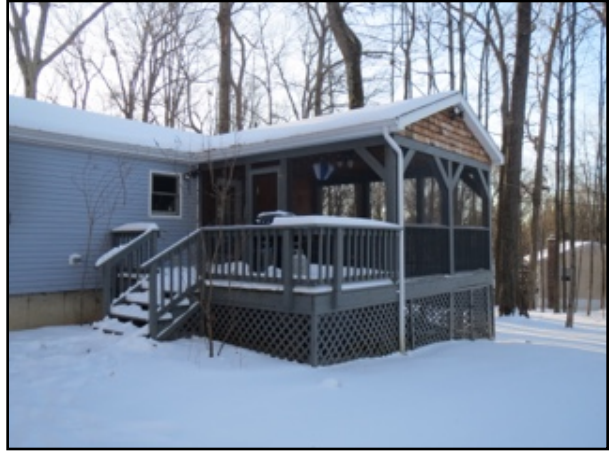
Recent snowfall completely covered the roof preventing visual inspection of shingle condition, flashings and roof penetrations. Although listed as a three year old roof with asphalt shingles and no signs of water intrusion in the house or attic, it is recommended that the roof be visually inspected once the snow melts.

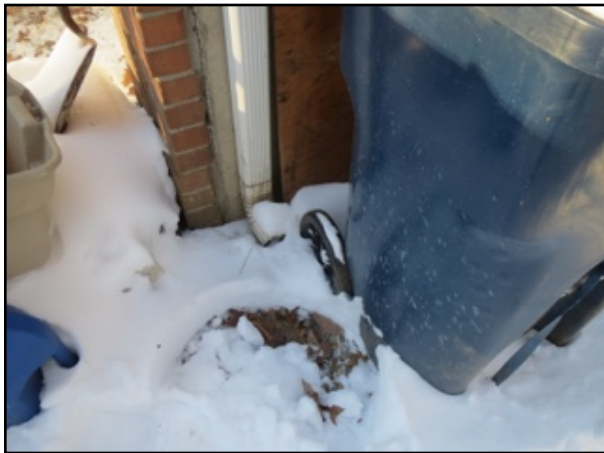
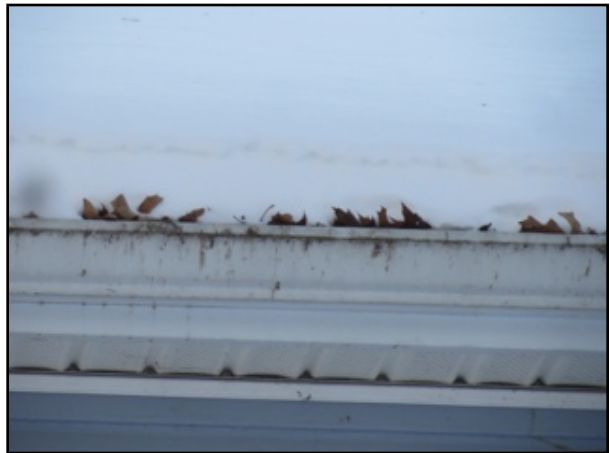
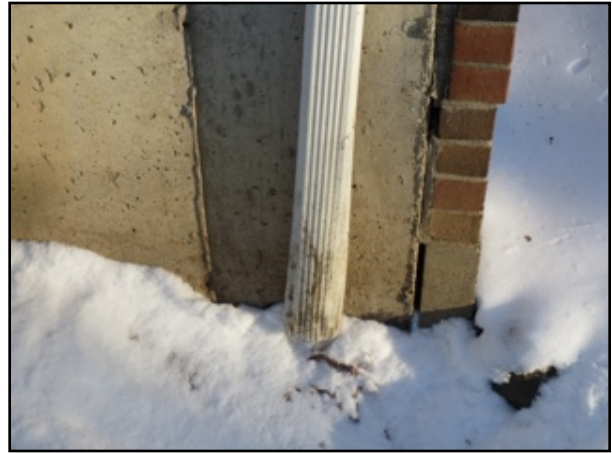
Gutters were noted around the perimeter of the house. Debris were visible in the gutter channel and one or more downspouts lacked an extension. Diverting water away from the house is important to extend the life of the foundation and associated systems. Recommend qualified person clean gutters and test operation. Consider installing gutter screens/downspout extensions.

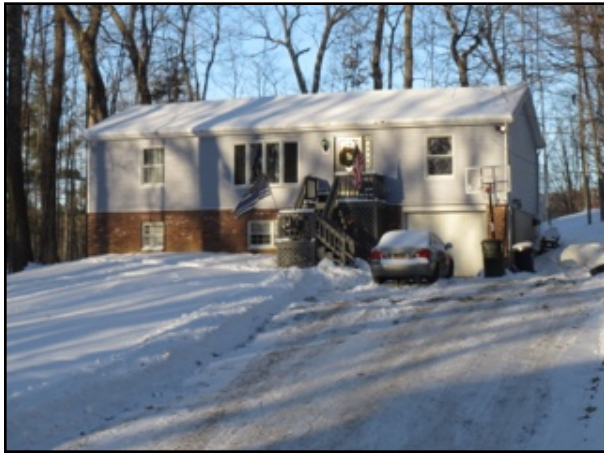
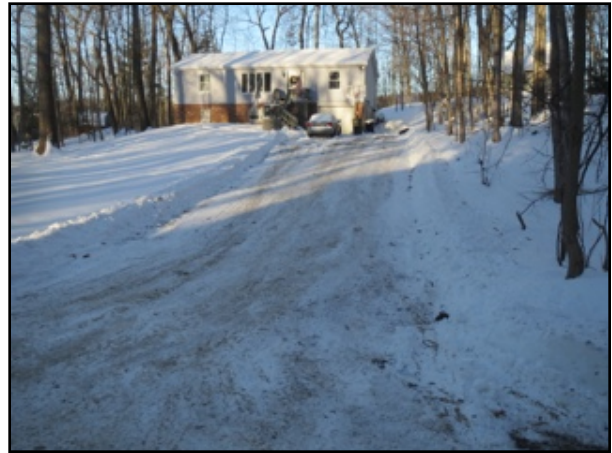
The gravel driveway was completely snow-covered preventing a visual of evaluation of its condition. Gravel driveways will require periodic maintenance. Recommend qualified person evaluate once snow melts, repair, replace or maintain as necessary.

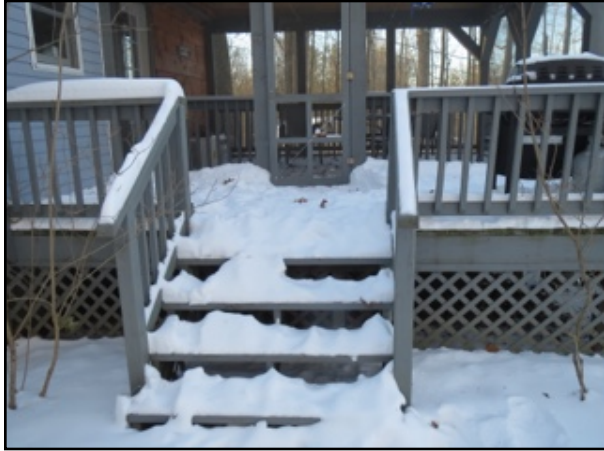
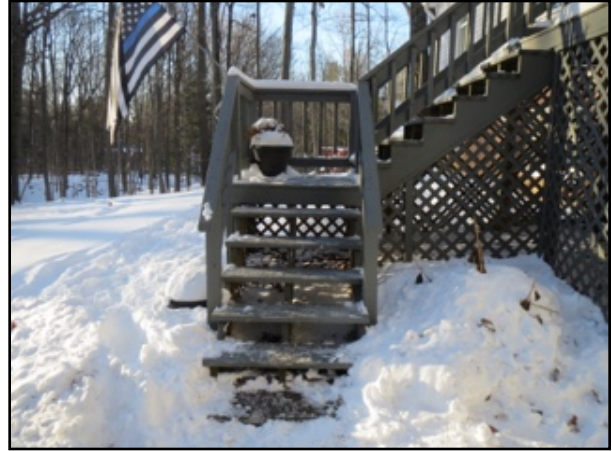
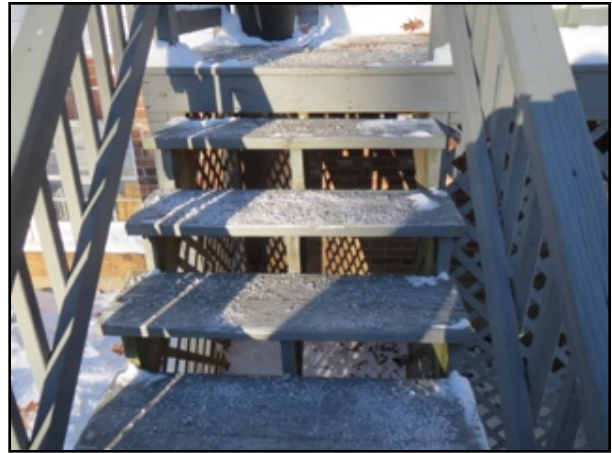
The main entry steps and rear porch steps lacked a graspable handrail and had open risers. Although this is a common building practice, this can create a safety hazard especially for older adults and younger children. Recommend qualified contractor repair or replace as necessary.

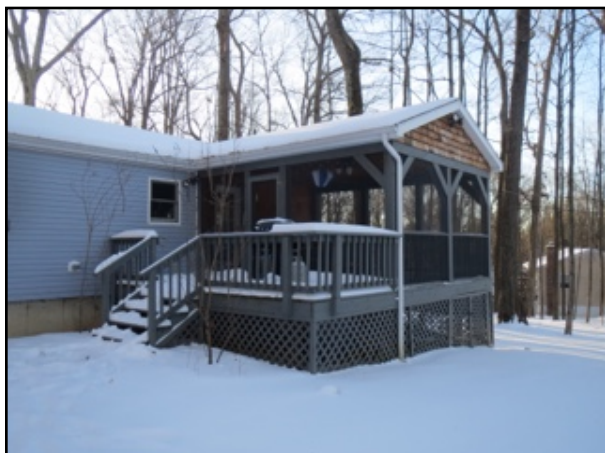
Figure 9-1

Visible portions of the rear deck and covered porch were noted to be satisfactory. Snow cover prevented a full of evaluation of flooring condition. Recommend walk-through/evaluation once snow has melted.

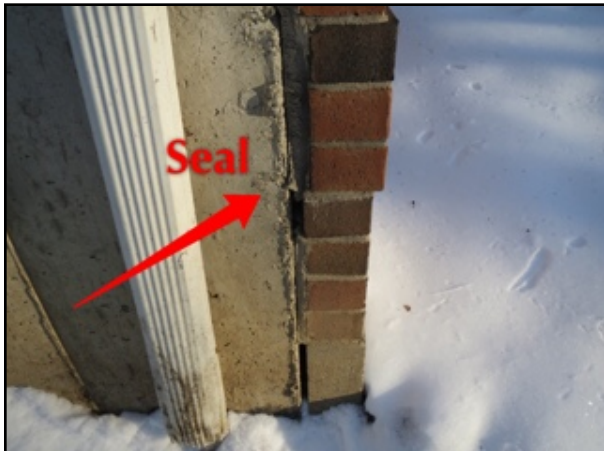
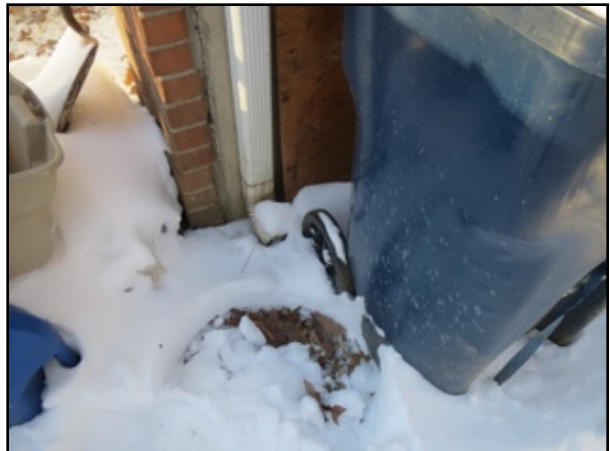
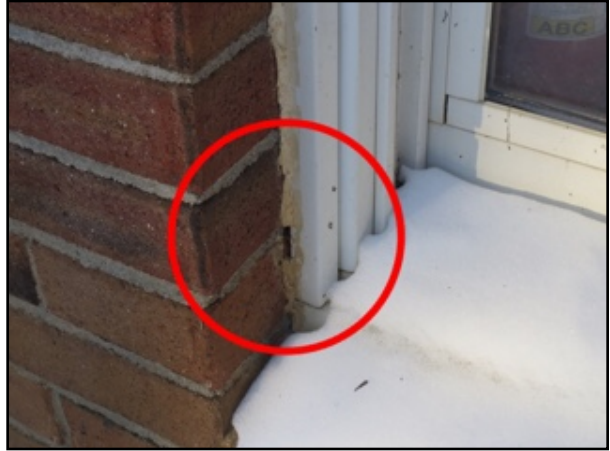
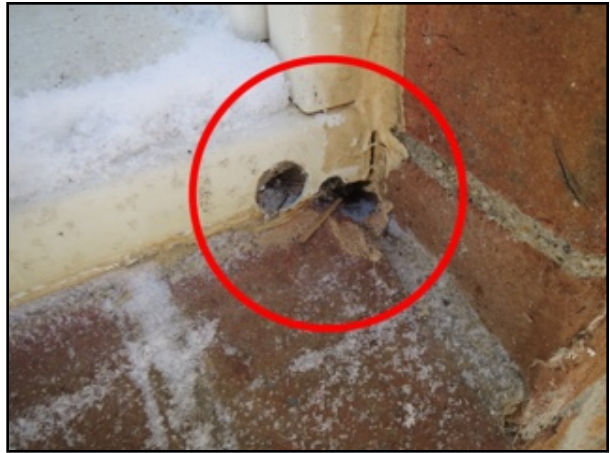
One or more areas of windows, exterior doors, or brick finish were noted to require maintenance (caulk, paint or seal). This is important to increase the life of these systems and prevent the infiltration of pests and moisture. Recommend qualified person repair or replace as necessary.

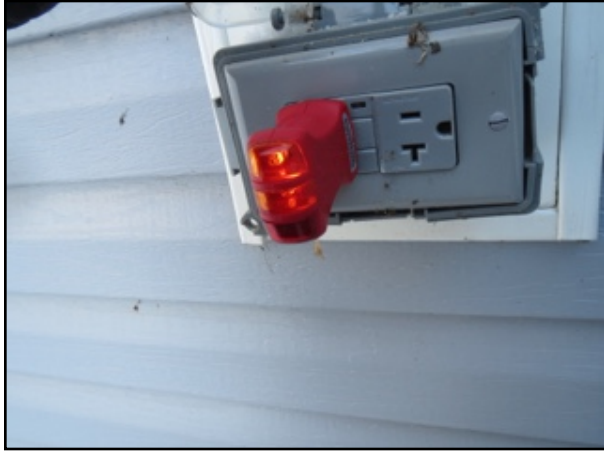
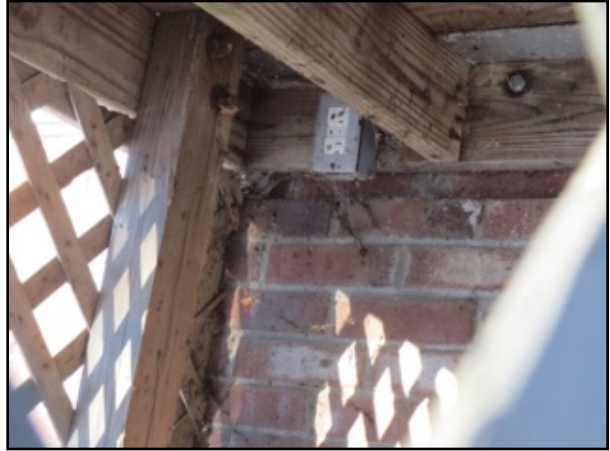
The rear exterior outlet functioned as intended. The front exterior outlet was not tested due to lack of access. Recommend qualified person test GFCI outlet when access is available.

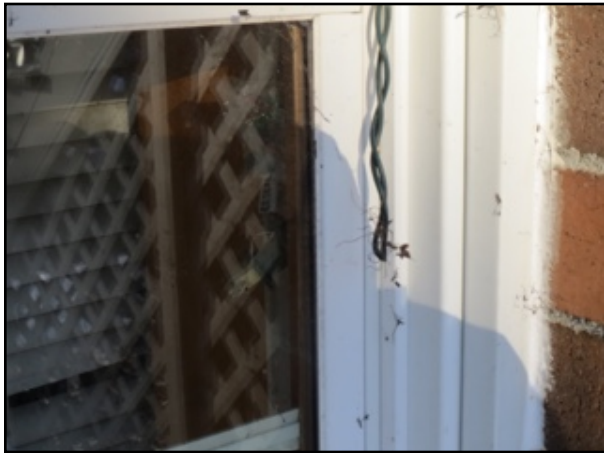
Figure 12-1

Christmas lighting wires were noted terminated outside one of the front basement windows. This represents a potential safety hazard if the interior portion is plugged in. Recommend remove wire.

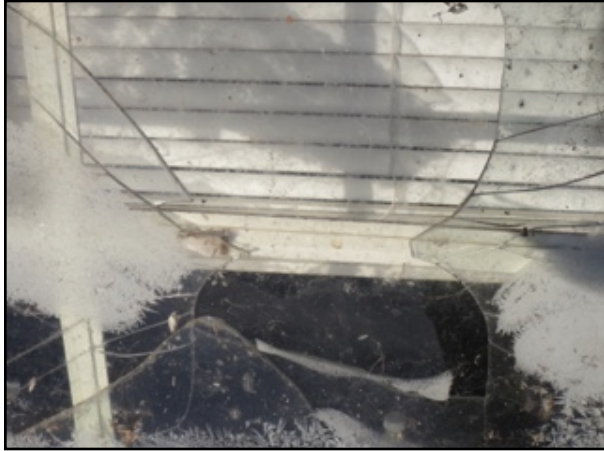
Figure 13-1

One or more basement windows were noted with cracked and or broken window panes. This can affect the energy efficiency of the house. Recommend qualified contractor repair or replace as necessary.

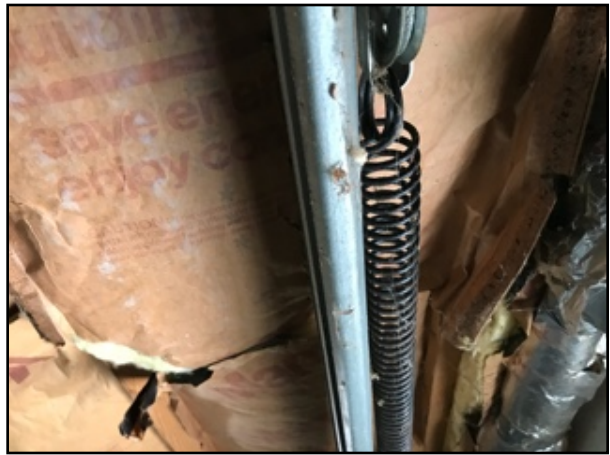
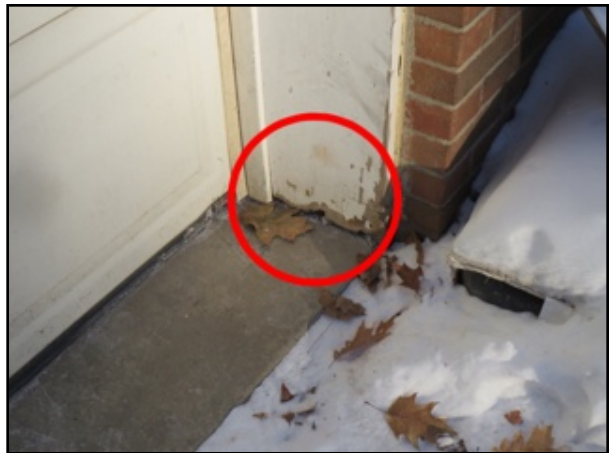
Noted belt driven single car garage door that did not open when energized. The door began to open and stopped. Also noted weatherstripping to have air gaps and one or more springs to lack a safety cable. A photo electric eye was installed but could not be tested due to the door not operating. Also noted exterior door trim to require maintenance/repair (see comments on gutter extensions to take excess moisture away from the house perimeter in the Roof section). Recommend qualified contractor evaluate, repair or replace as necessary.

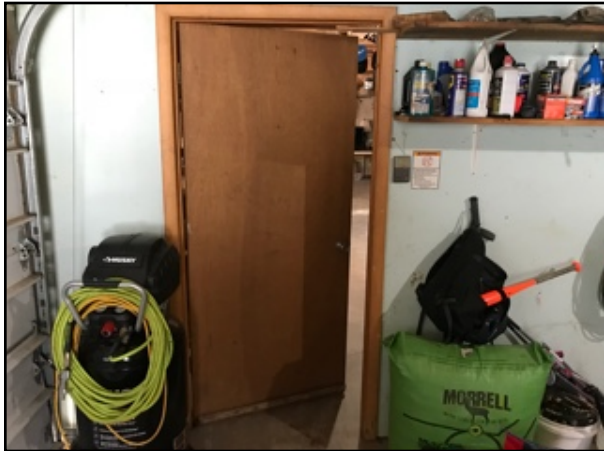
Figure 15-1

Noted door between garage and basement to be not fire rated or self closing. This can allow for fumes to enter the house and is considered a fire safety issue. Recommend qualified contractor install self closing fire rated door.

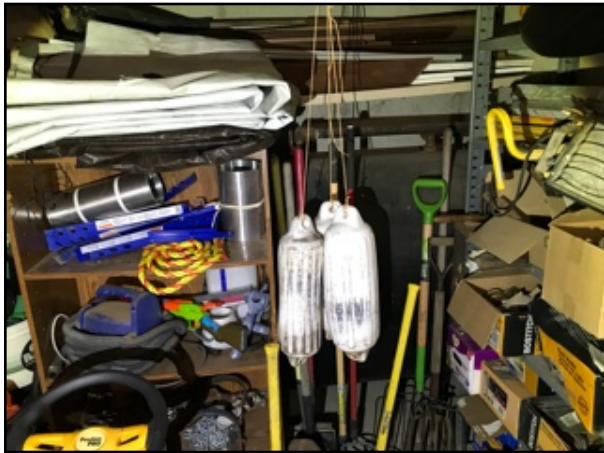
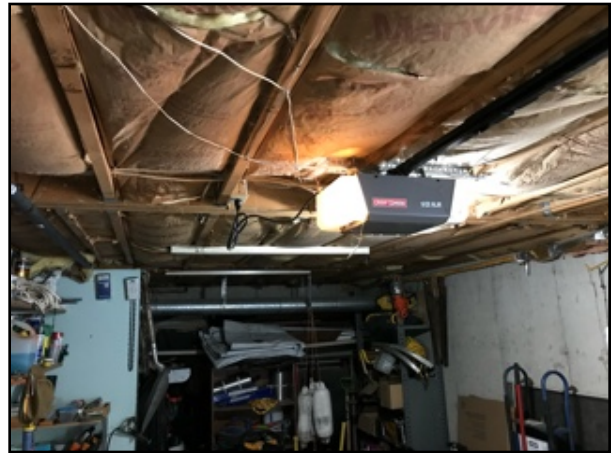
Noted garage with numerous stored items that prevented a full evaluation of the garage space. Visible portions of the garage are considered acceptable with the exception of the ceiling covering. There are living/sleeping areas above the garage and no ceiling covering is present. This is considered a fire hazard. Recommend walkthrough/evaluation once stored items are removed and qualified contractor install fire rated material on ceiling. Repair or replace as necessary.

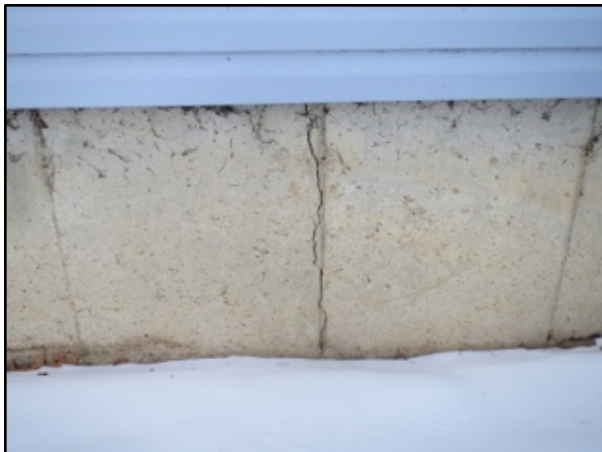
Figure 17-1

Noted one or more cracks in poured concrete foundation. This crack is considered non-structural, but may allow for the infiltration moisture . Recommend qualified person seal crack in concrete.

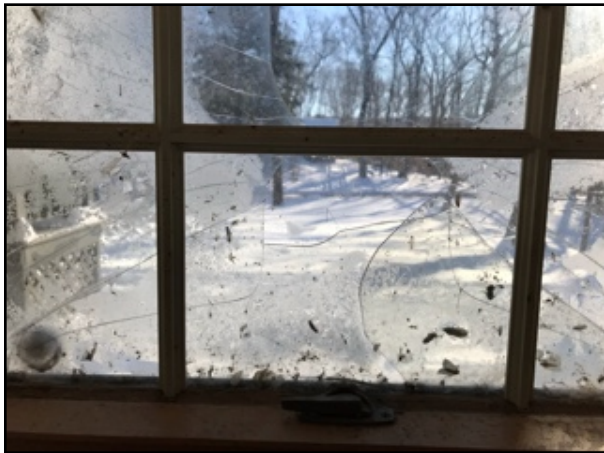
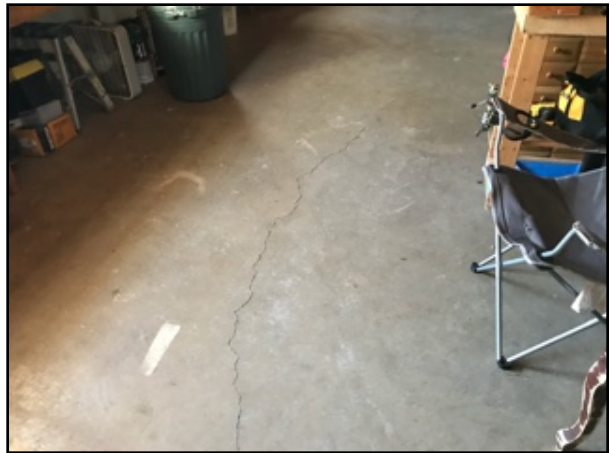
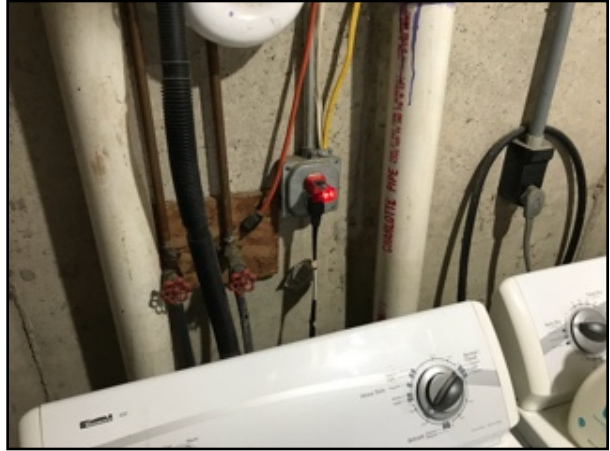
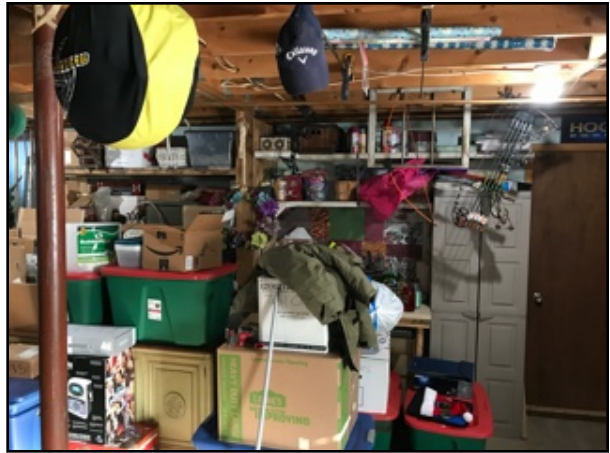
Noted basement without visible signs of moisture intrusion. One or more windows have broken panes as described in the exterior section and require repair. Cracks noted in the floor are considered normal and non-structural. Installed outlets are not GFCI protected. Recommend licensed electrician repair or replace outlets as necessary.

Numerous stored items prevented a complete visual inspection of walls, floors and overhead. Visible portions were considered satisfactory. Recommend walk-through/evaluation once stored items are removed.

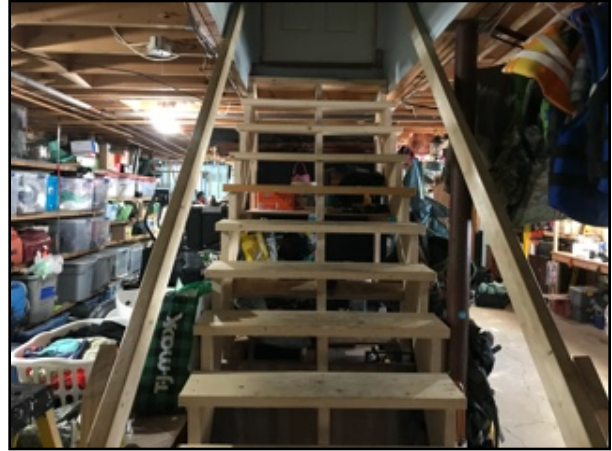
Basement stairs lacked a graspable handrail, had open risers and lacked balusters. Although this is often a common building practice, it is considered a safety hazard, especially for young children and older adults. Recommend a qualified contractor repair or replace as necessary.

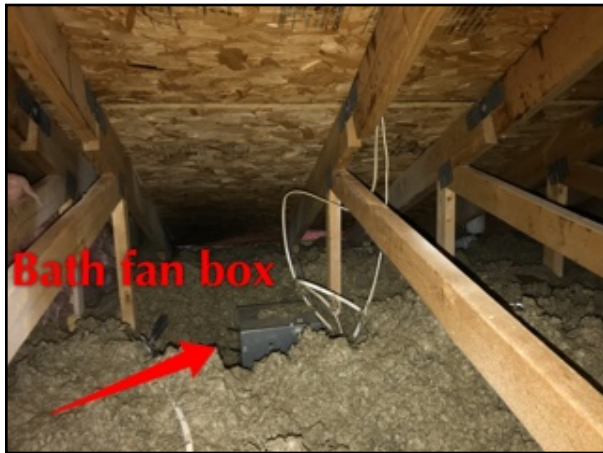
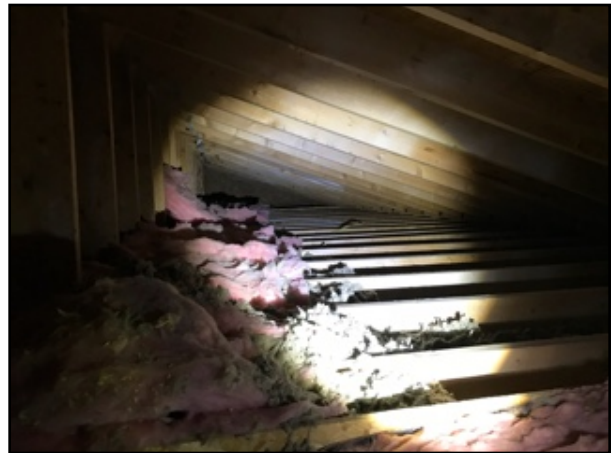
Noted attic with viewing only from hatchway. The kitchen vent stack, kitchen range vent and bathroom fan venting were not visible and their discharge point could not be determined. If bath/kitchen venting terminates in the attic, excess moisture will be pumped into the attic space. Recommend contact owner of record to determine where venting terminates and have qualified contractor repair or replace as necessary. There were no visible signs of excess moisture from the viewing location.

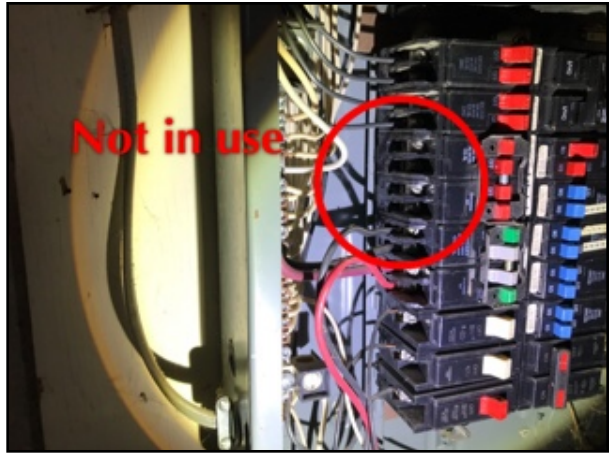
Noted electric panel with light corrosion and one or more internal wires terminated but not capped. Also noted one or more wires external to the panel not in electric box, not terminated properly or lacking electrical box covers. Additionally, several breakers are installed but not in use which can create confusion. Recommend licensed electrician repair, replace or remove as necessary.

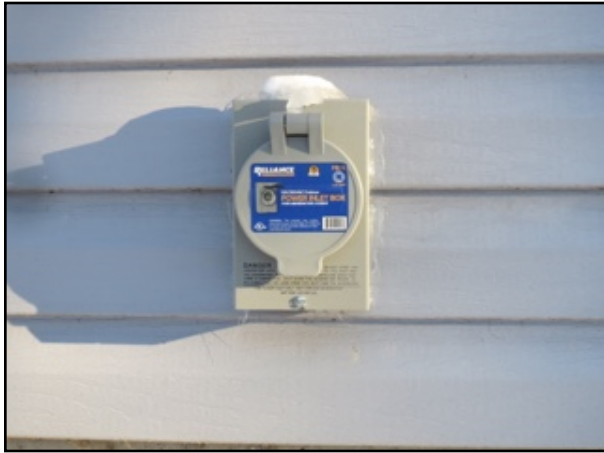
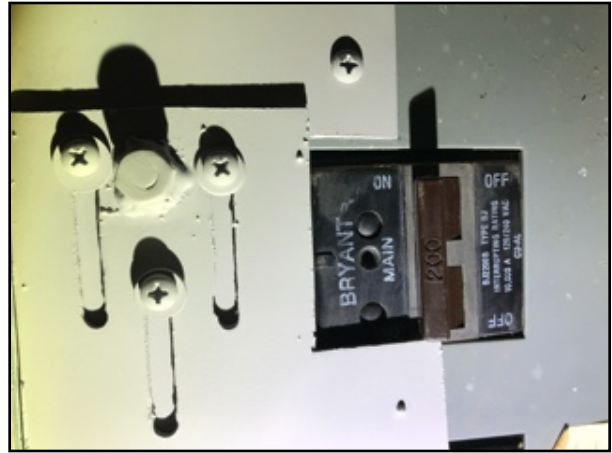
Noted exterior plug for generator with mechanical main disconnect isolation in circuit breaker panel. This system was not tested.

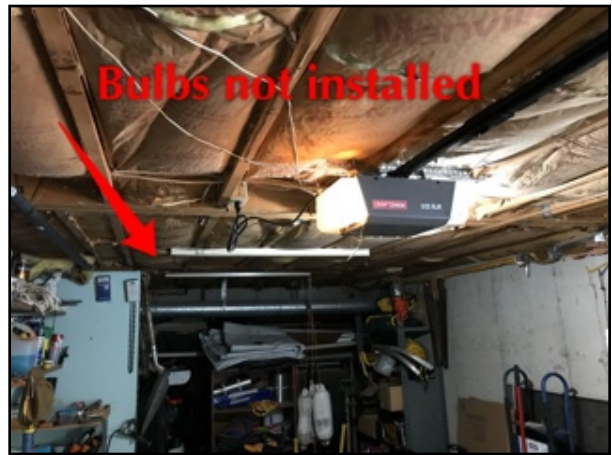
Noted attic (behind access panel) and garage to have light fixtures without bulbs installed. This represents a potential safety hazard. Recommend qualified person install bulbs in these fixtures.

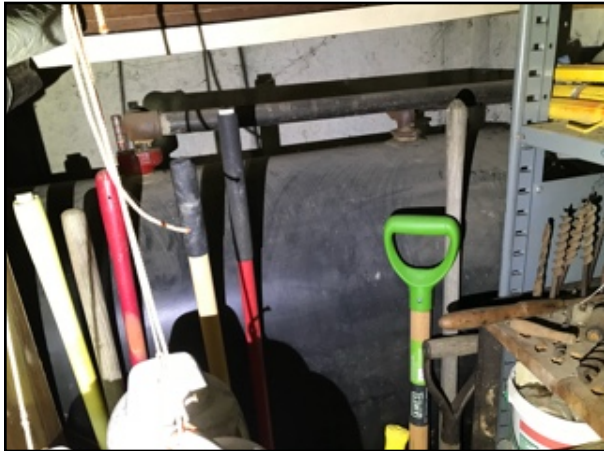
Figure 24-1

The oil tank located in the garage was covered by stored items and could not be fully inspected. Although visible portions appeared satisfactory, the tank should be evaluated by a heating systems professional once stored items are removed. This should be accomplished prior to closing.

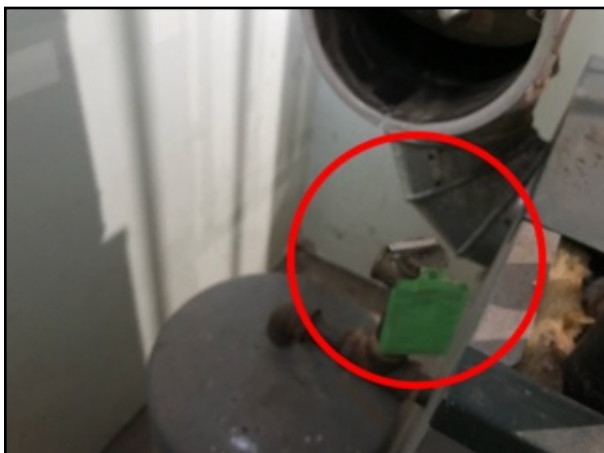
Figure 25-1

The boiler lacks a safety relief valve extension. This extension is intended as a safety device in the event of hot water discharge. Recommend qualified contractor repair or replace as necessary.

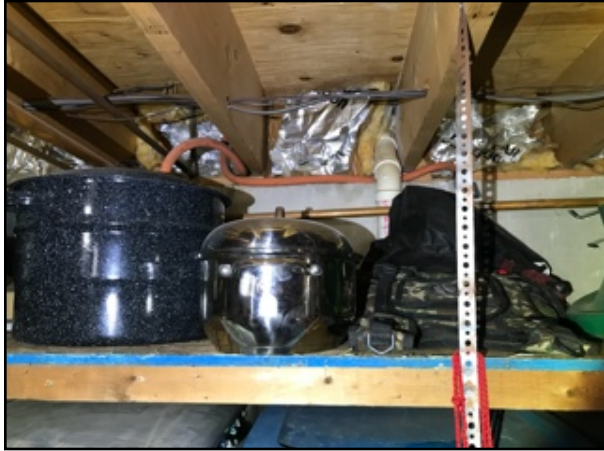
Figure 26-1

A rubber like tubing was noted to be part of the heating system. Recommend licensed plumber/HVAC contractor evaluate material for suitability. Repair or replace as necessary.

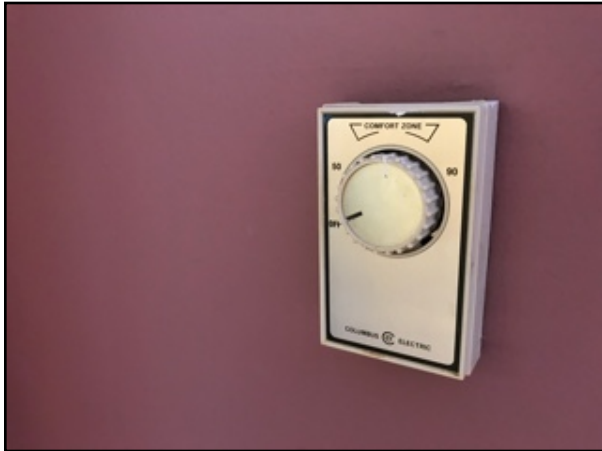
Figure 27-1

One bedroom has a thermostat from what appears to be a previous electric heat source. If this thermostat is no longer in use recommend qualified contractor remove to prevent confusion.

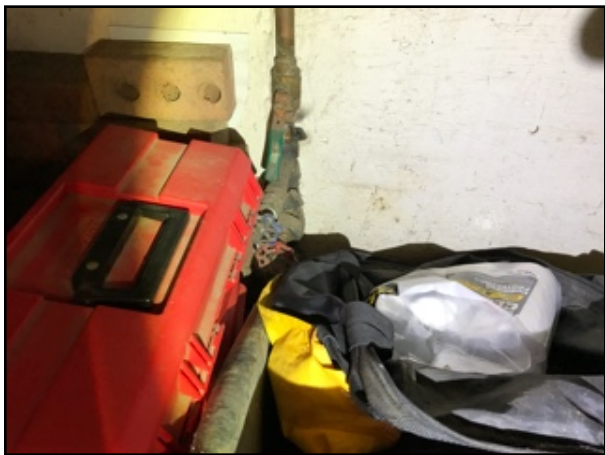
Figure 28-1

The copper supply pipe was wrapped in insulation and not readily visible. Light corrosion was noted in one or more areas on copper distribution piping. No leaks were noted. These locations should be periodically monitored and repaired/maintained as necessary.

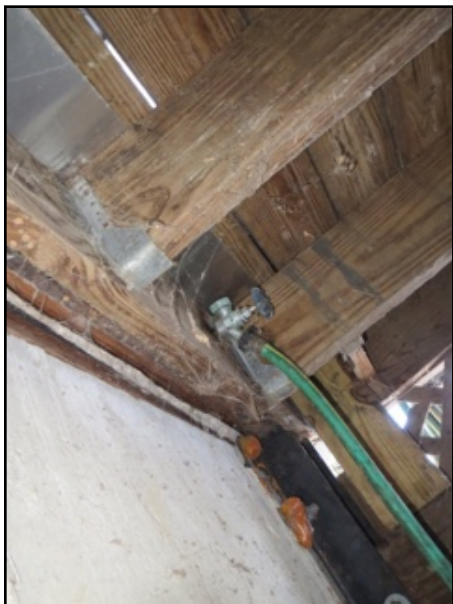
Figure 30-1

Noted PEX waterline feeding outside hose bib to be disconnected from house plumbing. This has been done to prevent the hose bib from freezing in the winter. Although functional, recommend consult licensed plumber to determine a more permanent solution.

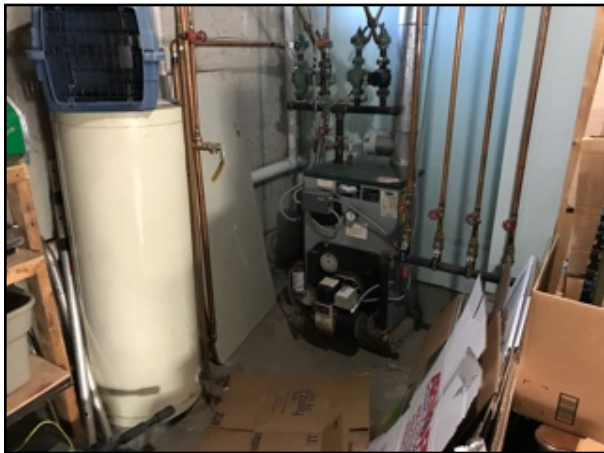
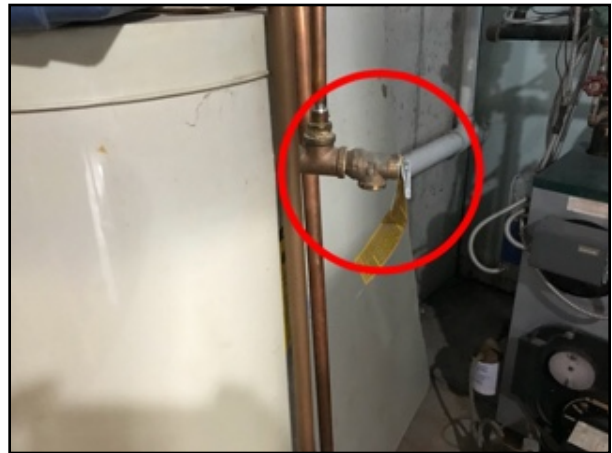
Noted indirect fired water heater without a safety extension on the pressure relief valve. The safety extension is a safety device designed to protect someone in the event of hot water discharge. Recommend qualified contractor repair or replace as necessary.

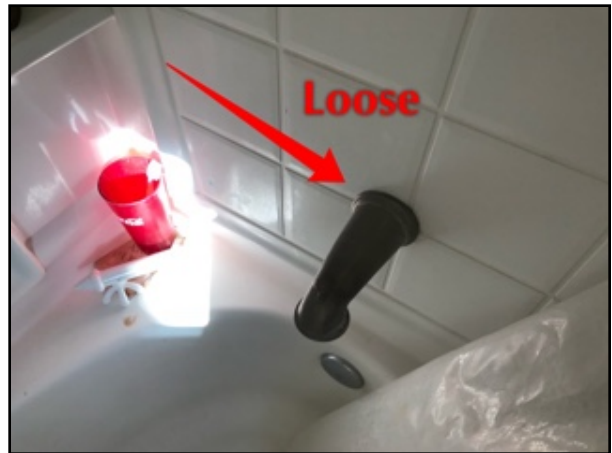
Noted master bathroom to be satisfactory with the exception of a loose vanity sink top, loose tub spout, non-functional window latch and non-functional sink stopper. Recommend qualified person repair or replace as necessary.

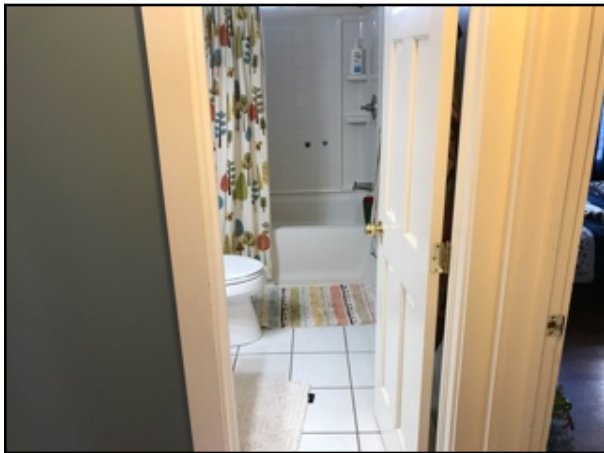
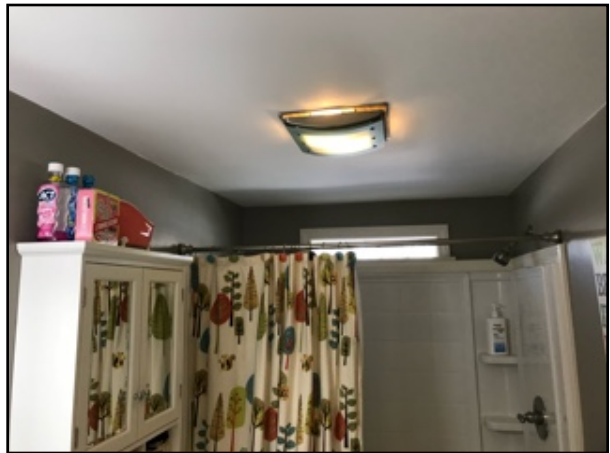
Noted second bathroom to be satisfactory except for nonfunctional exhaust fan and nonfunctional sink stopper. The controlling GFCI outlet was noted to be located at the rear exterior of the house. Recommend qualified contractor repair or replace as necessary.

Also noted incomplete spray pattern at showerhead and small leak at attachment point. Recommend qualified person clean shower head and tighten shower head. Repair or replace as necessary.

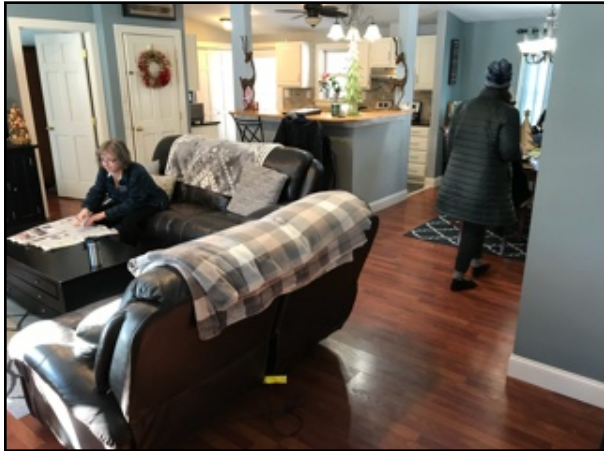
Figure 35-1

Stored items and furniture prevented a complete evaluation of interior house components. Recommend evaluation/walk-through once items are removed.

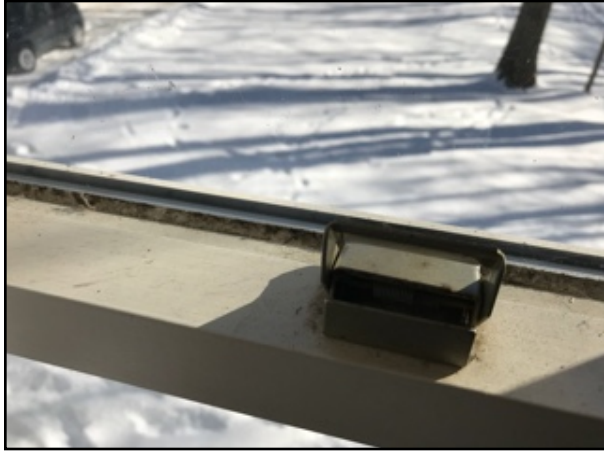
Figure 36-1

A representative sampling of window operation was conducted. All windows except the master bedroom window operated as intended. The master bedroom window failed to latch closed. Recommend qualified contractor repair or replace as necessary.

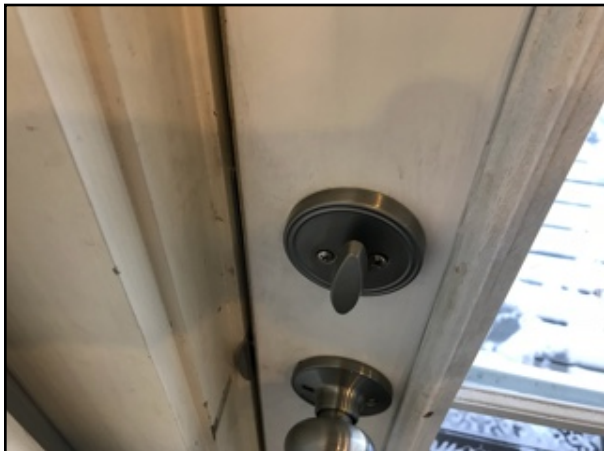
Figure 37-1

The rear exterior door deadbolt failed to fully close. Recommend qualified person adjust, repair or replace as necessary.

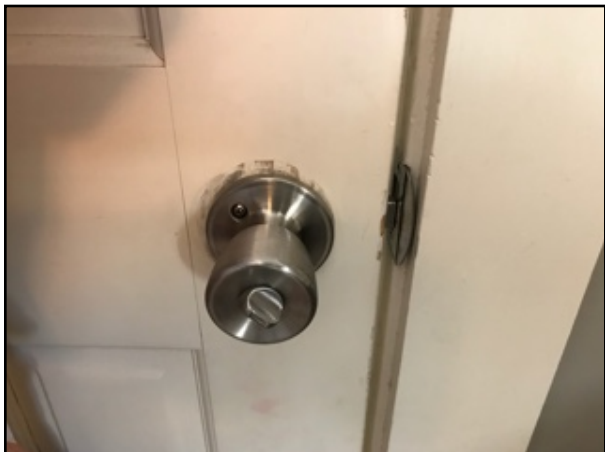
Figure 38-1

One or more interior doors failed to latch when closed. Recommend qualified person adjust, repair or replace as necessary.

One or more panels of the master bedroom closet doors are cracked. The doors operate as intended. Recommend qualified person repair or replace as necessary.

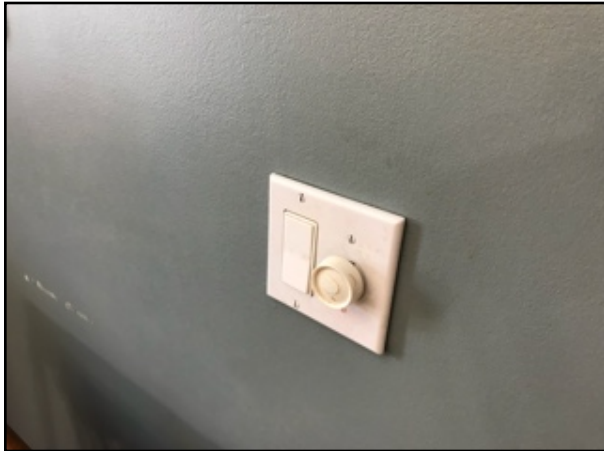
Figure 39-1

The dining room light exhibited a strobe effect when the dimmer was activated. This could be due to the presence of LED lights. Recommend change lightbulbs. If condition continues, recommend licensed electrician repair or replace as necessary.

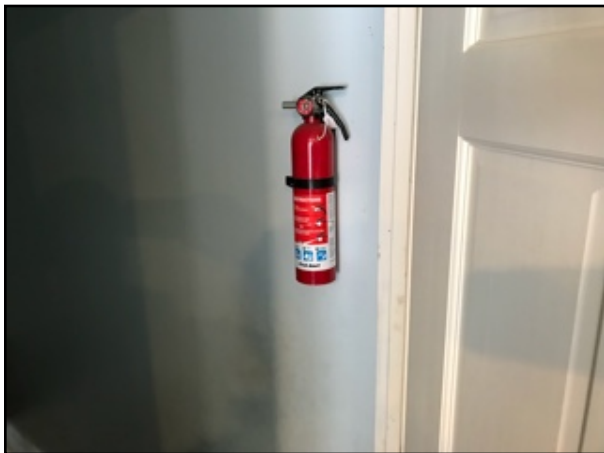
Figure 40-1

Noted fire extinguishers installed in one or more locations. These devices are always recommended in homes. Recommend contacting local fire department for recommended placement and servicing requirements.

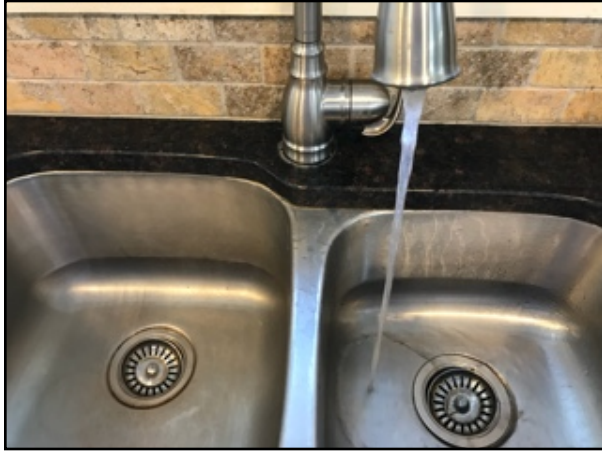
Figure 41-1

Water pressure at the kitchen sink was noted to be low compared to bathroom sinks. Recommend check screen for debris and clean fixture in attempt to increase pressure. This is not a defect.

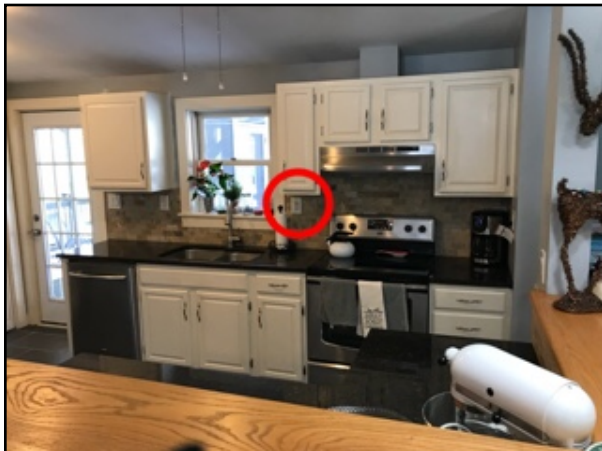
Figure 42-1

**Comment 42:**
The kitchen GFCI outlet tripped as intended, but failed to reset. Recommend licensed electrician repair or replace as necessary.

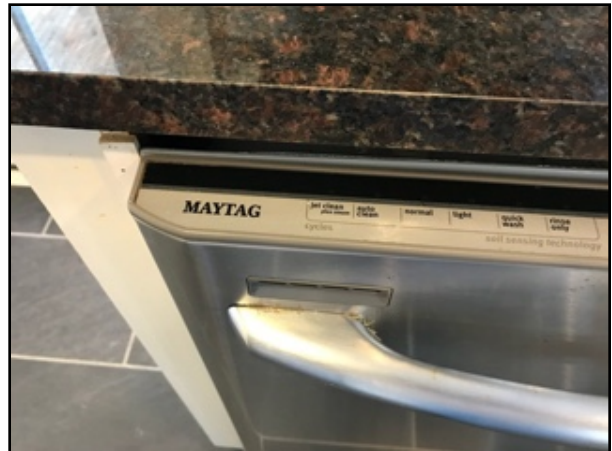
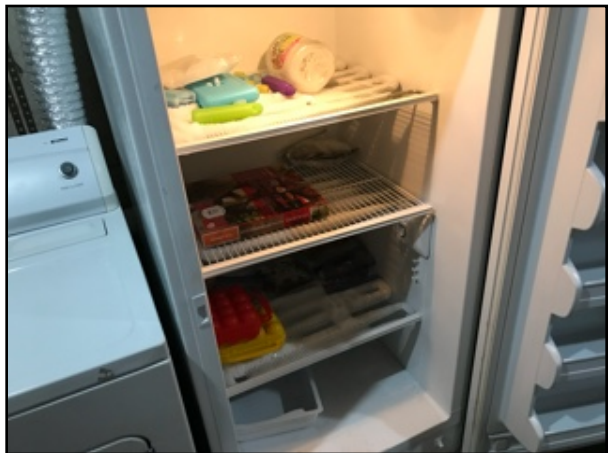
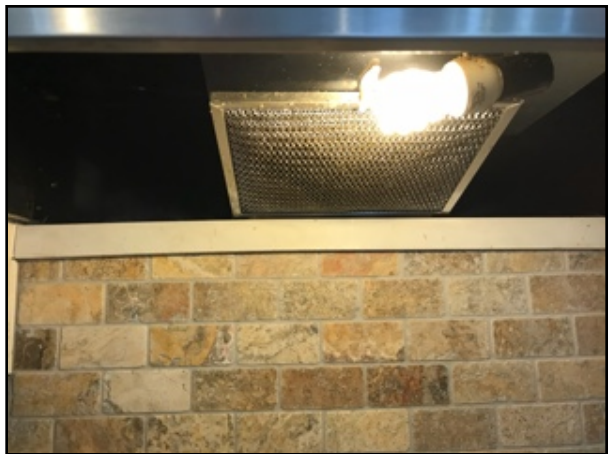
Testing of appliances is beyond the scope of a normal home inspection, however some appliances were tested for operation as indicated above. The refrigerator was noted to have a loose handle. The dishwasher was not tested as the circuit breaker was turned off and indications are that it may not be functioning correctly. Recommend qualified appliance technician repair refrigerator and evaluate dishwasher for repair or replacement as necessary.

Also noted was a GE freezer in the basement. The interior was noted to be frozen.

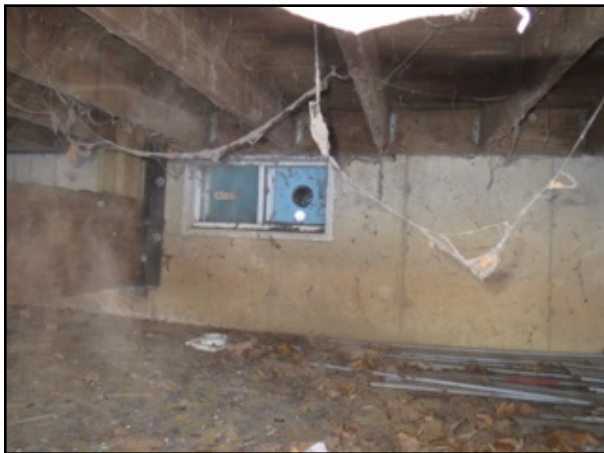
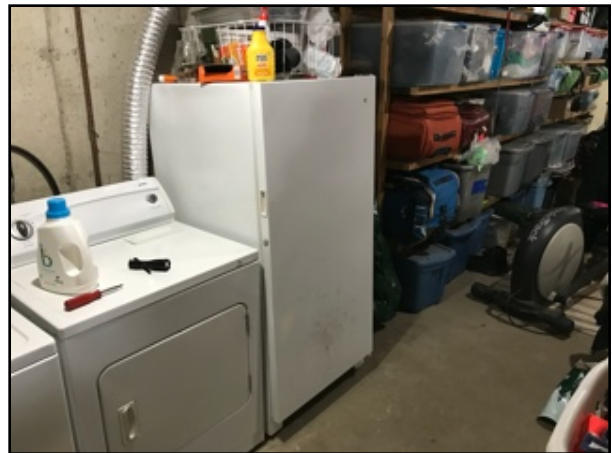
Noted dryer vent made of lightweight flexible foil type metal piping. The dryer vent discharges underneath the deck which can result in excess moisture under the deck. The dryer vent cover is not attached. This can result in moisture, vermin and pest infiltration. Recommend qualified person repair or replace as necessary. No lint was noted at the dryer exterior termination indicating the pipe is relatively new. Dryer venting should be cleaned periodically to prevent it from becoming a fire hazard.

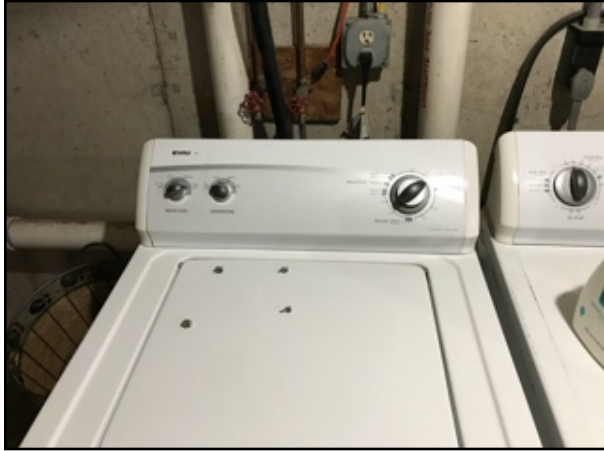
Figure 45-1

The washer and dryer were not tested. This is beyond the scope of a normal home inspection. Should testing be desired, recommend qualified appliance technician test equipment. Also noted additional washer hook up in kitchen closet.
