# Home Inspection Report

**481 Tablerock, Murphy, TX 75094**

# PROPERTY INSPECTION REPORT

**Concerning:** 481 Tablerock Murphy, TX 75094

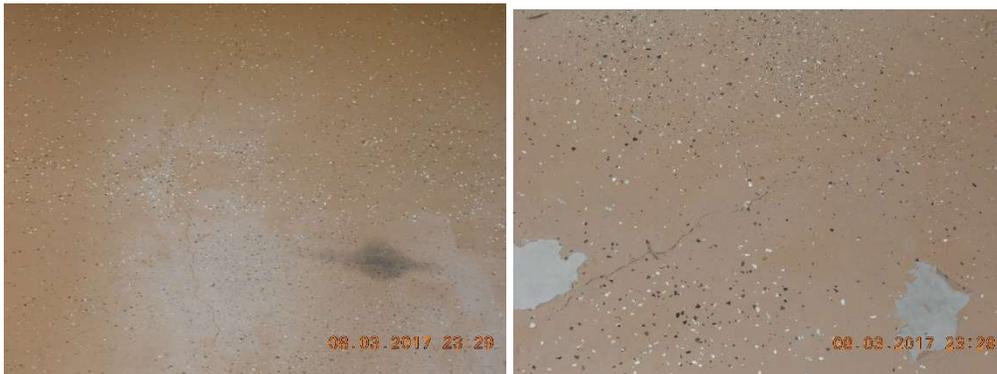
- Common minor cracks were observed in the foundation garage floors of the house. This is normal but should be monitored. There's a stress crack at the entry which is also normal but likely warrantable.
- There is evidence of pest (bees, wasps) activity in the eaves. A pest control specialist should be consulted in this regard.

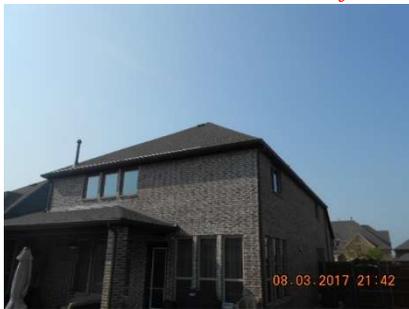
- The roofing is considered to be in fair condition. **Installer left toe boards which could cause leaks if not removed and sealed appropriately (rear above patio).**
- The clearance of the fascia at roof overhangs should be 1-2". This condition leaves the siding vulnerable to rot. Fascia seems to touch shingles in various locations pictured.
- **Damage to the roof covering materials may result from walking on the roof; determine the number of layers of roof covering material; identify latent hail damage; or provide an exhaustive list of locations of water penetrations or previous repairs.**

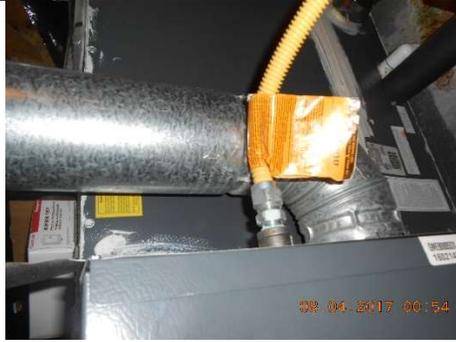
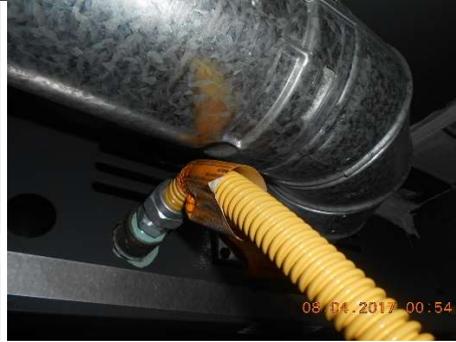
- HVAC vent pipe clearance is 1"; gas line is touching the vent stack. Contact a qualified technician and proceed as guided.

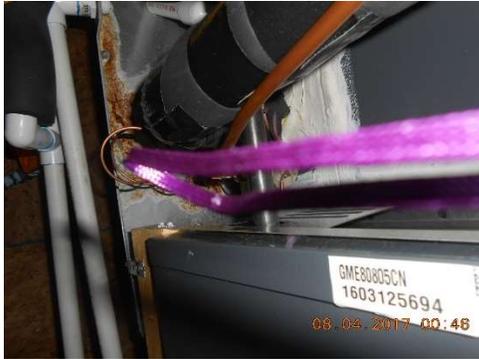
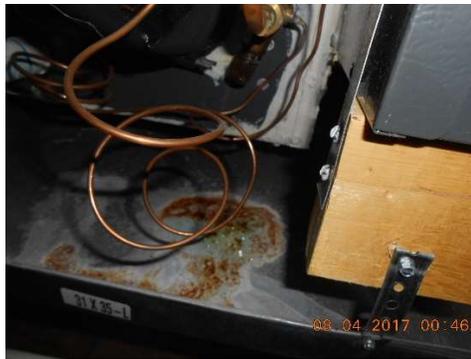
Evidence of prior leakage was observed at the condensate tray of the air conditioning system. Repairs should be undertaken, if necessary

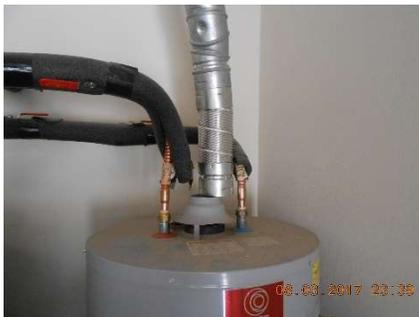
- For enhanced safety, it is recommended that the connections of the water heater venting system be improved. **Water temp is currently >130°**, so I recommend reducing to <120° for safety
- **The flue/vent is separated from the WH and should be reattached. This vent is currently ineffective and can lead to increased levels of CO in the area, and continued degrading of nearby materials.**

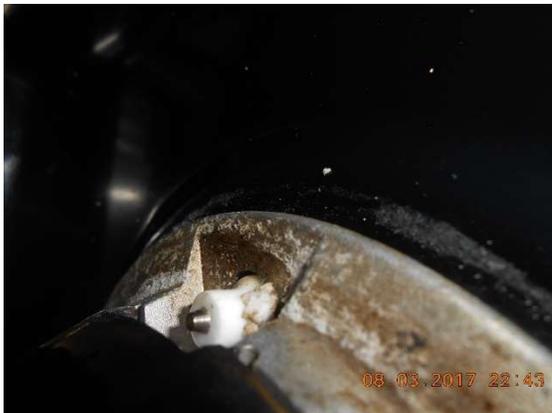
- **The pilot light for the gas range is not functioning consistently.** Back burner doesn't fire immediately. If not addressed during warranty period you could lose coverage for repairs.
