II. REVIVING A HALLICRAFTERS S-38C

by a mysterious CHRS member.

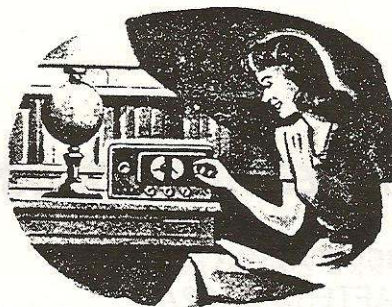
I traded for my Hallicrafters S-38C at a CHRS swapmeet. "Does it work?" I asked. "Oh, yes!" the seller replied. Upon getting it home, I found that it had an incredible AC hum that overshadowed even AM broadcast reception. I tested the power supply filter caps on our Sencore Capacitor Tester at work. All three caps in the cans were very leaky. They did not reform on their rated voltages, even overnight. I was then obliged to pry the can open, and replace the caps with modern (Nichicon) units. I sealed the can with paraffin, and the results were indistinguishable from the original.

With this rectification* [* use a pun, go to prison -- ed.] I then tested the tubes. All checked fine. I did, however, replace the JAN metal cased tubes with vintage glass envelope units. The radio now worked. It was, unfortunately, way off frequency. To align the receiver, I borrowed a buddy's EICO Signal Generator, and also used a frequency counter from work. After the AM band, I soon found that the frequency counter lacked the sensitivity to work the short wave bands accurately. I therefore trusted to "Kentucky Windage" and the EICO Company to align the short wave bands. Lacking a schematic, I turned one cap at a time to align methodically the three short wave bands. I then marked and sealed each cap with a drop of White-out.

What to do? Isolate the ground. I used a 0.001 mf at 600VDC Mylar cap to bypass the ground terminal on the beaverboard back panel of the radio, and another in series with the antenna terminal. This prevented an further monkey business with poor grounding. The S38 then worked probably as well as it ever had, considering it is a six tube, transformer-less AC/DC job which probably sold for \$29.95 plus two box tops when new. With the new Mylar and modern electrolytics, it may just work for a couple of more years. -- 73 --
