# Inspection Report

**Property Address:**  
333 Wild Raspberry Lane  
Etowah NC

**Hubert Lowe Home Inspections**

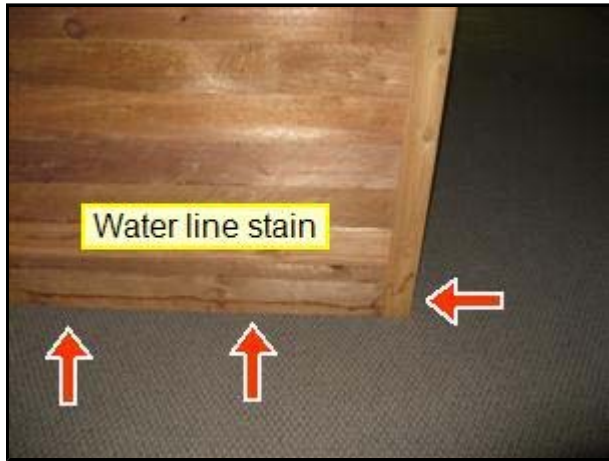
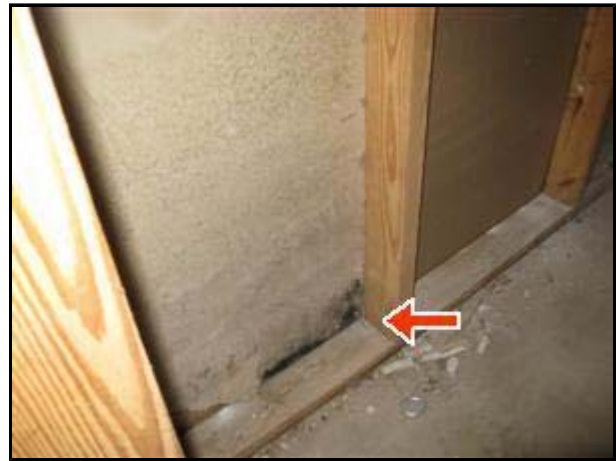
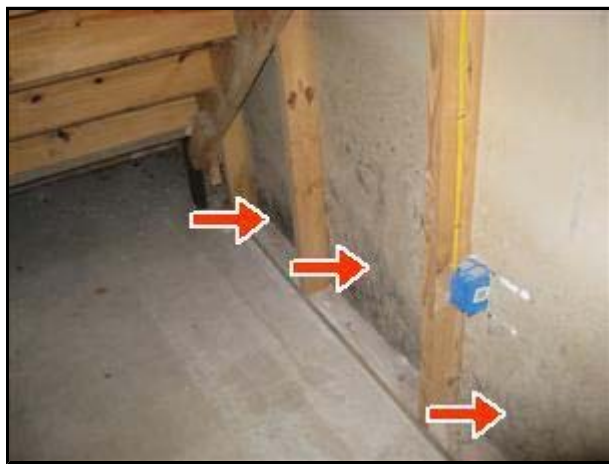
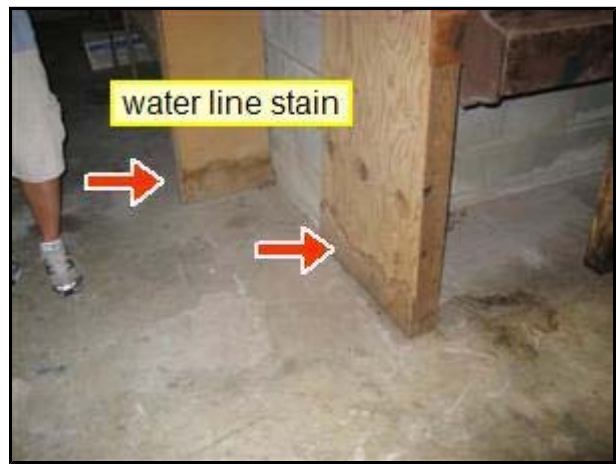
**1.0 (1)** White efflorescence (powder substance) on block wall indicates moisture is in contact with the masonry. This does not necessarily indicate that intrusion will occur. I recommend checking the gutters and the downspout drain lines for proper operation. Also, a water proofing paint could be applied to the interior side of the block if necessary. Efflorescence is found on many homes without water intrusion occurring inside the home. But, it should alert you to the possibility that future steps may be needed.

**(2)** Water signs on cedar wall and trim. Also a mold like substance on carpet at lower level and under stairs. I did not inspect or test for mold and I am unable to determine if water intrusion occurs.

(1) White efflorescence (powder substance) on block wall indicates moisture is in contact with the masonry. This does not necessarily indicate that intrusion will occur. I recommend checking the gutters and the downspout drain lines for proper operation. Also, a water proofing paint could be applied to the interior side of the block if necessary. Efflorescence is found on many homes without water intrusion occurring inside the home. But, it should alert you to the possibility that future steps may be needed.

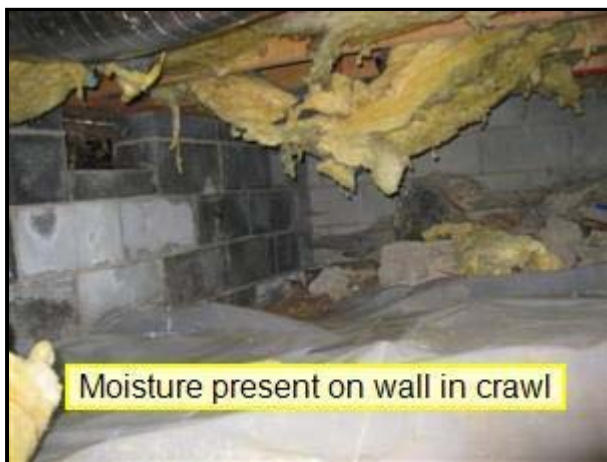
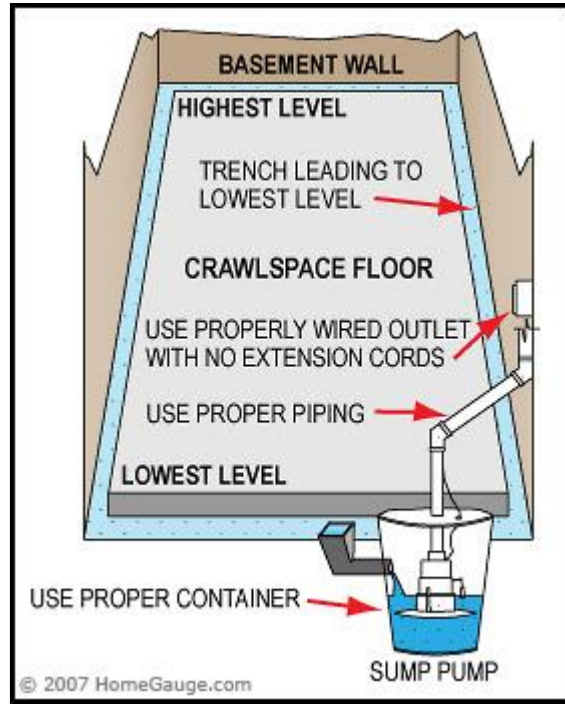
1.0 Picture 5 crawlspace under kitchen

🔍 (3) Visible signs of water intrusion in the crawlspace (along front of home) are present from dampness along the block wall. I am unable to determine the extent of intrusion or how often it occurs. Cross ventilation may help as the crawls has no ventilation. I recommend further investigation or correction by a qualified licensed contractor or water infiltration specialist. Refer to the diagram as a guide if a drainage system is needed.

(3) Visible signs of water intrusion in the crawlspace (along front of home) are present from dampness along the block wall. I am unable to determine the extent of intrusion or how often it occurs. Cross ventilation may help as the crawls has no ventilation. I recommend further investigation or correction by a qualified licensed contractor or water infiltration specialist. Refer to the diagram as a guide if a drainage system is needed.

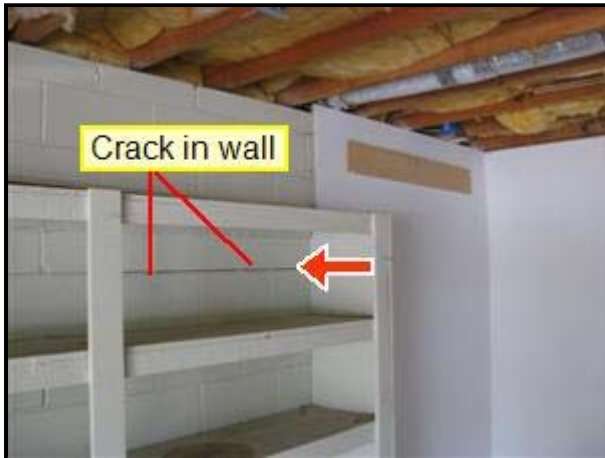
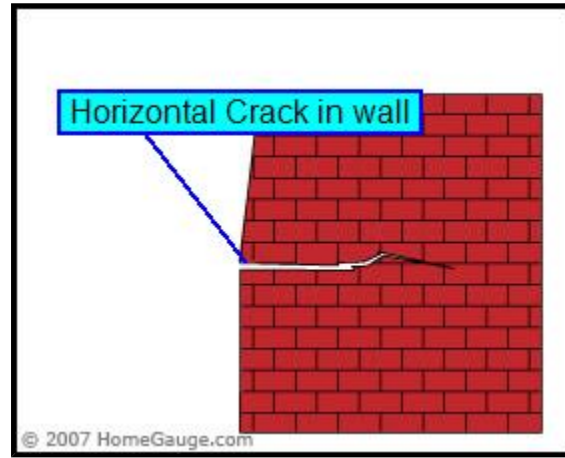
🔍 **1.1** There is a horizontal crack(s) in the foundation wall at the left side (facing front). These cracks do not appear significant to require repairs at this time. This is my opinion and you should seek a second opinion by a qualified person.

There is a horizontal crack(s) in the foundation wall at the left side (facing front). These cracks do not appear significant to

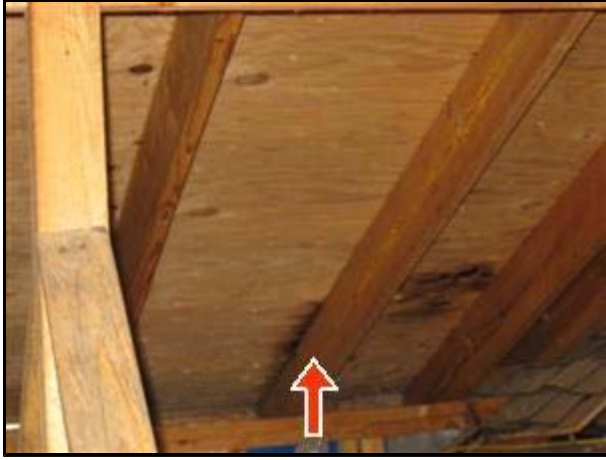
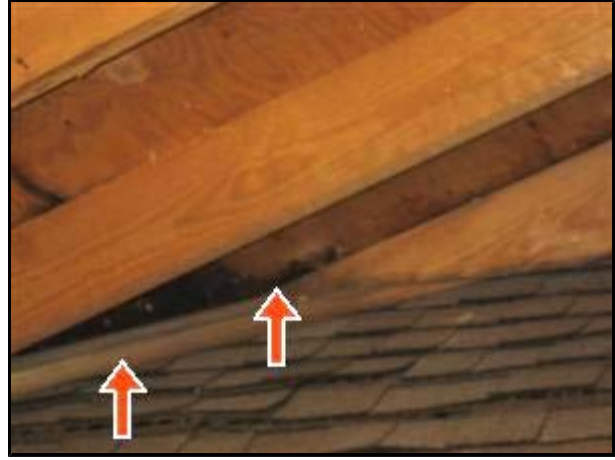
🔍 **1.5** Leak signs in attic perhaps or likely from the *old roof* as this newer roof appears in tact. I am unable to determine if leak exists due to no recent rain.

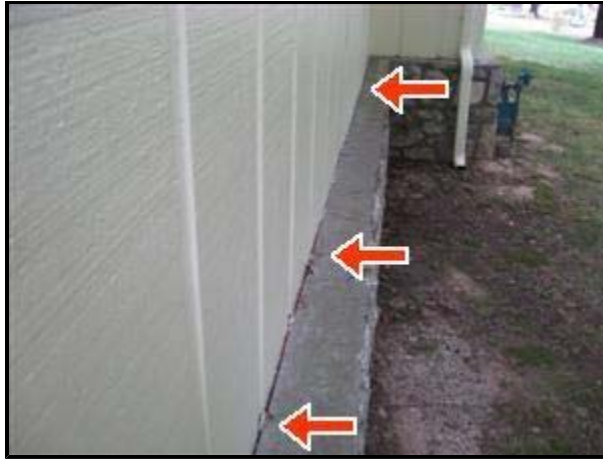
2.0 Picture 1

2.0 Periodical maintenance caulking needed and recommended to keep water from weeping under siding at concrete shelf. FYI

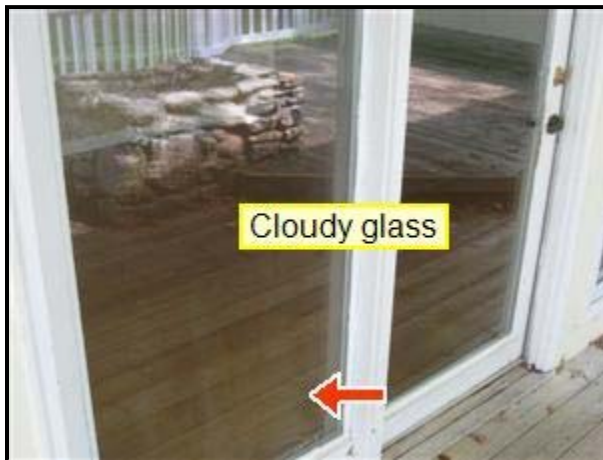
2.1 Picture 1

**2.1** Patio doors at rear of home are cloudy or seal is broken. Glass panes that have lost their seal (cloudy) can usually be replaced without replacing the entire unit. A qualified contractor should inspect and repair as needed.

Patio doors at rear of home are cloudy or seal is broken. Glass panes that have lost their seal (cloudy) can usually be replaced without replacing the entire unit. A qualified contractor should inspect and repair as needed.

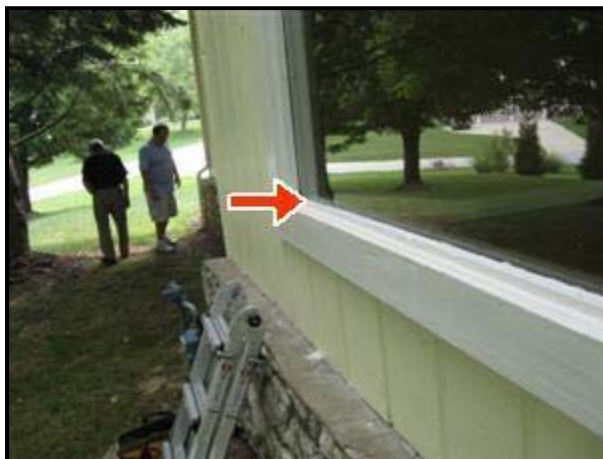
2.2 Picture 1

**2.2** The trim stop for fixed pane is weathered and indicates that water may be getting below trim. I recommend a paintable sealant be applied and paint trim.

The trim stop for fixed pane is weathered and indicates that water may be getting below trim. I recommend a paintable sealant be applied and paint trim.

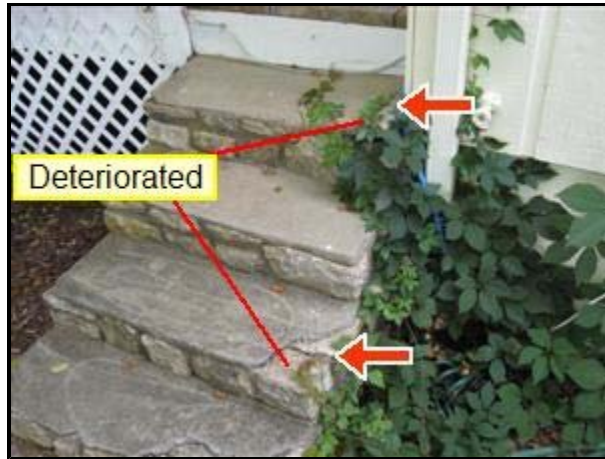
2.3 Picture 1

**2.3** (1) The step tread on steps on the deck at the rear of home are deteriorated. A repair or replacement is needed. A skilled masonry contractor should perform the work.

A handrail may be needed

(1) The step tread on steps on the deck at the rear of home are deteriorated. A repair or replacement is needed. A skilled masonry contractor should perform the work.

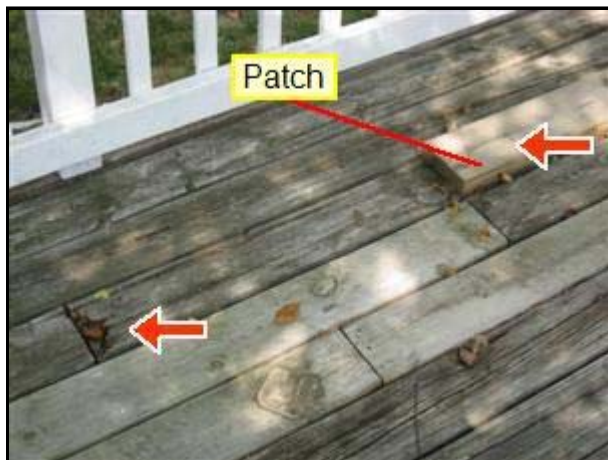
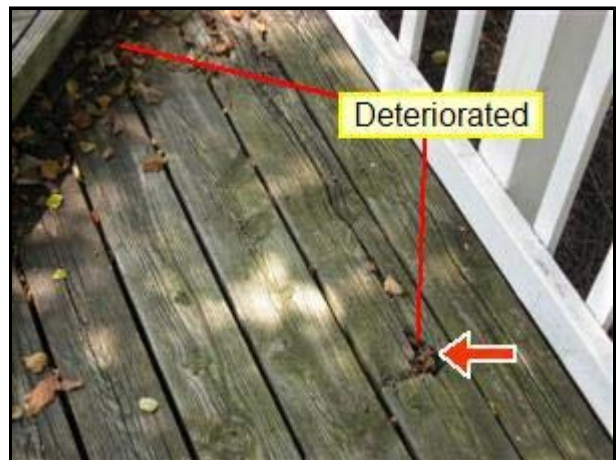
🔨 (2) The 2x6 decking on the deck at the rear of home has several boards that are deteriorated. A general replacement is likely. A qualified contractor should determine whether a repair or replacement is needed.

(2) The 2x6 decking on the deck at the rear of home has several boards that are deteriorated. A general replacement is likely. A qualified contractor should determine whether a repair or replacement is needed.

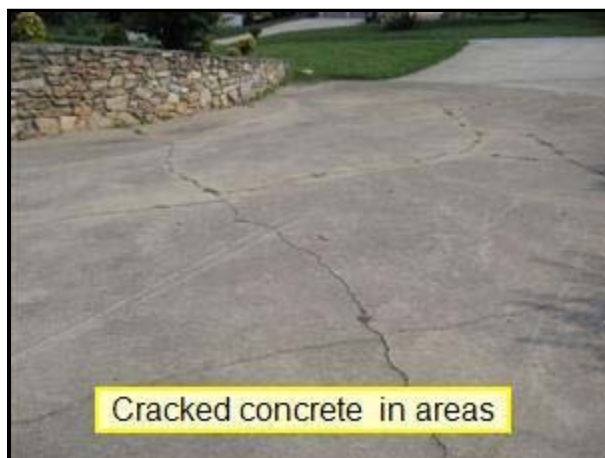
2.4 Picture 1

🔨 **2.4** The concrete drive at the front of home is pitted in areas and has settlement cracks. Further deterioration can occur if not repaired. A qualified contractor should inspect and repair as needed.

The concrete drive at the front of home is pitted in areas and has settlement cracks. Further deterioration can occur if not repaired. A qualified contractor should inspect and repair as needed.

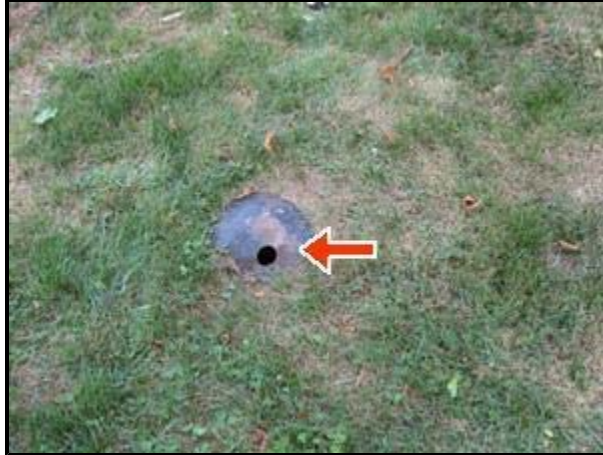
2.6 Picture 1

🔍 **2.6** (1) Old propane tank in ground and is discontinued. I did not determine if gas remains in discontinued tank? I recommend further investigation by a qualified person.

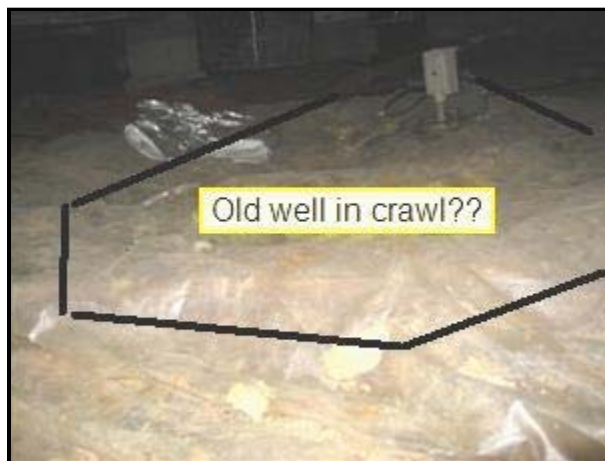
2.6 Picture 2 in crawlspace under new addition

🔍 (2) There is an odd configuration in ground under addition in crawlspace. This may be an old well? I am unable to determine. I recommend a qualified well drilling company or plumber investigate further to determine if any further action is needed to correct.

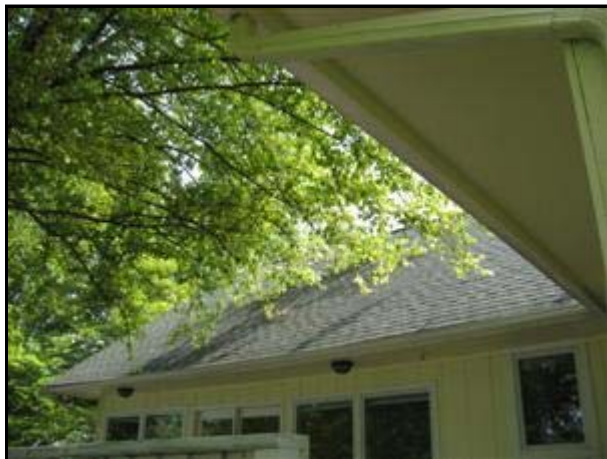
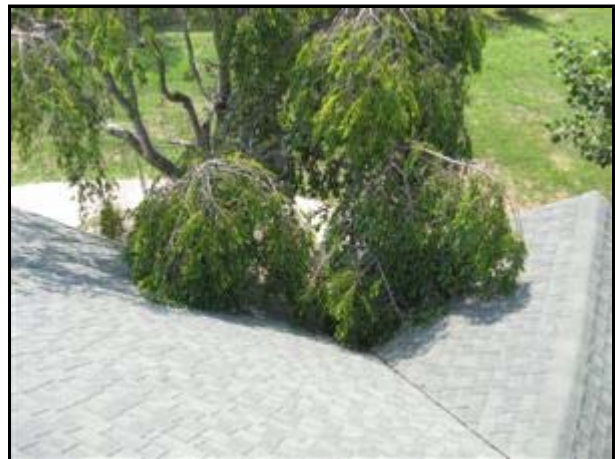
3.0 (1) The tree limbs that are in contact with roof or hanging near roof should be trimmed.

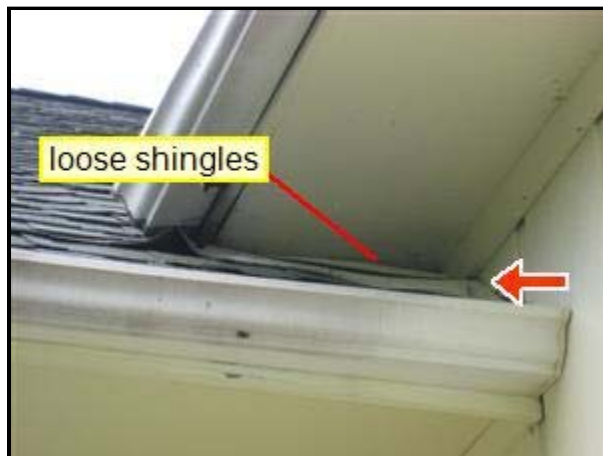
3.0 Picture 3

(2) Shingles loose under eave at front of home, needs adhesive.

(2) Shingles loose under eave at front of home, needs adhesive.

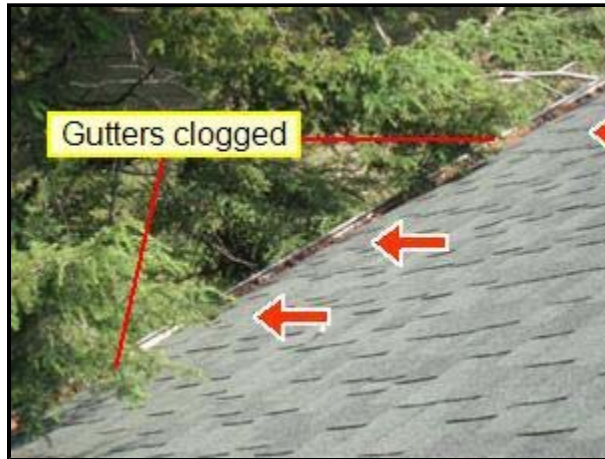
3.3 Picture 1

**3.3** The gutter needs cleaning of debris at the virtually all areas where gutters are installed. Gutters that drain poorly or clogged can lead to many costly problems such as deterioration of fascia, soffit or roof edge. It can also cause gutters to pull loose and lead to possible water intrusion. A qualified person should repair or replace as needed.

The gutter needs cleaning of debris at the virtually all areas where gutters are installed. Gutters that drain poorly or clogged can lead to many costly problems such as deterioration of fascia, soffit or roof edge. It can also cause gutters to pull loose and lead to possible water intrusion. A qualified person should repair or replace as needed.

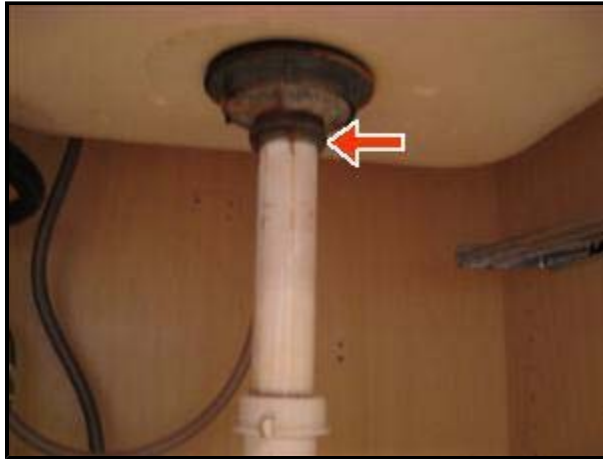
4.0 Picture 1 Right sink basin

**4.0 (1)** The basket strainer had leaked and corrected itself for the time being at the Kitchen sink. Repairs are needed. A qualified person should repair as necessary.

(1) The basket strainer had leaked and corrected itself for the time being at the Kitchen sink. Repairs are needed. A qualified person should repair as necessary.

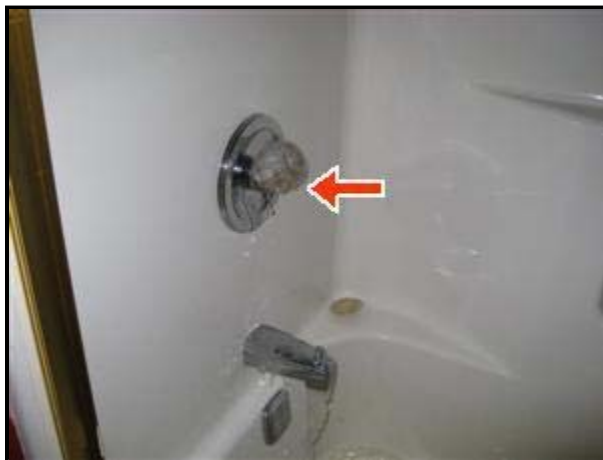
4.1 Picture 1 hall bath

🔧 **4.1** (1) The control knob leaks at the hall bath. Repairs are needed. A qualified licensed plumber should repair or correct as needed.

(1) The control knob leaks at the hall bath. Repairs are needed. A qualified licensed plumber should repair or correct as needed.
-

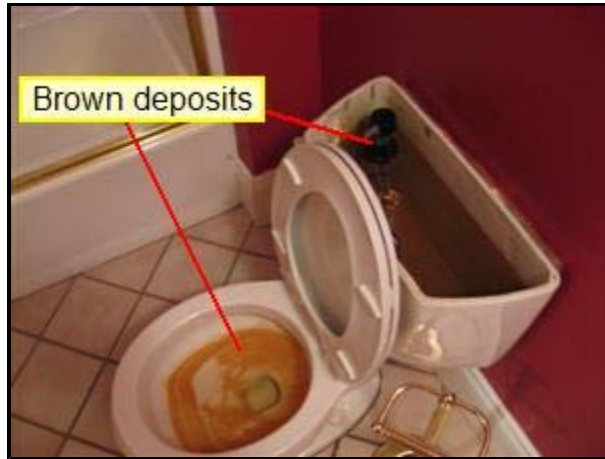
4.1 Picture 2

🔍 (2) Brown deposits are on the plumbing fixtures which indicates a filter may be needed. Filter in place and appears dirty but I am unable to determine if you need a different or additional filter. I did not test water for bacteria or other. I recommend contacting a water filtration company.

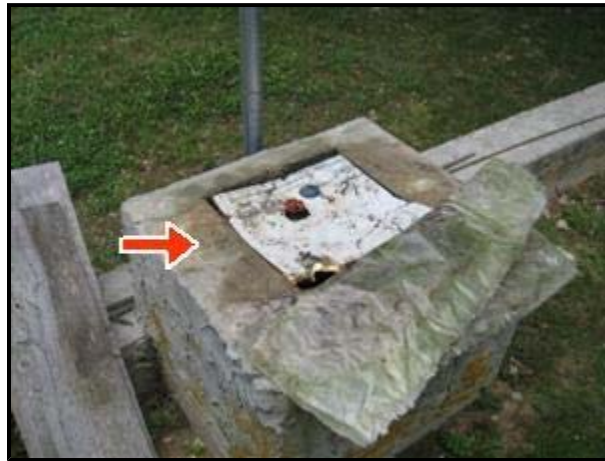
4.1 Picture 3 Well head

🔧 (3) I recommend the well head lid be insulated better before winter. FYI

(3) I recommend the well head lid be insulated better before winter. FYI

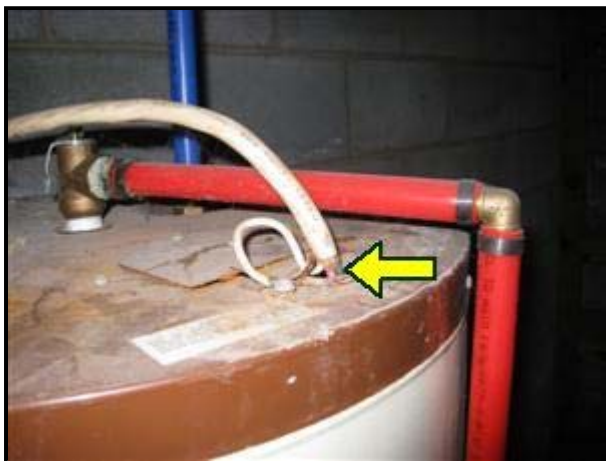
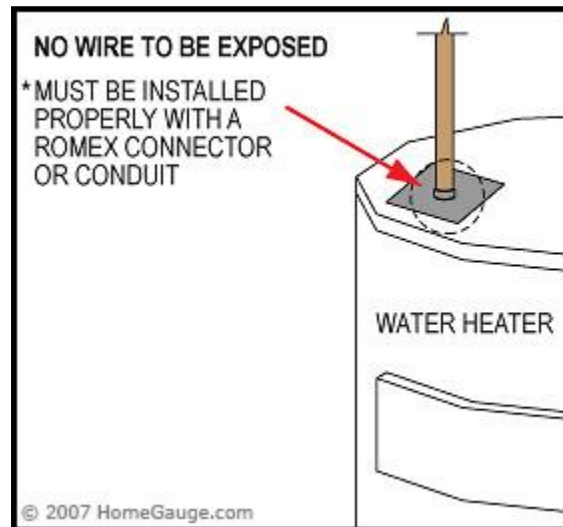
🔧 **4.2** The wiring for the water heater missing romex connector. Electrical issues are considered a hazard until repaired. I recommend a licensed electrician correct as necessary.

The wiring for the water heater missing romex connector. Electrical issues are considered a hazard until repaired. I recommend a licensed electrician correct as necessary.

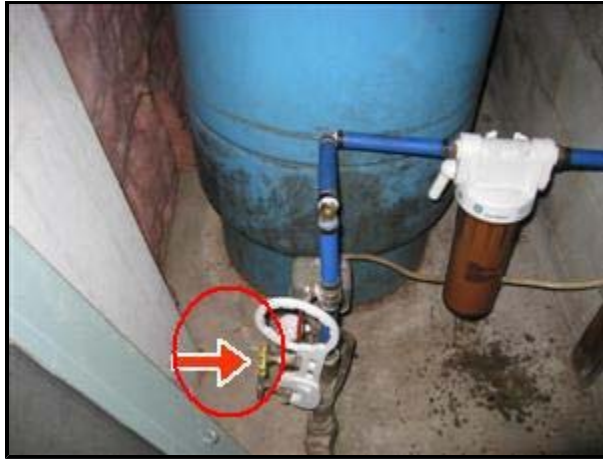
4.3 Picture 1 In basement

**4.3** The main shut off is the yellow knob located in the basement at the pressure tank. This is for your information.

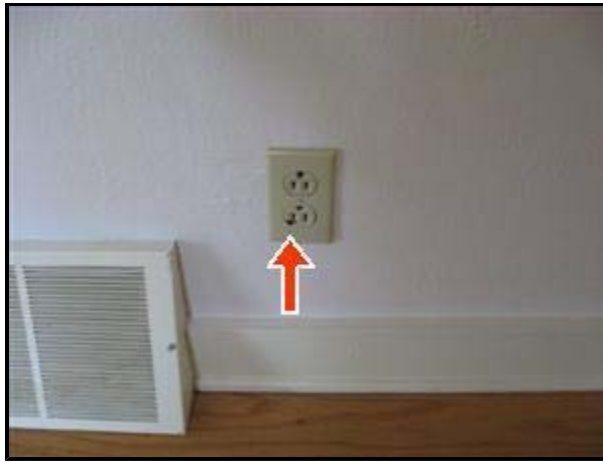
5.3 Picture 1

**5.3** (1) The wall switch is broken (unsafe) at the upstairs closet for air handler. At least two outlets are broken at LR and entry way. Electrical issues are considered a hazard until repaired. A qualified licensed electrician should perform repairs that involve wiring.

(1) The wall switch is broken (unsafe) at the upstairs closet for air handler. At least two outlets are broken at LR and entry way. Electrical issues are considered a hazard until repaired. A qualified licensed electrician should perform repairs that involve wiring.
-

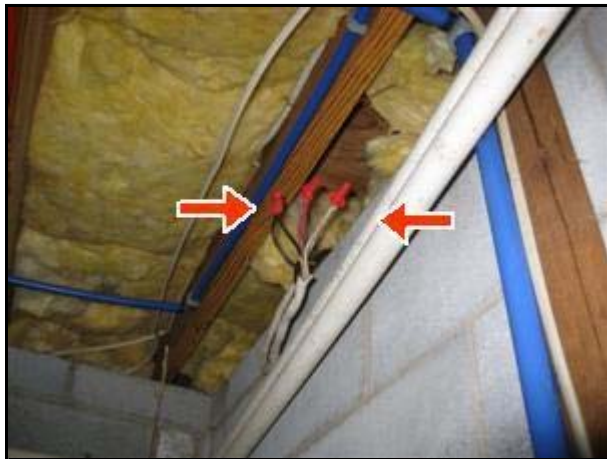
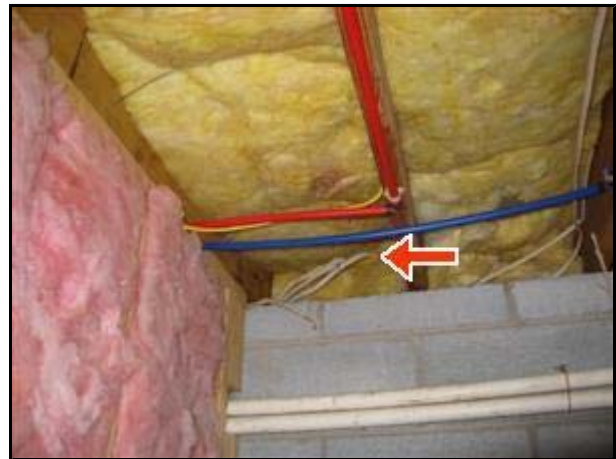
🔧 (2) Several loose wire ends needs placing inside a box with a cover-plate in the basement at the pressure tank of well. I recommend repair as needed.

(2) Several loose wire ends needs placing inside a box with a cover-plate in the basement at the pressure tank of well. I recommend repair as needed.

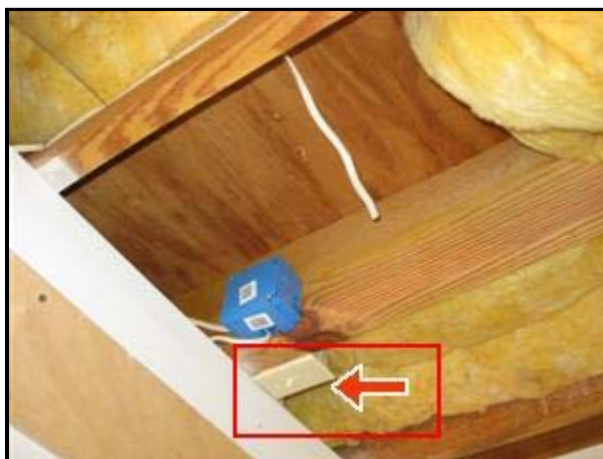
5.3 Picture 4

🔍 (3) Wall switch on ceiling in Garage, purpose unknown

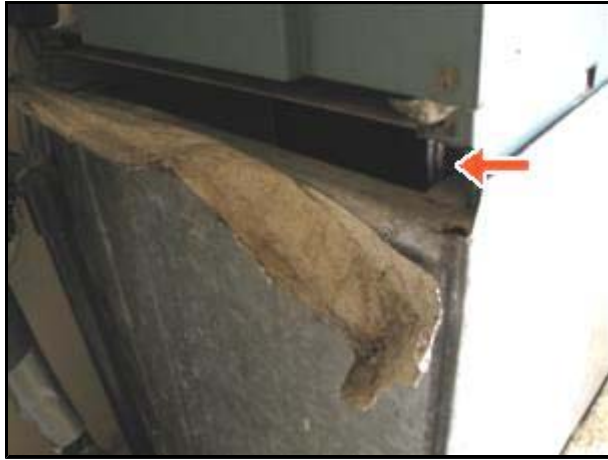
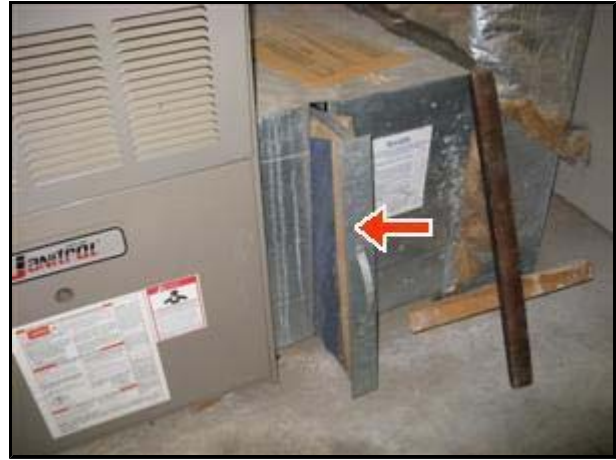
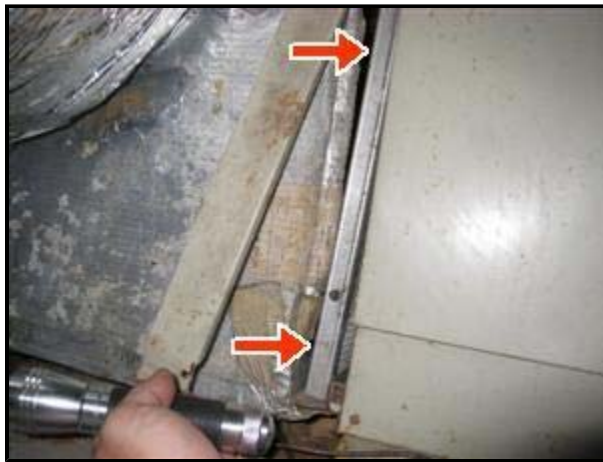
**6.3** (1) The washable filter is collapsed and needs replacing at upstairs. The filter needs replacing with a rigid frame to prevent filter from falling out of alignment. ( Picture 1 ) The filter in basement ( Picture 2 ) needs replacement and in crawlspace which is difficult to access due to the crawlspace ( Picture 3 ). A qualified person should repair or replace as needed

(1) The washable filter is collapsed and needs replacing at upstairs. The filter needs replacing with a rigid frame to prevent filter from falling out of alignment. ( Picture 1 ) The filter in basement ( Picture 2 ) needs replacement and in crawlspace which is difficult to access due to the crawlspace ( Picture 3 ). A qualified person should repair or replace as needed
-

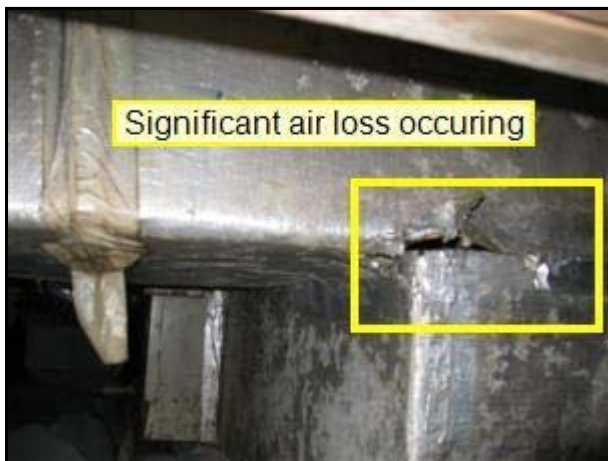
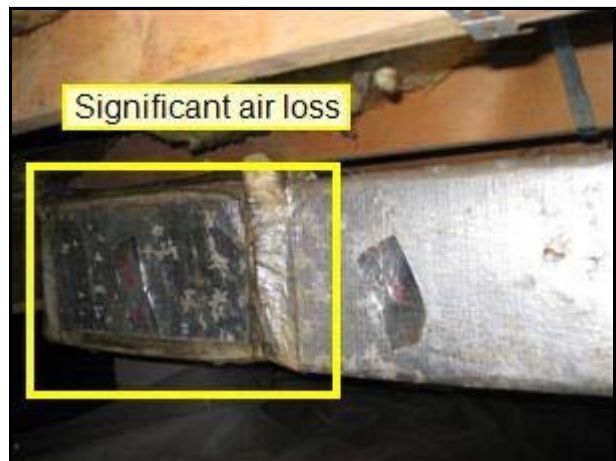
6.3 Picture 4 crawlspace new addition

🔧 (2) The supply duct pipe or main plenum is failing in the crawlspace. Energy loss is occurring in crawlspace and immediate correction is needed. A licensed HVAC contractor should service or repair unit.

(2) The supply duct pipe or main plenum is failing in the crawlspace. Energy loss is occurring in crawlspace and immediate correction is needed. A licensed HVAC contractor should service or repair unit.

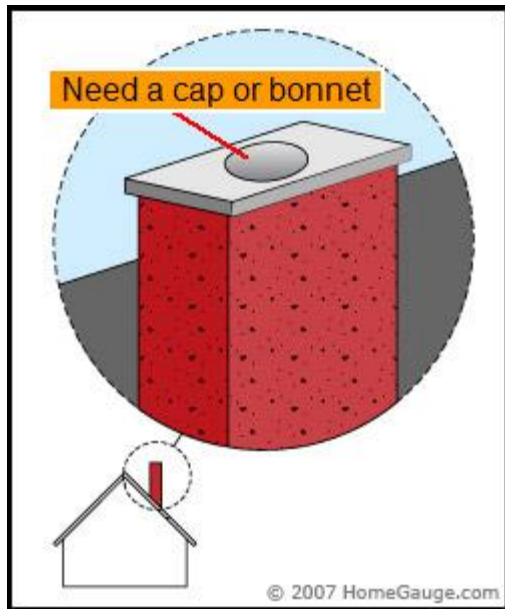
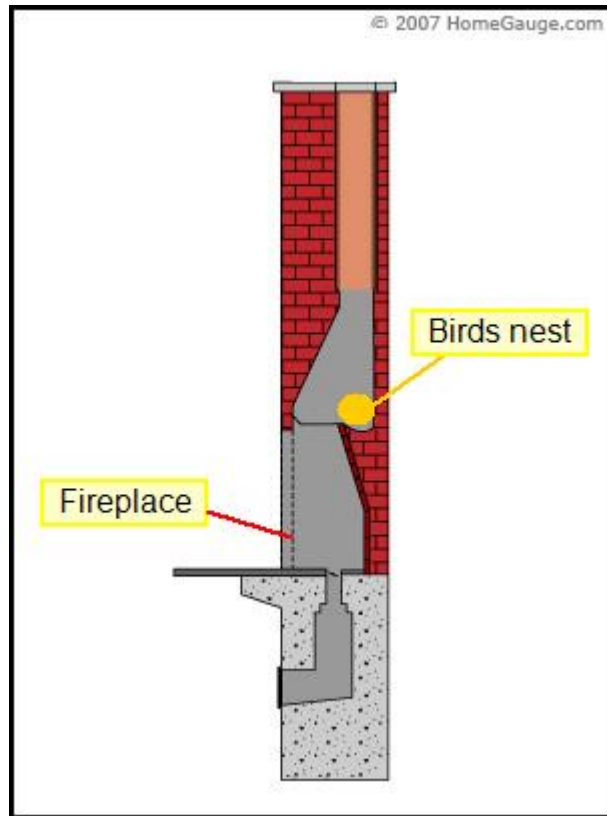
**6.5** An active birds nest is currently in chimney. It is recommended to install a cap or bonnet on chimney this fall.

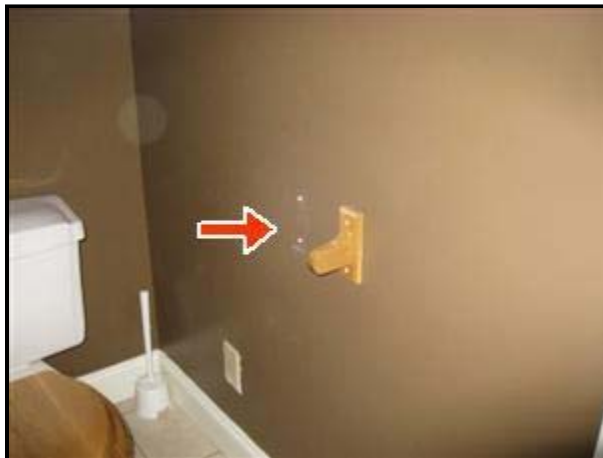
8.1 Picture 1

**8.1** The tissue holder on the wall is damaged at the master bath. I recommend repair as necessary.

The tissue holder on the wall is damaged at the master bath. I recommend repair as necessary.

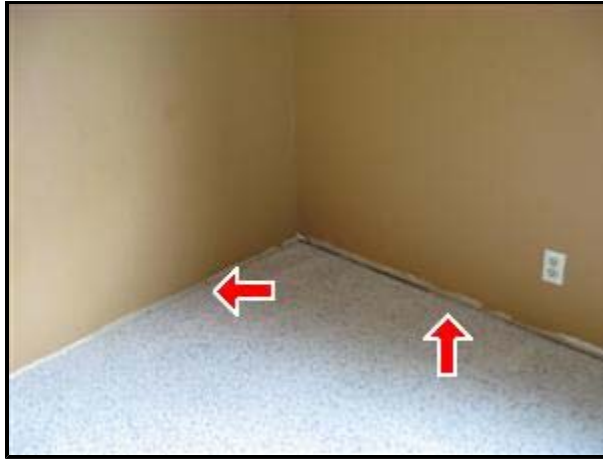
8.2 Picture 1

**8.2** (1) The Baseboard is missing at the upstairs (right of hall bath). Repairs are needed. A qualified contractor should inspect and repair as needed.

(1) The Baseboard is missing at the upstairs (right of hall bath). Repairs are needed. A qualified contractor should inspect and repair as needed.
-

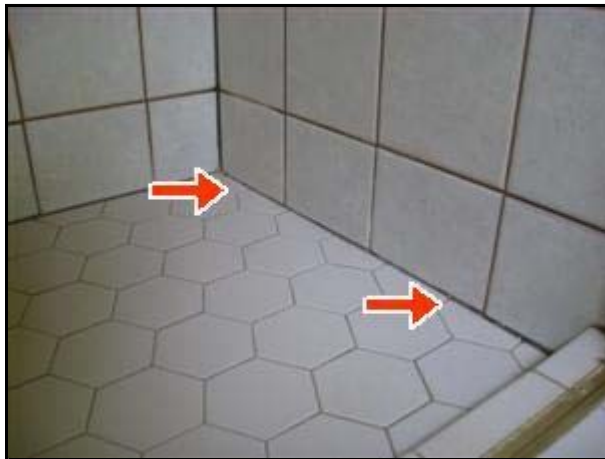
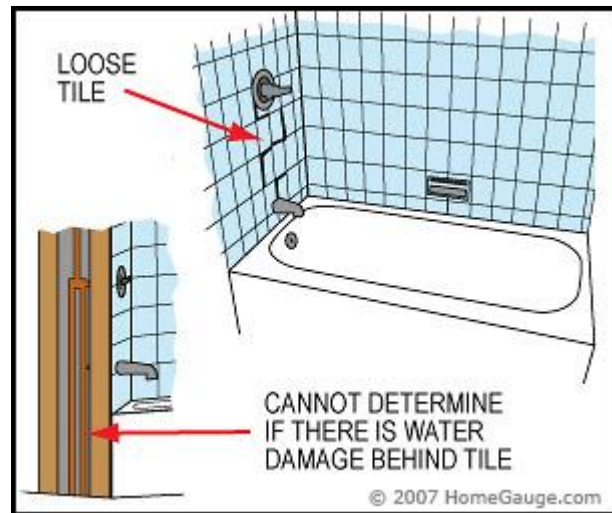
8.2 Picture 2 Upstairs bath

🔧 (2) Tile at shower pan and wall surround are loose and missing mortar or grout and sealer at the upstairs bath. Repairs are needed to prevent water damage to shower/bath. A qualified person should repair or replace as needed.

(2) Tile at shower pan and wall surround are loose and missing mortar or grout and sealer at the upstairs bath. Repairs are needed to prevent water damage to shower/bath. A qualified person should repair or replace as needed.

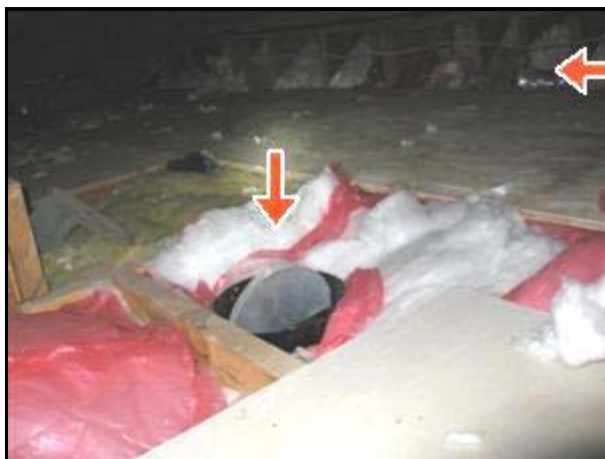
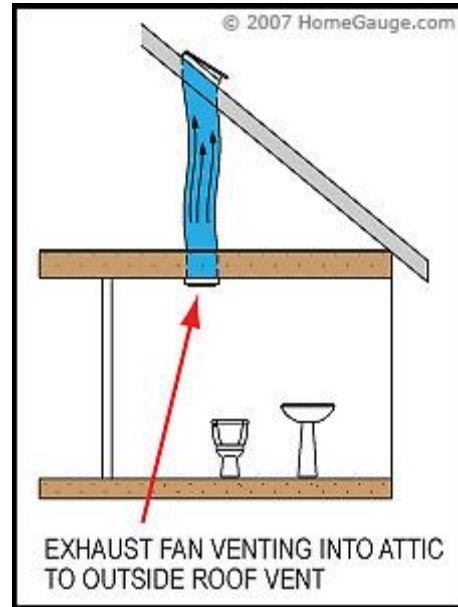
**9.4** The Exhaust fan does not vent to outside at the hall bath and master bath. Vent pipes should terminate outside and not in the attic. Many homes have their vent pipe poised at the roof vent such as yours. It is up to you to determine whether or not this is a concern or needs further consideration from a general contractor. A qualified contractor should inspect and repair as needed.

The Exhaust fan does not vent to outside at the hall bath and master bath. Vent pipes should terminate outside and not in the attic. Many homes have their vent pipe poised at the roof vent such as yours. It is up to you to determine whether or not this is a concern or needs further consideration from a general contractor. A qualified contractor should inspect and repair as needed.

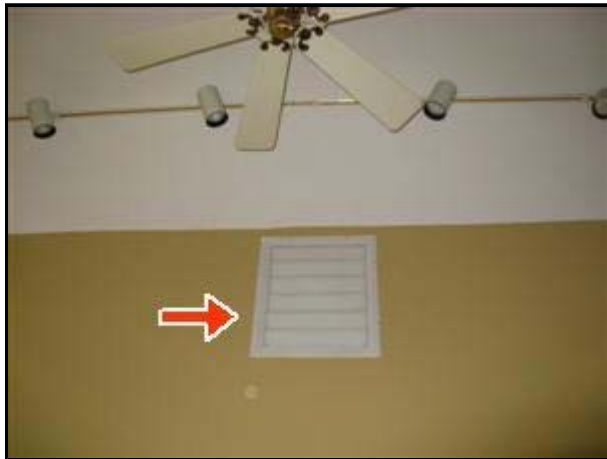
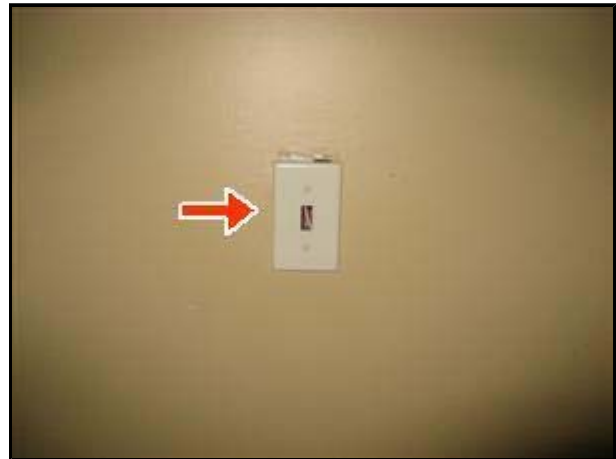
🔧 9.5 Wall switch for room fan in wall has been removed. It is inoperable.
