# **Air Conditioning Maintenance**

## **Leak Prevention For All Residents**

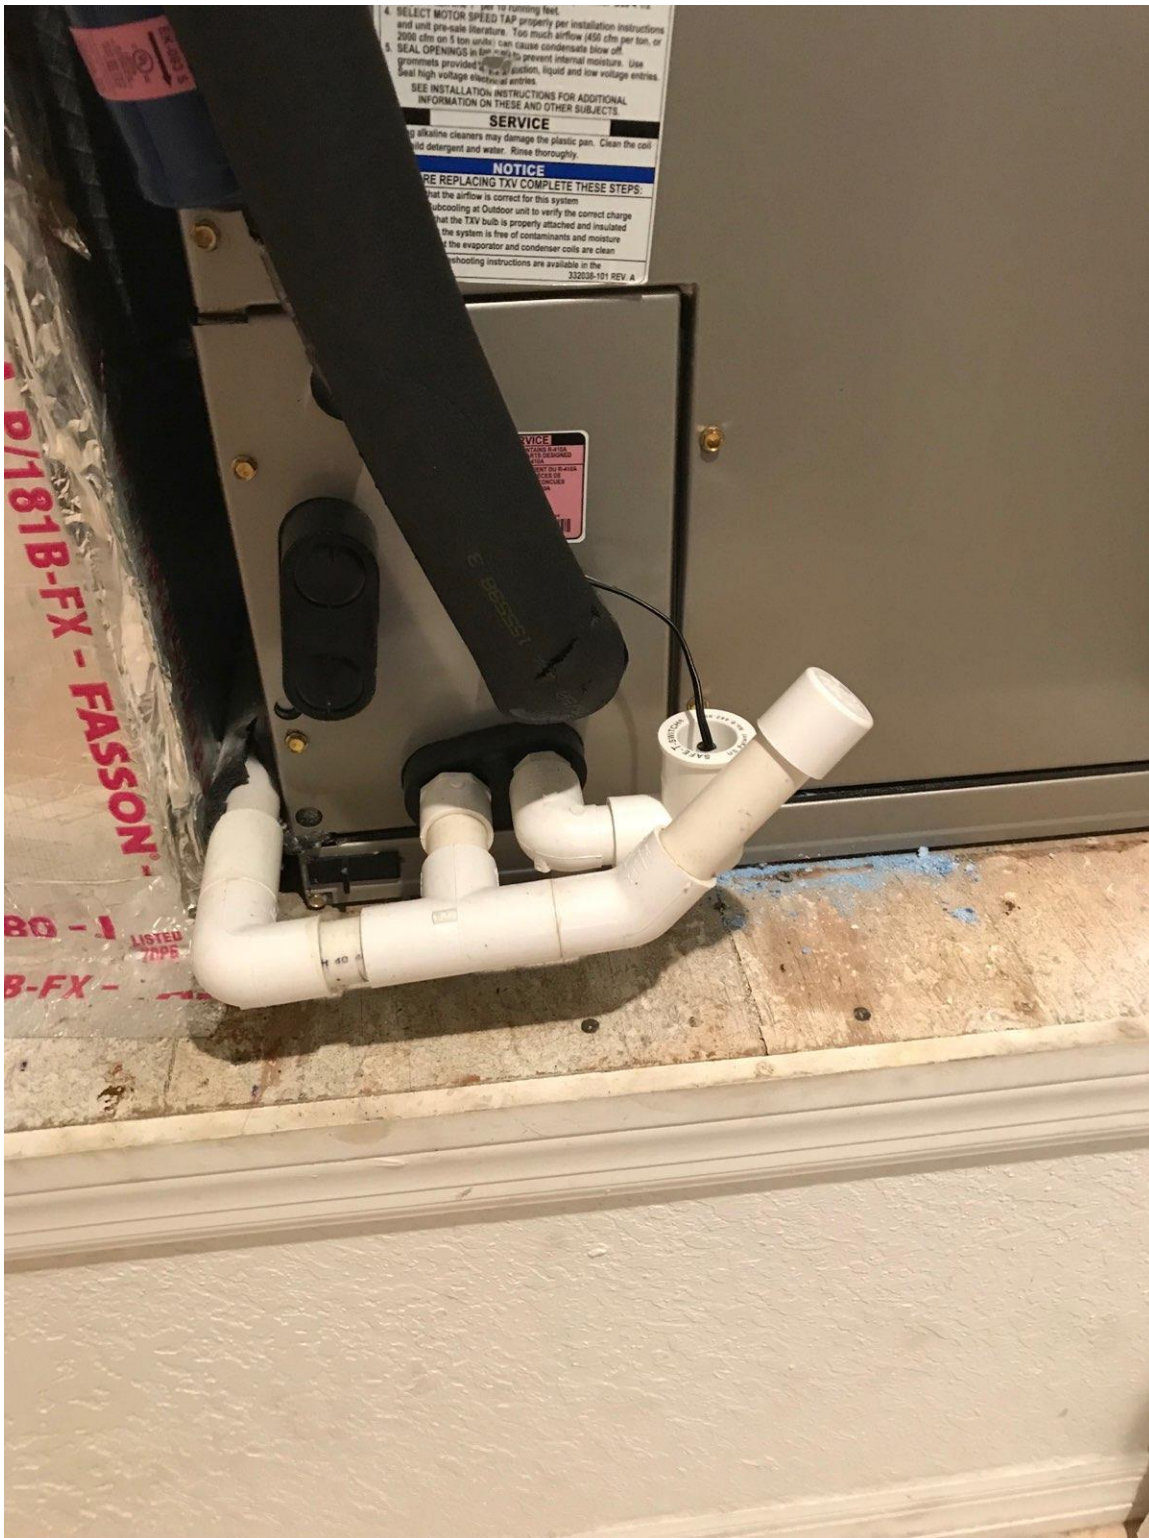
Figure 1- Locate drainage tube at base of AC unit - Remove Cap from Drainage Tube

- 2- Once per month, remove the tube cap as in Figure 1. It is located on the bottom of your AC unit.
  - Pour one cup (8 ounces) of white distilled vinegar into the tube. This will act to dissolve any residue or mineral buildups. (See Figure 2.)

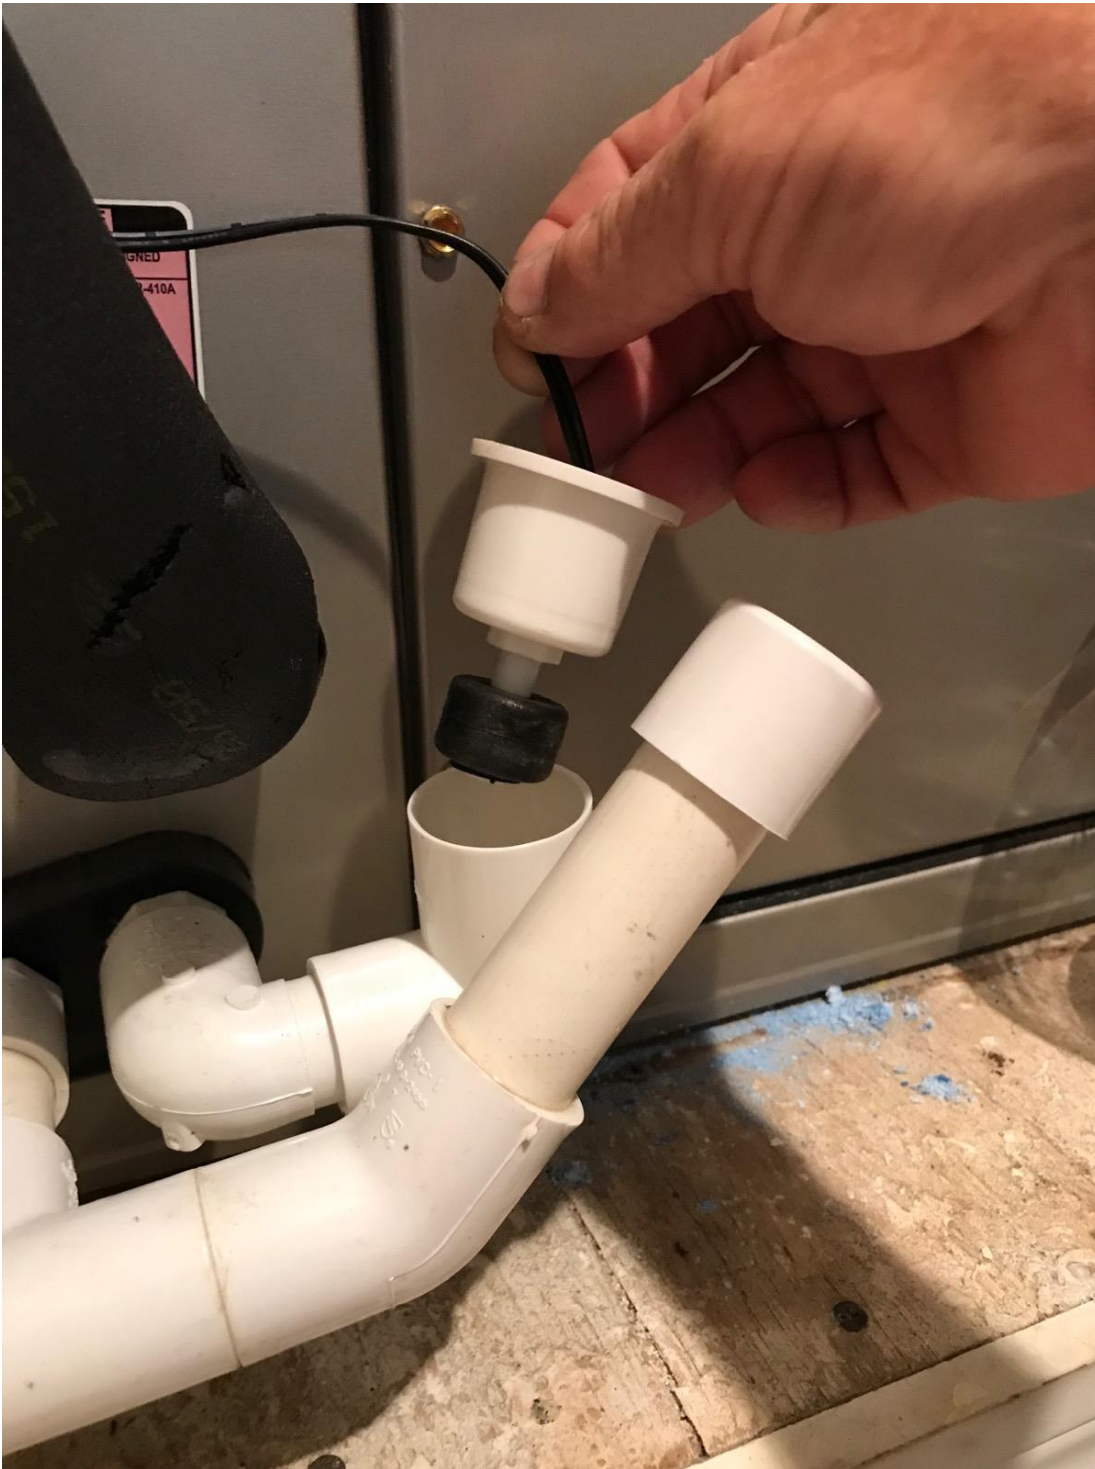
Figure 3- Have your AC Technician inspect the sensor valve to ensure it is clean and functioning and replace back in proper position place when done.

- 1- Have your **AC TECHNICIAN** inspect your unit now to ensure that your overflow sensor is working properly and that the water collection area within your AC is draining properly.

**Please do not fiddle with the overflow sensor yourself as improper placement can cause sensor malfunction and leaking. This is a job for your AC TECHNICIAN.**

Do not assume that regular 6-month AC inspections are sufficient- they are not. Please see Figure 3 for an illustration of the sensor valve and location.
