FISH HEALTH INSPECTORATE VISIT REPORT

BUSINESS NO FB0297
SITE NO FS0511
INSPECTOR [redacted]

DATE OF VISIT 14 June 2023
SITE NAME Forgue
CASE NO 20230255

ENHANCED CONTAINMENT INSPECTION

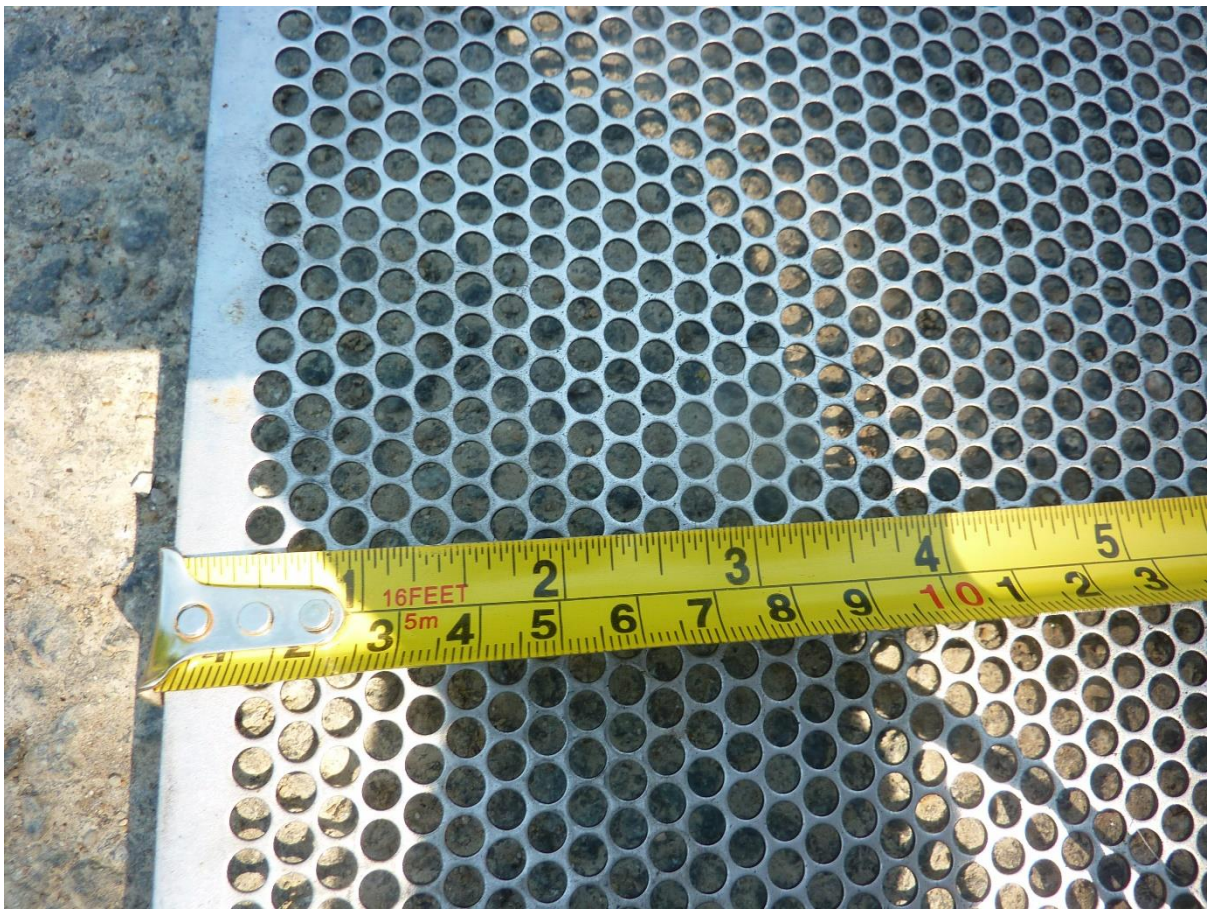
Screen material used at end of settlement pond and in some fish ponds
