MEMORANDUM

DATE: July 3, 2024

RE: MS4 General Permit Compliance Illicit Discharge Detection and Elimination Program
Permit Year 6 Catchment Investigation Summary

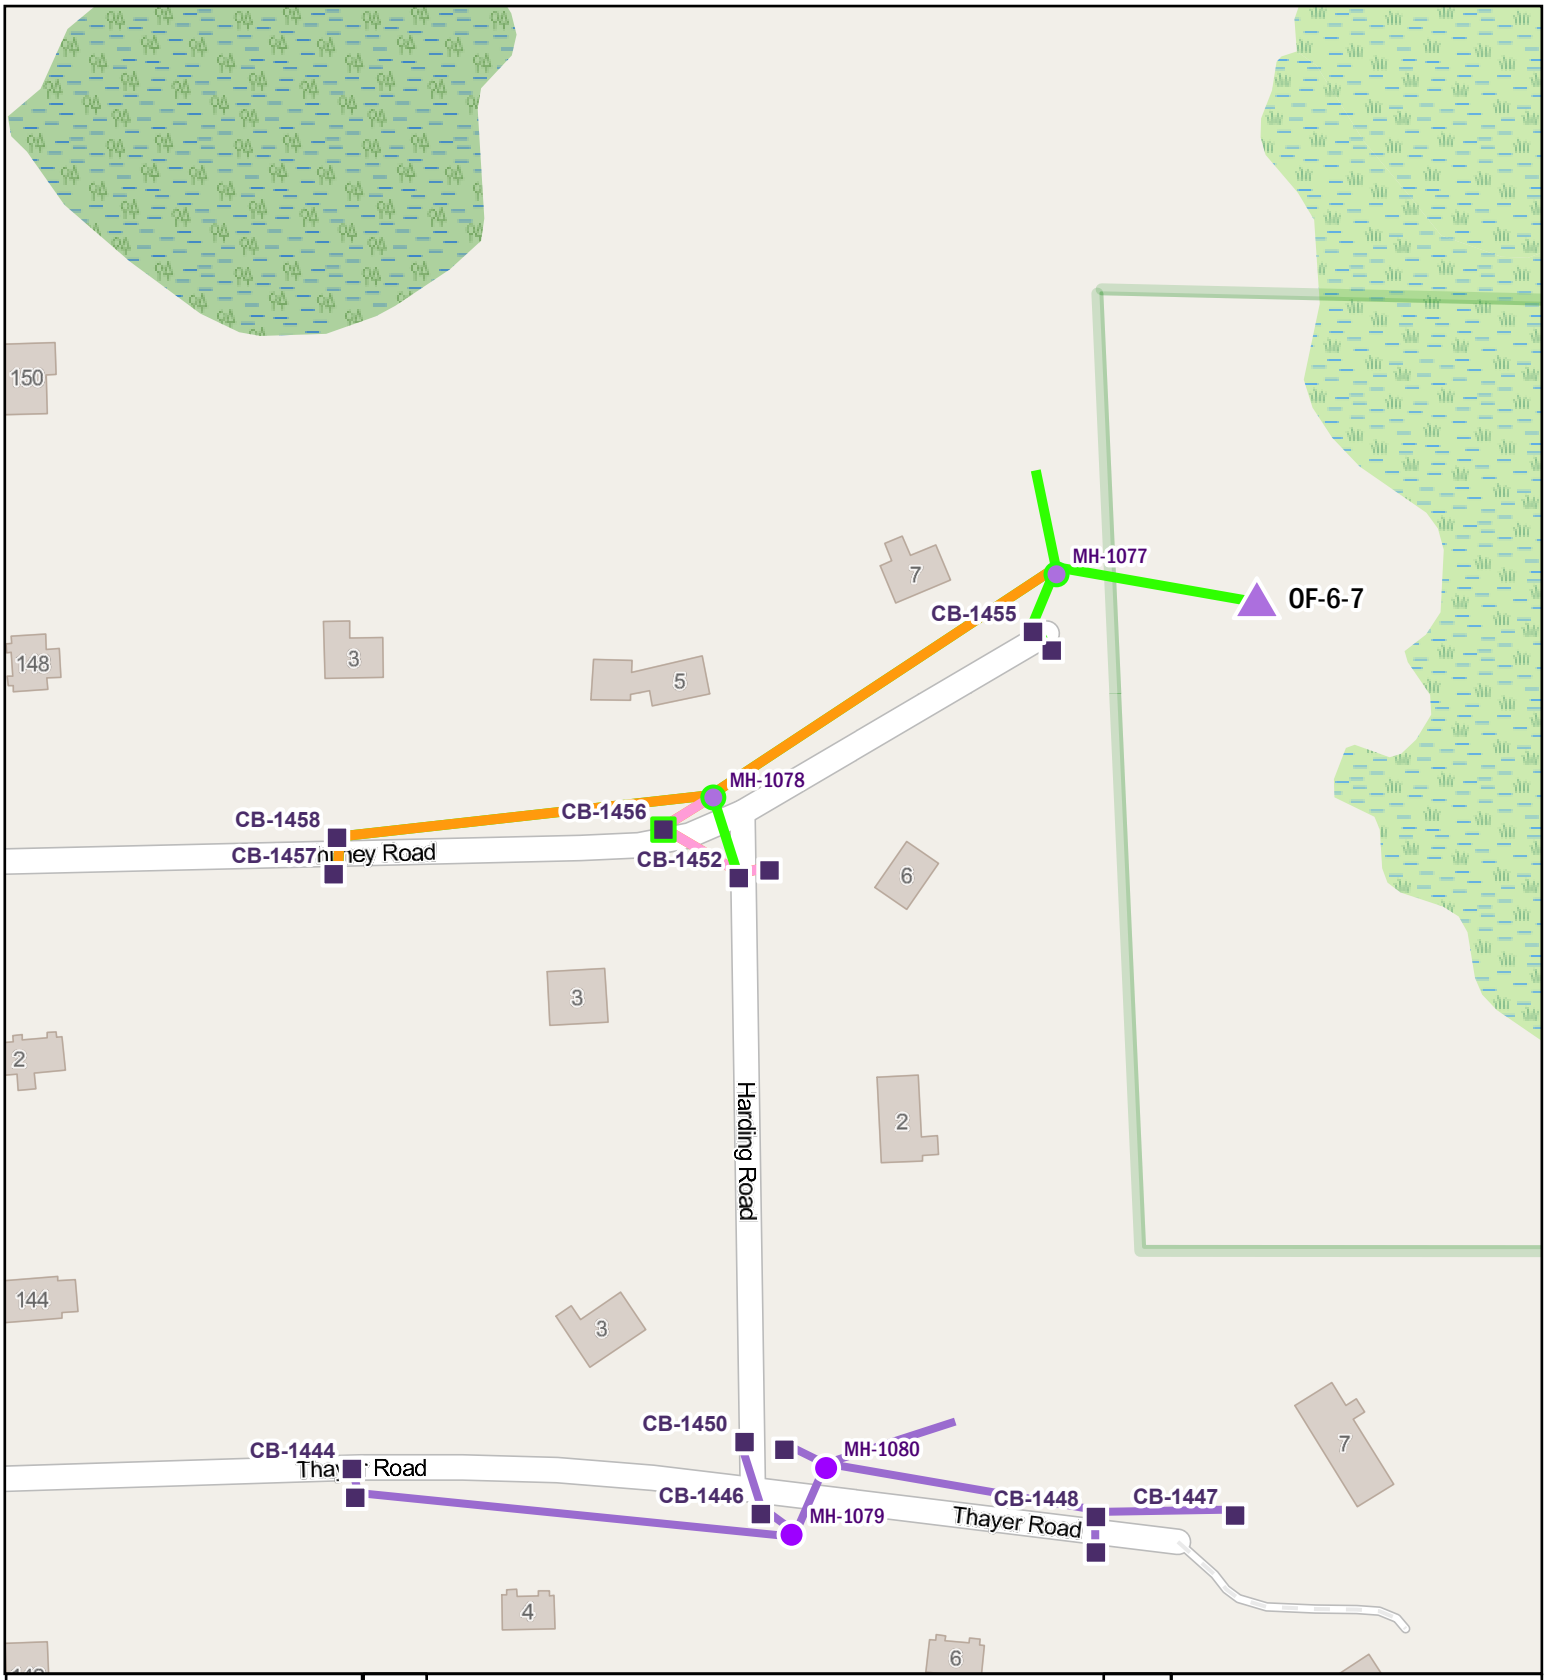
Standing water was observed in pipe segments within several catchments, as depicted on figures in **Attachment A** and the notes recorded in the summary tables in **Attachment C** and **Attachment D**. Locations where standing water has been identified should be maintained and/or evaluated to determine and abate the cause to promote adequate drainage through the catchment. After maintenance has been completed, these catchments should be revisited to attempt to complete catchment investigations.
