PHASE I ENVIRONMENTAL SITE ASSESSMENT
APA Headquarters Feasibility Study – Phase I ESA
3 Main Street, Saranac Lake, New York

Project Number: 23010004G

Issued: August 16, 2023

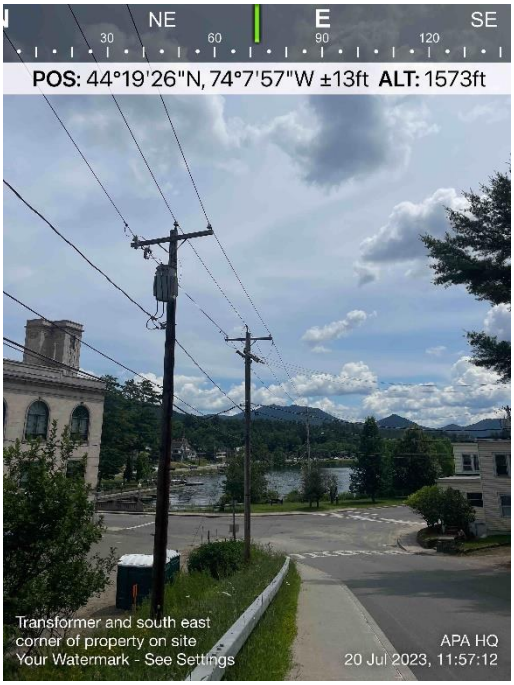
Photograph 25: Transformer at southeast corner of Property, on site.

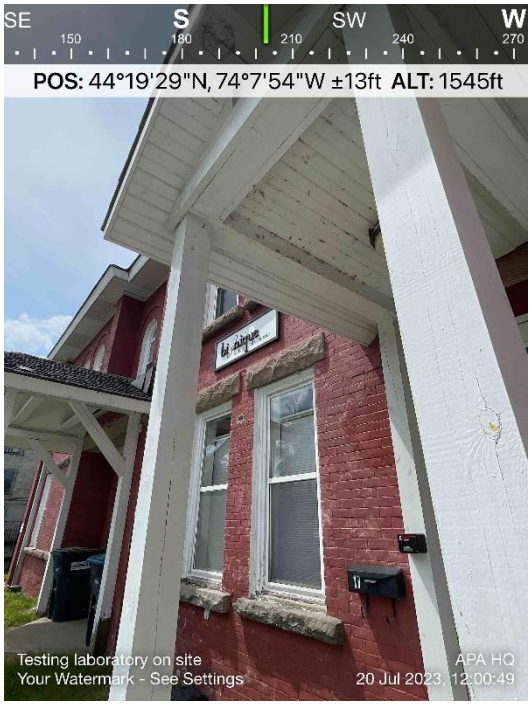
Photograph 28: Testing laboratory, on site.

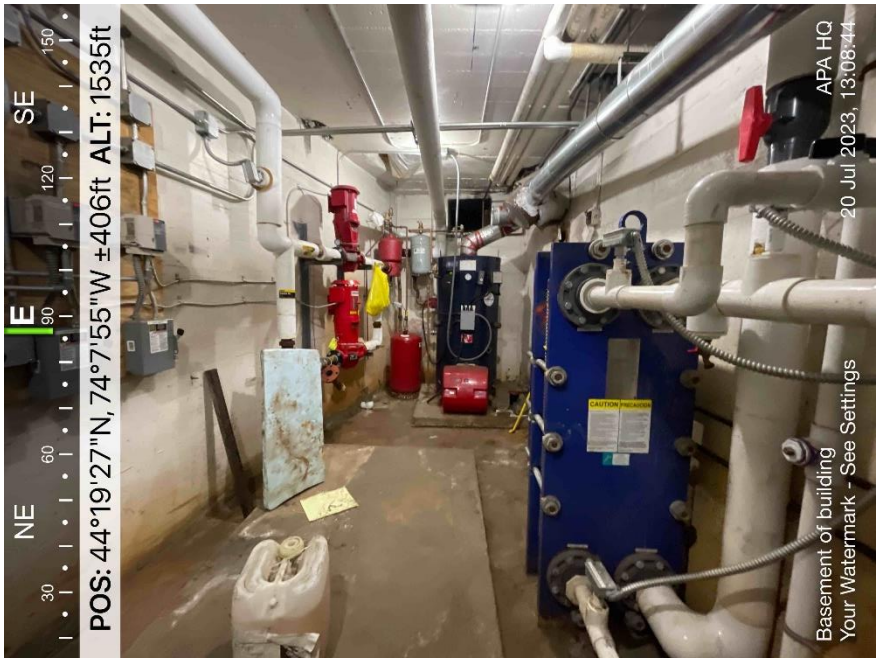
Photograph 37: Basement, interior of building.

- Additionally, semi-volatile organic compounds (SVOCs) may have been used as a component in rail ties that may have been present at the site.
- A corroded pipe was noted in the basement of the historical building located on the Subject Property. The corroded pipe is likely from an oil leak via a suspect former tank and/or PCBs. Bergmann personnel recommends wipe test sampling be done to determine contaminant of concern.
