Sidewalk Network Inventory and Assessment

FOR THE CHAMPAIGN URBANA URBANIZED AREA

FEBRUARY 2016

rpc CHAMPAIGN COUNTY REGIONAL PLANNING COMMISSION

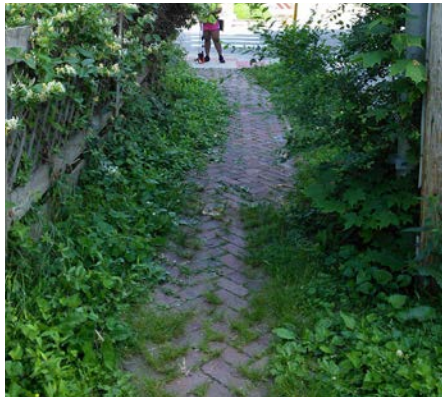
Figure 3-16 **Obstruction Types**

Obstructions are any foreign objects that intrude on the pedestrian path, reducing its passable width below the allowed minimum. Field staff recorded the presence of the following categories of obstructions (see *Figure 3-16*):

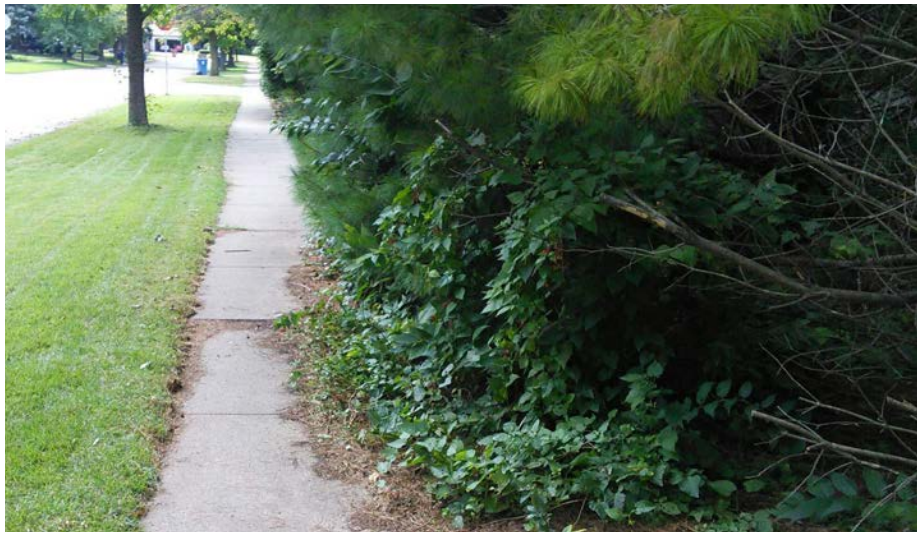
In this block of sidewalk, vegetation overgrowth acts as an obstruction and reduces the passable width to 39 inches. The largest vertical fault on the block is over ½ inch, and the maximum cross slope is 10 percent, resulting in a combined compliance score of 15.

This block of sidewalk is 60 inches wide and has no vertical faults or obstructions. With a maximum cross slope of 2.3 percent, it scores 95 on the combined compliance index.

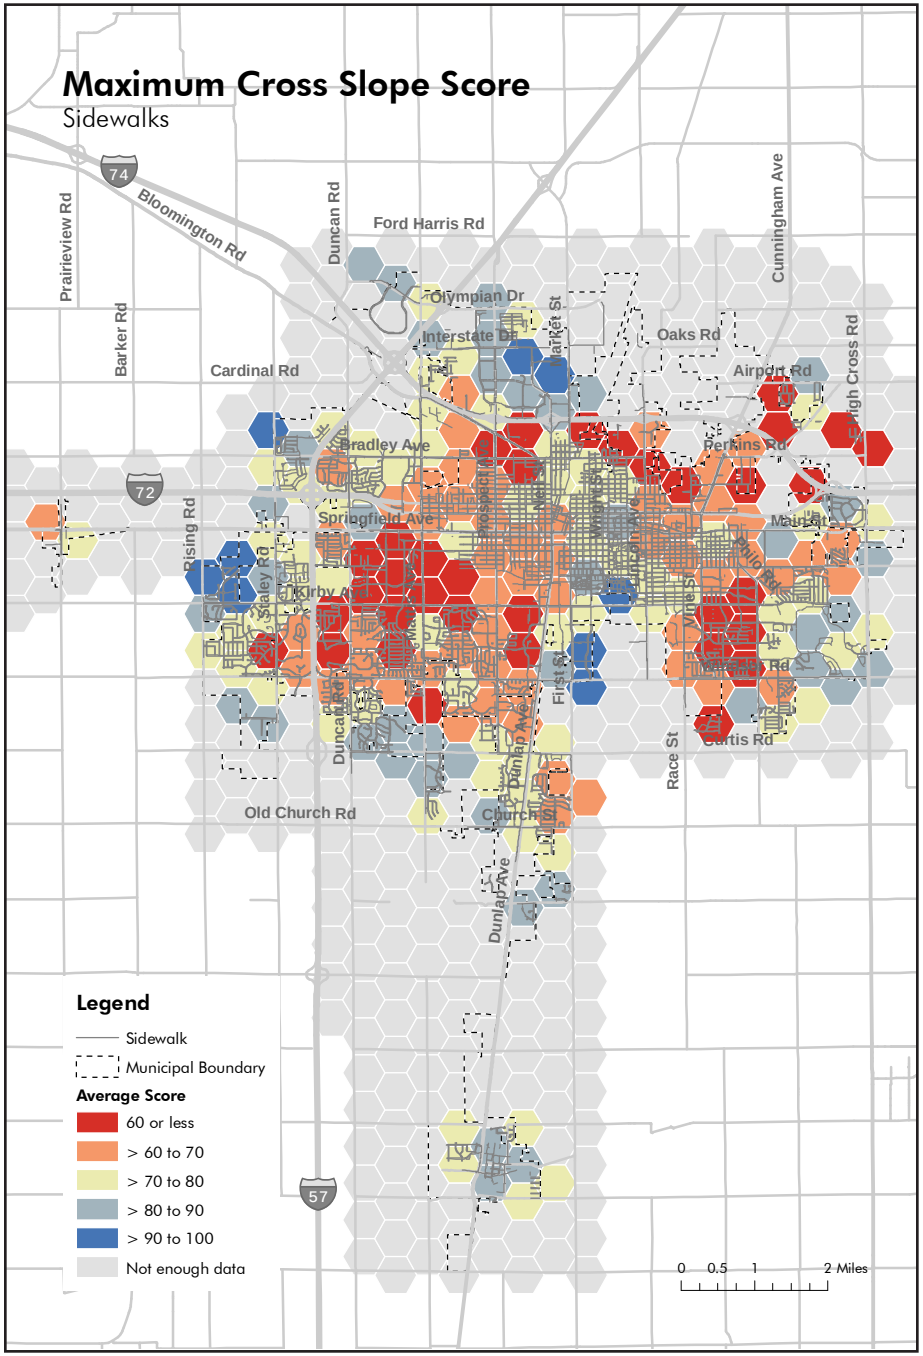
Figure 4-2 **Sidewalk Cross Slope Scores**

Of the total sidewalk length in the urbanized area, only about 18 percent met the standard for maximum cross slope. More than 75 percent of sidewalks by length had a maximum cross slope between 2.1 and 8.0 percent. Very high maximum cross slopes greater than 8.0 percent were relatively rare and comprised about 6 percent of the total sidewalk length in the urbanized area.

Maximum sidewalk cross slopes were highest in older residential neighborhoods with frequent driveway crossings (see *Figure 4-2*). Downtowns, commercial areas, and newer residential neighborhoods had lower maximum cross slopes. The University of Illinois campus area had lower maximum sidewalk cross slopes than most other parts of the urbanized area, though on average, many parts of the of the campus still exceeded the 2.0 percent PROWAG threshold.

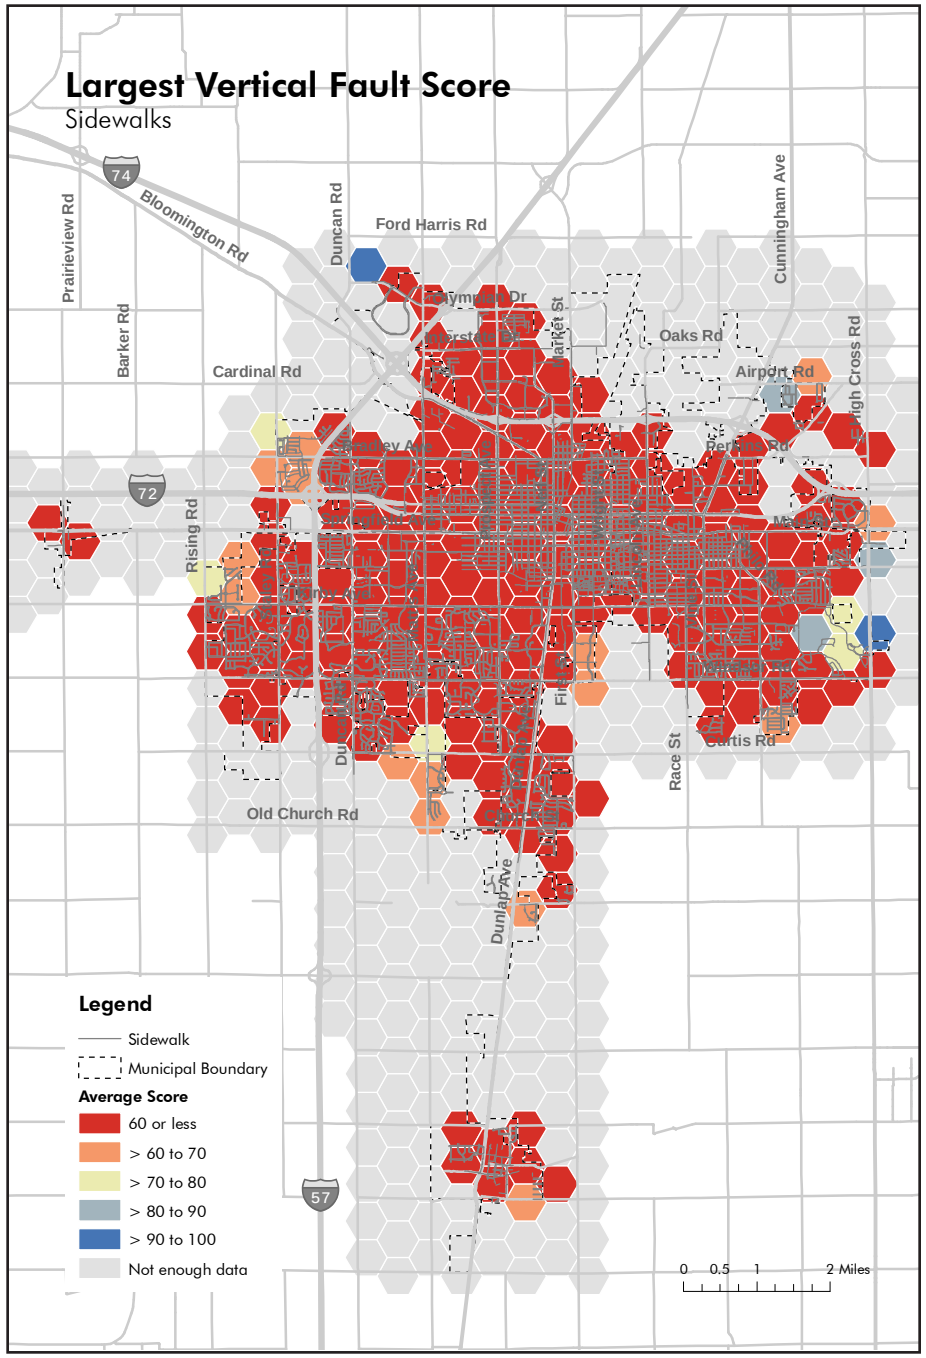
Figure 4-3 **Sidewalk Vertical Fault Size Scores**

Less than 12 percent of sidewalks by length met the PROWAG standard for the largest vertical fault. However, about 38 percent of sidewalk had vertical faults between ¼ inch and ½ inch, which could be addressed using beveling. The remaining half of sidewalks by length had larger faults that would require more extensive repairs, such as concrete leveling or replacement of panels.

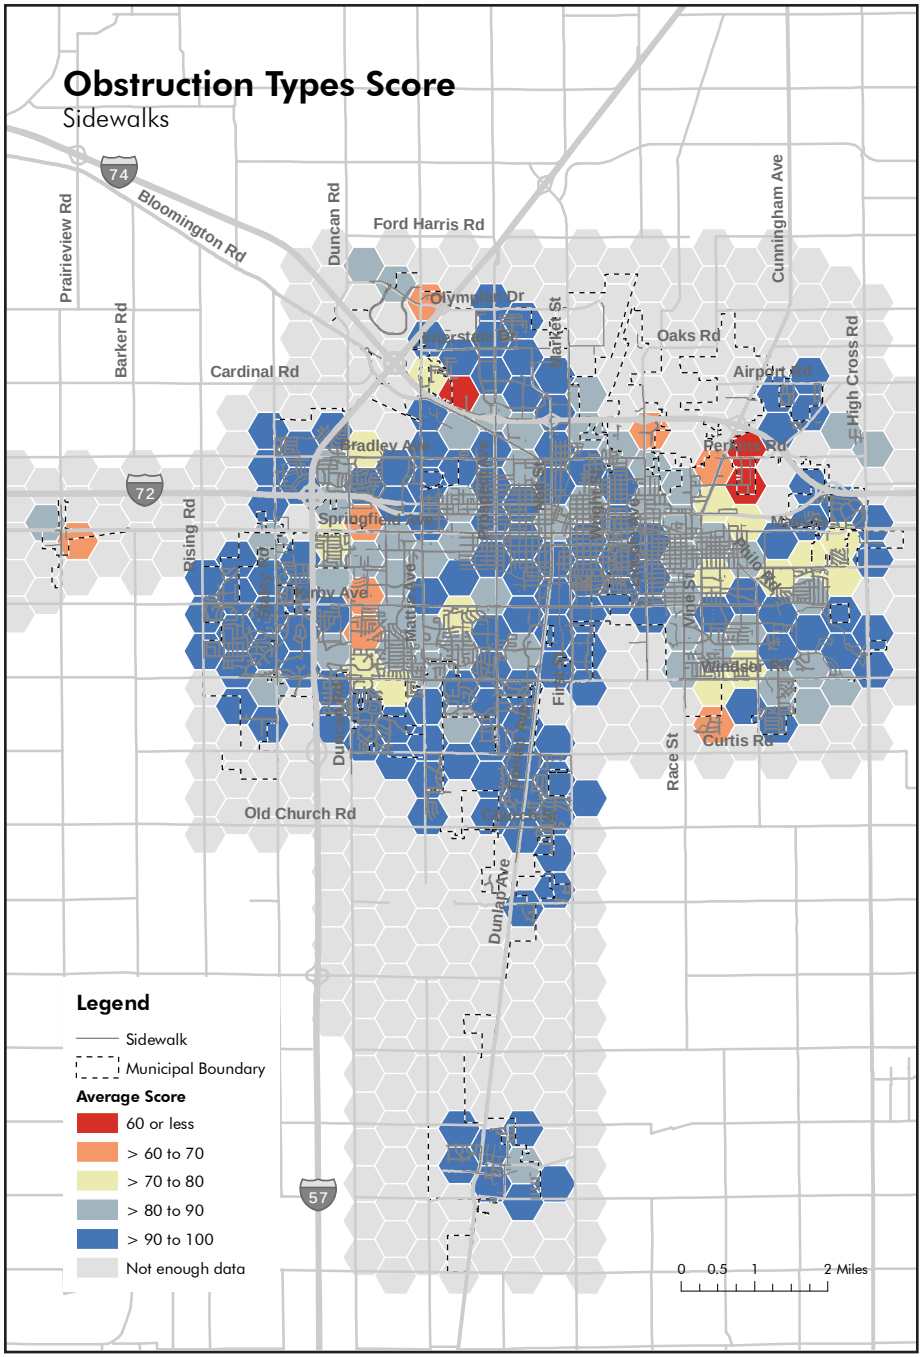
Figure 4-4 **Sidewalk Obstruction Scores**

Less than 20 percent of sidewalks by length had an obstruction, and only about one percent had more than one type of obstruction. Tree trunk or other vegetation was the most common type of obstruction, followed by other obstructions, such as gravel, street furniture, or planters. Areas with high concentrations of sidewalk obstructions included the Duncan Road corridor and Dobbins Downs area in Champaign; and the Cunningham Avenue corridor, East Washington Street corridor, and Meadowbrook Park area in Urbana (see *Figure 4-4*).

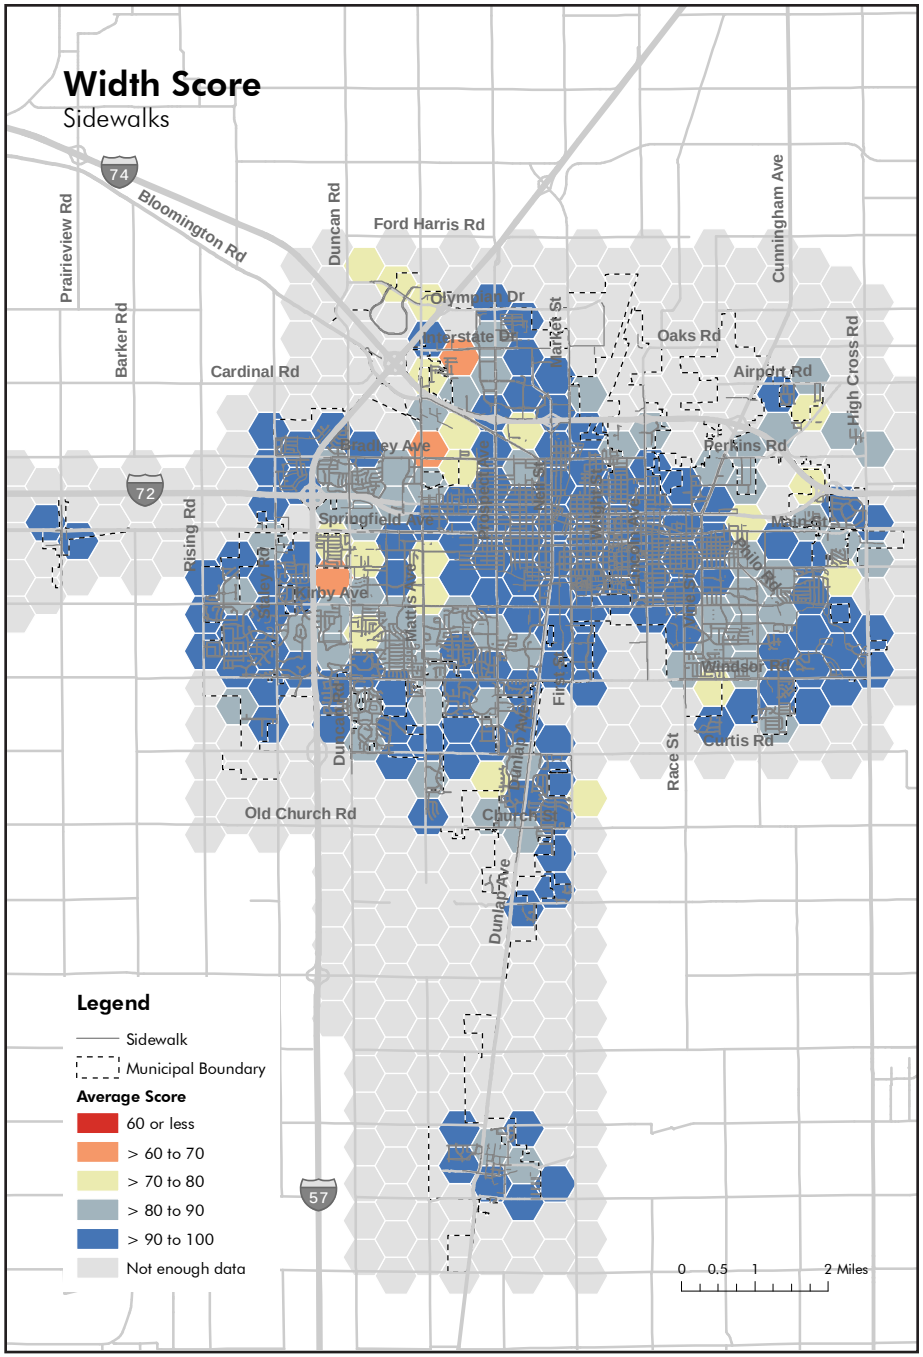
Figure 4-5 **Sidewalk Width Scores**

Areas where sidewalk width was most problematic included central Champaign between I-57 and Mattis Avenue; north Champaign between Mattis and Prospect Avenues; and scattered areas in Urbana and Savoy (see *Figure 4-5*). Sidewalk width was higher in the central part of the urbanized area and in newer developments along the fringe.

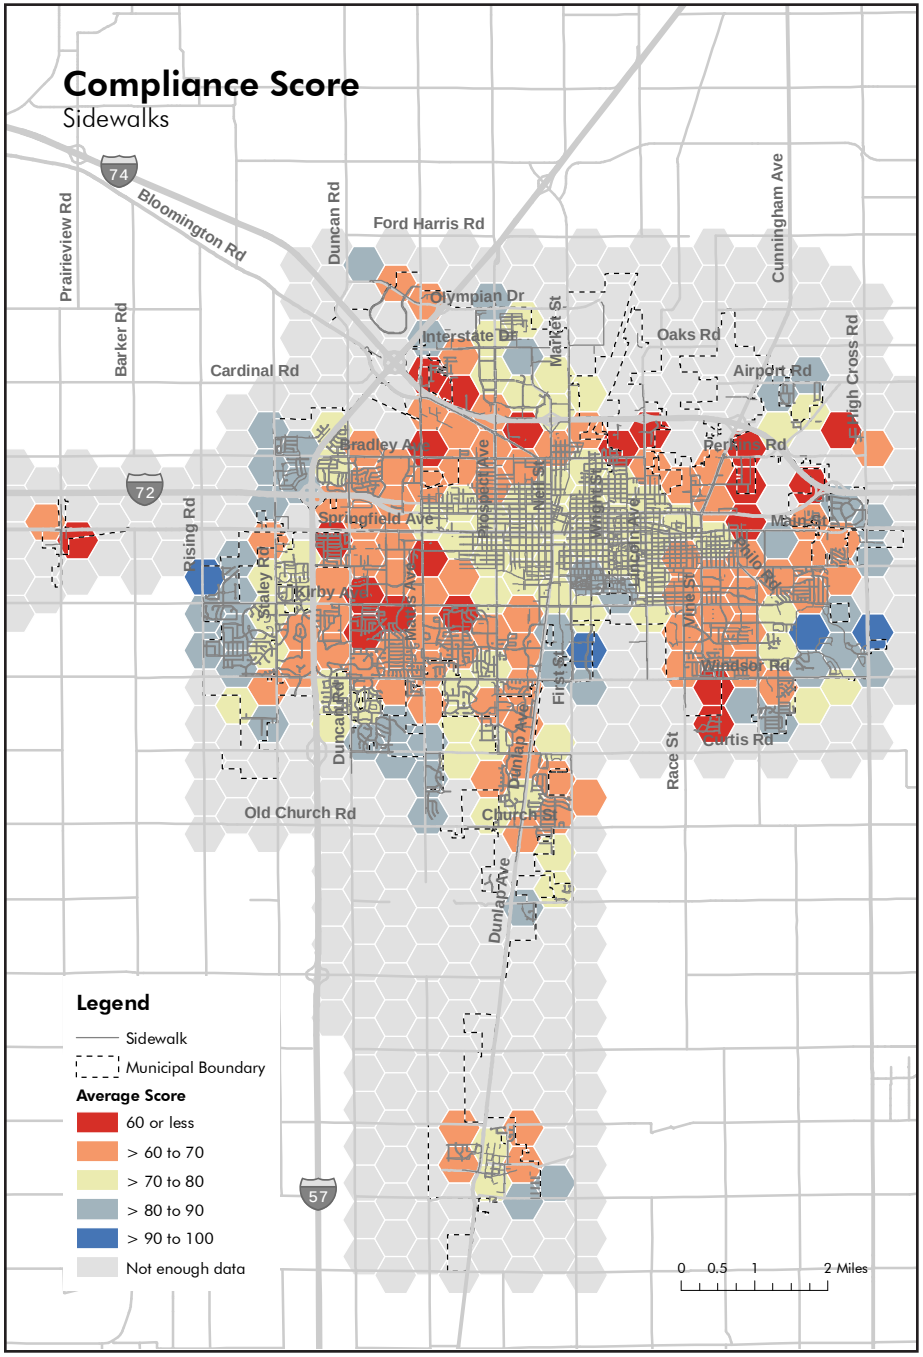
Figure 4-6 **Sidewalk Compliance Scores**

Though the low scores underscore the large amount of work necessary to bring sidewalks into compliance with PROWAG standards, they also reflect assumptions inherent in the data collection methodology. Since field staff recorded only the most severe defect for each block (e.g., the largest vertical fault and the minimum passable width), the results tend to exaggerate the magnitude of sidewalk non-compliance. This effect is most pronounced for long blocks, which are statistically more likely to contain severe defects than short blocks.

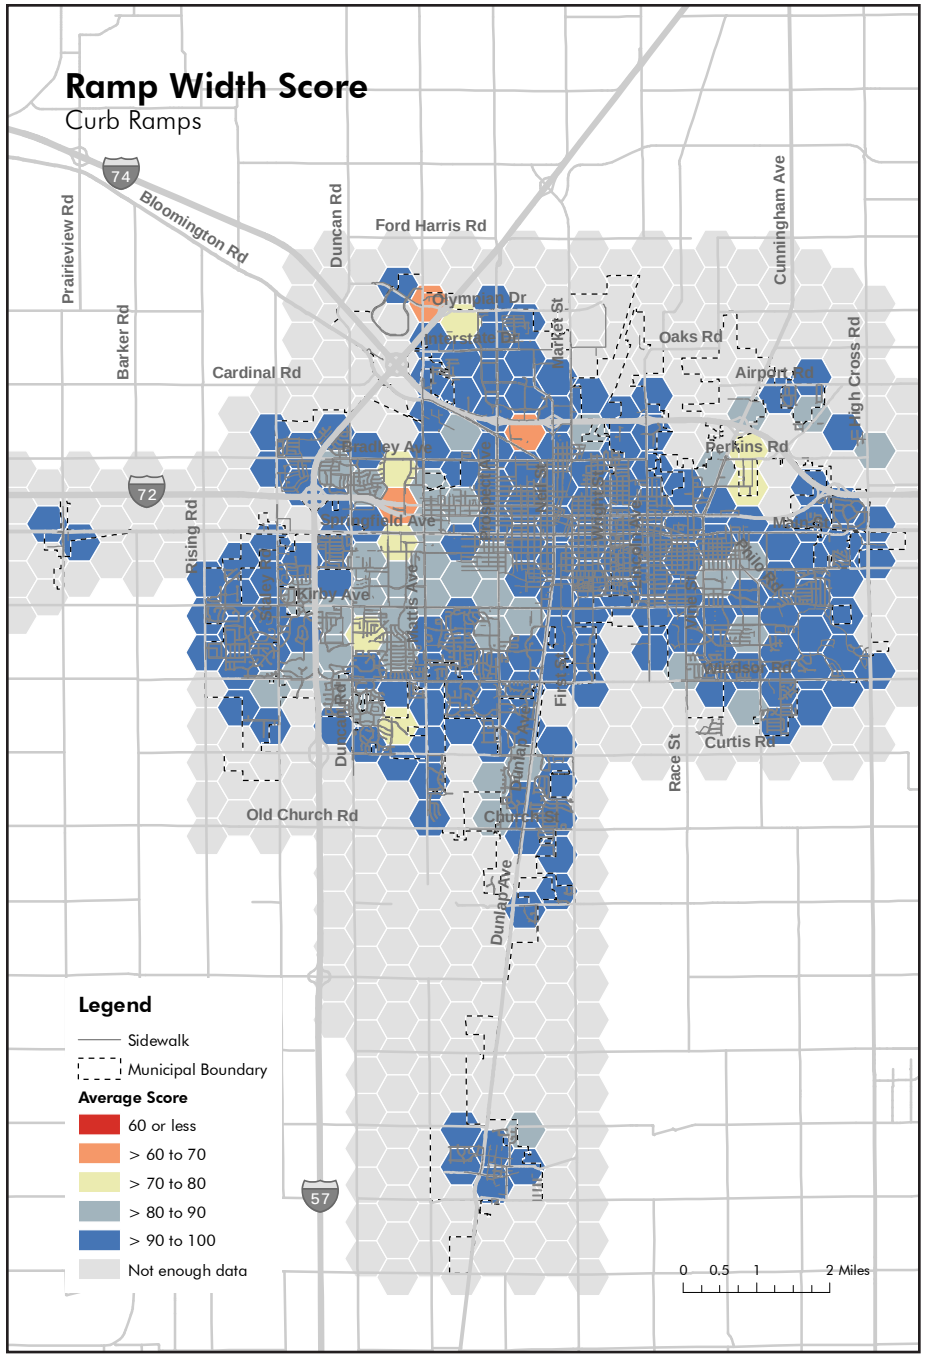
Figure 4-8 **Curb Ramp Width Scores**

Nearly 84 percent of curb ramps measured met the PROWAG standard for width. Less than 3 percent of all ramps were less than 42 inches wide. Areas with higher levels of noncompliant ramp width included central Champaign between I-57 and Mattis Avenue, north Champaign near the I-57/Olympian Drive interchange, and north Urbana near the I-74/Cunningham Avenue interchange (*Figure 4-8*).

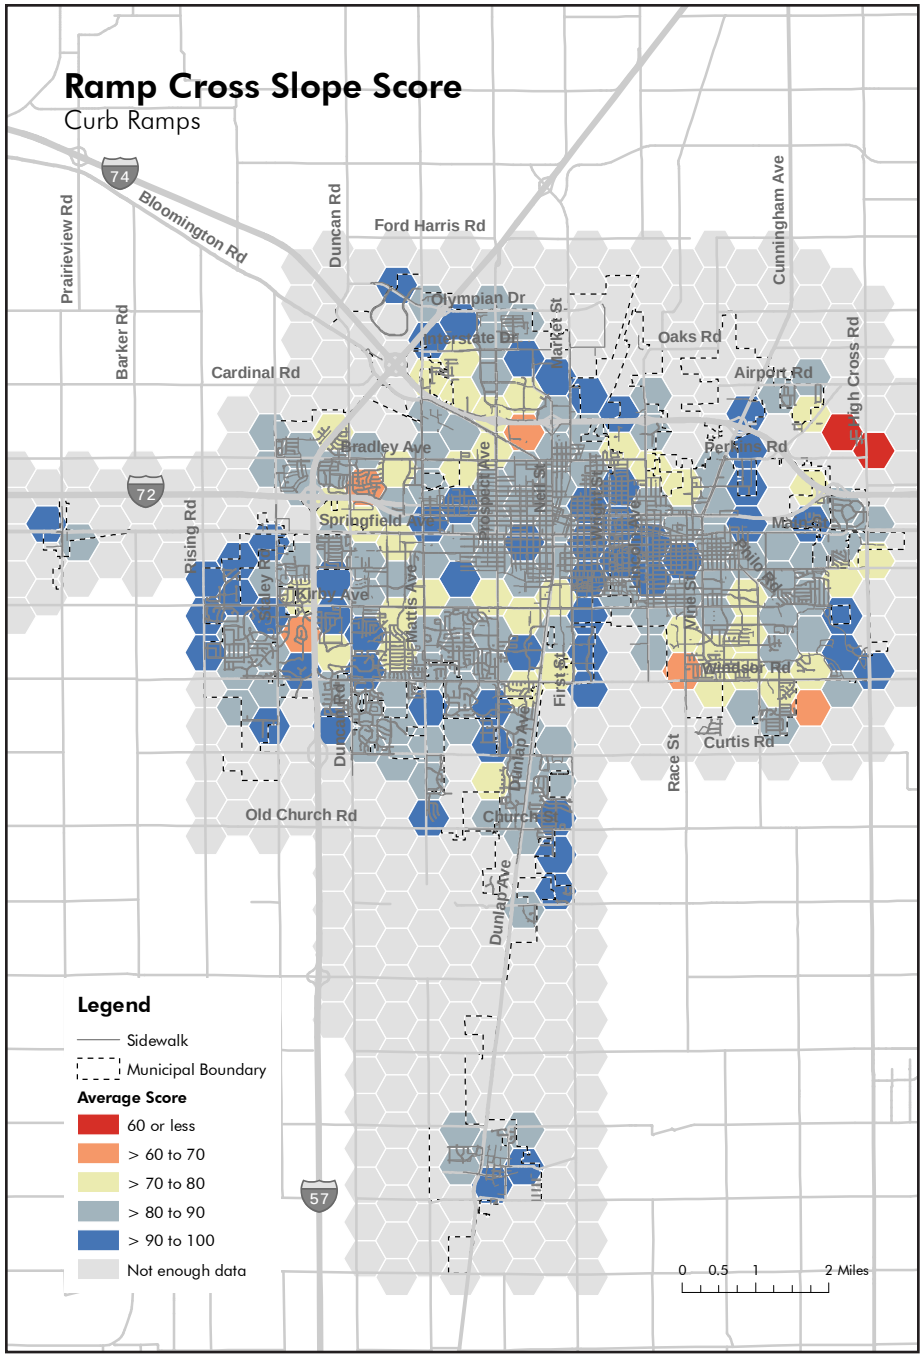
Figure 4-9 **Curb Ramp Cross Slope Scores**

The scattered pattern of problematic ramp cross slopes suggests that these cross slopes were the result of specific construction practices and standards used in particular developments rather than the time at which the ramp was built. However, the most recently developed areas also tended to have higher levels of compliance. On average, the University of Illinois campus area, west Champaign, and south Savoy had relatively low ramp cross slopes, reflecting the higher proportion of recently constructed curb ramps in these areas.

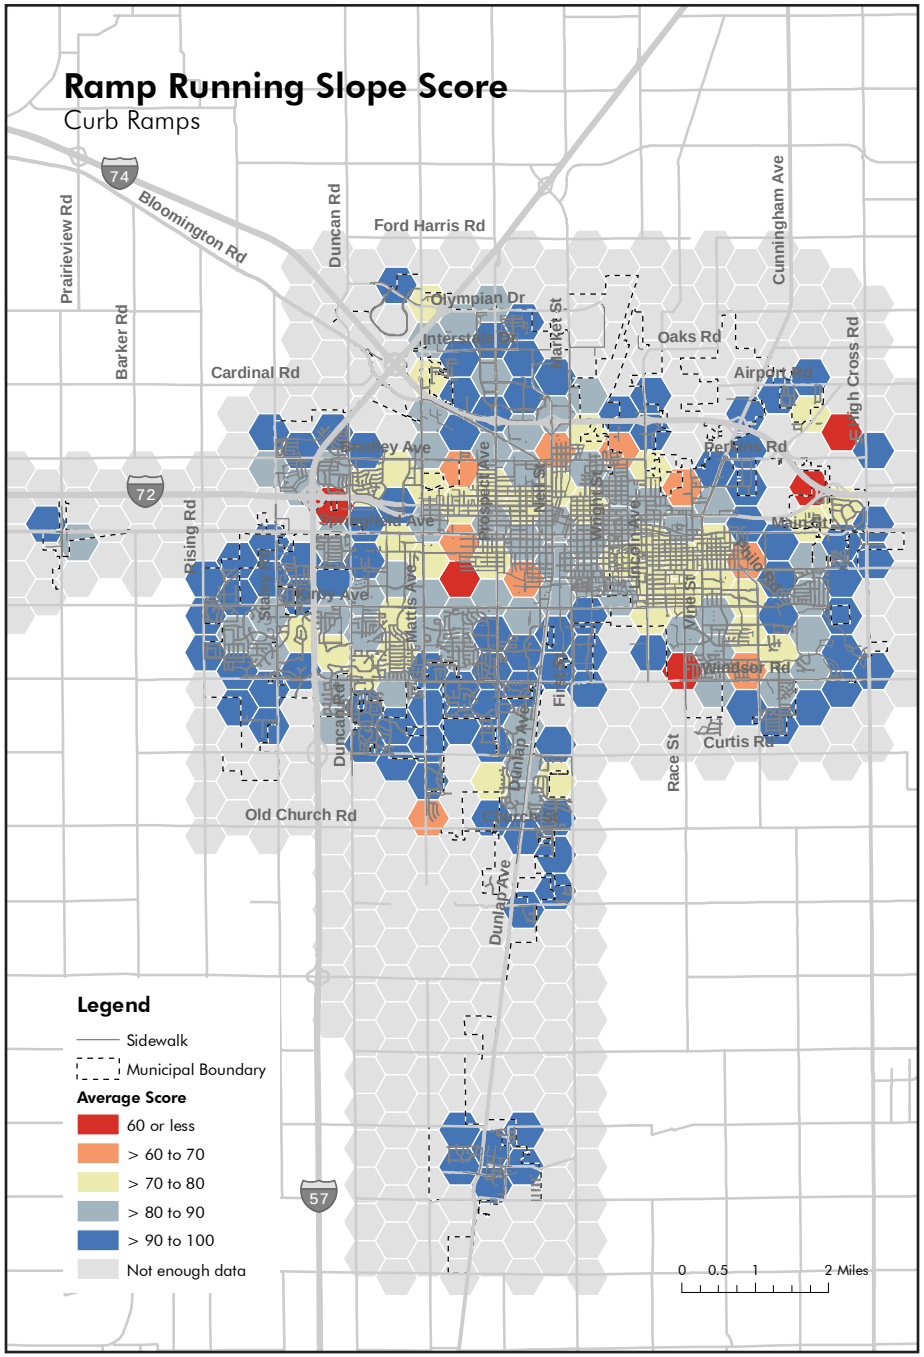
Figure 4-10 **Curb Ramp Running Slope Scores**

Unlike ramp cross slope, high ramp running slopes were most common in the central part of the urbanized area, particularly in some of the oldest residential neighborhoods in Champaign and Urbana (see *Figure 4-10*). This spatial pattern likely reflects changing understandings of what constitutes a safe ramp slope for all users and the corresponding evolution of standards.

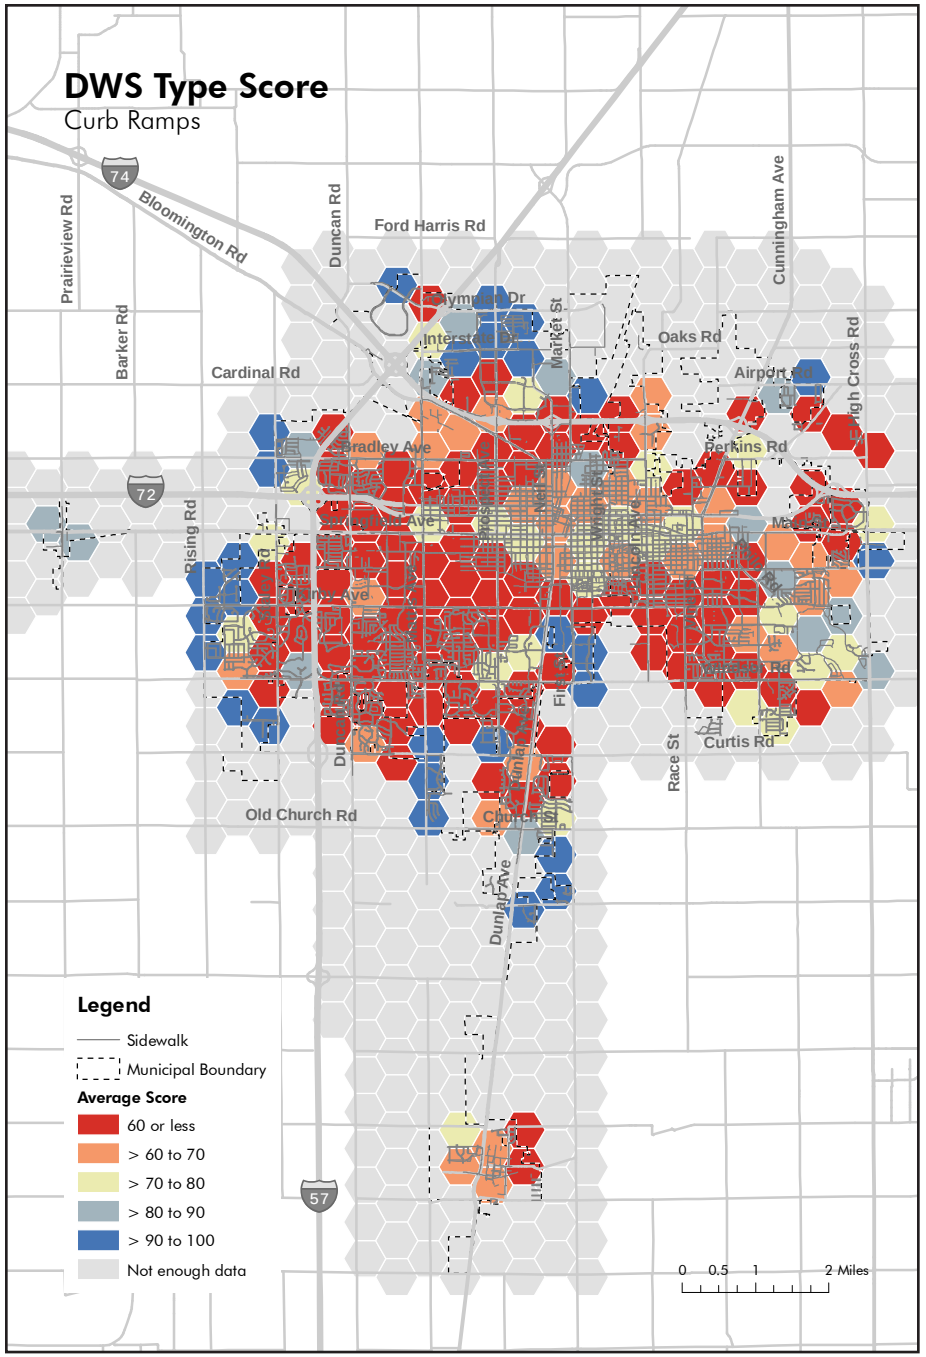
Figure 4-11 **Curb Ramp Detectable Warning Surface Type Scores**

Truncated domes were most prevalent in the newest developments around the fringe of the urbanized area, reflecting the evolution in accessibility standards (see *Figure 4-11*). The University of Illinois campus area had more ramps with truncated domes than most other parts of Champaign and Urbana, but even there coverage remained incomplete.

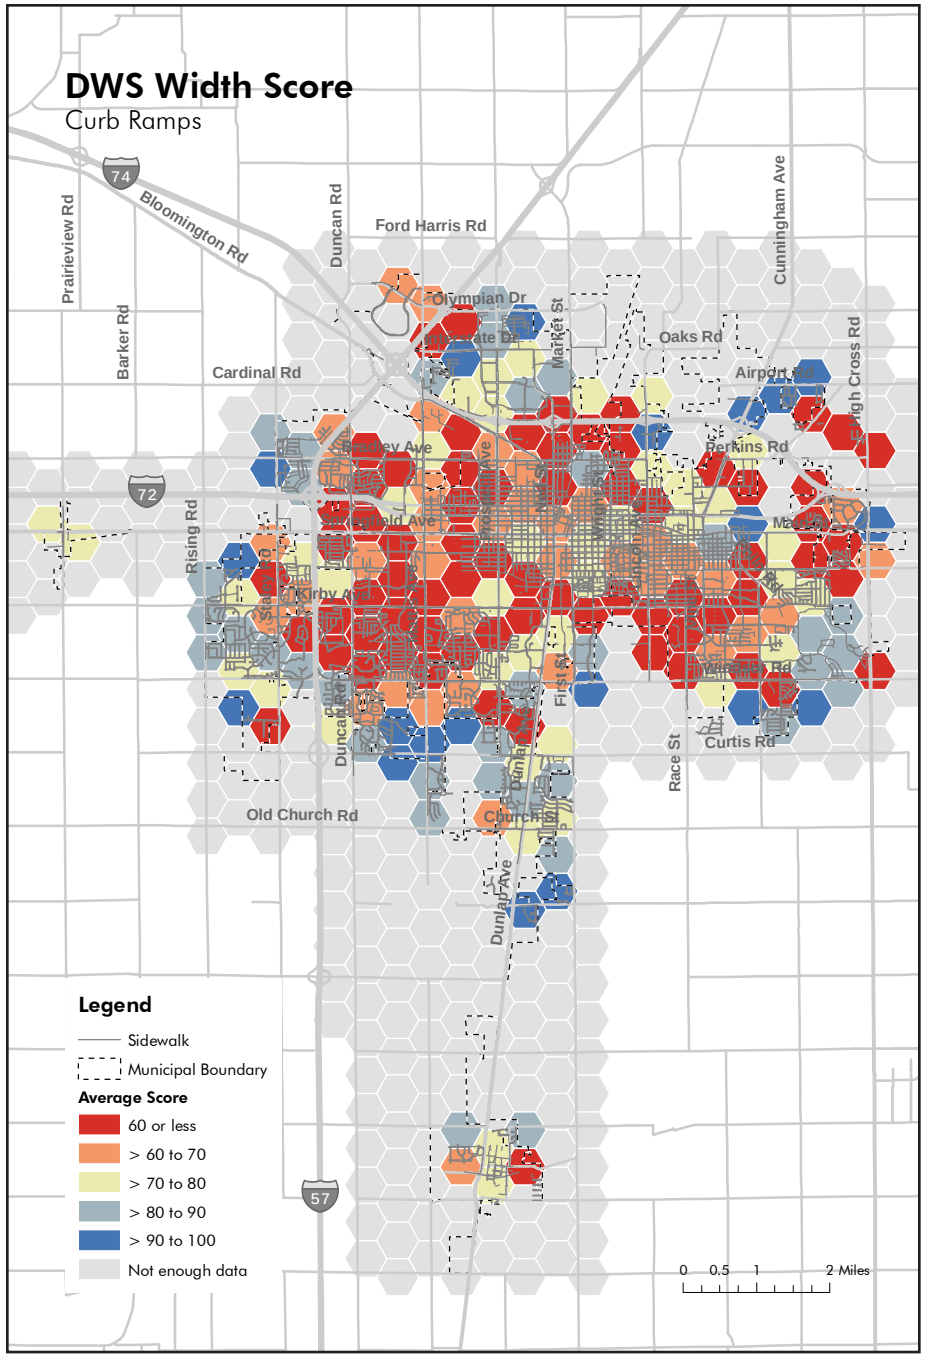
Figure 4-12 **Curb Ramp Detectable Warning Surface Width Scores**

The spatial pattern of detectable warning surface width compliance was similar to that of surface type, suggesting that the age of the ramp was a significant factor in determining compliance (see *Figure 4-12*). The areas with the highest levels of compliance were more recent developments on the periphery of the urbanized area, particularly on the south side of Champaign, Urbana, and Savoy.

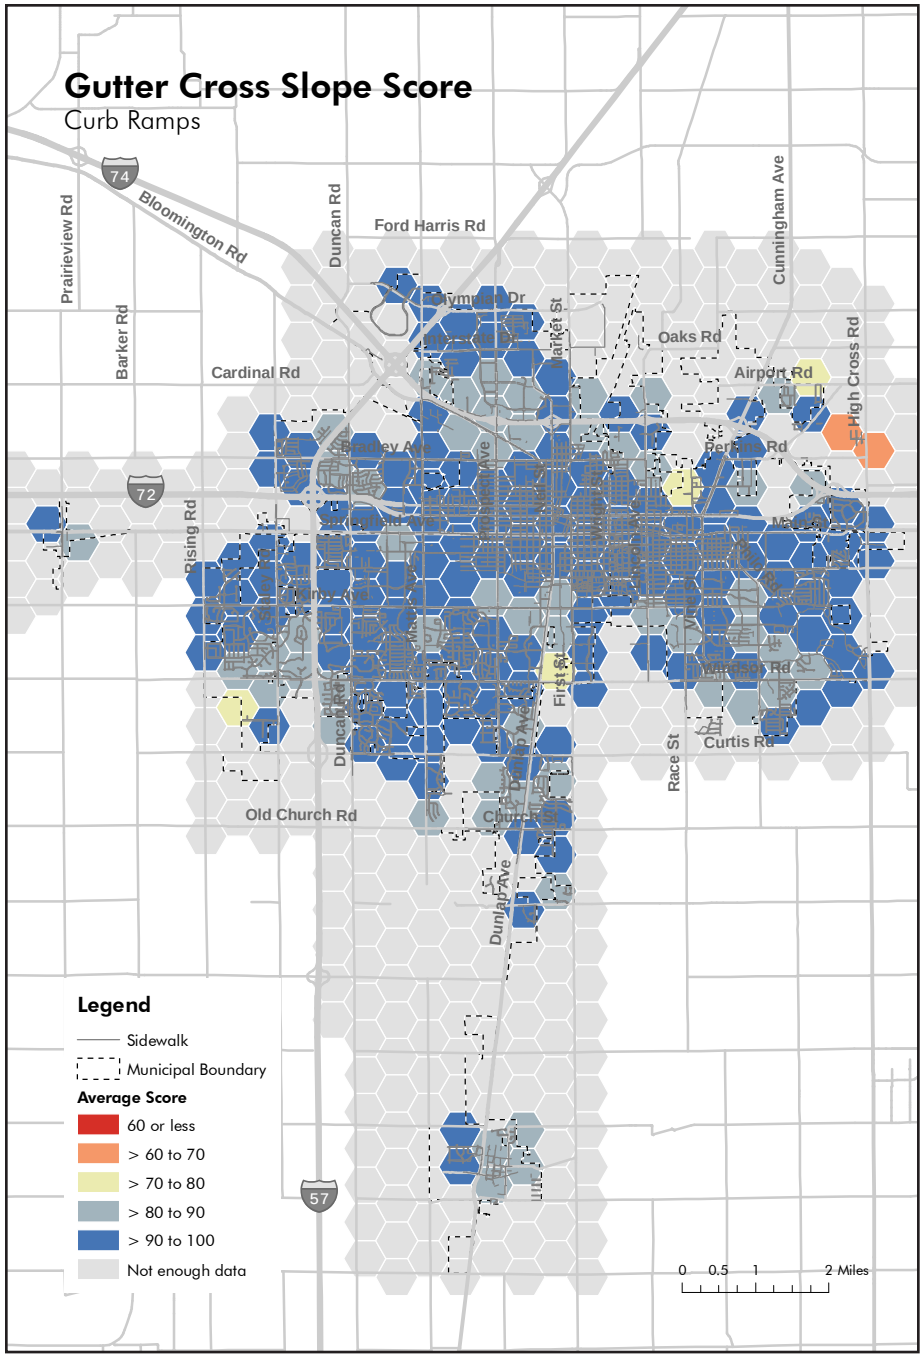
Figure 4-13 **Curb Ramp Gutter Cross Slope Scores**

Areas with lower levels of gutter cross slope compliance included areas north and south of I-74 in Champaign and Urbana; southwest Champaign west of I-57; Urbana south of Florida Avenue; and the U.S. 45/Dunlap Avenue corridor south of Kirby Avenue (see *Figure 4-13*).

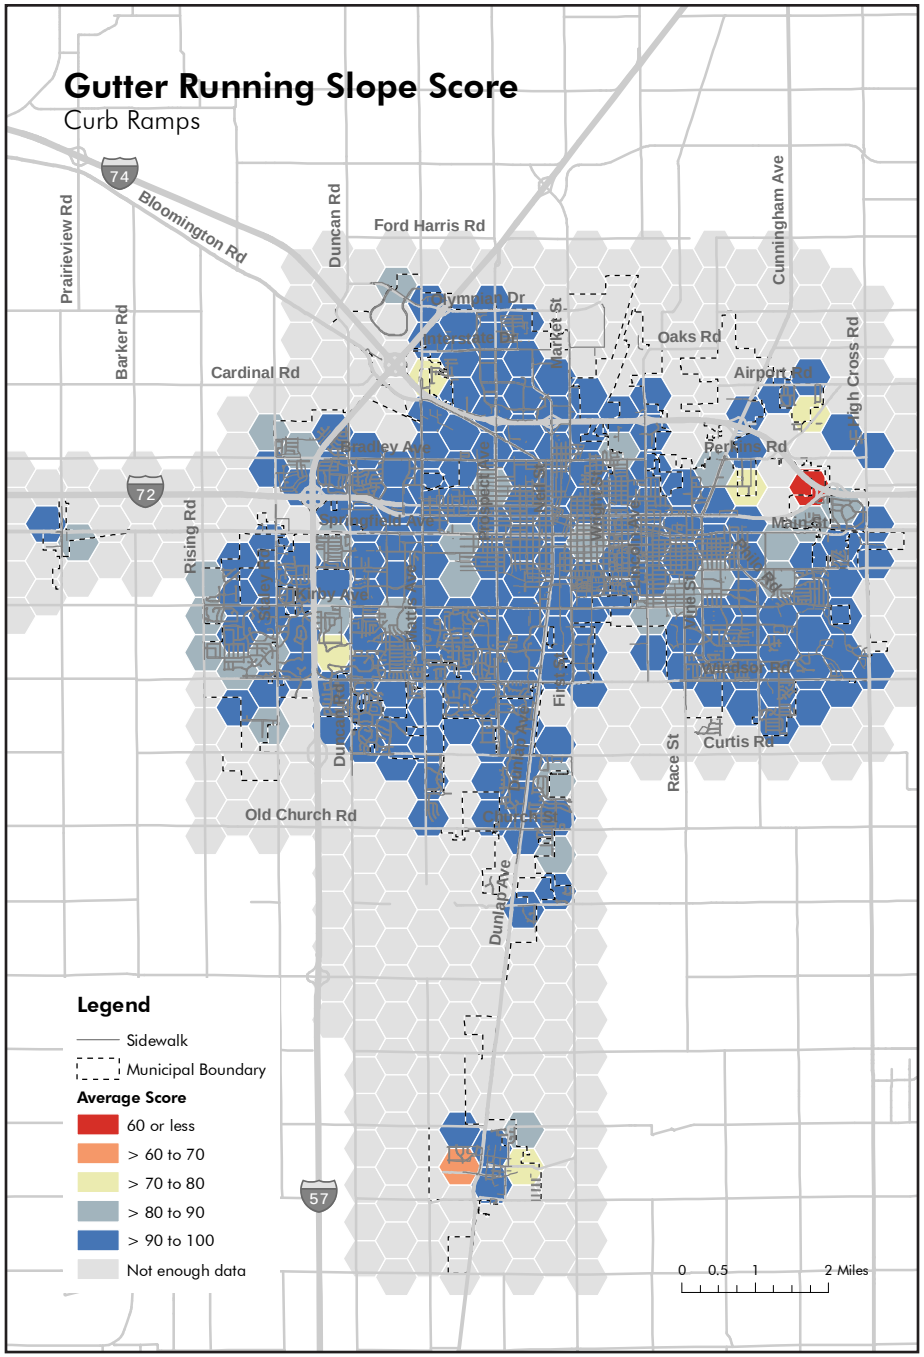
Figure 4-14 **Curb Ramp Gutter Counter Slope Scores**

Noncompliant gutter counter slopes were scattered throughout the urbanized area (see *Figure 4-14*). This spatial pattern suggested that noncompliance was primarily related to the properties of specific streets and gutters rather than systematic issues in street and gutter construction.

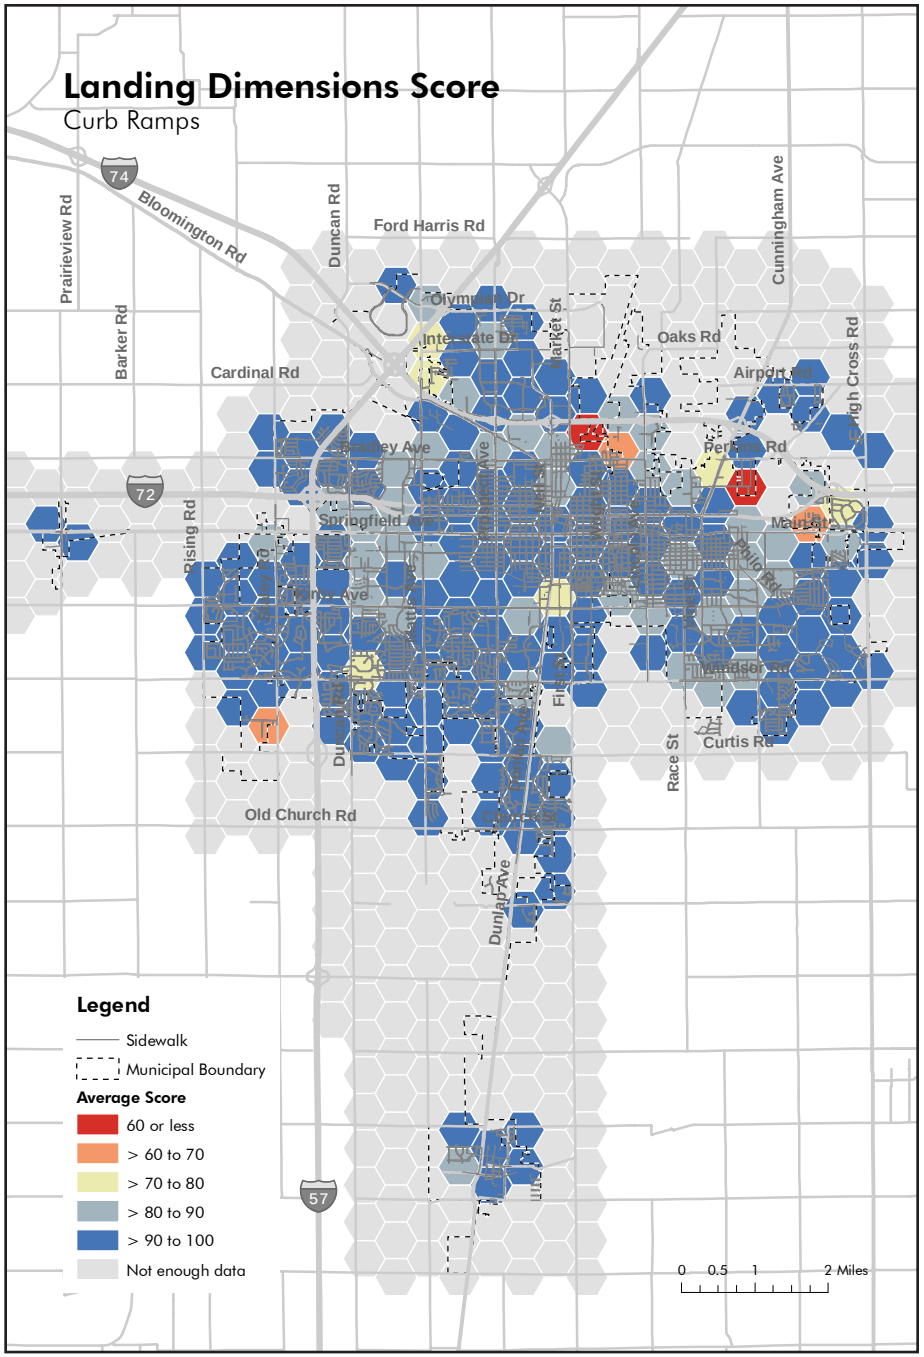
Figure 4-15 **Curb Ramp Landing Dimensions Scores**

Of curb ramps that required a landing, about 83 percent had a landing that met PROWAG standards for dimensions. However, nearly eight percent of ramps with running slopes greater than 5.0 percent lacked a flat landing area, requiring pedestrians to turn on the sloped ramp surface. Approximately nine percent of ramps had a landing area that was present but too small. Noncompliant landing dimensions were concentrated in the north and central portions of Champaign and Urbana (see *Figure 4-15*).

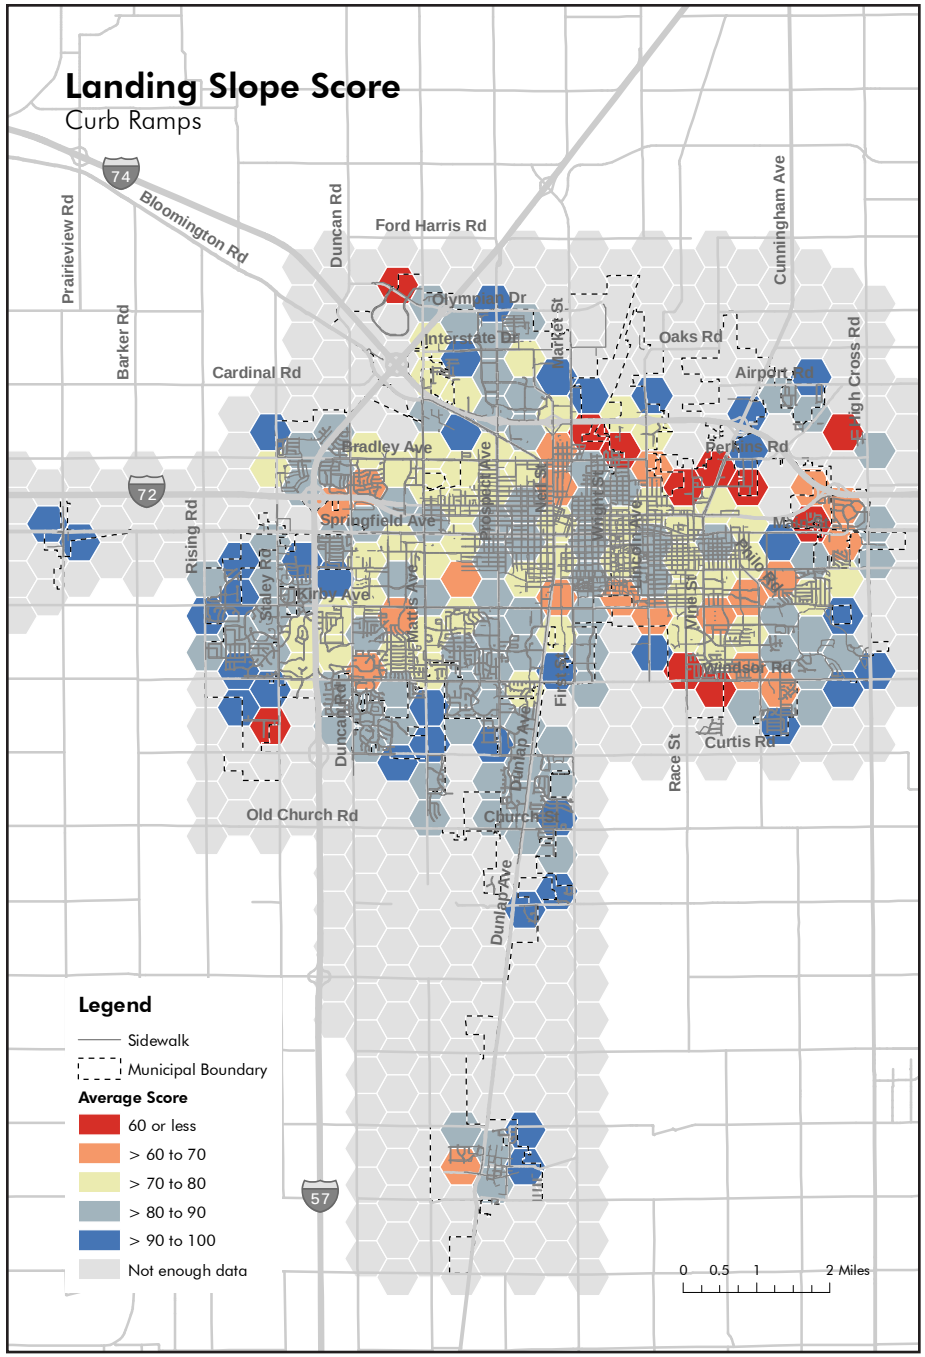
Figure 4-16 **Curb Ramp Landing Slope Scores**

Landing cross slopes were most problematic in the older core of the urbanized area (see *Figure 4-16*). However, the highest concentrations of noncompliance were observed in north and south Champaign and Urbana. Southwest Champaign, southeast Urbana, Savoy, and Tolono had the highest levels of landing slope compliance.

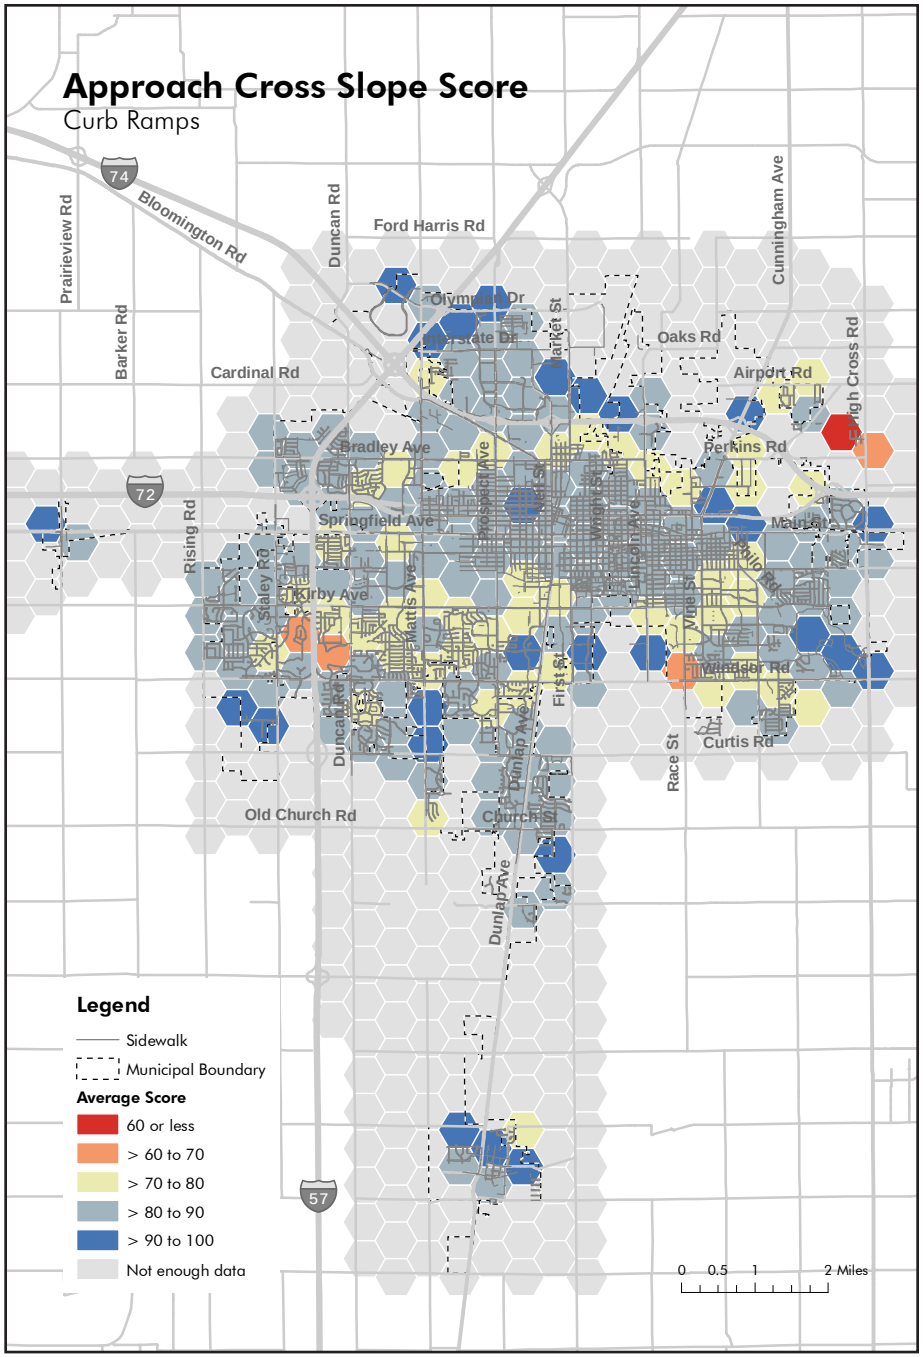
Figure 4-17 **Curb Ramp Approach Cross Slope Scores**

Approach cross slope was most often compliant on the periphery of the urbanized area and in the core (see *Figure 4-17*). Compliance was lowest in the ring of mid to late twentieth century residential neighborhoods surrounding the core of the community.

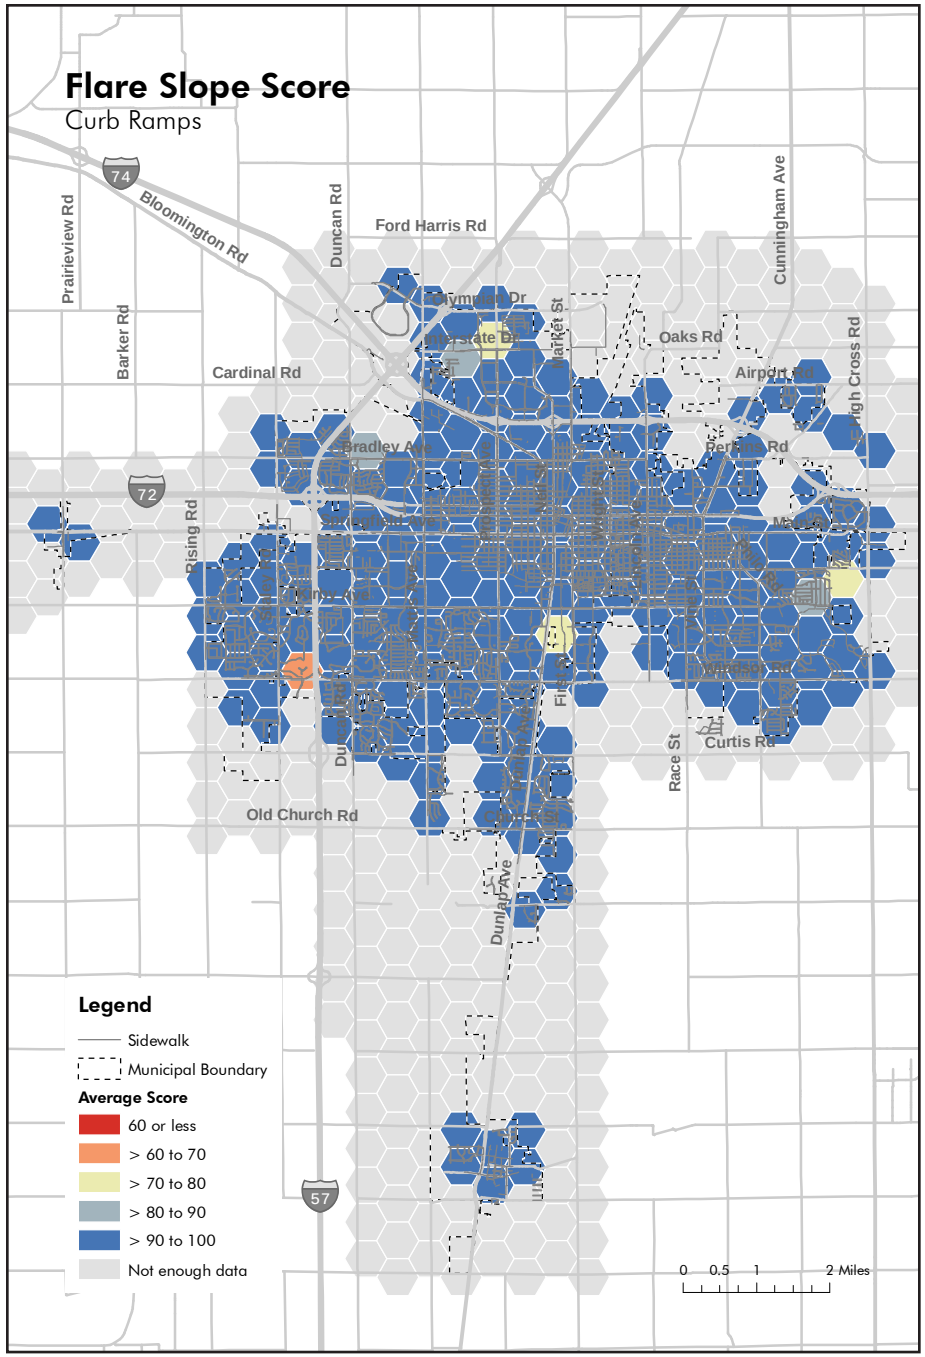
Figure 4-18 **Curb Ramp Flare Slope Scores**

Because of the small number of ramps with curb flares, no spatial pattern in flare slope compliance was evident (see *Figure 4-18*).
