Sidewalk Network Inventory and Assessment

FOR THE CHAMPAIGN URBANA URBANIZED AREA

FEBRUARY 2016

rpc CHAMPAIGN COUNTY REGIONAL PLANNING COMMISSION

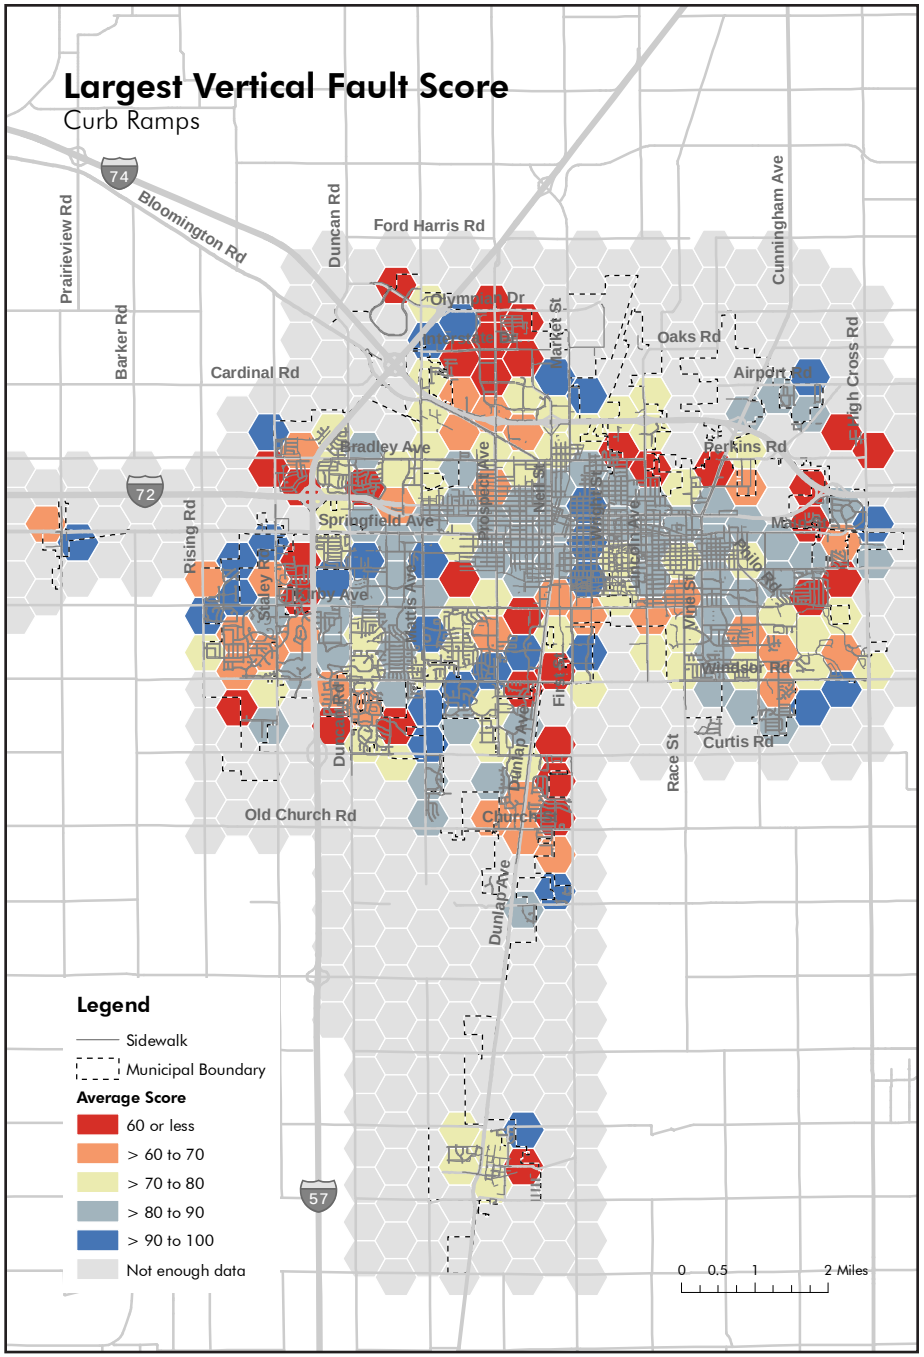
Figure 4-19 **Curb Ramp Vertical Fault Size Scores**

Vertical fault compliance scores for curb ramps were highest in the central part of the urbanized area, including the downtowns of Champaign and Urbana and the University of Illinois campus area (see *Figure 4-19*). Clusters of noncompliance were scattered throughout the outer parts of the urbanized area, most notably in the North Prospect Avenue commercial district in Champaign.

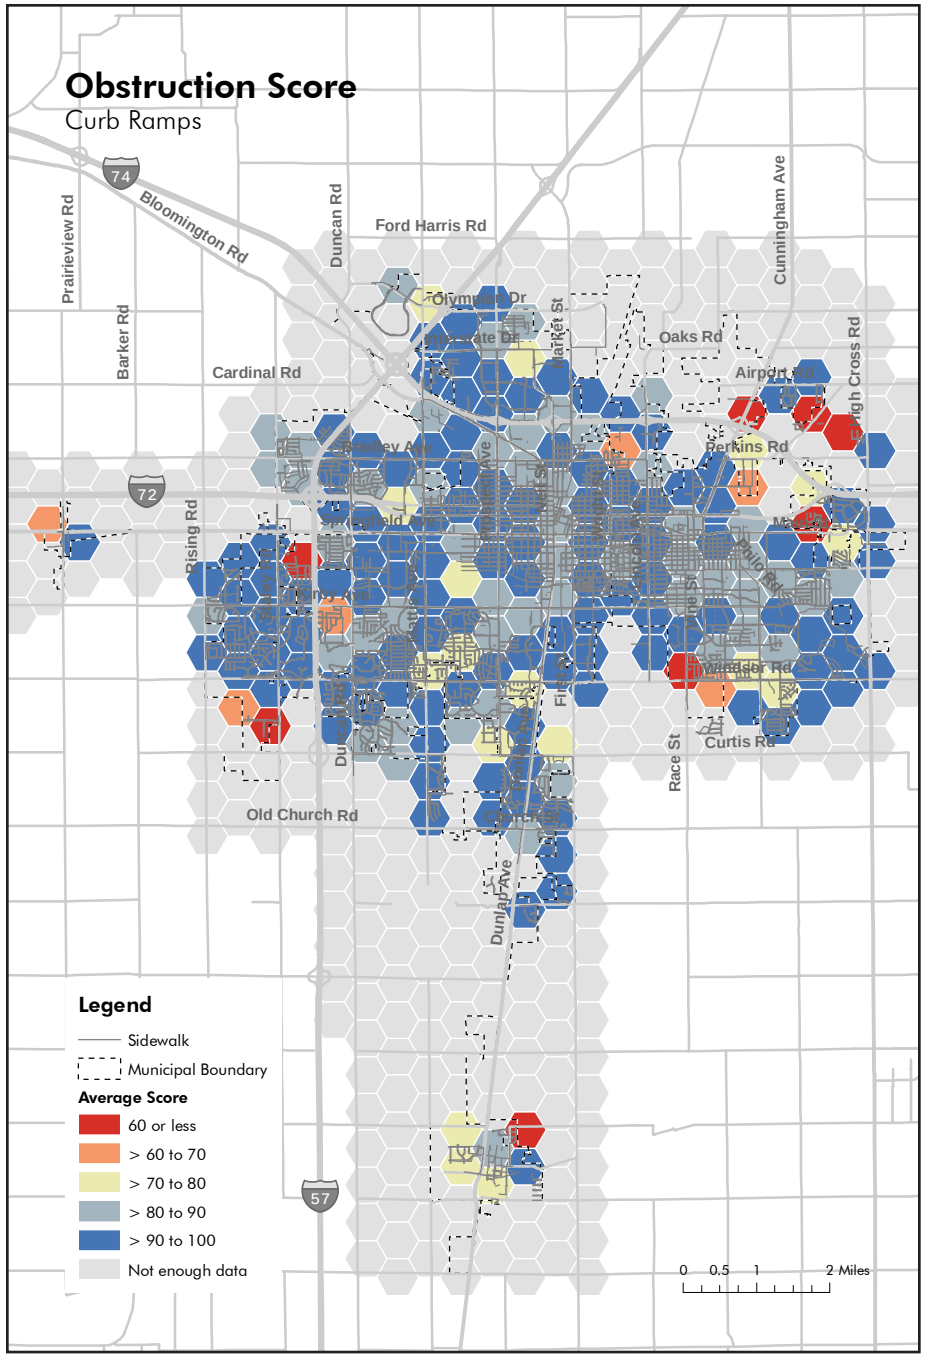
Figure 4-20 **Curb Ramp Obstruction Scores**

Areas with high concentrations of curb ramp obstructions were scattered throughout the urbanized area and included the northeast corner of the urbanized area along I-74, the Windsor Road corridor in Urbana, some areas along I-57 in southwest Champaign, and fringe areas of Tolono (see *Figure 4-20*).

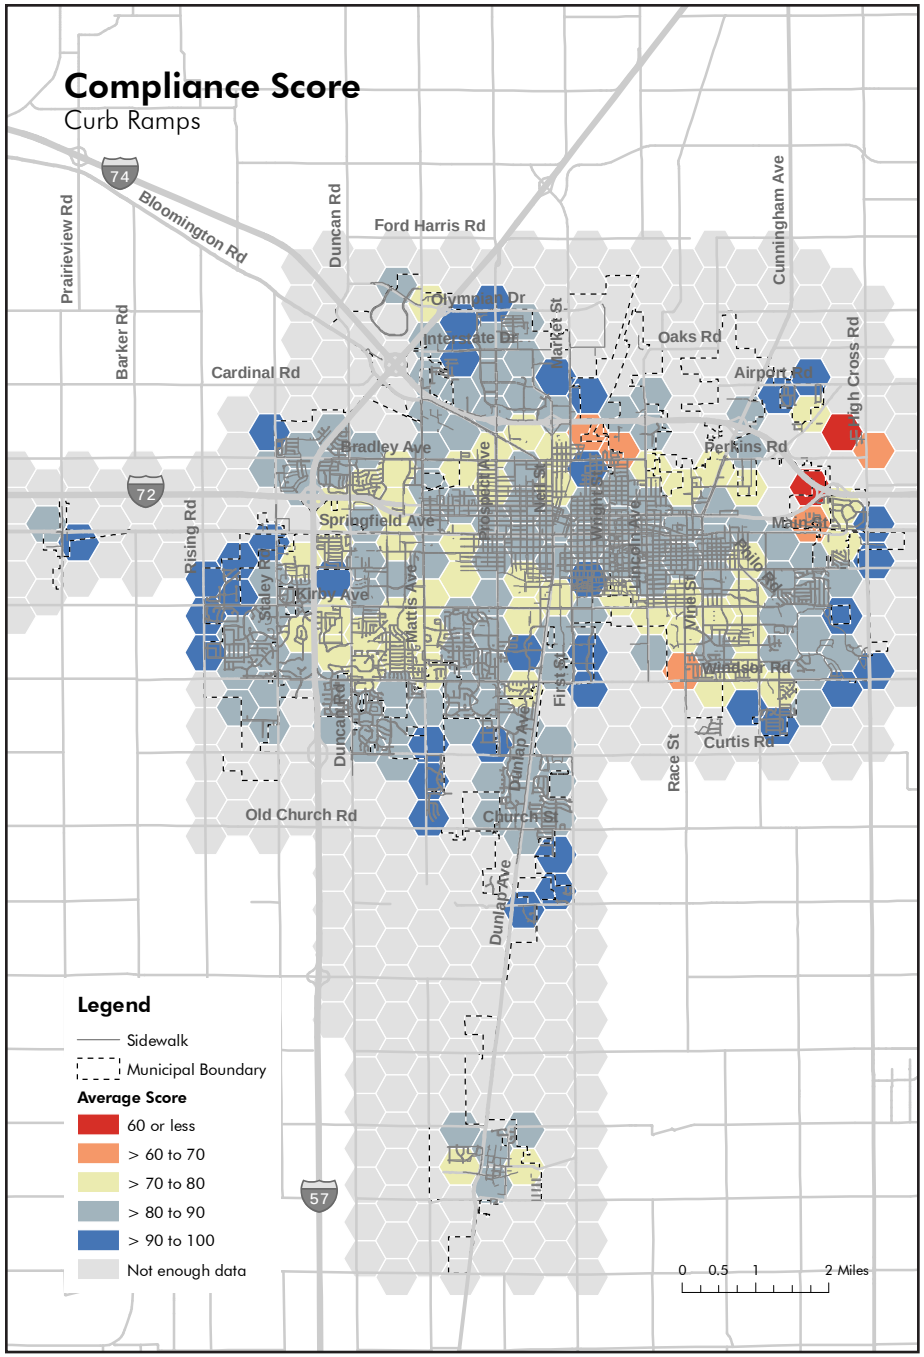
Figure 4-21 **Curb Ramp Compliance Score**

The combined compliance scores were highest on average in newly-constructed developments at the fringe of the community (see *Figure 4-21*). These consistently high scores appeared on virtually all sides of the urbanized area, including north, west, and south Champaign; east Urbana; and Savoy. Ramps in these areas tended to be newer, on average, and conformed more closely to the current PROWAG standards, particularly with regard to the use of truncated domes.

In some cases, such as ramps that are missing truncated domes, it may be possible to retrofit the noncompliant ramps to bring them into compliance with PROWAG standards. Other problems, such as incorrect geometry in the ramp and approaches, may require total reconstruction of the ramp area. In such cases, it may be necessary to replace one ramp type with a different type, such as replacement of a perpendicular ramp with combination ramps, in order to remedy overly steep ramp runs.

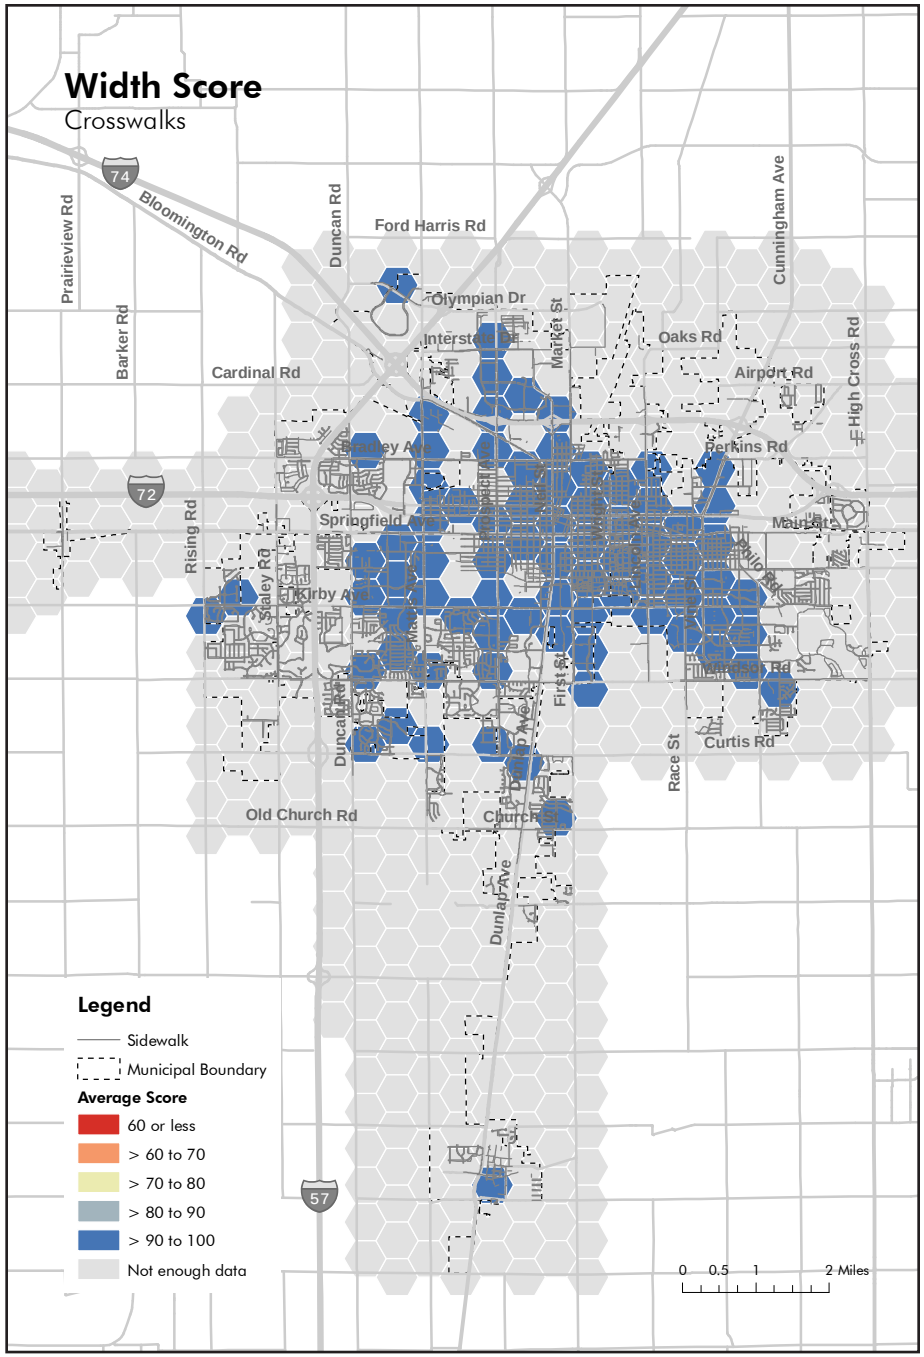
Figure 4-23 **Crosswalk Width Scores**

All of the crosswalks measured had a width of at least four feet. Marked crosswalks are most prevalent in core of the community, including the downtowns of Champaign and Urbana and the University of Illinois campus area (see *Figure 4-23*).

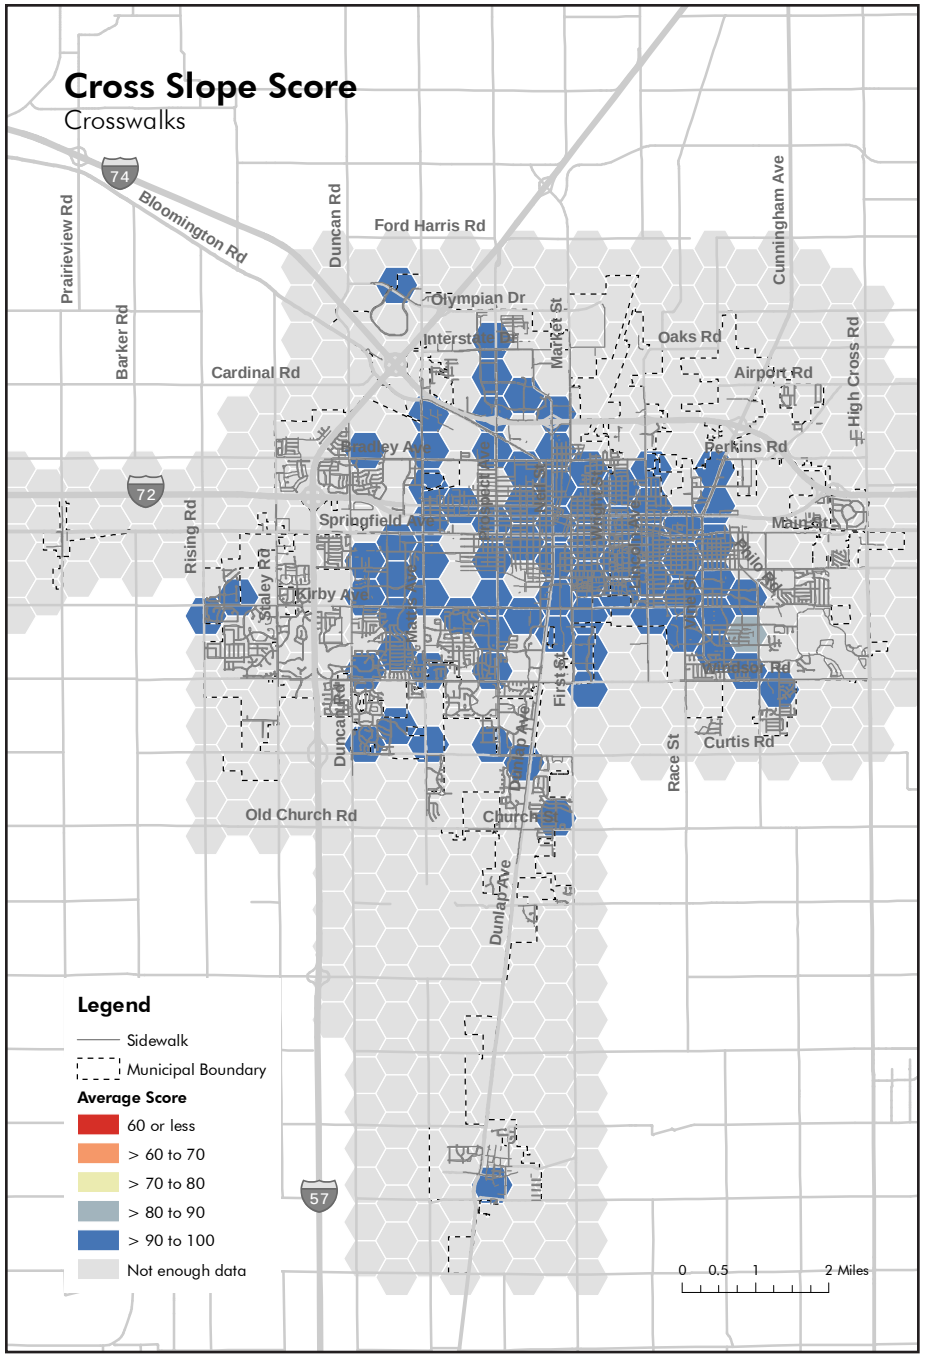
Figure 4-24 **Crosswalk Cross Slope Scores**

Approximately 94 percent of crosswalks at intersections had a cross slope within the compliant range. Most of the remaining intersection crosswalks had cross slopes in the second score tier, while extreme cross slopes were relatively rare. Because of the high level of compliance, no spatial pattern is evident in the cross slope compliance scores (see *Figure 4-24*).

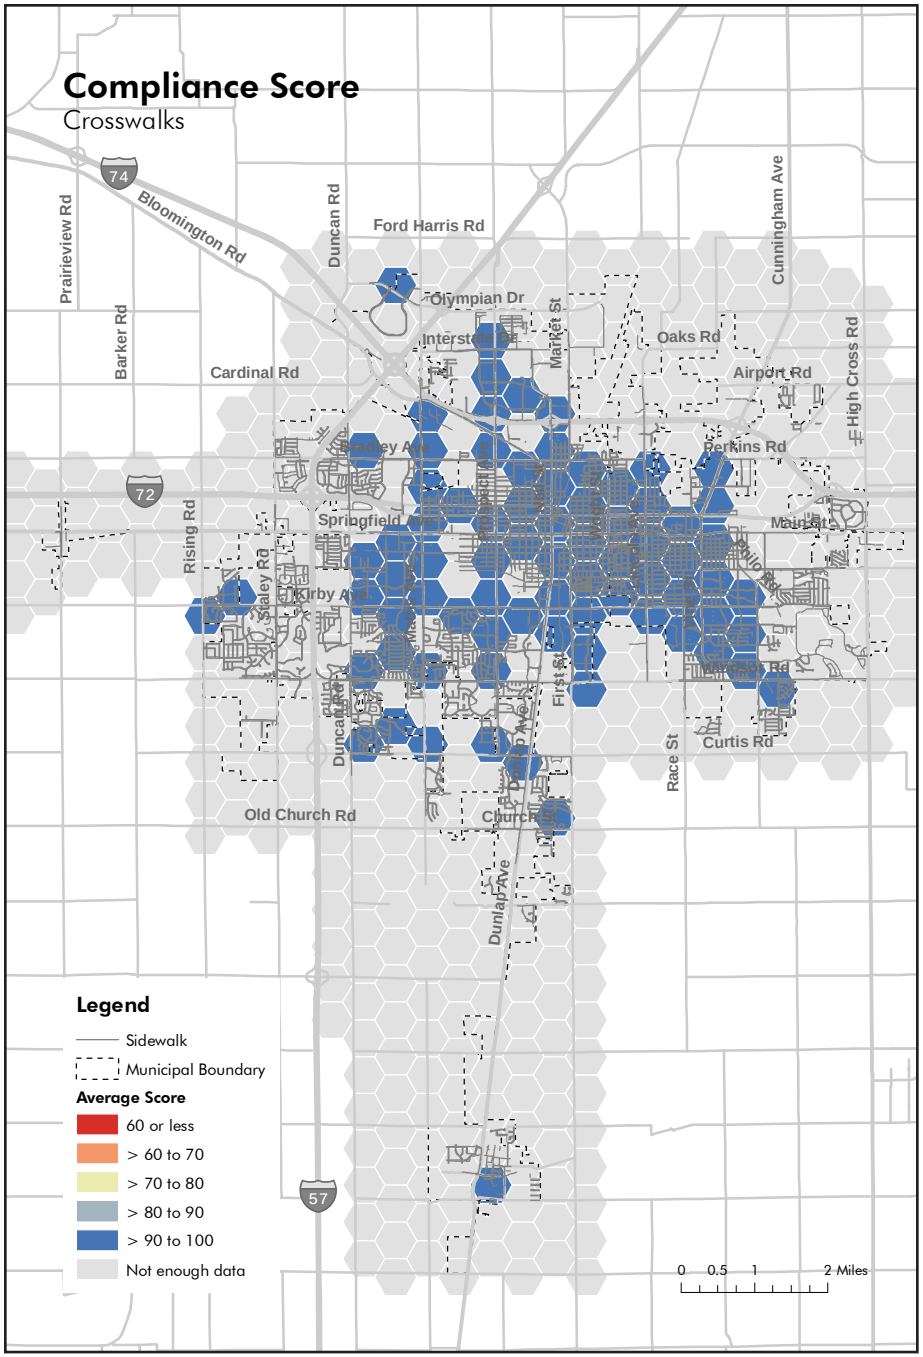
Figure 4-25 **Crosswalk Compliance Scores**

Nearly 95 percent of crosswalks scored above 90 on the compliance index, and more than 99 percent scored above 80 (see *Table 4-28*). The high scores reflect the limited set of variables available for assessing crosswalk compliance as well as the high level of compliance on the criteria examined. Because of the high level of compliance among crosswalks, no spatial pattern was evident in the compliance results (see *Figure 4-25*).

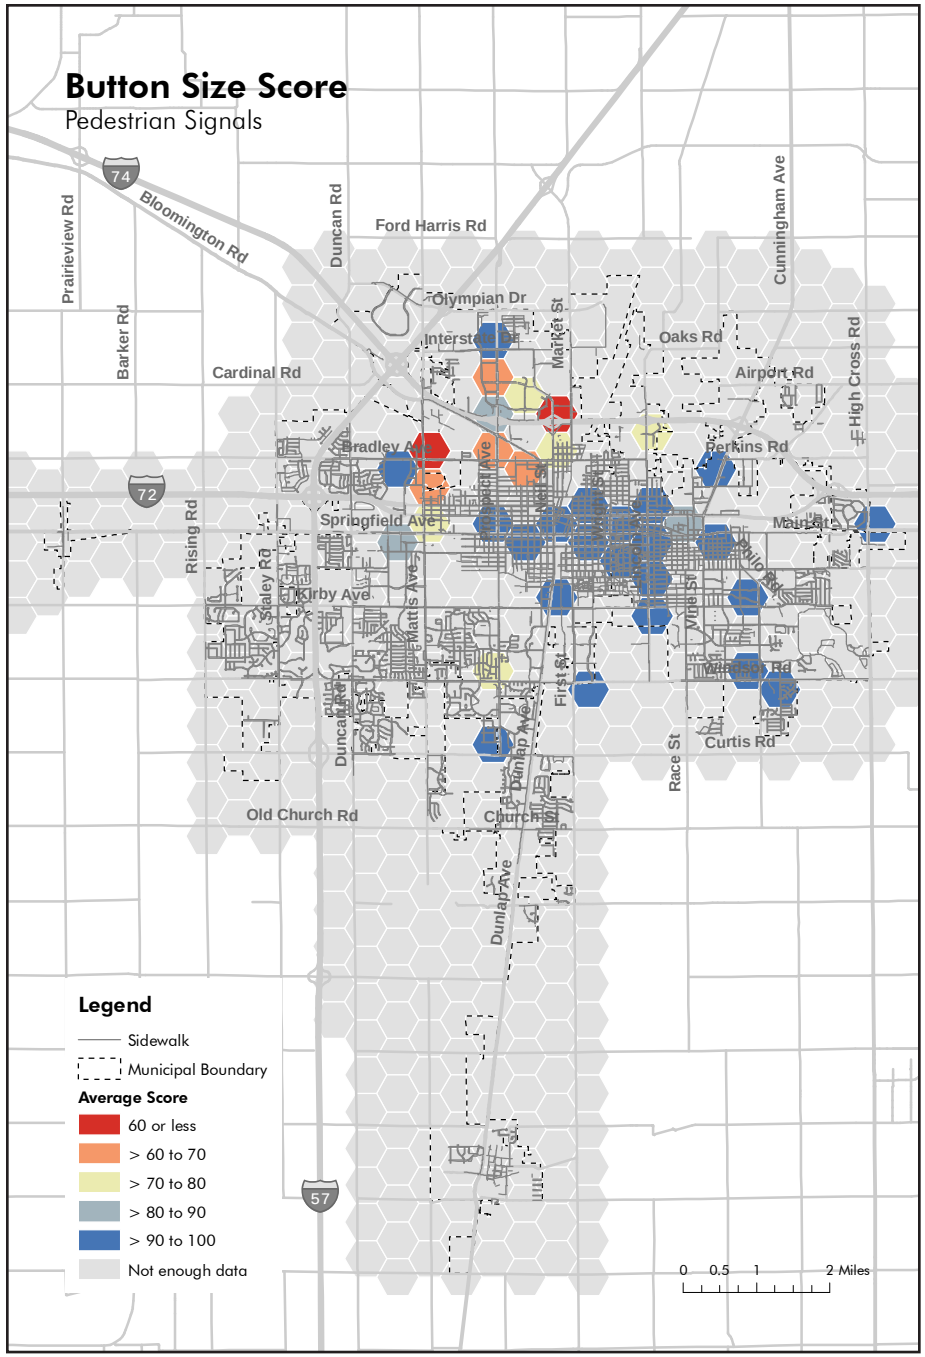
Figure 4-27 **Pedestrian Signal Button Size Scores**

Approximately 72 percent of pedestrian signals with pushbuttons were accessible based on button size. Less than 10 percent of pushbuttons were the smallest, least accessible button size. Accessible pushbuttons were least common on the north side of the urbanized area and in the Mattis Avenue corridor (see *Figure 4-27*).

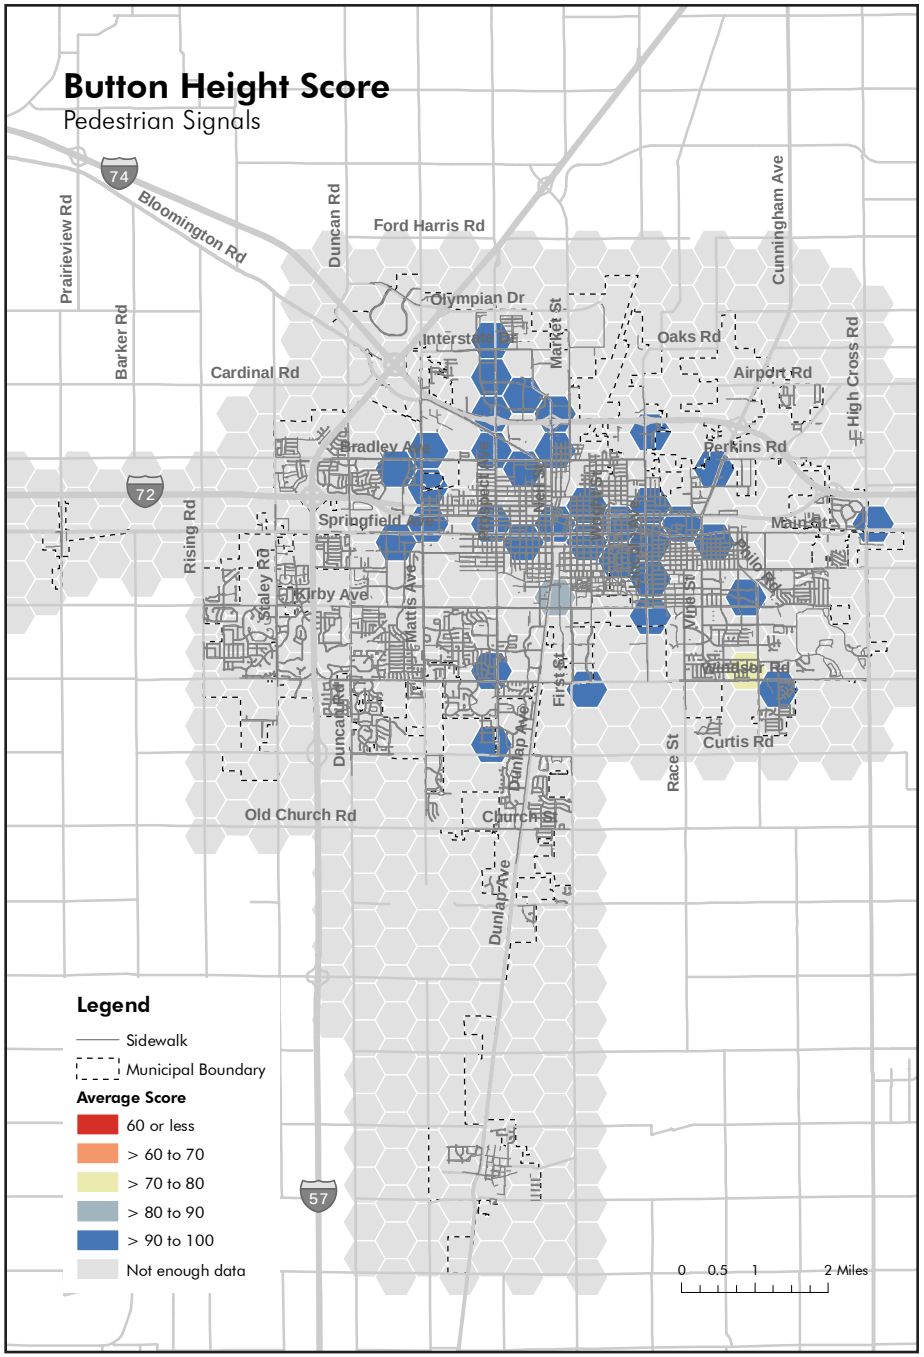
Figure 4-28 **Pedestrian Signal Button Height Score**

More than 93 percent of pedestrian pushbuttons were mounted at an accessible height, and no pushbuttons were located too low. Approximately 6 percent of pushbuttons were located between one and ten inches too high. Because of the high level of compliance for button height, no spatial pattern was evident (see *Figure 4-28*).

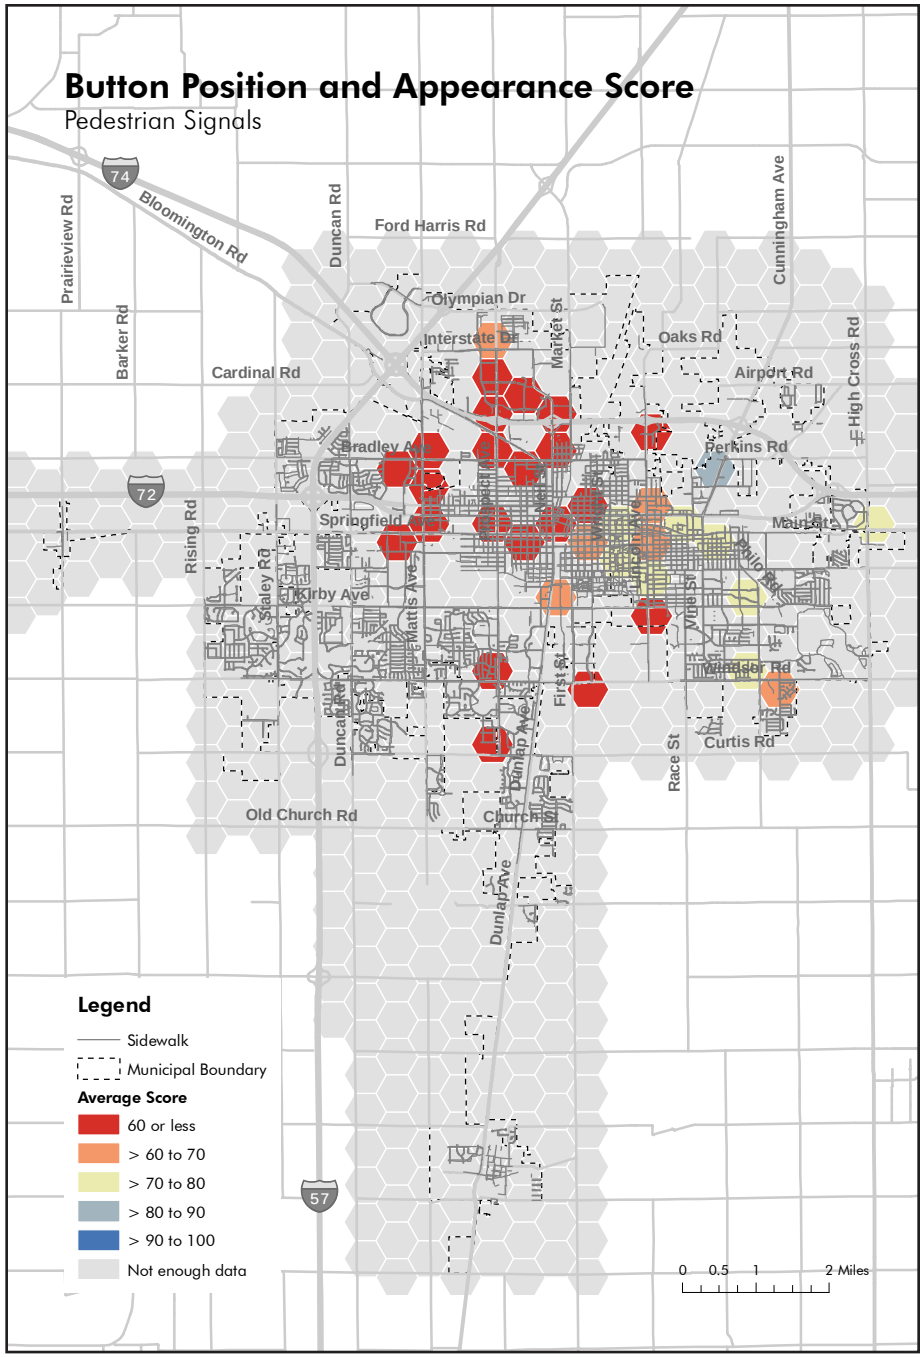
Figure 4-29 **Pedestrian Signal Button Position and Appearance Scores**

Pushbutton accessibility features were most common in Urbana, in and around the University of Illinois campus, and in some parts of the North Prospect Avenue shopping district (see *Figure 4-29*).

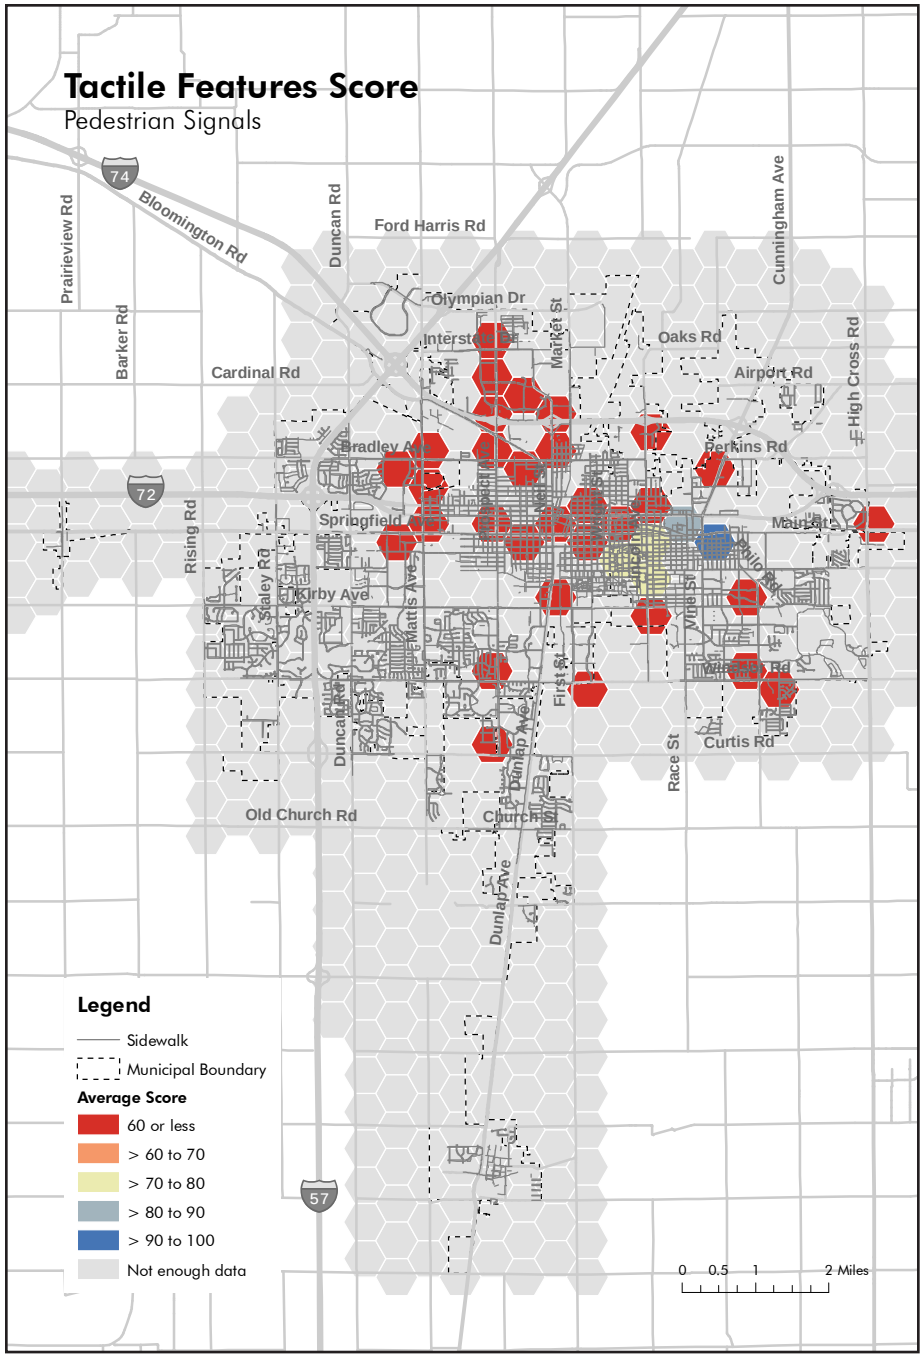
Figure 4-30 **Pedestrian Signal Tactile Features Scores**

Tactile features were relatively rare. Tactile arrows were present at only about 41 percent of pedestrian signals, and vibrotactile indicators were available at less than one quarter of signals. These features were most likely to be present in downtown Urbana and in the University of Illinois campus area (see *Figure 4-30*).

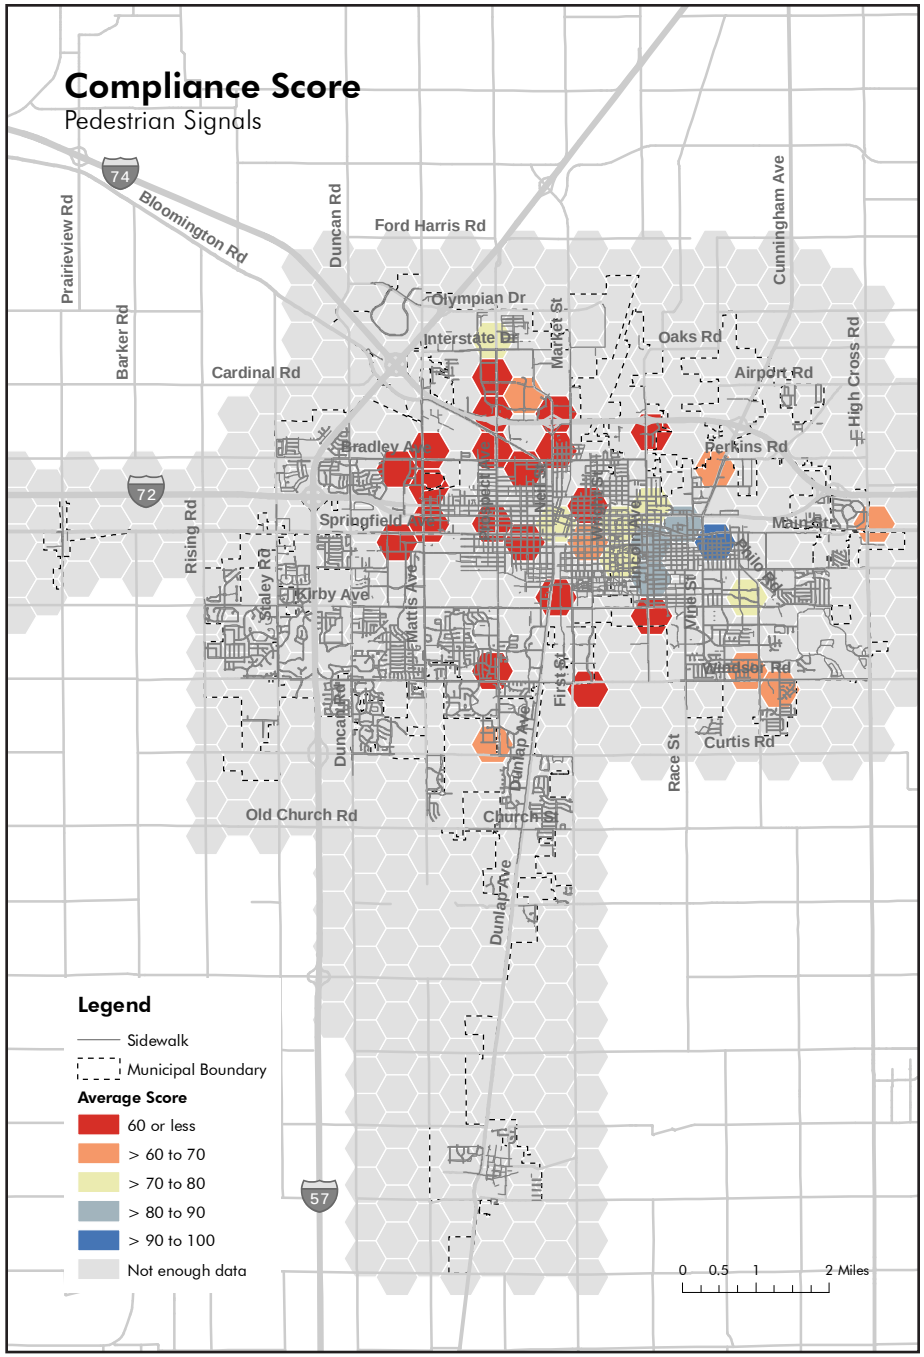
Figure 4-31 **Pedestrian Signal Compliance Scores**

Pedestrian signal compliance scores were highest in the core of the community, particularly in downtown Urbana and in the University of Illinois campus area (see *Figure 4-31*). Pedestrian signals along outlying arterials, such as Mattis Avenue and Bradley Avenue, had relatively low compliance scores.

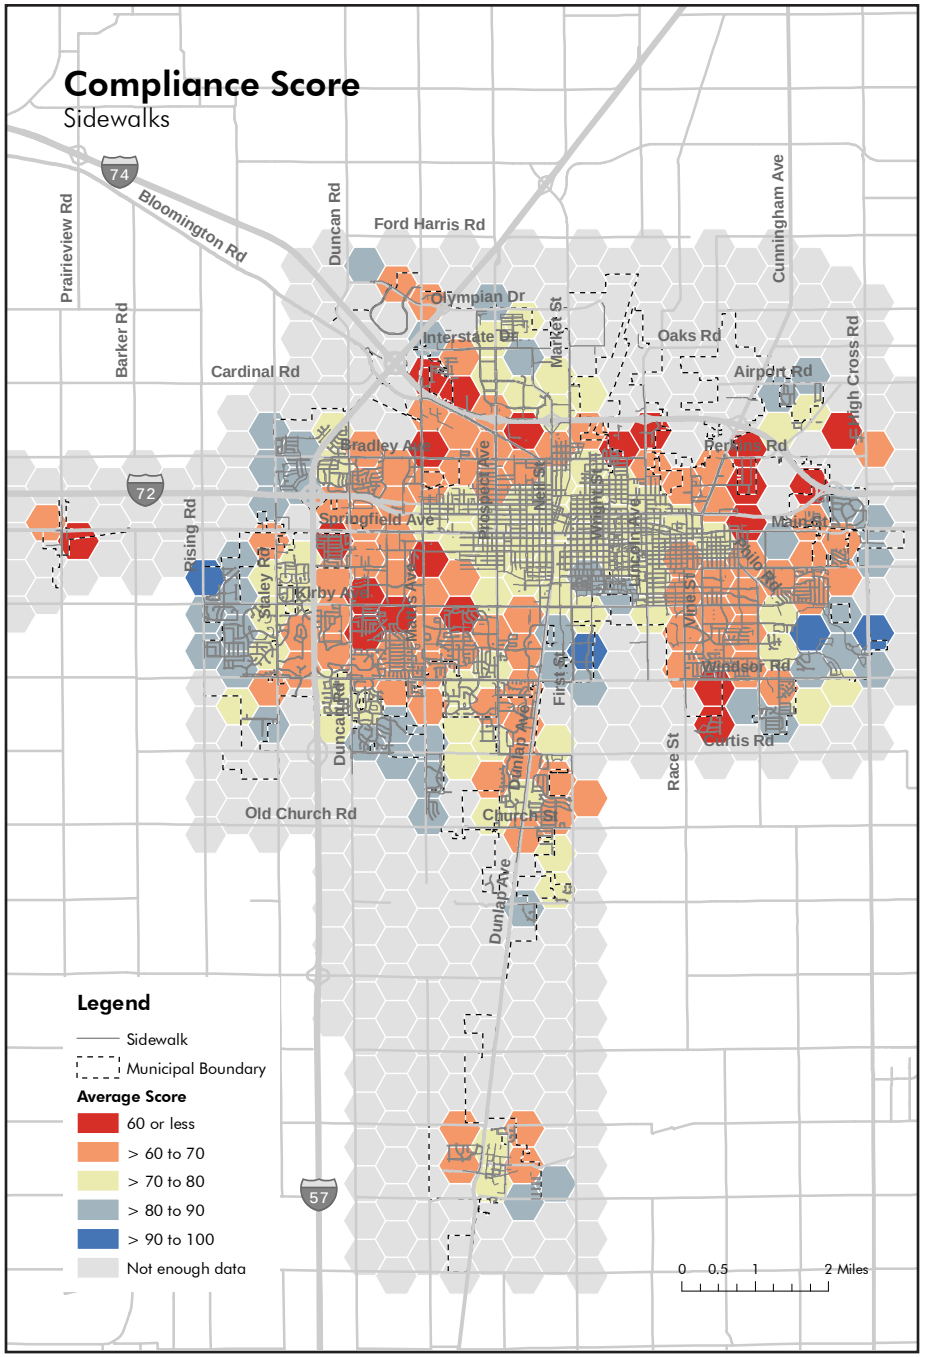
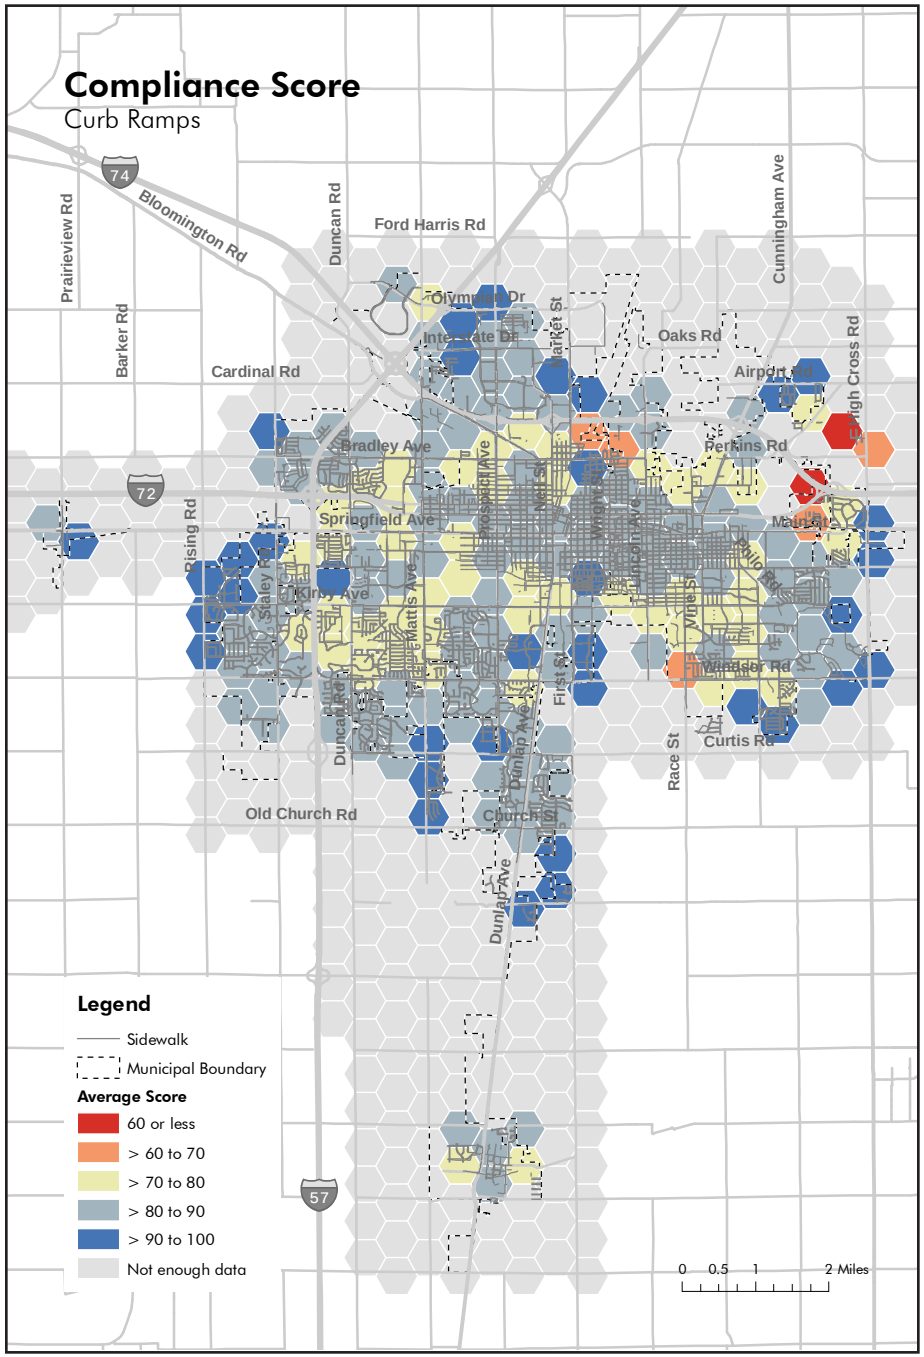
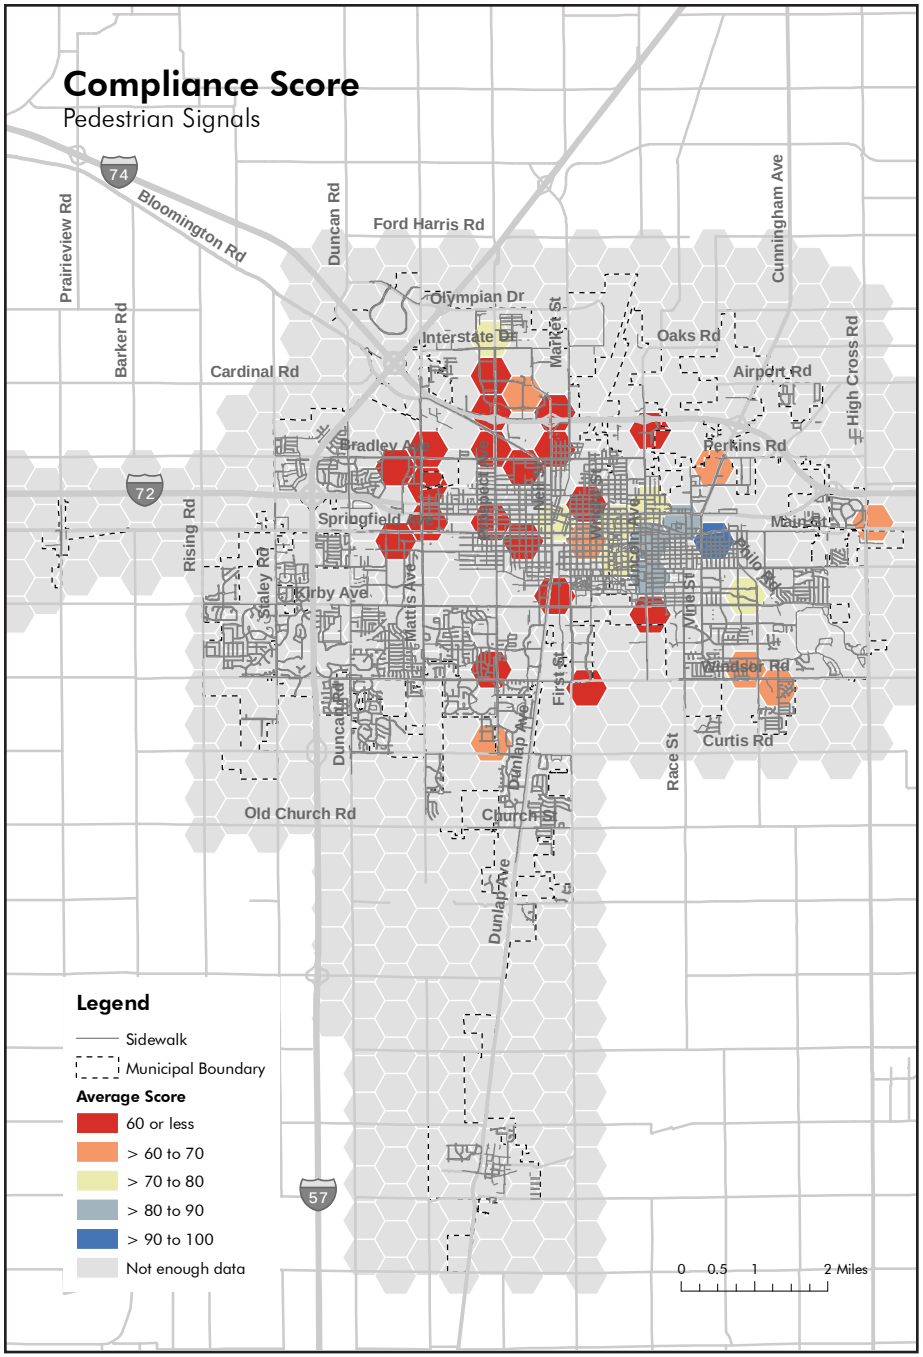
Figure 4-32 **Comparison of Compliance Scores by Feature Type**

The ring of noncompliance is significantly narrower for curb ramps than for sidewalks, suggesting that ramps were added to some neighborhoods after the initial construction of sidewalks. Bondville, where sidewalk compliance is low and curb ramp compliance is high, also exhibits this trend.

Pedestrian signals display a spatial pattern similar to sidewalks and curb ramps, except that compliance is highest at the center, rather than the fringe, of the urbanized area. Unlike for sidewalks and curb ramps, where the core of compliance is centered on the University of Illinois campus, the highest level of compliance for pedestrian signals is located in Urbana, east of the campus area.

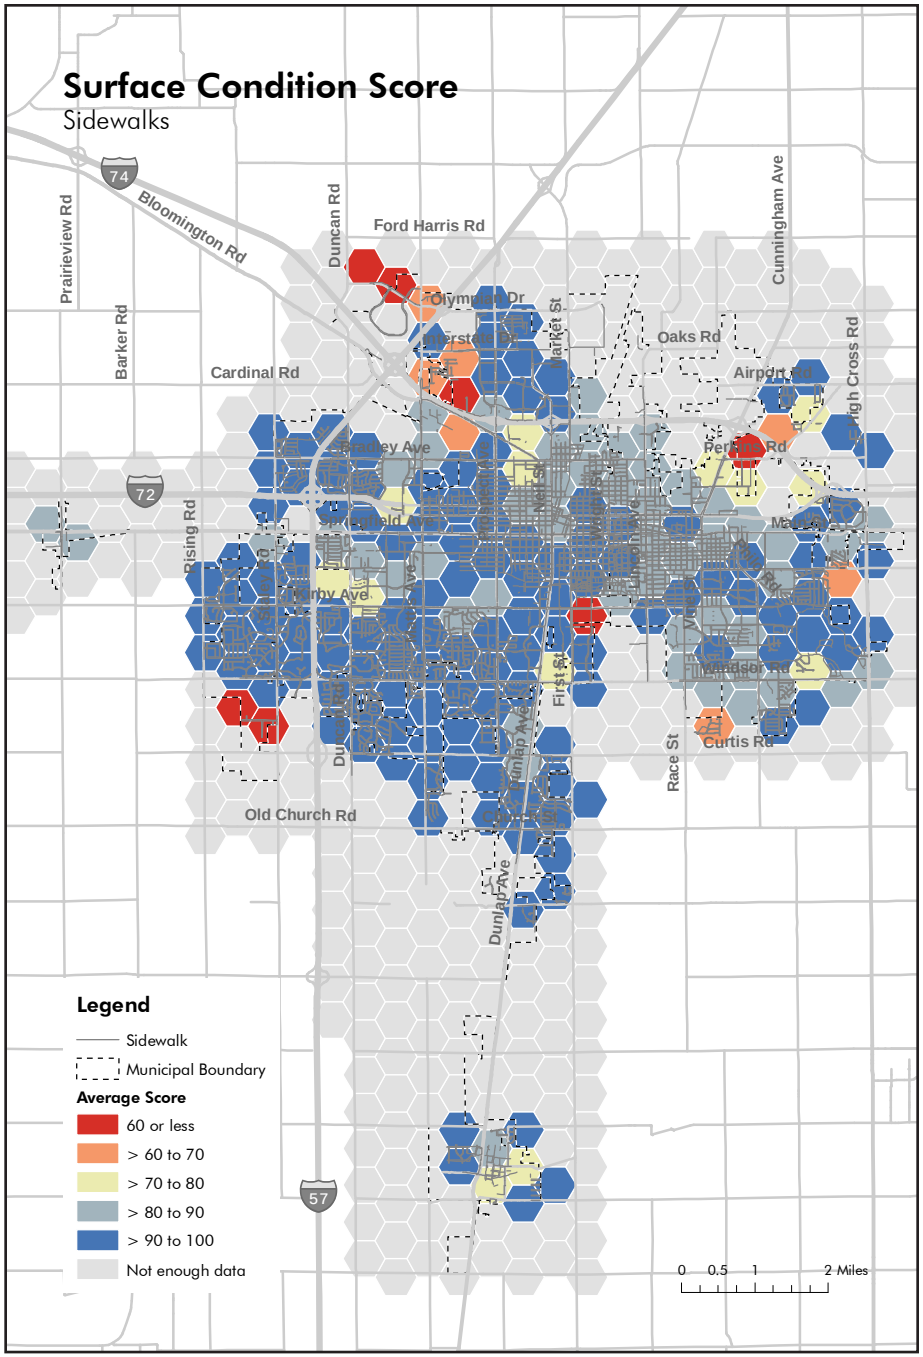
Figure 5-1 **Sidewalk Surface Condition Scores**

Sidewalk surface condition issues were most common in certain clusters, particularly near the fringe of the urbanized area (see *Figure 5-1*). Among these clusters were areas surrounding the I-74/Cunningham Avenue interchange and areas to the north and east of the I-57/I-74 interchange.

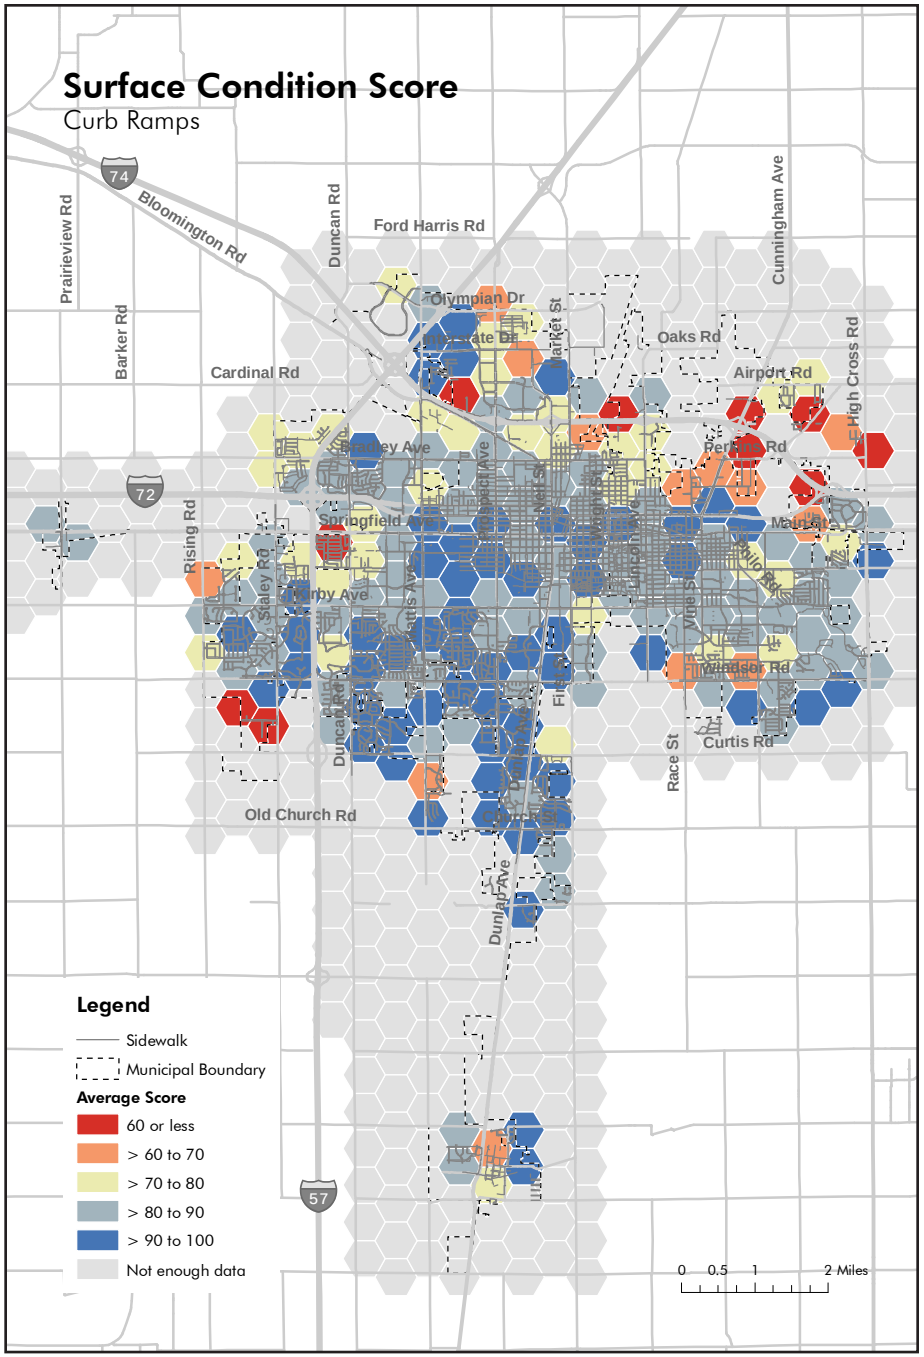
Figure 5-2 **Curb Ramp Surface Condition Scores**

Curb ramp surface condition issues appeared more widespread, covering much of the northern portion of the urbanized area, particularly areas north and immediately south of I-74 (see *Figure 5-2*). However, the difference is due in part to the scoring system used. A feature with cracking, the most common issues found on sidewalks, scored twice as high as a feature with grass, the most common issue for curb ramp surfaces.

In some cases surface condition issues on curb ramps coincided with surface condition problem on sidewalks. In other areas, particularly in areas west of I-57 and in the northeast corner of the urbanized area, curb ramp surface condition issues occurred in the absence of significant sidewalk surface condition problems. This spatial mismatch reflects differences in the types of issues affecting sidewalks and curb ramps. Sidewalks surfaces were more likely to suffer from structural defects, such as spalling and cracking, while curb ramp surfaces were more likely to experience maintenance-related issues, such as dirt and grass.
