Sidewalk Network Inventory and Assessment

FOR THE CHAMPAIGN URBANA URBANIZED AREA

FEBRUARY 2016

rpc CHAMPAIGN COUNTY REGIONAL PLANNING COMMISSION

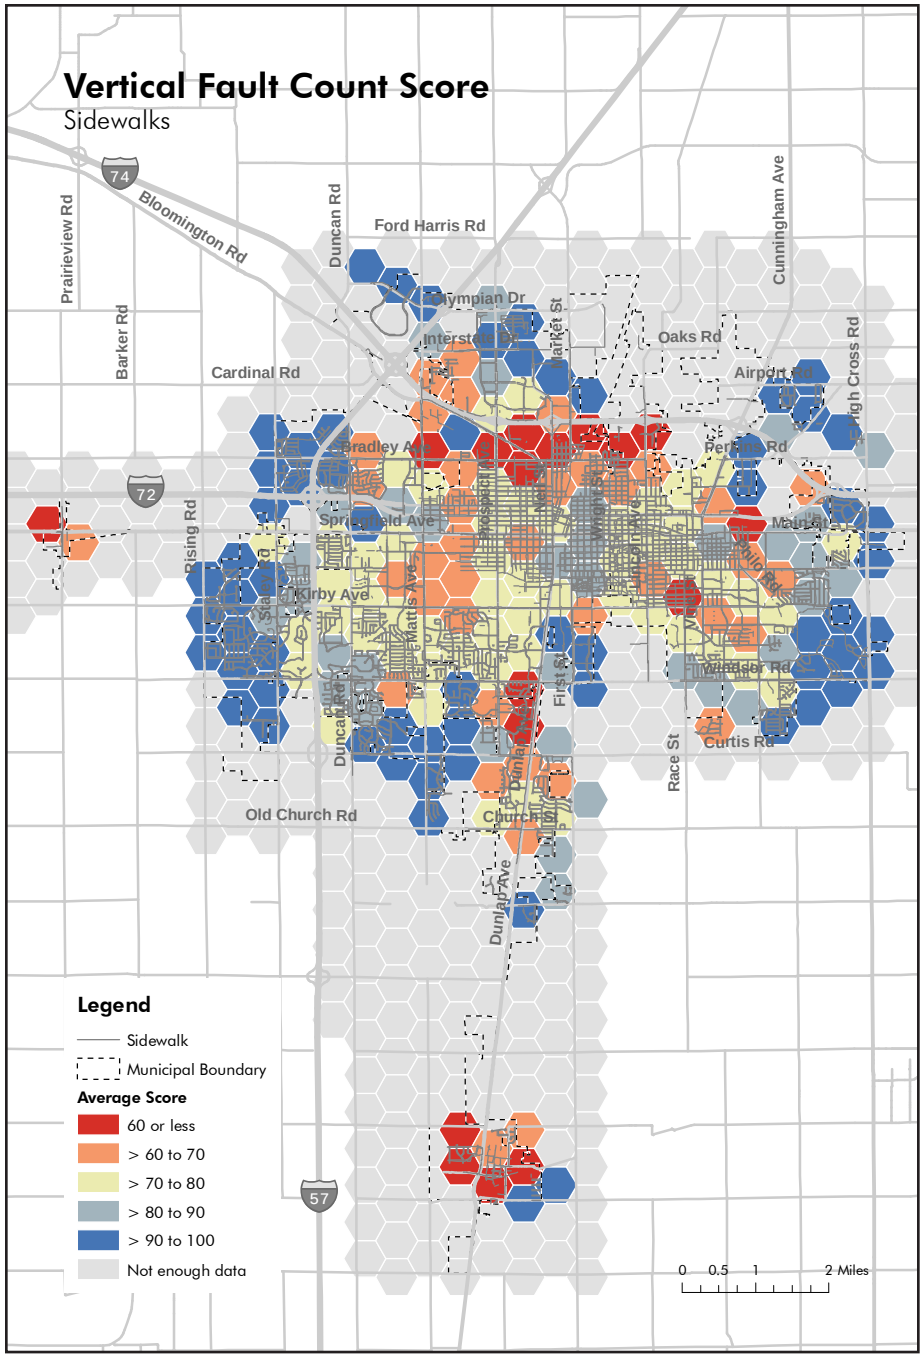
Figure 5-3 **Sidewalk Vertical Fault Frequency Scores**

Sidewalks at the periphery of the urbanized area had the fewest vertical faults, while those in the core of the community tended to have more frequent faults (see *Figure 5-3*). The highest concentrations of vertical faults occurred in the northern portion of the urbanized area south of I-74; in north Savoy along U.S. 45; and in Bondville and Tolono.

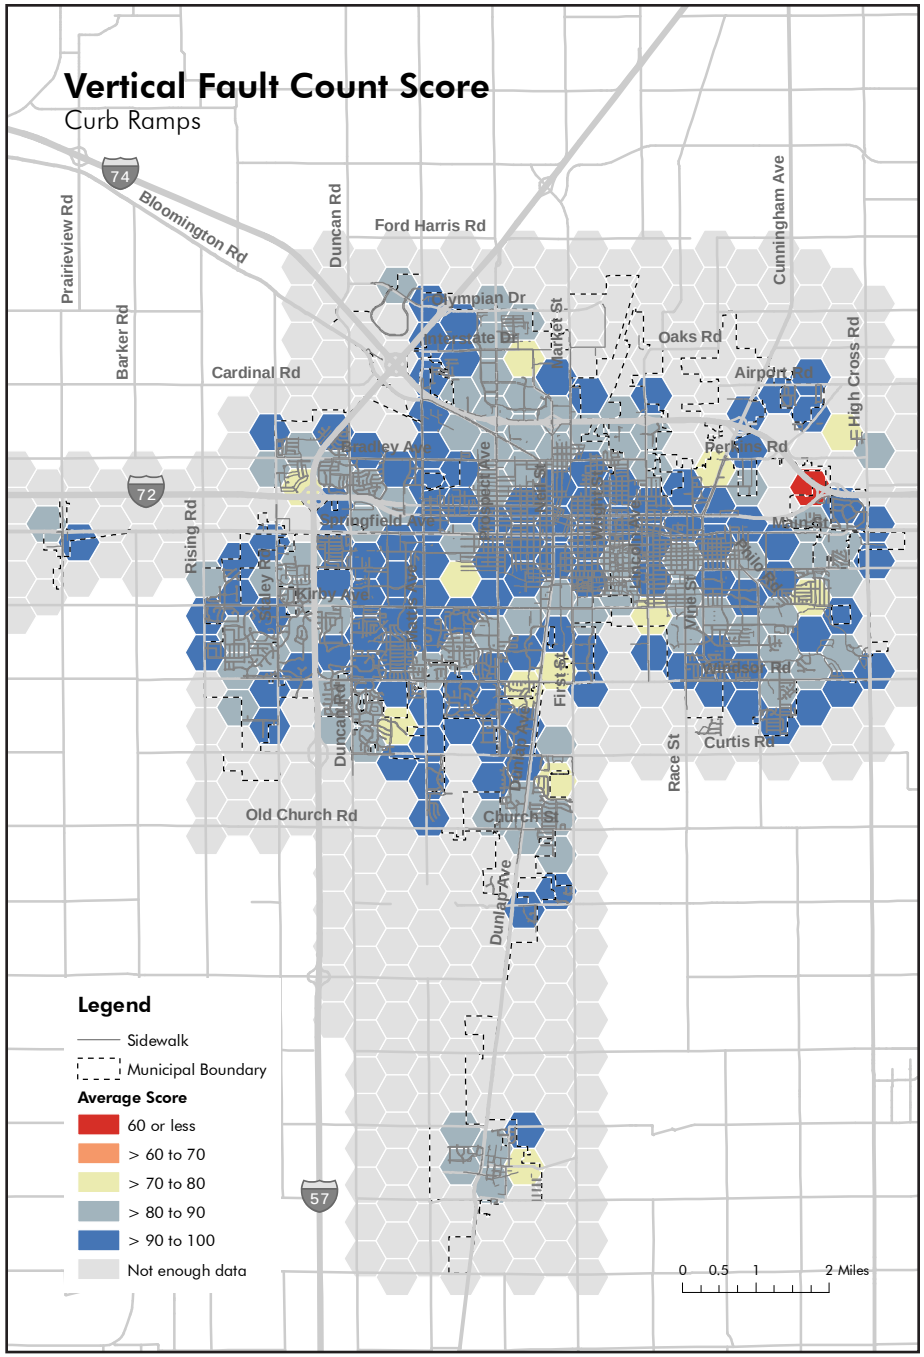
Figure 5-4 **Curb Ramp Vertical Fault Frequency Scores**

Areas with frequent curb ramp vertical faults were somewhat more scattered, though the I-74 corridor also had a higher concentration of curb ramps with vertical faults than most other parts of the urbanized area (see *Figure 5-4*). The lack of strong spatial correlation between vertical faults in sidewalks and curb ramps suggested that different factors may influence the formation of faults in these feature types.

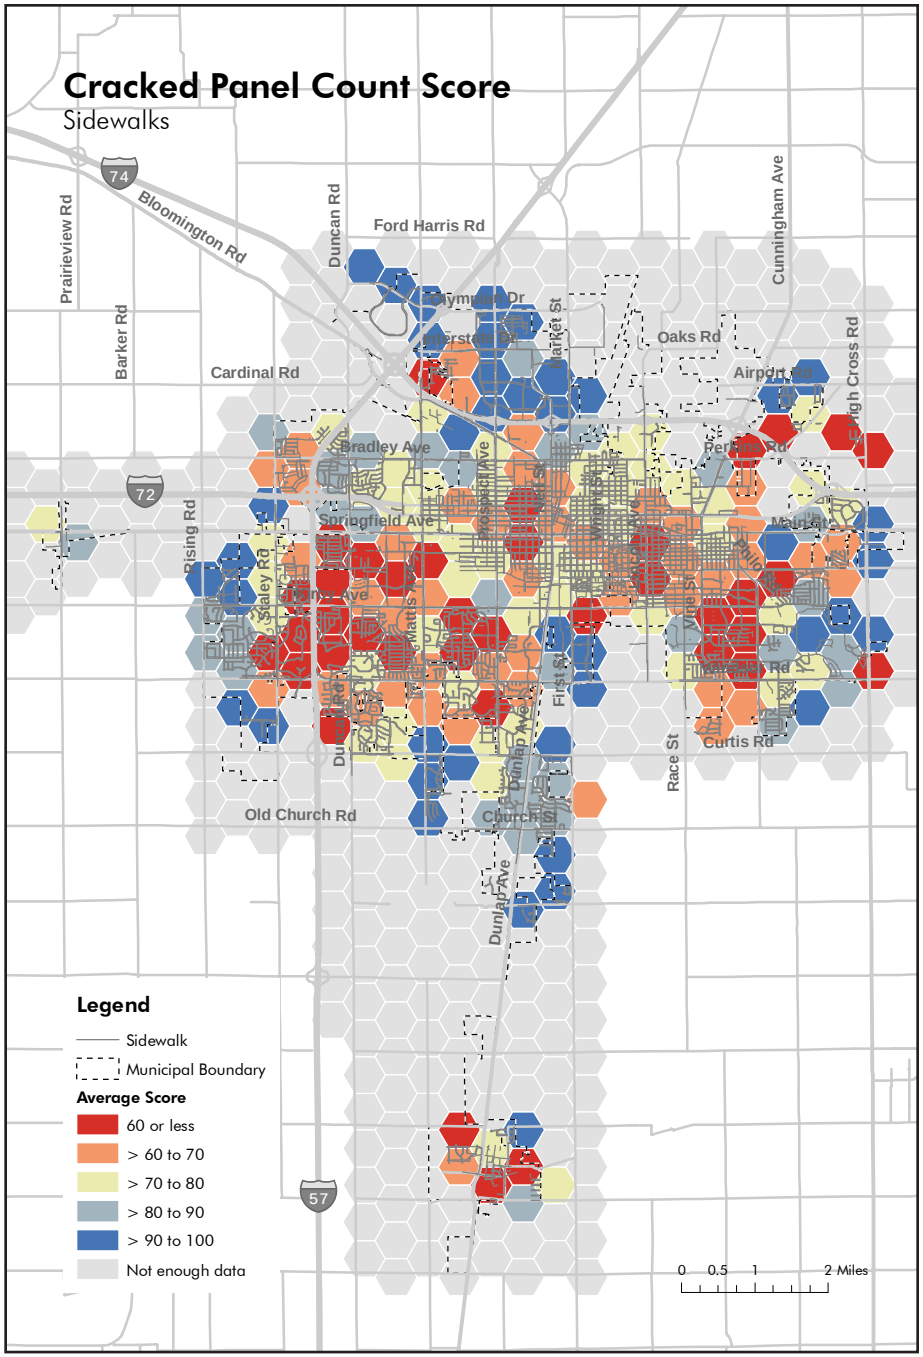
Figure 5-5 **Sidewalk Cracked Panels Scores**

Unlike vertical faults, cracked panels in sidewalks were most common in the suburban-style neighborhoods in central Champaign and Urbana, as well as in some of the older urban neighborhoods (see *Figure 5-5*). Sidewalks in the newest neighborhoods at the periphery of the urbanized area and in the commercial areas on the north side of the community had fewer cracked panels.

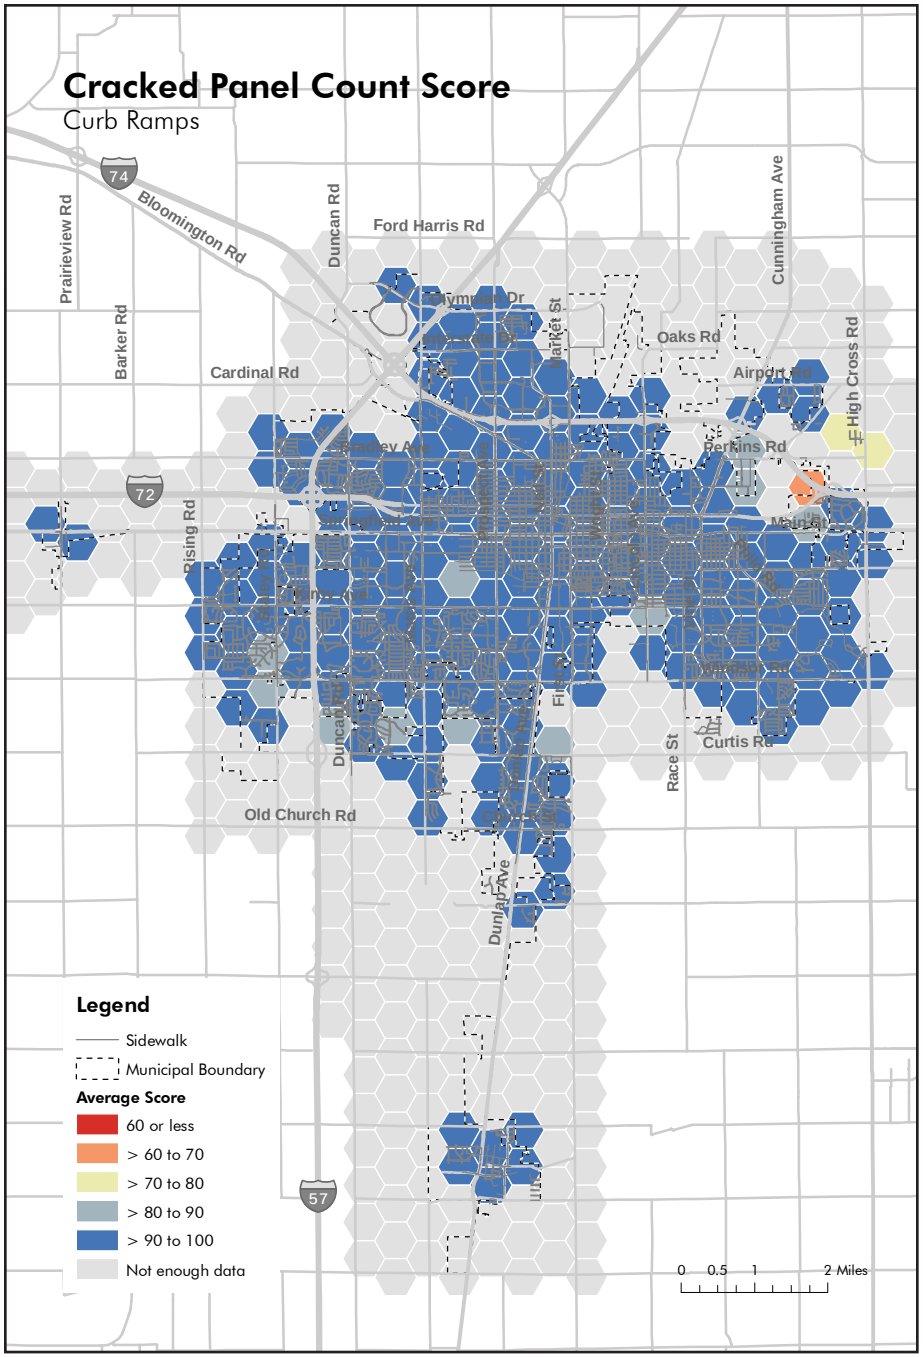
Figure 5-6 **Curb Ramp Cracked Panels Scores**

Because of the relative infrequency of cracked panels in curb ramps, no spatial patterns were evident in the curb ramp data (see *Figure 5-6*).

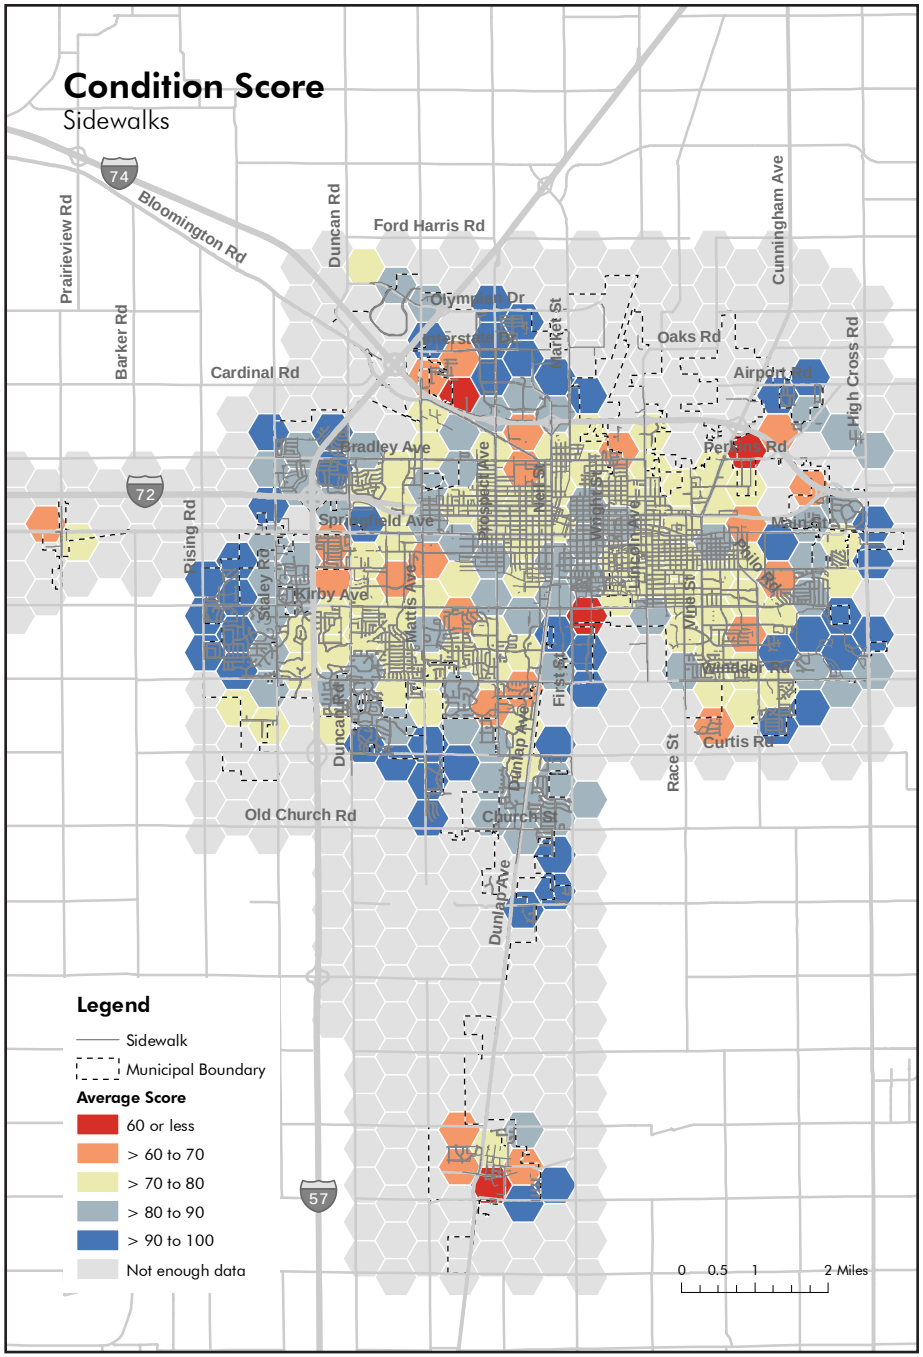
Figure 5-7 **Sidewalk Condition Scores**

The spatial pattern of sidewalk condition scores was similar to that of sidewalk compliance scores, suggesting that ADA compliant sidewalks tend to be newer and in better condition than noncompliant sidewalks (see *Figure 5-7*). As with compliance, condition scores were highest at the fringe of the urbanized area, followed by the core of the community.

The results of the condition analysis suggest that most sidewalk condition issues can be addressed in conjunction with compliance updates. For curb ramps, however, separate maintenance efforts may be necessary to address curb ramps that are nearly or fully compliant with PROWAG standards but that suffer from surface condition issues.

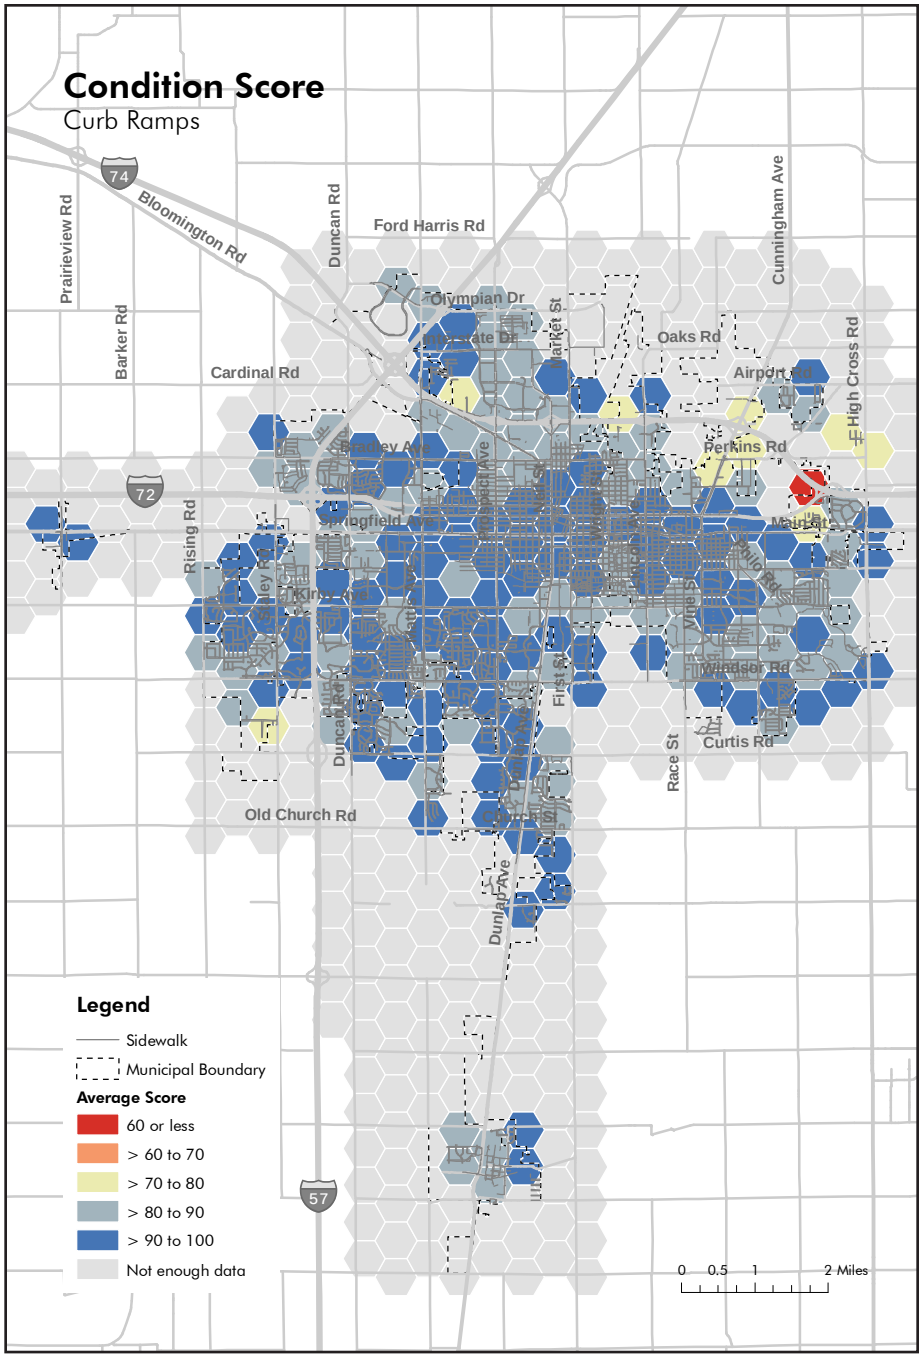
Figure 5-8 **Curb Ramp Condition Scores**

Curb ramp condition scores were more scattered with less of a recognizable spatial pattern (see *Figure 5-8*). Areas that scored poorly on sidewalk condition did not necessarily correspond to those with curb ramps in poor condition, suggesting that in some areas, the curb ramps were newer than the adjacent sidewalks. This pattern reflects the compliance mechanism in ADA, which requires curb ramp updates in conjunction with roadway modifications but does not require the replacement of adjacent sidewalks.

The lowest curb ramp condition scores occurred on the north side of the urbanized area, particularly near I-74. This corridor also had relatively low curb ramp compliance scores, though most of the lowest-scoring areas contained relatively few curb ramps.
