# At the Repair Bench – Victoreen Geiger Counter – August 2023

Of the units that were brought to me for repair, this article will discuss the Victoreen CD V-700 Model 6A Radiological Survey Meter. This unit is a two-transistor design that uses a geiger tube as the sensing element, and originally used a corona discharge regulator tube in the high voltage power supply, which operated at about 900 volts. The unit is powered by four standard "D" cells as found in most flashlights at that time. The geiger tube is mounted in a remote probe connected to the main unit via a thirty-six inch long cable. The probe is a nickel-plated brass tube with a window that can be opened to varying degrees to admit beta radiation. This unit will detect both beta and gamma radiation.

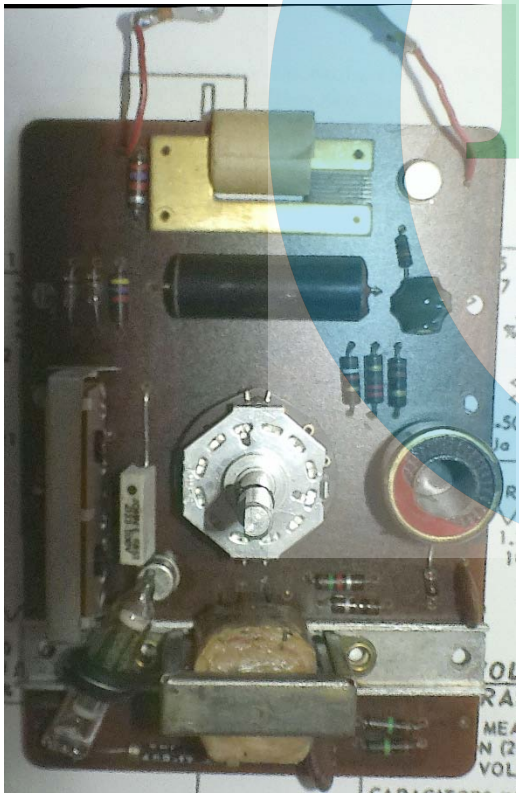
*Figure 1 - PCB before repair*

The most apparent problem with this unit was the fact that both transistors had failed, as had the corona discharge tube. I was able to source a kit that contained all of the necessary parts including a Zener diode stack on a small PCB that replaced the corona discharge tube and now serves as the 900V regulator.

While the ceramic capacitors in this unit had not failed, I replaced them with their counterparts from the kit, as the replacements were rated for considerably higher voltages, some of which were operating at voltages very near their rated limits. The sole electrolytic capacitor exhibited severe leakage, with an ESR off the high end of the scale on my ESR meter. It too was in the repair kit, and was thus easily replaced.

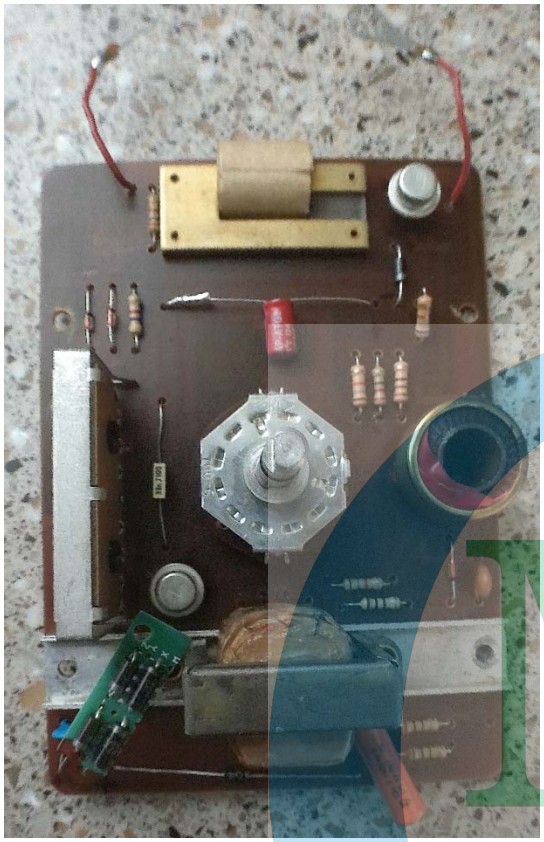
*Figure 2 - PCB after repair*

The range switch was severely oxidized and required extensive cleaning and restoration. This was a job for the DeoxIT® G100L (DeoxIT Gold) cleaner and lubricant. A quarter-hour with some cotton swabs and the DeoxIT® did the trick, and the switch was restored to a fully operational condition. This might be a good point for a word or two about the DeoxIT® products that I use. I regularly use the DeoxIT® D5 cleaner and lubricant, which I purchase in an aerosol can. This is my everyday go-to product for switch and pot cleaning and restoration. I also use the DeoxIT® X10S Precision Instrument Lubricant for lubrication of such things as meter movements, tuning capacitor bearings and bushings, control shaft bushings, and so forth. However, when a really bad switch or pot shows up, I reach for the DeoxIT® G100L. This product is *expensive* (about $50 for a 25ml bottle), and as a result I use it only when I really need to, but when it *is* needed, there is no substitute! Sales talk ended…
