Accurate Home Inspection

Property Inspection Report

Property address: **1212 Sample Ave
Coloma, MI 49038**

Inspection date: **Sunday, April 10, 2016**

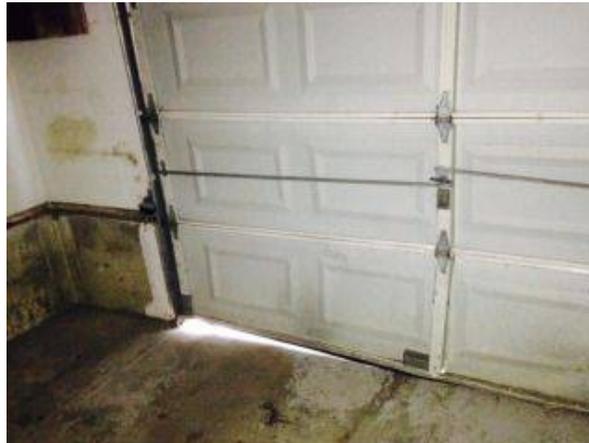
Photo 46-2

One or more garage vehicle doors were difficult or unable to open or close. Vehicle doors should open and close smoothly and easily. A qualified person should evaluate and repair as necessary. This may require lubrication or repair to hardware such as rollers or brackets.
