Sum, Sum Pro & Krypton Pro - Seatpost Saddle Top Clamp Replacement Program

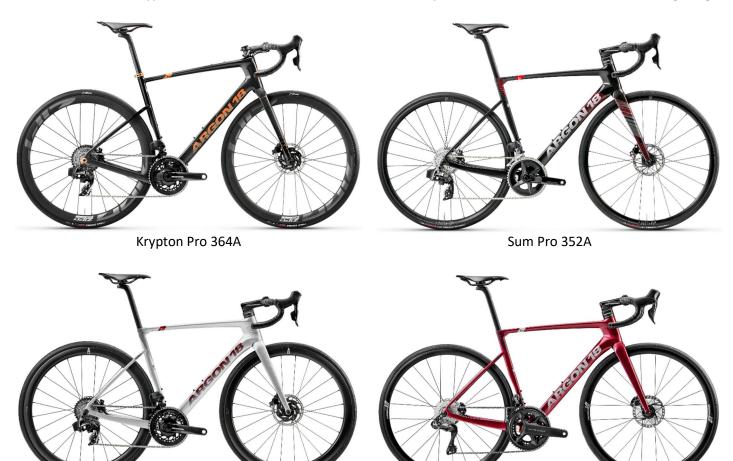
The Sum, Sum Pro & Krypton Pro 2020-2024 models can be identified by their artwork, as shown in the following images:

Sum 353A

Sum 353B
