FACILITY CONDITION ASSESSMENT

Farr Avenue Elementary School
933 Farr Avenue
Escondido, California 92025

164076.23R000-006.017

September 17, 2023

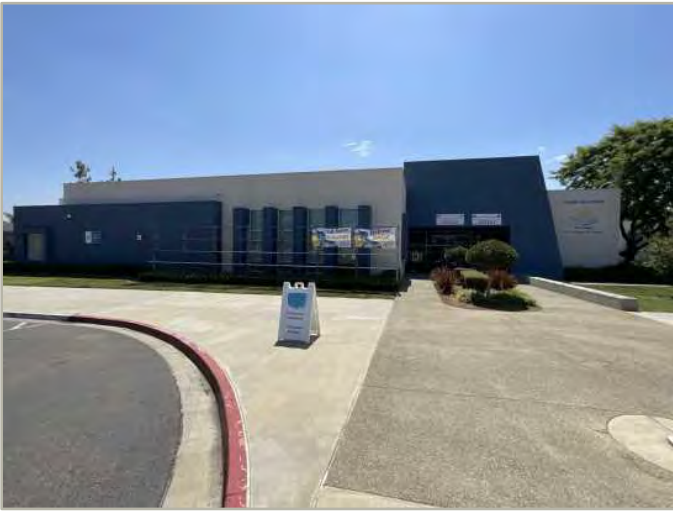
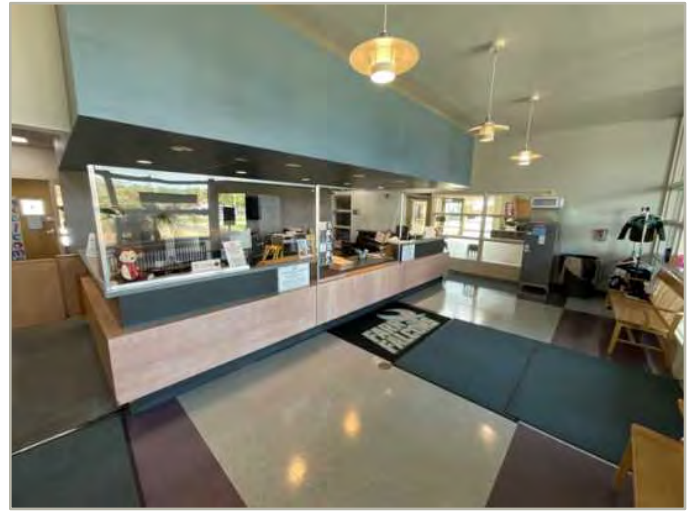
2. Administration Building

Electrical	Source & Distribution: Main panel with copper wiring Interior Lighting: LED Emergency Power: None	Fair
Fire Alarm	Alarm panel, smoke detectors, alarms, strobes, pull stations, back-up emergency lights, and exit signs	Fair
Equipment/Special	None	--
Accessibility	Presently it does not appear an accessibility study is needed for this building. See Appendix D.	
Key Issues and Findings	Package units in poor condition

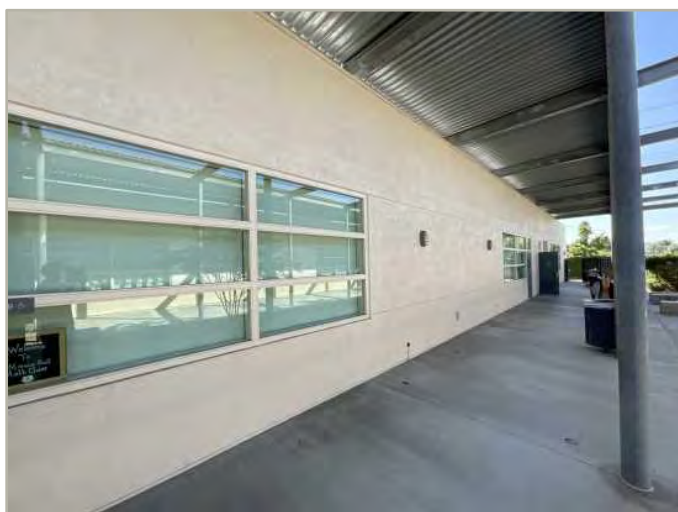
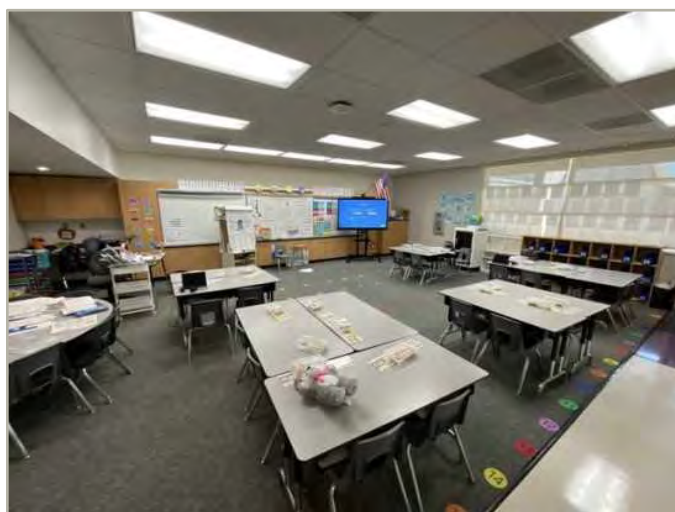
3. Classroom Building 1

Electrical	Source & Distribution: Main panel with copper wiring Interior Lighting: LED Emergency Power: None	Fair
Fire Alarm	Alarm panel, smoke detectors, alarms, strobes, pull stations, back-up emergency lights, and exit signs	Fair
Equipment/Special	None	--
Accessibility	Presently it does not appear an accessibility study is needed for this building. See Appendix D.	
Key Issues and Findings	Package units in poor condition

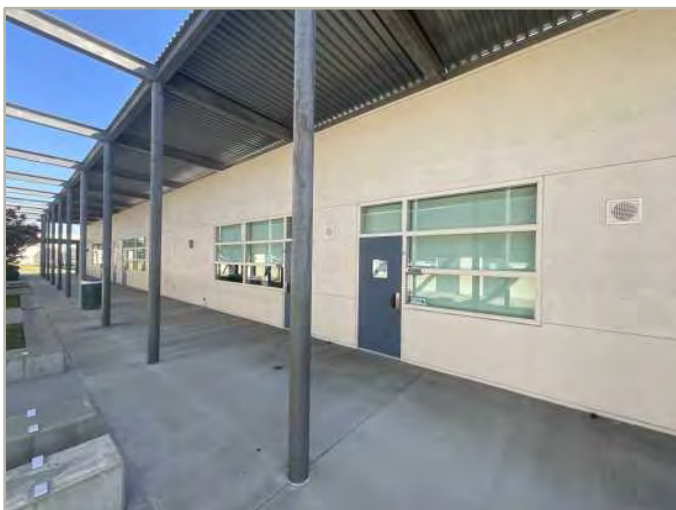
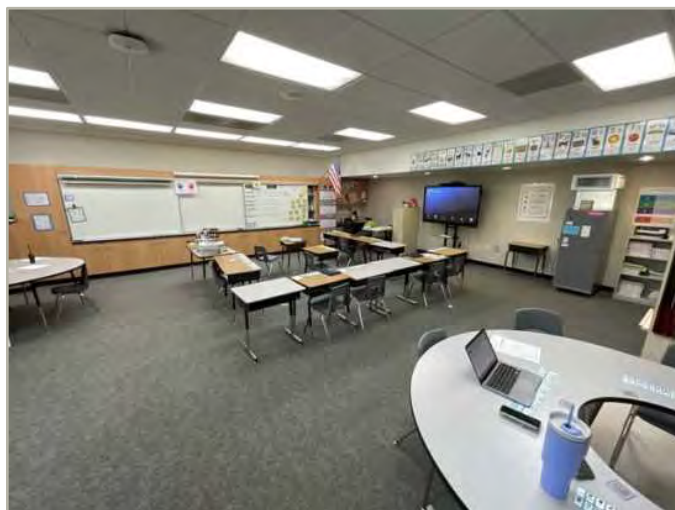
4. Classroom Building 2

Classroom Building 2: Systems Summary		
Electrical	Source & Distribution: Main panel with copper wiring Interior Lighting: LED Emergency Power: None	Fair
Fire Alarm	Alarm panel, smoke detectors, alarms, strobes, pull stations, back-up emergency lights, and exit signs	Fair
Equipment/Special	None	--
Accessibility	Presently it does not appear an accessibility study is needed for this building. See Appendix D.	
Key Issues and Findings	Package units in poor condition

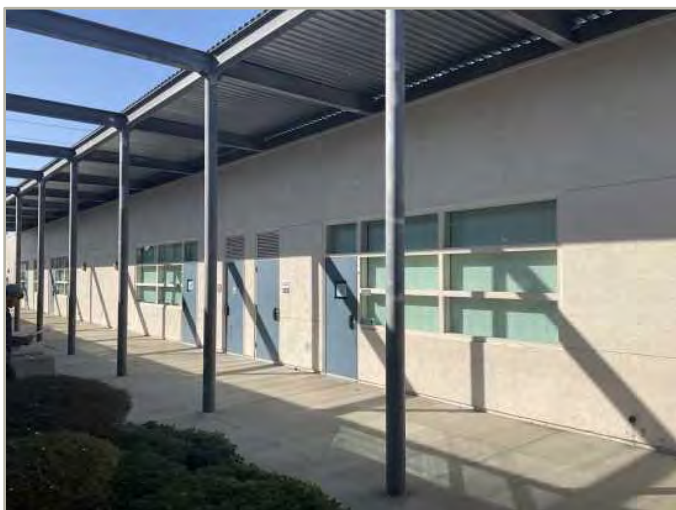
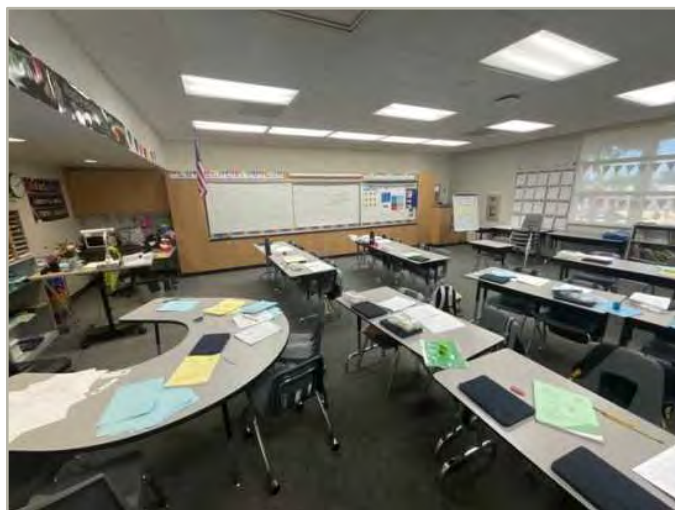
5. Classroom Building 3

Electrical	Source & Distribution: Main panel with copper wiring Interior Lighting: LED Emergency Power: None	Fair
Fire Alarm	Alarm panel, smoke detectors, alarms, strobes, pull stations, back-up emergency lights, and exit signs	Fair
Equipment/Special	None	--
Accessibility	Presently it does not appear an accessibility study is needed for this building. See Appendix D.	
Key Issues and Findings	Package units in poor condition

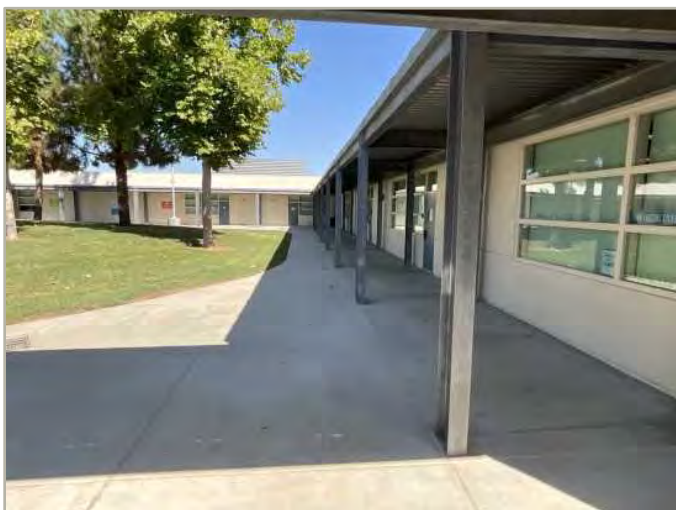
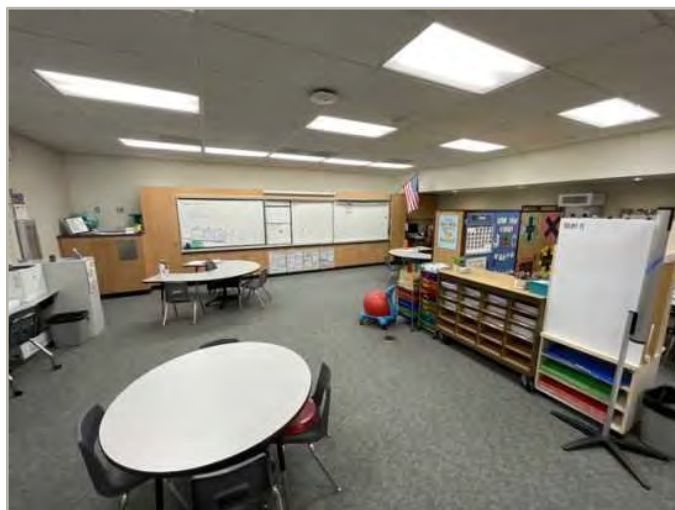
6. Kindergarten Building

Electrical	Source & Distribution: Main panel with copper wiring Interior Lighting: LED Emergency Power: None	Fair
Fire Alarm	Alarm panel, smoke detectors, alarms, strobes, pull stations, back-up emergency lights, and exit signs	Fair
Equipment/Special	None	--
Accessibility	Presently it does not appear an accessibility study is needed for this building. See Appendix D.	
Key Issues and Findings	Package units in poor condition

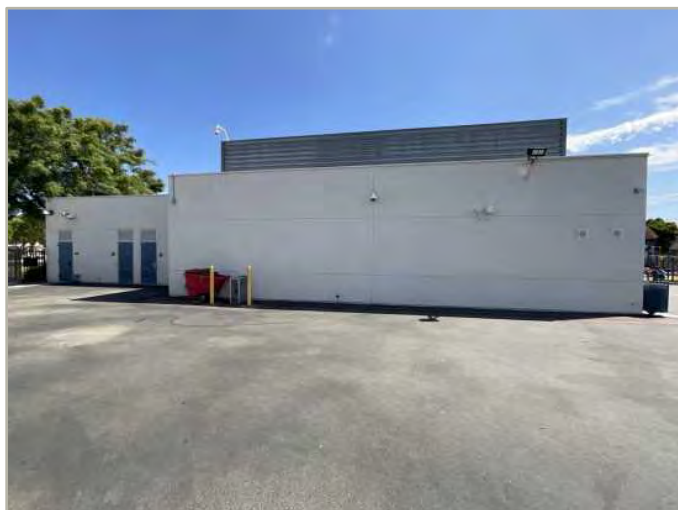
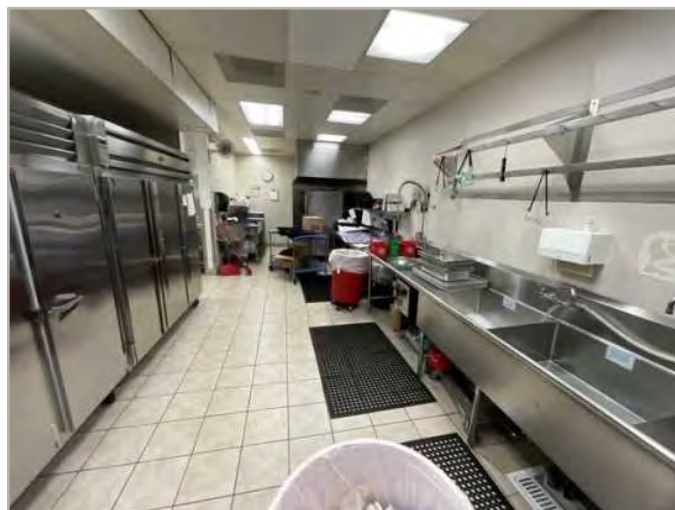
7. Kitchen Building

Electrical	Source & Distribution: Main panel with copper wiring Interior Lighting: LED Emergency Power: None	Fair
Fire Alarm	Alarm panel, smoke detectors, alarms, strobes, pull stations, back-up emergency lights, and exit signs	Fair
Equipment/Special	Commercial kitchen equipment	Fair
Accessibility	Presently it does not appear an accessibility study is needed for this building. See Appendix D.	
Key Issues and Findings	Package units in poor condition

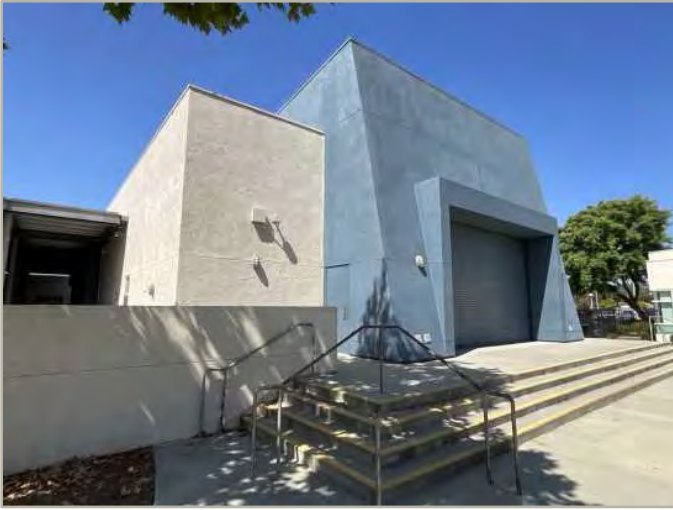
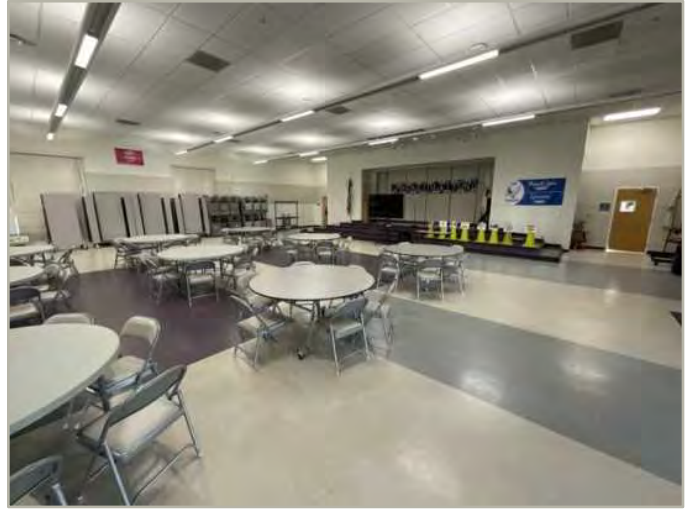
8. Multi-Purpose Building

Electrical	Source & Distribution: Main panel with copper wiring Interior Lighting: LED Emergency Power: None	Fair
Fire Alarm	Alarm panel, smoke detectors, alarms, strobes, pull stations, back-up emergency lights, and exit signs	Fair
Equipment/Special	None	--
Accessibility	Presently it does not appear an accessibility study is needed for this building. See Appendix D.	
Key Issues and Findings	Package units in poor condition

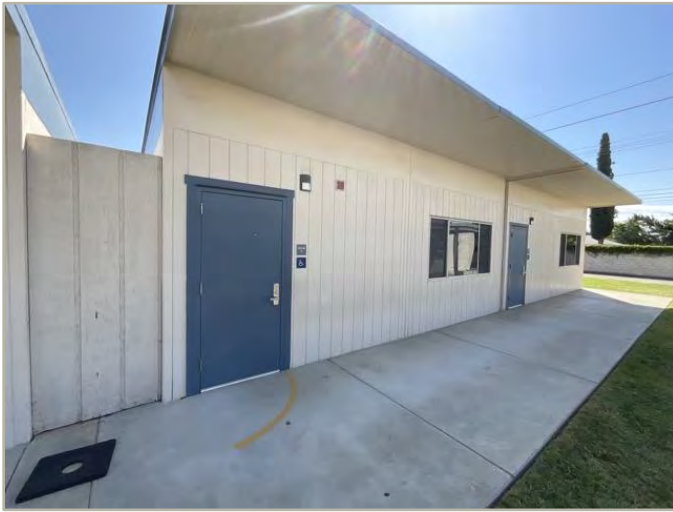
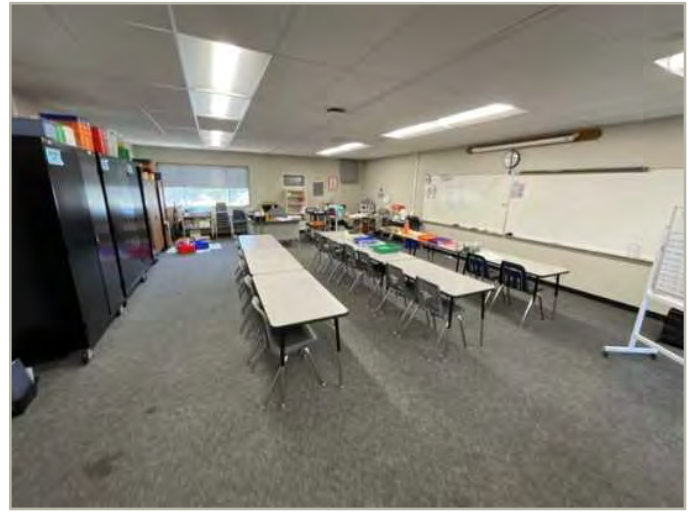
9. Relocatable Buildings

Electrical	Source & Distribution: Main panel with copper wiring Interior Lighting: LED Emergency Power: None	Fair
Fire Alarm	Alarm panel, smoke detectors, alarms, strobes, pull stations, back-up emergency lights, and exit signs	Fair
Equipment/Special	None	--
Accessibility	Presently it does not appear an accessibility study is needed for this building. See Appendix D.	
Key Issues and Findings	Package units in poor condition

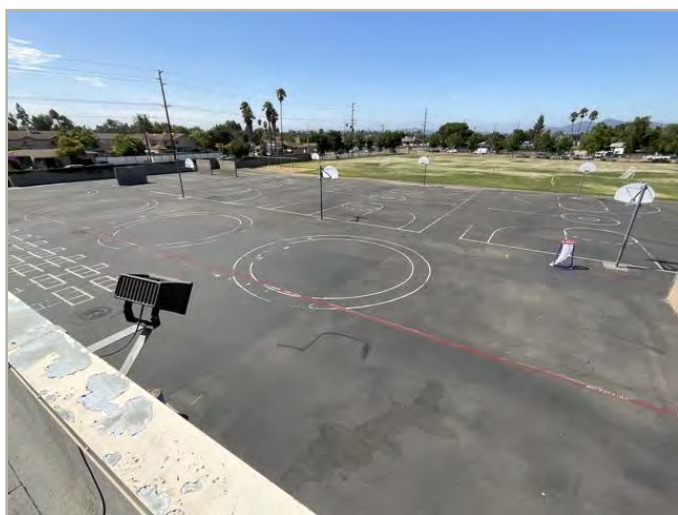
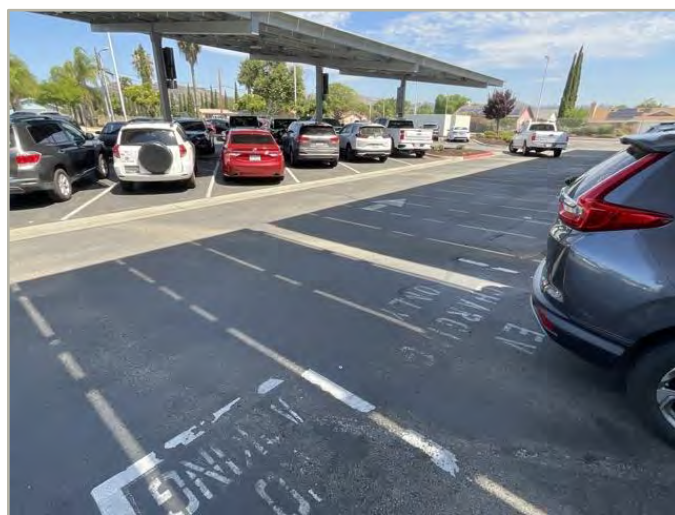
10. Site Summary

<i>System</i>	<i>Description</i>	<i>Condition</i>
Pavement/Flatwork	Asphalt lots with limited areas of concrete aprons and pavement and adjacent concrete sidewalks, curbs, ramps, and stairs	Fair
Site Development	Building-mounted and Property entrance signage; chain link and wrought iron fencing Sports fields and basketball court with fencing, and site lights Furnished with park benches, picnic tables, trash receptacles	Fair
Landscaping and Topography	Moderate landscaping features including lawns, trees, bushes, and planters Irrigation present Low to moderate site slopes throughout	Fair
Utilities	Municipal water and sewer Local utility-provided electric and natural gas	Fair
Site Lighting	Pole-mounted: LED Building-mounted: CFL	Fair
Ancillary Structures	Storage shed	Fair
Accessibility	Presently it does not appear an accessibility study is needed for the exterior site areas. See Appendix D.	
Key Issues and Findings	Poor site drainage
