FACILITY CONDITION ASSESSMENT

Rincon Middle School
925 Lehner Avenue
Escondido, California 92025

164076.23R000-021.017

August 22, 2023

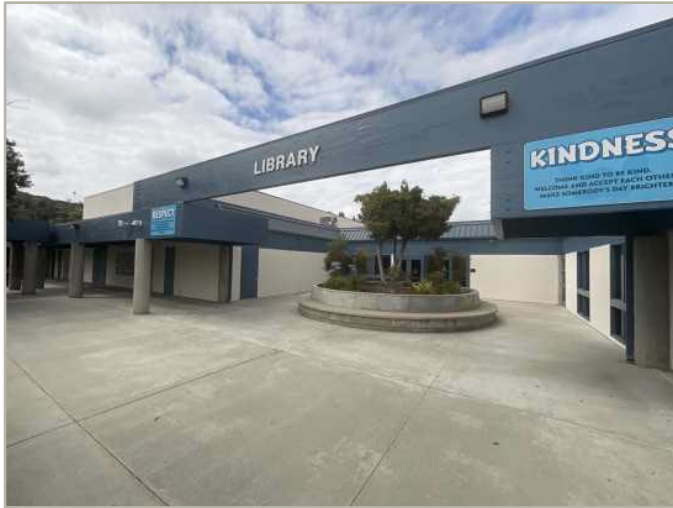
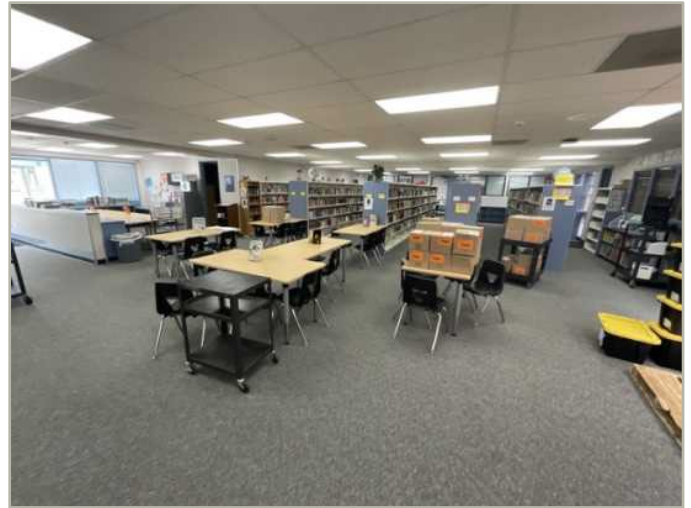
2. Building A: Library/Food Service

Fire Alarm	Central alarm panel for campus, smoke detectors, alarms, strobes, pull stations, back-up emergency lights, and exit signs	Fair
Equipment/Special	Commercial kitchen equipment	--
Accessibility	Presently it does not appear an accessibility study is needed for this building. See Appendix D.	
Key Issues and Findings	Aged roofing

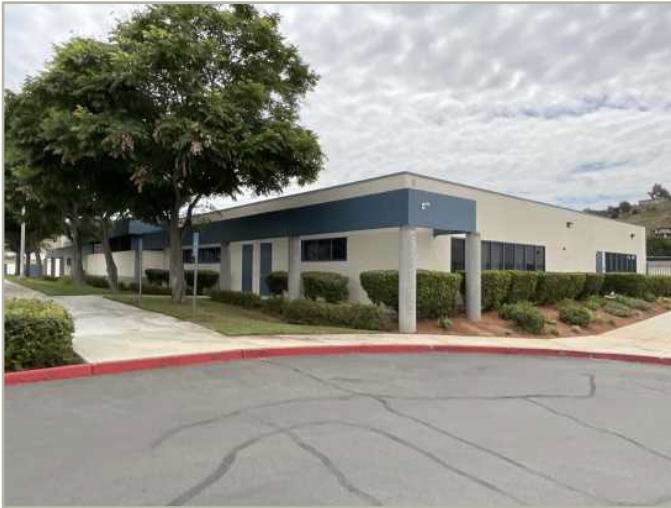
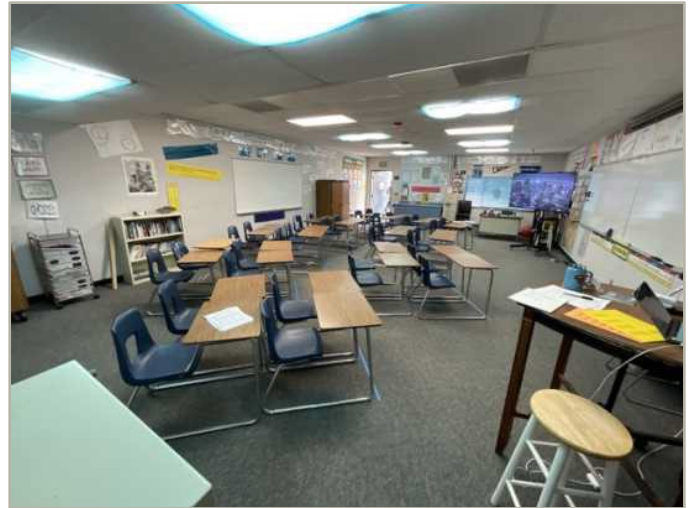
6. Building H-J-K-L-N - Classrooms

Electrical	Source & Distribution: Main switchboard with copper wiring Interior Lighting: LED Emergency Power: None	Fair
Fire Alarm	Smoke detectors, alarms, strobes, back-up emergency lights	Fair
Equipment/Special	None	--
Accessibility	Presently it does not appear an accessibility study is needed for this building. See Appendix D.	
Key Issues and Findings	Modified bituminous roofing is deteriorated, with numerous patches. Single ply roofing has ponding, aging and is developing leaks.

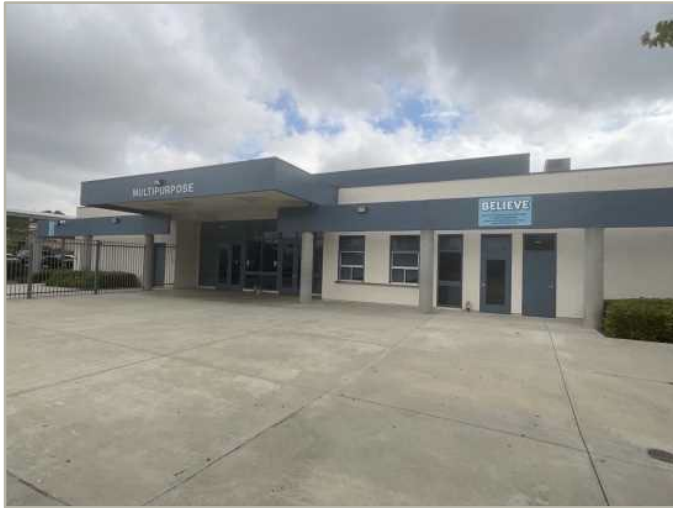
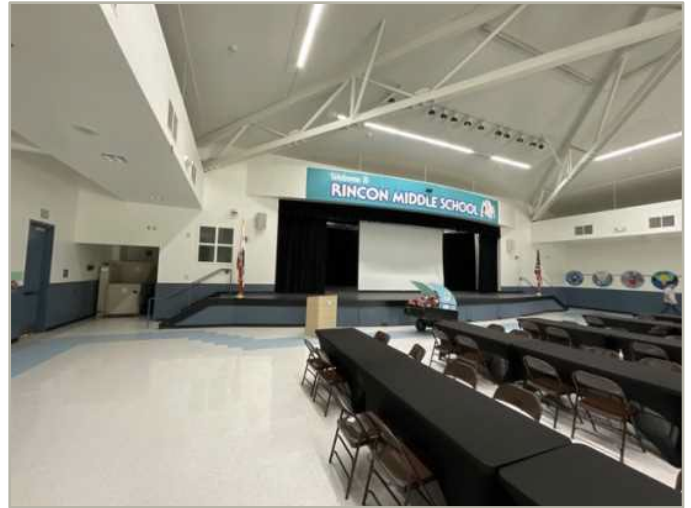
7. Building M - Multipurpose

Electrical	Source & Distribution: Main panel with copper wiring Interior Lighting: LED Emergency Power: None	Fair
Fire Alarm	Smoke detectors, alarms, strobes, back-up emergency lights	Fair
Equipment/Special	None	--
Accessibility	Presently it does not appear an accessibility study is needed for this building. See Appendix D.	
Key Issues and Findings	Aged roofing

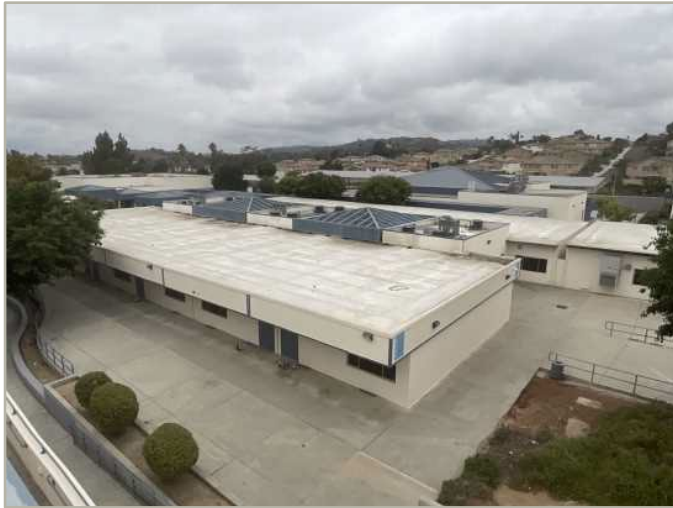
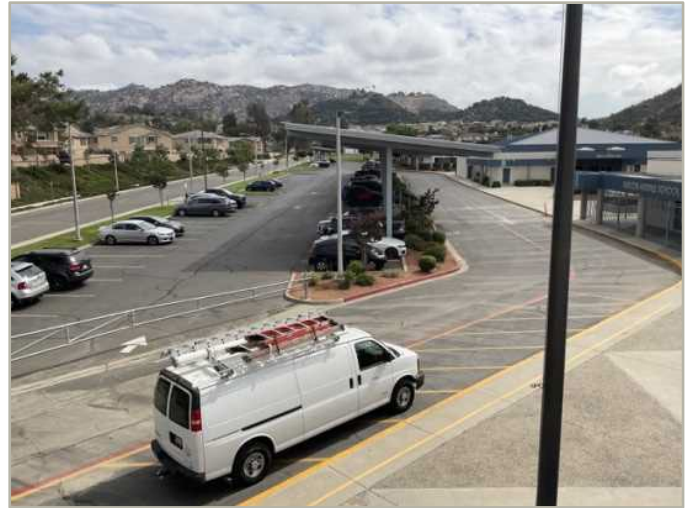
11. Site Summary

System	Description	Condition
Pavement/Flatwork	Asphalt lots with limited areas of concrete aprons and pavement and adjacent concrete sidewalks, curbs, ramps, and stairs	Fair
Site Development	Property identification signage, chain link and steel tube fencing Play fields and play courts	Fair
Landscaping and Topography	Moderate landscaping features Irrigation present Concrete retaining walls Low to moderate site slopes throughout	Good
Utilities	Municipal water and sewer Local utility-provided electric and natural gas	Fair
Site Lighting	Pole-mounted: LED Building-mounted: LED	Good
Ancillary Structures	Pre-fabricated metal storage building	Fair
Accessibility	Presently it does not appear an accessibility study is needed for the exterior site areas. See Appendix D.	
Key Issues and Findings	Widespread alligator cracking in main parking lot
