# FACILITY CONDITION ASSESSMENT

## **DLR Group**

Rock Springs Elementary School  
1155 Deodar Road  
Escondido, California 92025

September 12, 2023

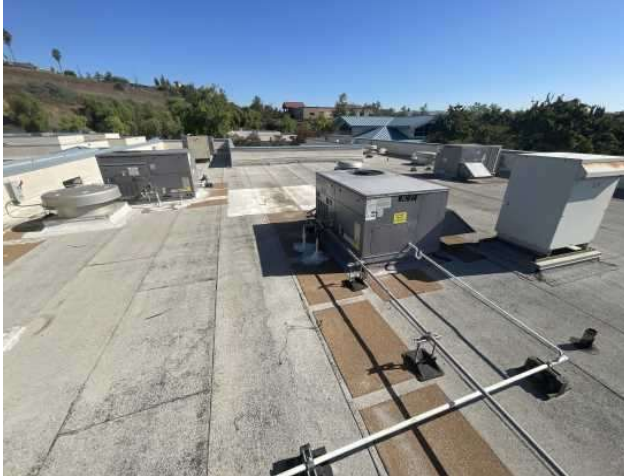
7 - ROOFING

Roof leaks throughout, custodian reported the roof is set to be replaced in the near future - AssetCALC ID: 6951023

Uniformat Code: B3010  
Recommendation: **Replace in 2024**

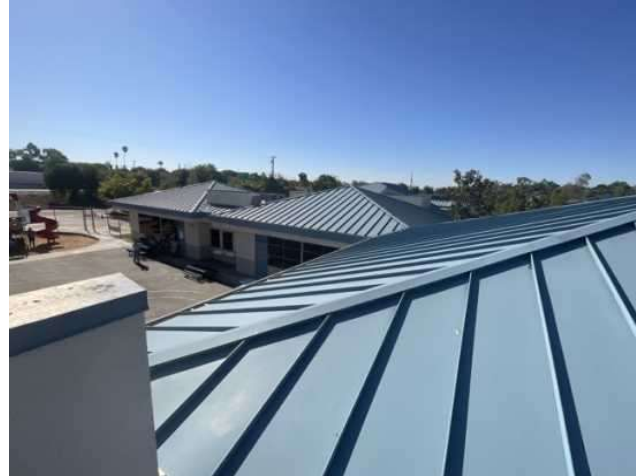
8 - ROOFING

Roof leaks throughout, custodian reported the roof is set to be replaced in the near future - AssetCALC ID: 6950989

Uniformat Code: B3010  
Recommendation: **Replace in 2024**

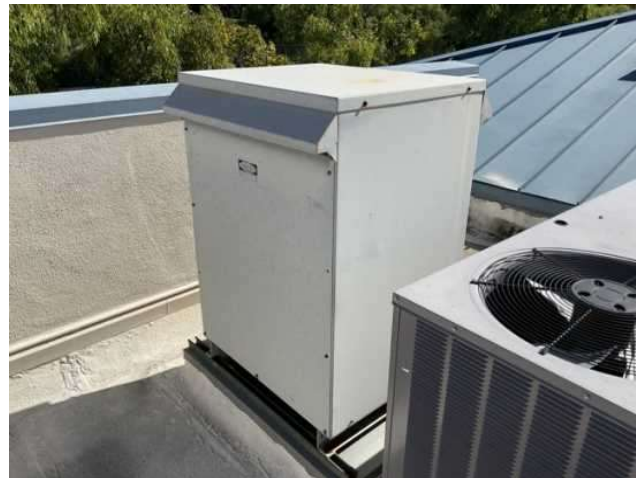
22 - SECONDARY TRANSFORMER

**Secondary Transformer in Poor condition.**

Unit is rusting, deteriorating, and has reached end of life - AssetCALC ID: 6950939

Uniformat Code: D5020  
Recommendation: **Replace in 2024**
