# FACILITY CONDITION ASSESSMENT

**Fallbrook Union Elementary School District**  
321 North Iowa Street  
Fallbrook, California 92028

Fallbrook STEM Academy  
405 West Fallbrook Street  
Fallbrook, California 92028

*February 4, 2023*

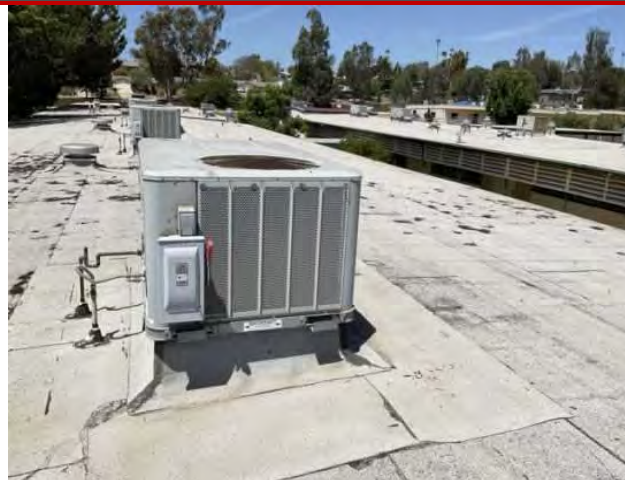
14 – ROOFTOP PACAKAGED UNITS

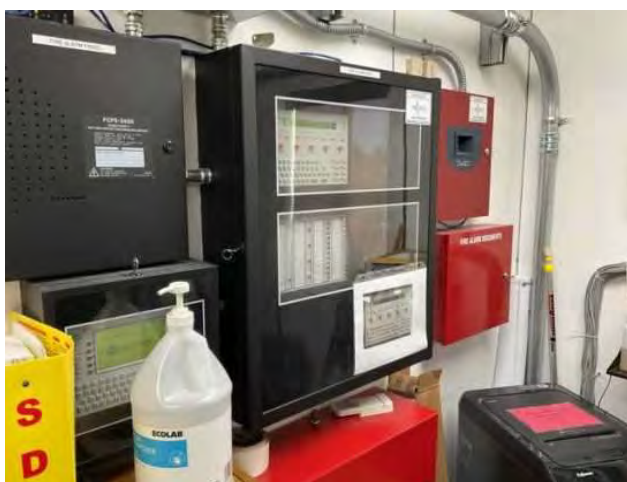
17 - FIRE ALARM PANEL

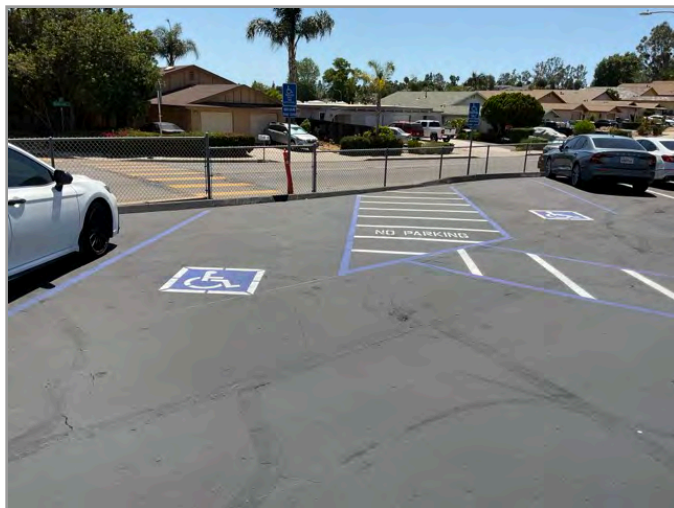
OVERVIEW OF ACCESSIBLE PARKING AREA

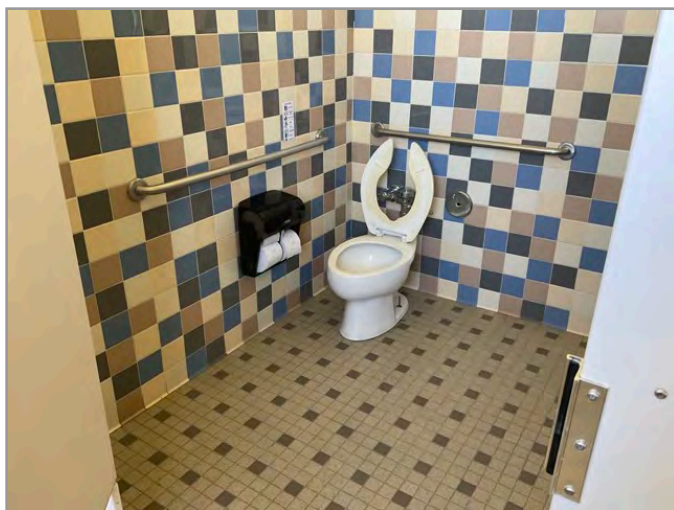
TOILET STALL OVERVIEW
