FACILITY CONDITION ASSESSMENT

Sonora High School
401 South Palm Street
La Habra, California 90631

162347.23R000-005.017

August 21, 2023

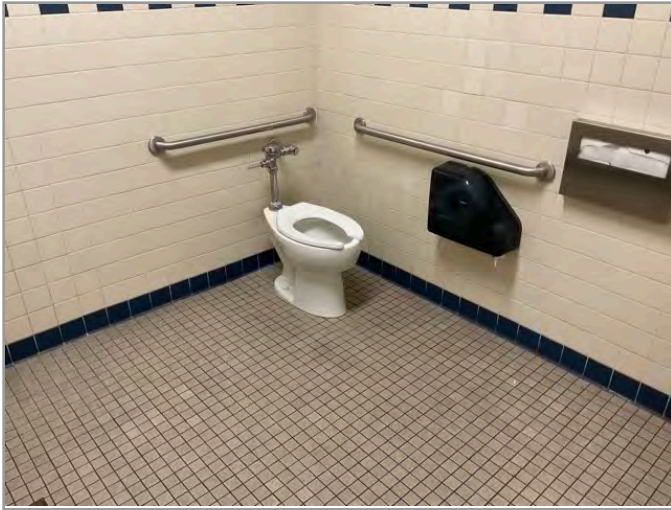
TOILET STALL OVERVIEW

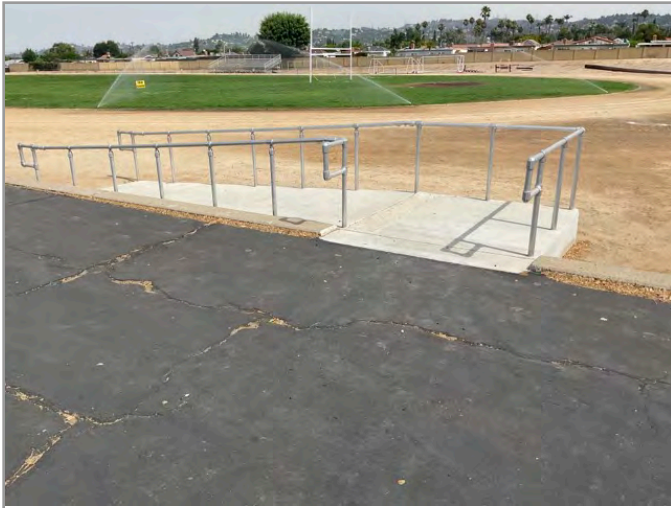
ACCESSIBLE ROUTE TO PLAYGROUND
