INTERIM REVIEW

LEAK OF RADIOACTIVE LIQUOR IN THE FEED CLARIFICATION CELL AT BNG THORP SELLAFIELD

REVIEW OF THE MANAGEMENT AND TECHNICAL ASPECTS OF THE FAILURE AND ITS IMPLICATIONS FOR THE FUTURE OF THORP

REPORT REF N° R3123-A2

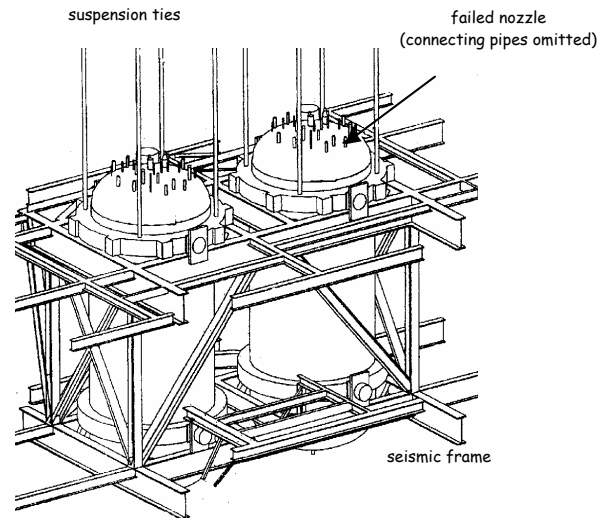
CELL 220 ACCOUNTANCY A & B TANKS

Both accountancy tanks, each approximately 2.5m diameter by 4.5m length, are cradled in a seismic protection frame, although each tank is suspended free of this frame on four relatively slender stainless steel tie rods that pass through the ceiling of the cell to a weighing device. The normal operational state of the tanks is in the suspended mode with the tanks being lowered onto the frame for a short period whilst the weighing system is calibrated, usually twice yearly.

The failure of the feed nozzle is in the form of a complete guillotine break of the 40mm diameter feed pipe just above the pipe to tank welded joint, with the disconnected pipe remaining slightly misaligned above the stub of the pipe. Because of this alignment, the gravity flow of the clarified feed liquor continued to run into the tank, with some of the flow splashing out and running down the tank side, spilling onto sections of the supporting steel frame.

Over the period of the leak, perhaps for about 9 months, the carbon steel frame sustained significant corrosion, with the spilling nitric acid etching into and completely eroding through the higher and lower south sections of the frame, including the 600mm wide web of the main I-beam at the lower level.
