Watercourse Assessment Report

Mangakōtukutuku Catchment

Final V4

Prepared for Hamilton City Council by Morphum Environmental Ltd

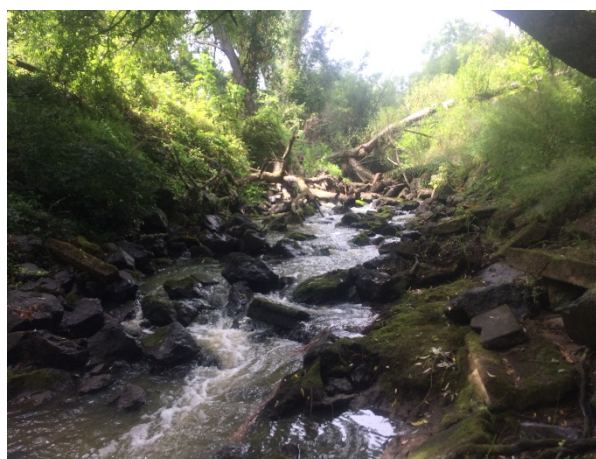
The lower channel (MGK_Main_1 to 2) has a 7 m wide wetted width and predominantly soft bottomed with varying bank height. The upper true right bank is typically steep dominated by mature pines and exotic vegetation whilst a large floodplain extends from the true left bank with mowed grass and a public walkway. The most significant native vegetation observed included a stand of kahikatea and mahoe seedlings on the left bank likely to be approximately 10 years old. Two erosion hotspots were located on the outside of meanders (both approximately 30 m²) with high sediment deposition in the lower reaches (Figure 7). There is a channel modification structure at MGK_Main_2 which is providing grade control and dissipation (Figure 8).

Figure 8: Channel/bed modification structure at MGK_Main_2.

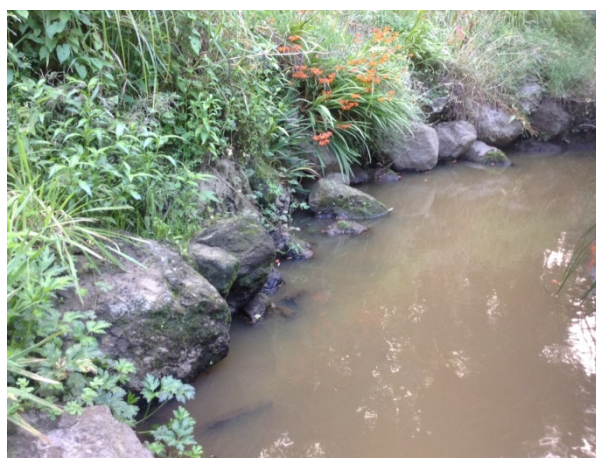
Upstream of the culvert at Peacockes Road, the channel (MGK_Main_3 to 5) is fairly uniform with an average channel width of 1 m and 1 m high banks. There is native regeneration planting along the banks (Figure 9.). There are isolated sections of channel modification along MGK_Main_5 which include stacked concrete sacks and placed rocks as bank lining (Figure 10).

Figure 10: Toe protection at MGK_Main_5.

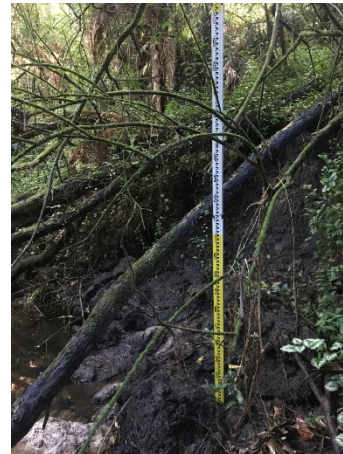
The lower reaches of the central sub-catchment extend to the State Highway 3 culvert. The channel ranges in width between 0.8 m and 3 m defined by steep upper banks and good riparian extent (Figure 11). Several large erosion hotspots (approximately 20 m²) were identified along the true left bank of MGK_C_Main_2 (Figure 12) downstream of Splitt Ave (refer to section 4.4 for more information). Upstream of Splitt Ave there is a considerable planting restoration project around the watercourse and on nearby land likely undertaken by active local residents (Figure 13).

Figure 12: Erosion hotspot along MGK_C_Main_2.

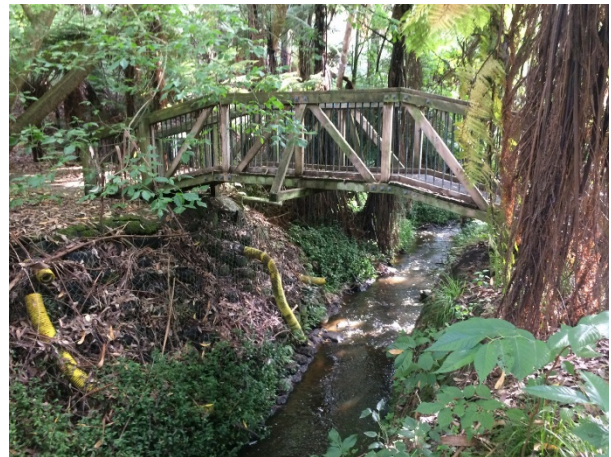
Further upstream in Te Anau Park, there are several seepage wetlands along the floodplains and upper banks (Figure 15). Most of the vegetation is native dominated by tree ferns through the understorey. There are also several bank lining assets along the watercourse in Te Anau Park which consist of stacked tyres or concrete sacks (Figure 16).

Figure 16: Bank lining along MGK_C_Main_4.

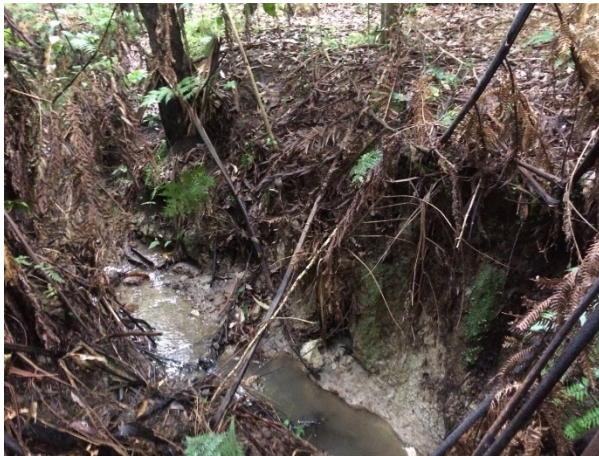
There is a small tributary, (MGK_W_Trib4) downstream of the Pelorus Street culvert, which has a deeply incised 100 m section with good overhead cover and sparse bank vegetation providing excellent potential fish habitat (Figure 17). The tributary receives stormwater discharge from a developed area and provides an example of how increases in flow volume and discharge can affect channel stability, in particular where the channel material has poor shear strength. The observed erosion is likely to be ongoing.

Figure 17: Incised and unstable tributary MGK_C_Trib4_1.

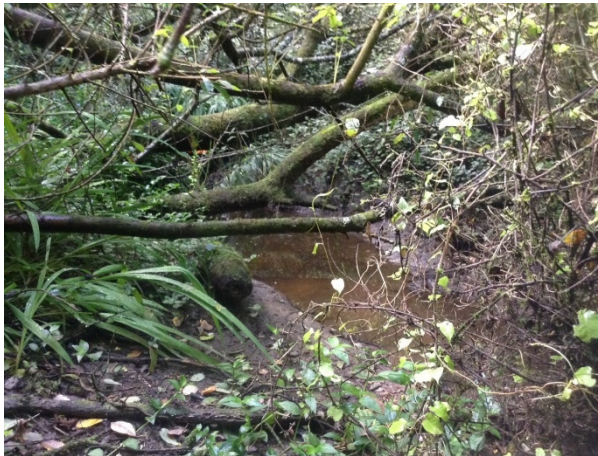
Figure 20: Sediment deposition within channel on MGK_C_Trib1_1.

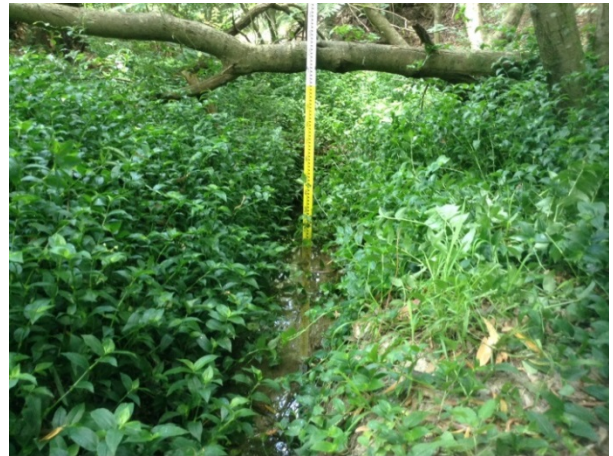
Figure 21: Extensive tradescantia cover along MGK_C_Trib1_3.

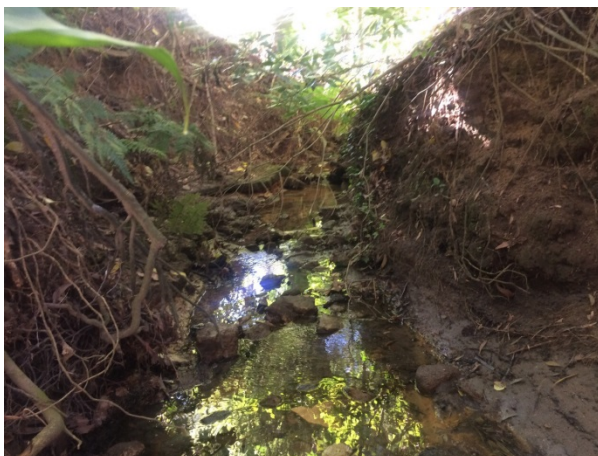
The average channel wetted width is 0.6 m and the average depth is 0.2 m with high upper banks (20 m in the lower reaches and 5 m in the upper reach). There is good riparian extent, diversity, and overhead cover which improves overall bank stability, however, several small active landslips (that did not meet the criteria for erosion hotspots due to small size) were observed which may be caused or exacerbated by seepage and springs located on the mid to upper banks (Figure 18). Near the landslips and along the gully floor there is active sediment deposition (Figure 20), being mainly fine sands and silts. Further upstream the reach is a meandering channel through a low-lying floodplain with extensive cover of tradescantia (Figure 21) which has established on the fine sediments deposits observed throughout. Downstream of the outlet at Waterford Road, there is significant down cutting of the channel which is discussed further in section 4.4.1 (Figure 22).

Figure 22: Active down-cutting and bank slumping of channel along MGK_C_TRIB1_4.

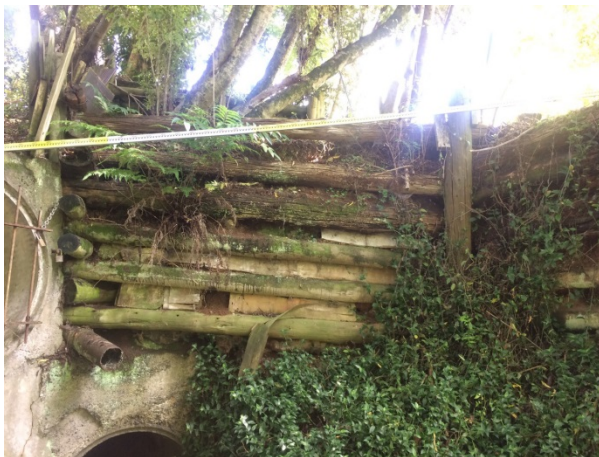
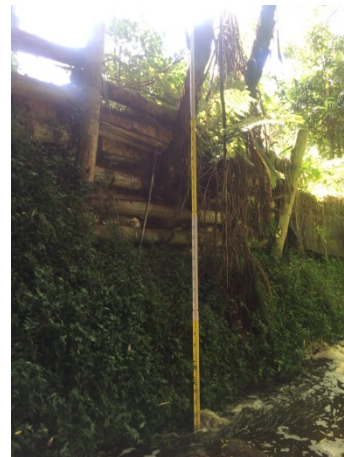
Downstream of the outlet under the State Highway (MGK_C_Fork1_1), there is a triple culvert with timber lining (above the culvert wingwall) on the upper true left bank (Figure 23 and Figure 24). The bank lining has vegetation growing and rubbish present between the timber planks. The structural integrity of the lining is compromised and the top end is leaning towards the watercourse. The lining is assessed to have a high likelihood of collapsing and maintenance or further assessment is required to remedy this.

Figure 23: Bank lining above culvert at MGK_C_Fork1_1.

Figure 24: Bank lining above culvert at MGK_C_Fork1_1.

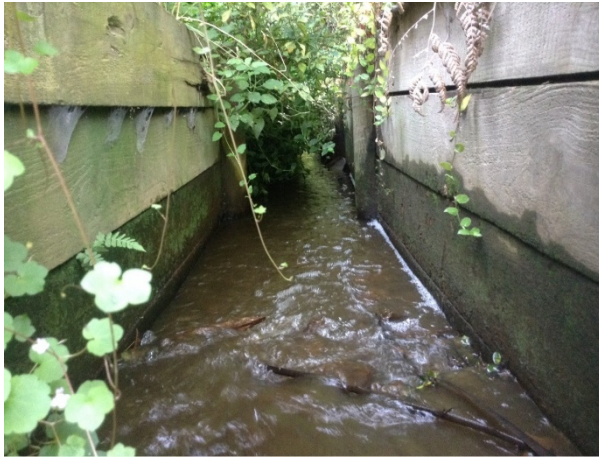
Upstream of the inlet to the State highway, there is a 40 m section of timber bank lining (1 m height) on both banks (see Figure 25) along MGK_C_Fork1_1. This lining is likely to restrict flows given the large upstream catchment and there is risk to neighboring properties. Further upstream (a timber bank lining structure has recently been erected on the true left bank approximately 3 m in height (Figure 26).

**Figure 25: Bank lining extending 40 m at
MGK_C_Fork1_2.**

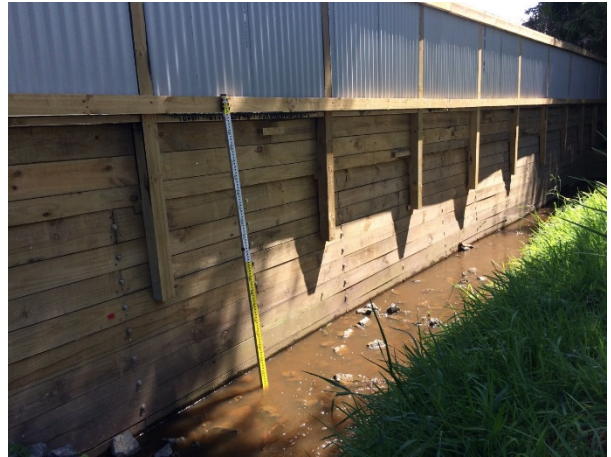
**Figure 26: Timber bank lining along property at
MGK_C_Fork1_2.**

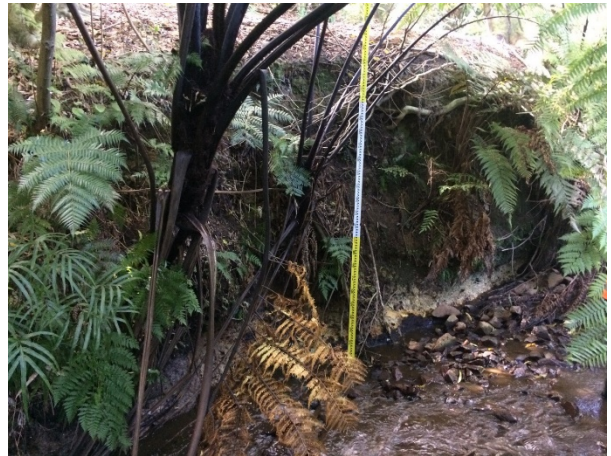
The watercourse extending towards John Webb Drive is a meandering stream with average bank height 1.5 m and dense tradescantia cover (Figure 27). There are areas of scour and erosion with the most significant area identified as an erosion hotspot just downstream of the John Webb Drive outlet (Figure 28).

Figure 28: Erosion hotspot on MGK_C_Fork1_2.

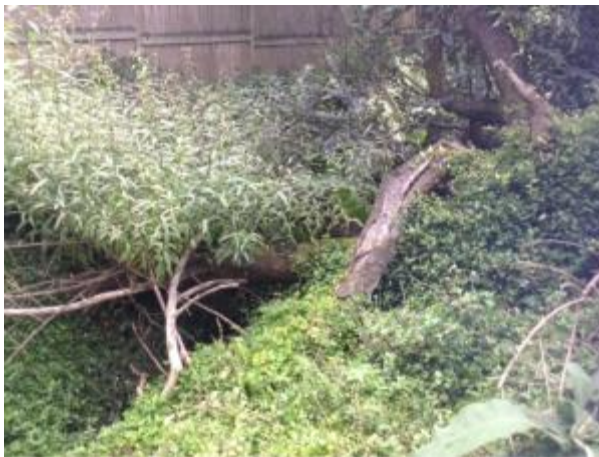
Figure 30: Willow fallen across incised stream at MGK_C_Fork2_1.

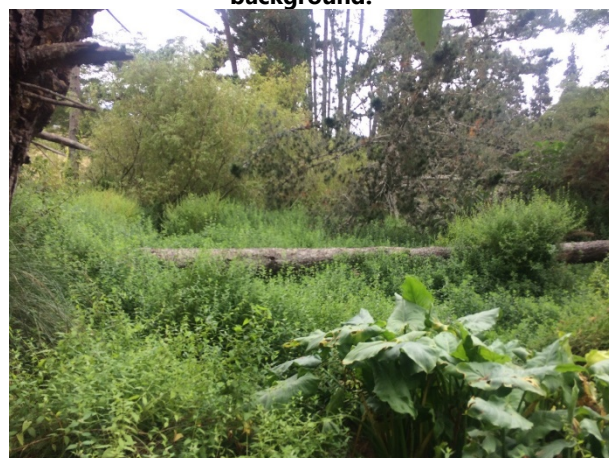
Further upstream along MGK_C_Fork2_4, the channel meanders through a floodplain. There is good riparian cover from pine canopy with weed infestations of blackberry, woolly nightshade and arum lily (Figure 33) in the understorey. The headwaters of the reach are two farm ponds, identified as Alderton A and B which were not assessed as part of this survey.

Figure 33: Floodplain and weedy infestations along MGK_C_Fork2_4.

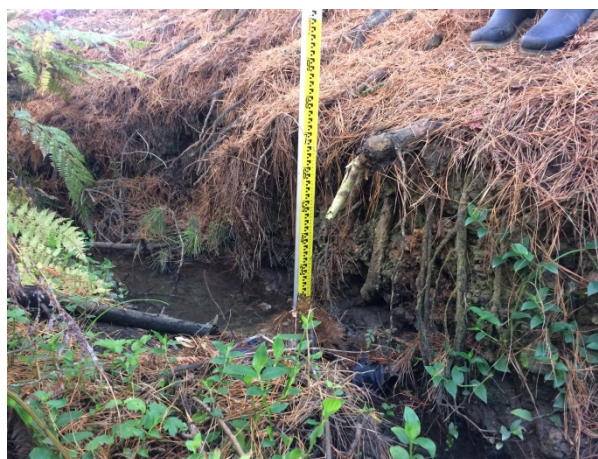
Further upstream, the watercourse diverges into two reaches. The reach to the right of the confluence (looking upstream), continues as an incised channel with steep gully banks (Figure 37 and Figure 38). The headwaters received piped discharge from the surrounding residential area and there is a small wetland area immediate downstream of the piped network outlet. The reach downstream of the wetland is likely to be ephemeral (Figure 39).

**Figure 38: Incised channel on
MGK_W_Trib1_Fork1_2.**

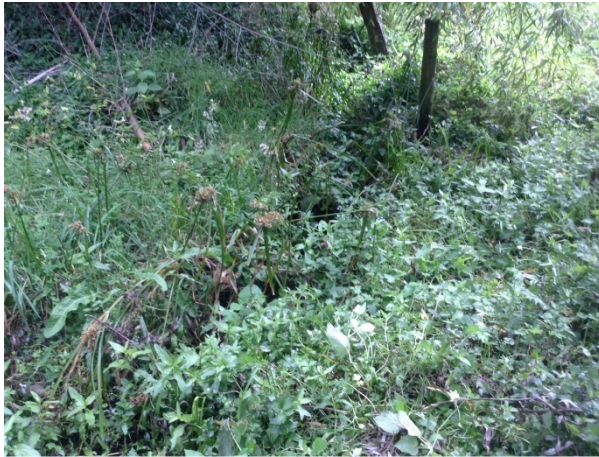
The reach to the left of the confluence also received piped discharge from the stormwater network. The reach is infested with weeds including tradescantia and blackberry (Figure 40 and Figure 41).

Figure 41: Channel and floodplain on MGK_W_Trib1_Fork2.

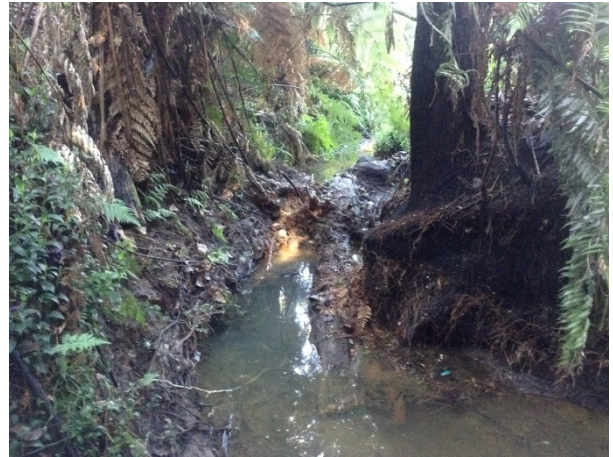
There are several tributaries located in the lower reaches of the western sub-catchment downstream of MGK_W_Main_4. The lower reaches of the first tributary (MGK_W_Trib1_1) are defined as a narrow-incised channel with high sediment deposition and high erosion scarring (Figure 42).

Figure 42: MGK_W_Trib1_1.

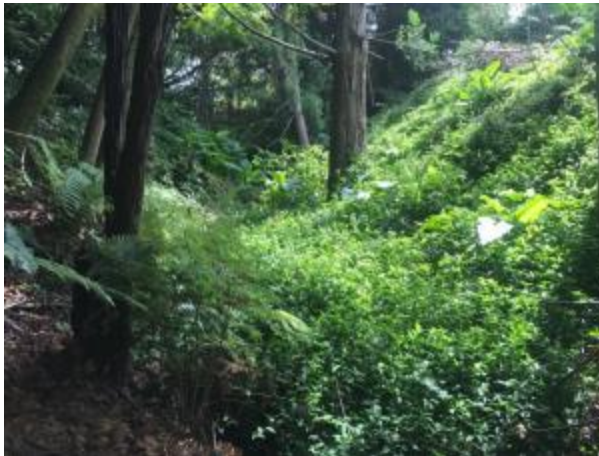
Tradescantia dominates the second tributary covering the entire extent along the upper banks (which are >15 m high) (Figure 43). There is significant bank scarring (40-60% on both banks) along the reach particularly in locations where the channel is highly incised. The tributary receives piped discharge from the stormwater network on either side of Ansford Place.

Figure 43: Tradescantia cover along MGK_W_Trib2.

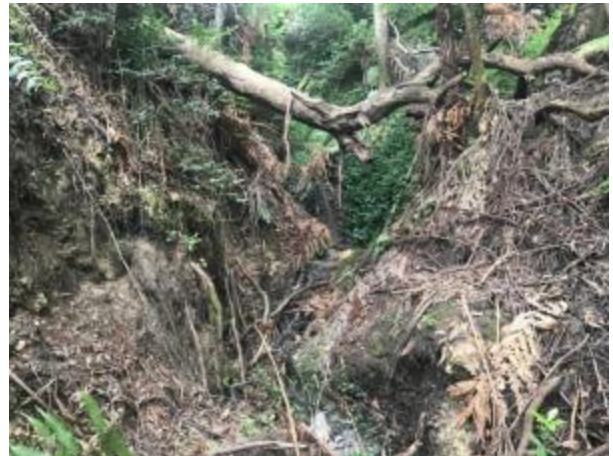
High gully banks > 20 m define the channel of Tributary 3 resulting in moderate incision and a high percentage of active bank scour affecting upper bank stability (Figure 44). Further information on erosion assessed along this reach is discussed in section 4.4. There are a series of timber weirs along the channel which extend along the banks as timber lining (Figure 45).

Figure 44: Example of channel along MGK_W_Trib3.

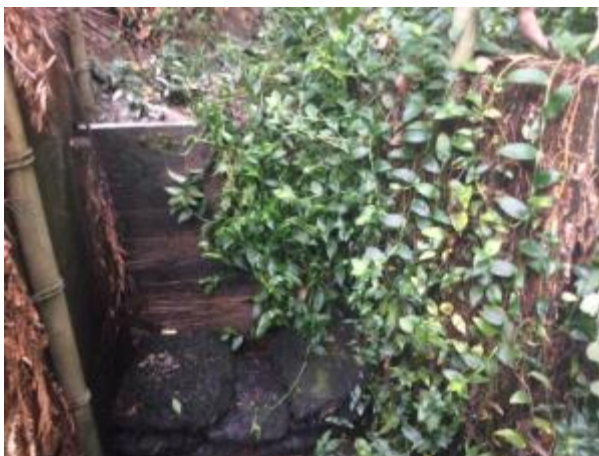
Figure 45: Timber weir along MGK_W_Trib3.

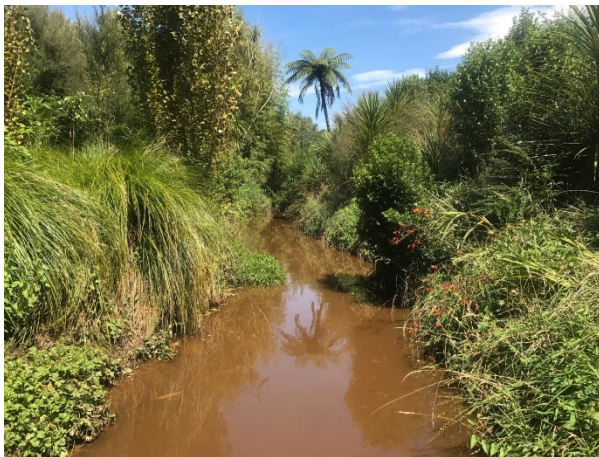
The western main channel immediately downstream of the State Highway 3 crossing and upstream towards the Hamilton City boundary (MGK_W_Main_9 to MGK_W_Main_13) has a channel averaging between 2 and 3 m wide wetted width and approximately 0.3 m deep. The upper bank height along these reaches is variable with the lower reaches typical of the steep gullies identified upstream. Further upstream in MGK_W_Main_10 to 12 the bank height decreases to between 1.2 and 2 m high. Recent native riparian planting was identified along both banks of MGK_W_Main_10 which was planted by Mangakōtuketuku Stream Care Group approximately 3-5 years ago (Figure 46).

Figure 46: Native planting along MGK_W_Main_10.

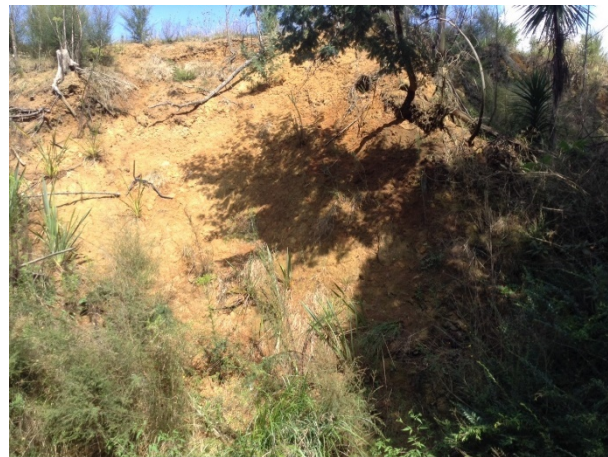
A new residential development is located on the upper banks of the true left bank around Stan Heather Drive (MGK_W_Main_12). There is an area of exposed loose sediment along the true left bank below the construction site which is pictured in Figure 47 and is recorded as an erosion hotspot, however, it is unlikely this was caused by the watercourse. Local residents have suggested that recent storm events have contributed to tree fall resulting in bank instability and sedimentation. The reach was assessed as fair for the overall bank stability score (Figure 48).

Figure 47: Erosion hotspot on true left bank MGK_W_Main_12 (Stan Heather development).

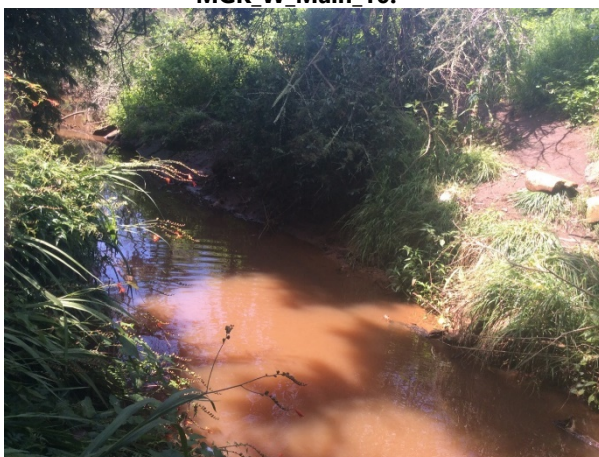
Figure 48: Channel at MGK_W_Main_12.

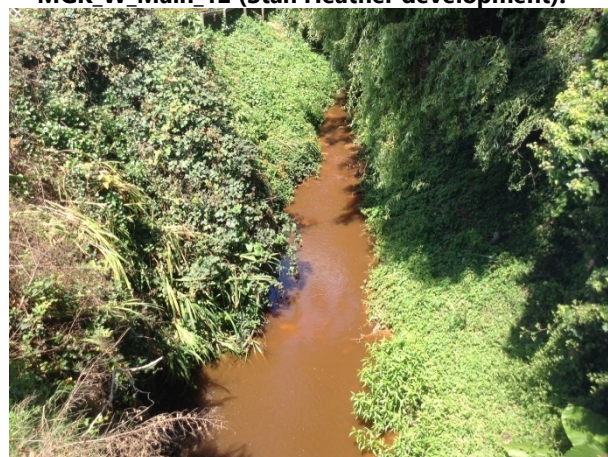
Riparian vegetation along this reach is dominated by exotic species with patches of native tree ferns, however, an infestation of tradescantia dominated both banks from Saxbys Road culvert to the end of MGK_W_Main_13 (Figure 49).

Figure 49: Upstream of Saxbys Road at MGK_W_Main_13.

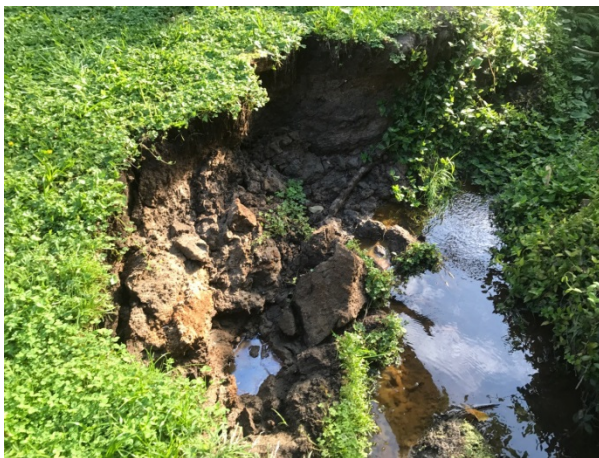
Tributary 5 is a modified perennial watercourse located on the true left bank of the main channel between MGK_W_Main_4 and 5. The tributary has steep gully banks (>20 m high) for majority of the extent with two isolated erosion hotspots on the immediate banks. These are located on the true right bank of MGK_W_Trib5_2 where the bank has recently slumped along the outside meander (see Figure 50) and MGK_W_TRIB5b_1. Most of the channel had good riparian cover dominated by tree ferns (which provide good fish habitat as per Figure 51) however other areas were dominated by thick tradescantia, blackberry and bindweed which limited access to the channel (Figure 52).

Figure 50: Erosion hotspot at MGK_W_Trib5_2.

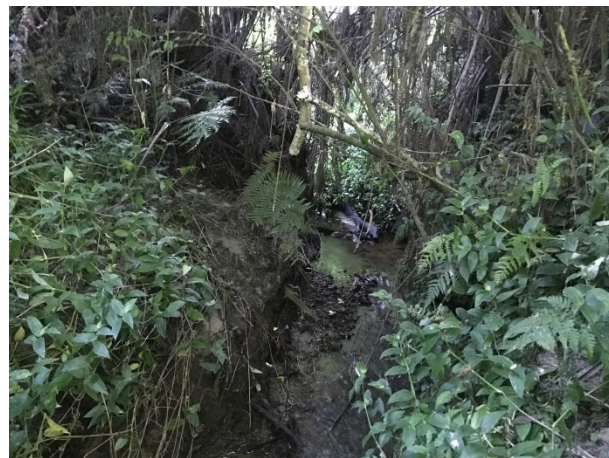
Figure 51: Good fish habitat on MGK_W_Trib5.

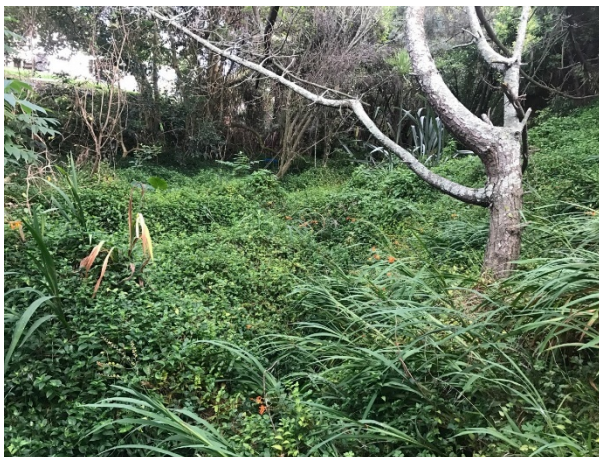
Figure 52: Thick tradescantia cover on MGK_W_Trib5_5.

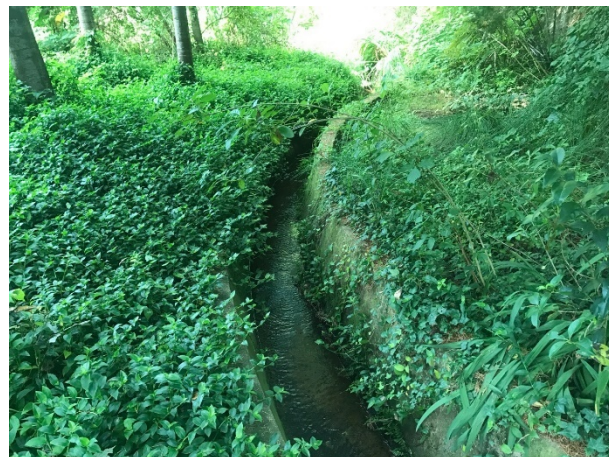
A 70 m long section in the upper reaches of the tributary is lined with concrete as shown in Figure 53.

Figure 53: Concrete lined channel on MGK_W_Trib5_7.

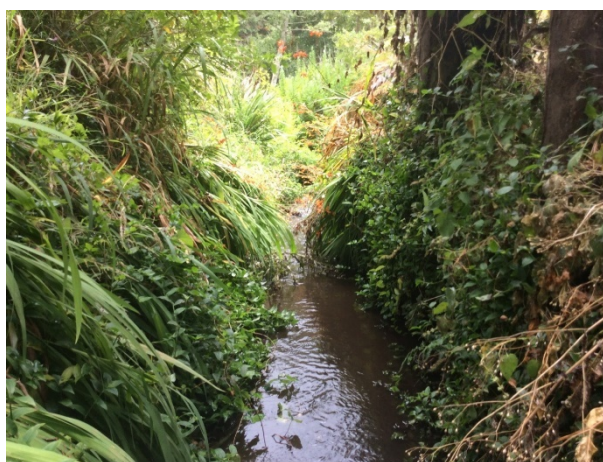
discussed further in section 5.1.1 and 5.2) (Figure 58). Some sections of the banks are well vegetated (albeit with weed infestations), whereas other areas have bare banks and high mass wasting. A section of the true right bank has had wool matting placed which is deteriorating (Figure 59).

Figure 58: Incised channel on MGK_E_Main_1.

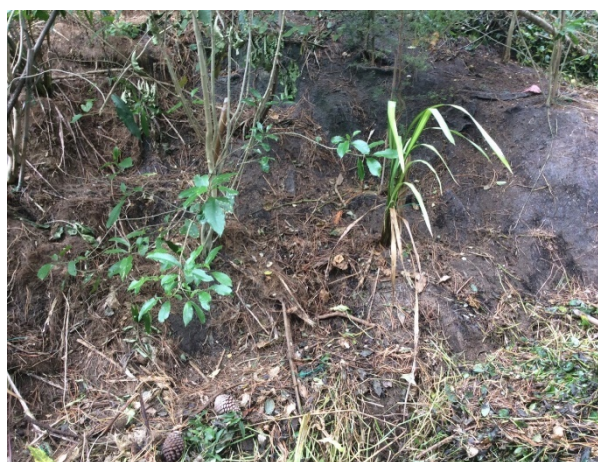
Figure 59: Wool matting on true right bank of MGK_E_Main_1.

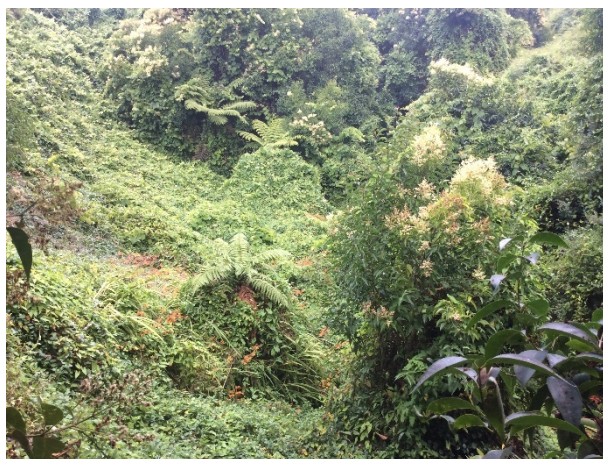
Upstream of the Waterford Road culvert, along MGK_E_Main_2, the watercourse continues as an incised channel with steep gully banks (>20 m) at approximately 60 degrees. The watercourse and upper banks are covered in thick tradescantia, privet and climbers which are smothering native tree ferns and carex grasses (Figure 60).

Figure 60: Tradescantia cover of banks and channel at MGK_E_Main_2.

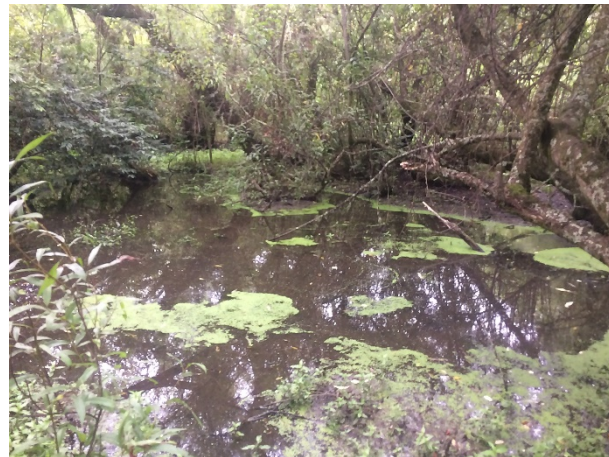
There are several pools and runs along the watercourse as well as areas of stagnant water with duckweed (Figure 63). Some sections of channels are undercut and scoured; often these areas have sparse ground cover and high overhead cover (shown in Figure 65 and Figure 67).

Figure 63: Stagnant water and willow cover at MGK_E_Main_3.

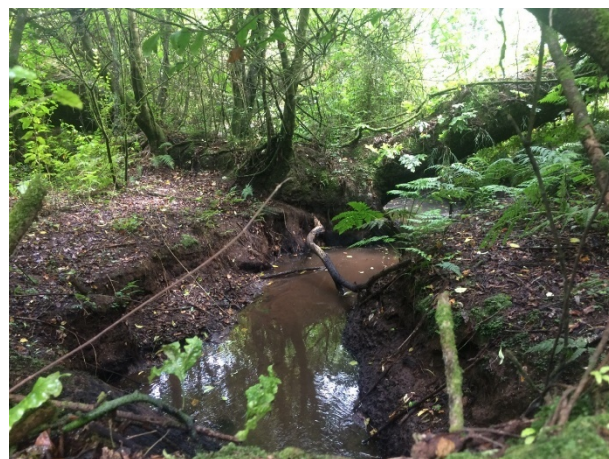
Figure 65: Gully floor of MGK_E_Main_7.

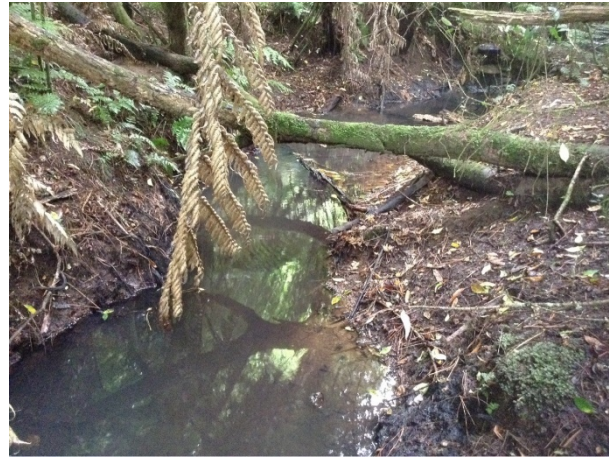
Figure 67: Gully floor of MGK_E_Main_10.

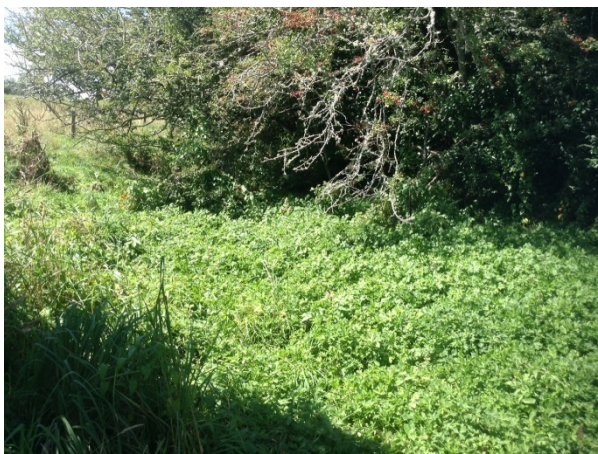
A 100 m section of the watercourse was not surveyed as consent was not provided. Further upstream, along MGK_E_Trib1_8, the watercourse is ephemeral with lower bank height and weed infestations of buttercup and bindweed (Figure 72 and Figure 73).

Figure 72: Weed infestation across ephemeral channel at MGK_E_Trib1_8.

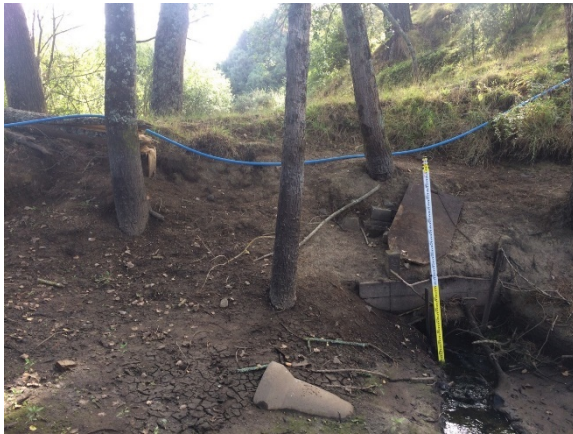
Figure 74: Buried culvert under farm crossing with wetland floodplain downstream.

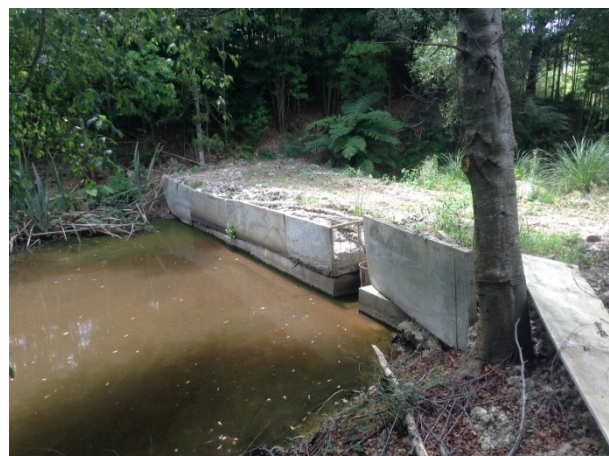
Upstream of MGK_E_Trib2_5, at 143 Hall Road, 800 m of the watercourse has been extensively modified by the landowner using concrete dam structures to provide a series of eight amenity ponds (Figure 76 to Figure 80). Many of the culvert and dam structures between the ponds were in poor condition.

Figure 77: Concrete dam structure.

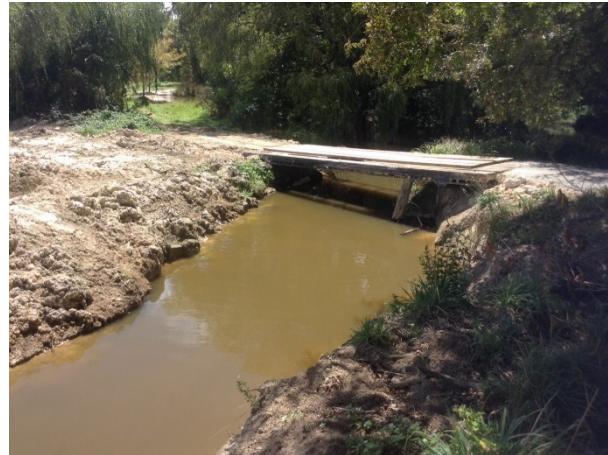
Figure 79: Bridge crossing and recent earthworks near sixth pond in series at 143 Hall Road.

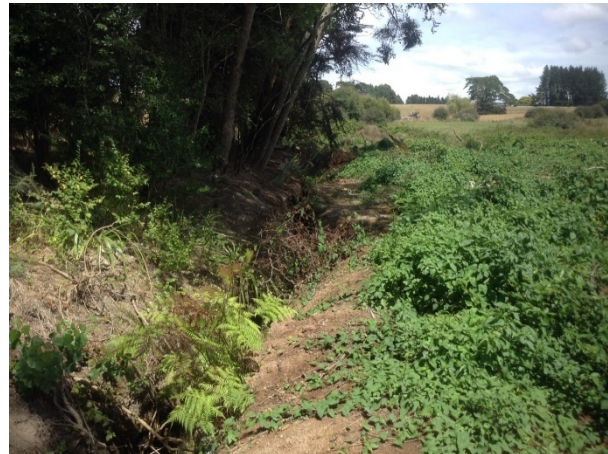
Figure 81: Looking upstream from 143 Hall Road boundary.

There is a 400 m reach upstream of the 143 Hall Road property that was not surveyed as access was not permitted. Looking upstream from the boundary of 143 Hall Road, this appears to be a straightened modified channel no riparian cover on the true left (Figure 81).

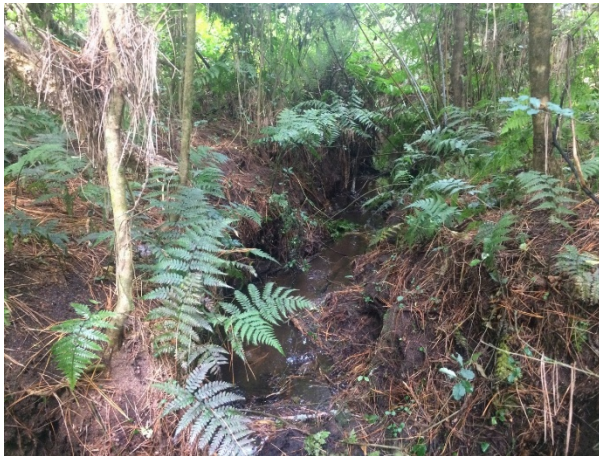
The third tributary along the eastern main channel is located on the true right bank between MGK_E_Main_7 and 8. The 200 m lower reach near the confluence (MGK_E_Trib3_1) is a small incised channel with steep upper banks. The channel meanders across the gully floor where the soft sediment is highly erodible and contributes to sedimentation downstream (Figure 82). There is a floodplain on both sides of the channel with sparse ground cover, fern and grey willow understorey and pine canopy on the upper banks.

Figure 82: Incised channel on gully floor on MGK_E_Trib3_1.

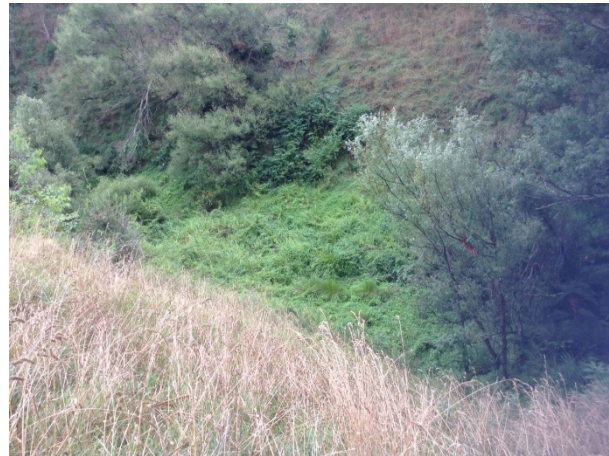
Further upstream, beyond the pine canopy block, the channel (MGK_E_Trib3_2) meanders across the wide floodplain. There is sparse canopy cover and carex grasses as well as tradescantia, ragwort and blackberry (Figure 83).

Figure 83: Gully Floor on MGK_E_Trib3_2.

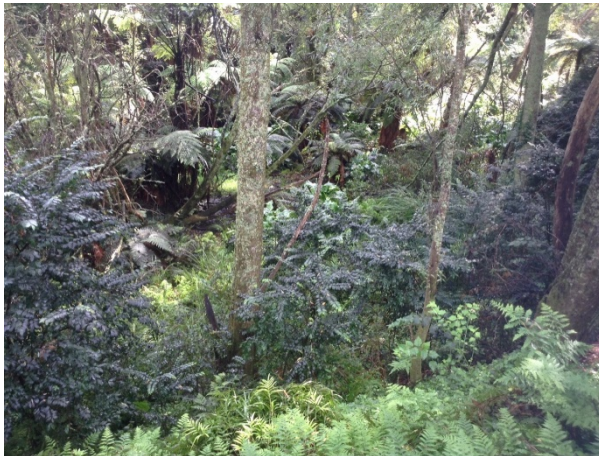
The watercourse at MGK_E_Trib3_3 maintains steep upper banks and a wide gully floor. The channel meanders across the floodplain with notable springs on the upper banks. There is good canopy cover from upper bank vegetation as well as willows, tree ferns and tradescantia along the gully floor (Figure 84).

Figure 84: Good overhead cover at MGK_E_Trib3_3.

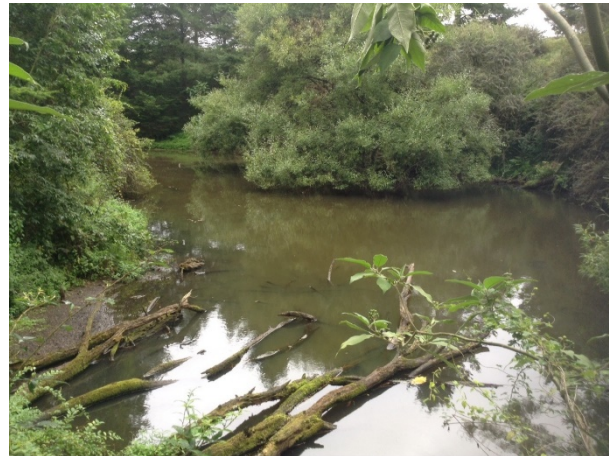
There is an informal farm crossing between MGK_E_Trib3_3 and 4 which currently provides access between two halves of the property. Upstream of the crossing is a large pond (Figure 85) which transitions into a wetland area (Figure 86).

Figure 85: Pond upstream of informal farm crossing MGK_E_Trib3_3.

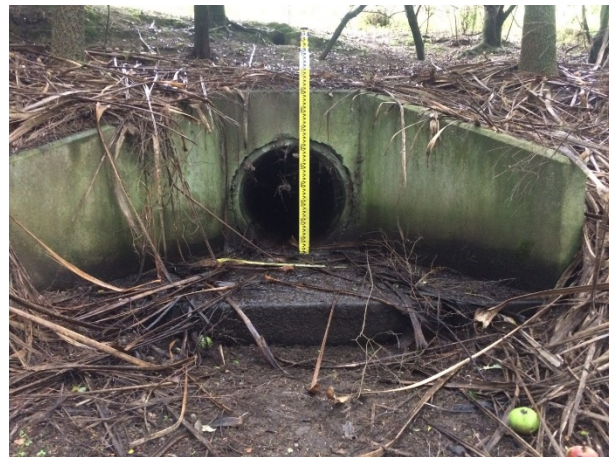
Figure 89: culvert under driveway of MGK_E_Trib3_6.

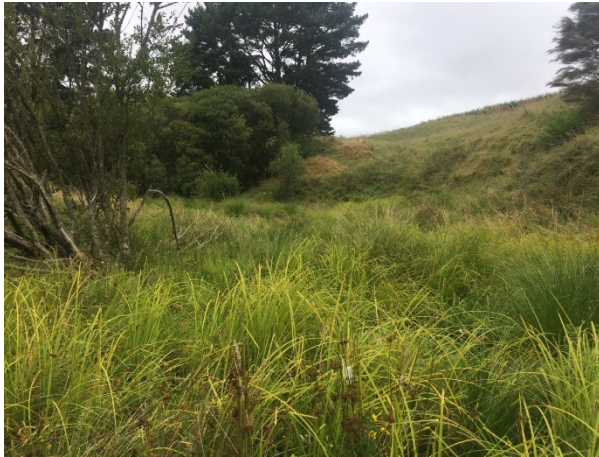
The fourth tributary on the eastern main channel is located on the true right bank between MGK_E_Main_8 and 9. The tributary has steep upper banks (>20 m) and a wide floodplain gully floor. The channel meanders across the wetland flood plain (see Figure 91). There is significant seepage wetlands located midway on the upper banks. The lower reach (MGK_E_Trib4_1) is shaded by willows growing along the floodplain. The dominant vegetation in upper reaches is carex and exotic grasses (Figure 90).

Figure 90: Wetland floodplain on gully floor at MGK_E_Trib4_1.

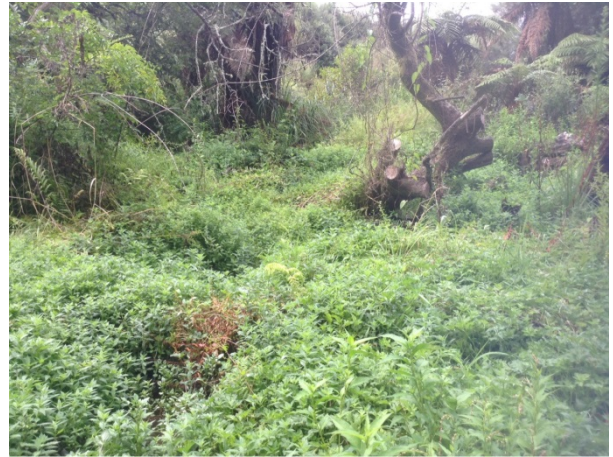
The gully at MGK_E_Trib6_1 and the upstream pond have steep upper banks (> 15 m) with a meandering channel along the floor. The gully has had extensive native planting restoration on both banks undertaken by the landowner (Figure 94). There are however; large infestations of weeds present along the gully floor (Figure 95).

Figure 95: Native planting with weed infestations along MGK_E_Trib6_1.

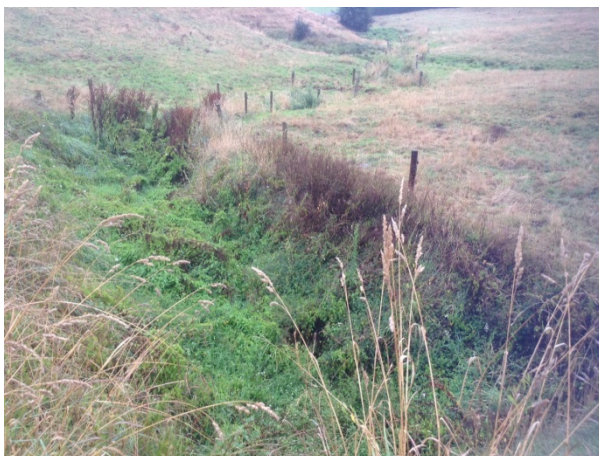
Upstream of the pond (which is pictured in Figure 96), there is a healthy rush wetland with gently sloping upper banks (approximately 5 m high) (Figure 97). Further upstream the channel becomes more incised with dense macrophyte cover and high sediment deposition (>1 m) (Figure 98 and Figure 99). These reaches (MGK_E_Trib6_2 to 4) appear to have been straightened along a farm track and are culverted.

Figure 98: Channel along MGK_E_Trib6_2.

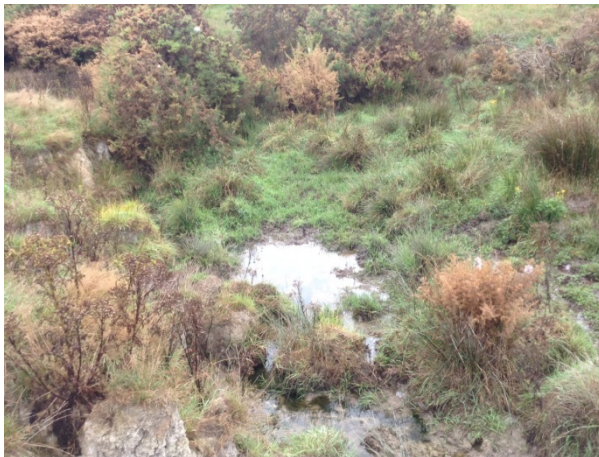
The seventh tributary of the eastern main channel (MGK_E_Trib8) is located on true left bank. The downstream reaches of the tributary are a spring fed rushland with deep pools and high sediment deposition (Figure 103). Further upstream from this rushland, within a deer farm, there is significant pugging and erosion on the banks and channel (Figure 104). The pugged wetland drains a significant sized pond at the top of the tributary (Figure 105).

Figure 104: Pugging of rush wetland with gorse along MGK_E_Trib7_2.

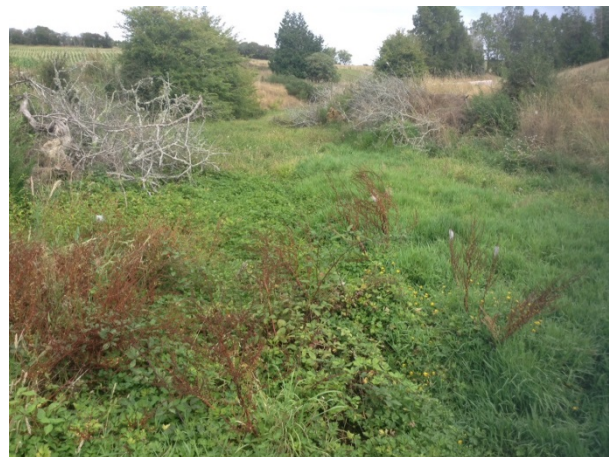
The eighth tributary of the eastern main channel is located on the true right bank upstream of MGK_E_Main_15. The tributary (MGK_E_Trib8) is a narrow channel which meanders across a wide floodplain with upper banks approximately 3 m high (Figure 106). The tributary is spring feed with seeps located mid-way up the upper banks. There is some pugging and slumping due to the reach being unfenced and large weed infestations (Figure 107).

Figure 107: Weed infestations along MGK_E_Trib8_1.

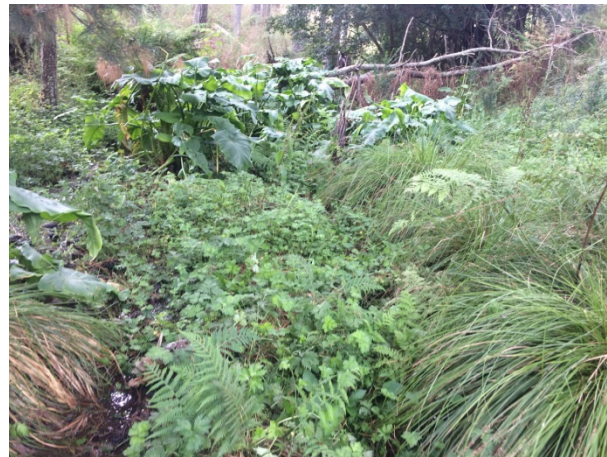
The lower reaches of the eastern sub-catchment headwaters have a wide floodplain and gently sloping upper banks. The channel is well defined along MGK_E_Main_17 where the watercourse has likely been excavated (see Figure 110). Further upstream there is no discernible channel and the floodplain has a dense cover of macrophytes, pasture grasses and carex grasses. The floodplain is entirely fenced with gently sloping upper banks (Figure 111). Upstream of this section the channel has a similar morphology but with dense cover of grey willows and fern undergrowth with patches of weed infestations (Figure 112 and Figure 113).

Figure 113: Weed infestations along MGK_E_Main_21.

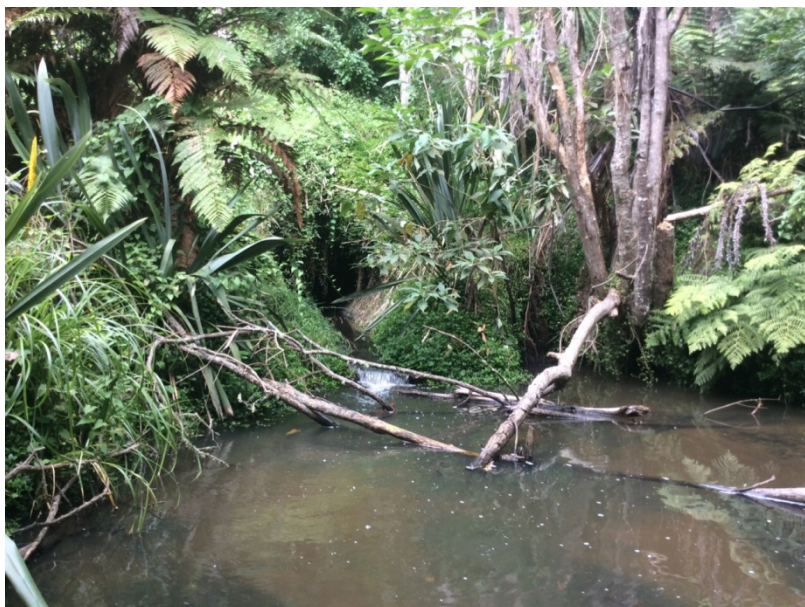
In the lower reaches of the eastern sub-catchment on MGK_E_Main_1 and 2, a number of unidentified galaxid were spotted in the scoured pool below Waterford Road outlet (Figure 125). The scoured pool is good habitat for fish with overhead cover from canopy and a substantial amount of debris in the pool. The culvert apron is causing a fish barrier with a drop of 0.1 m to water surface and 0.4 m to the channel bed.

Figure 125: Outlet of Waterford Road culvert.

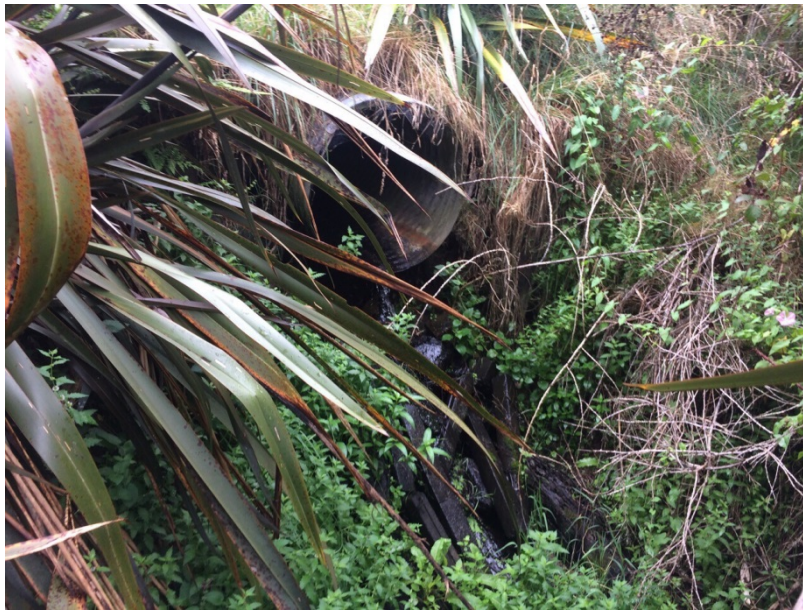
Along tributary 6, the channel has large pools and riffles and provides excellent habitat for fish. During survey banded kokopu and longfin eel were identified along the lower reaches of this tributary. There is a fish passage barrier downstream of the large pond along the tributary which looks to be fitted with a spat rope (Figure 128).

Figure 128: Spat rope fitted at culvert upstream of MGK_E_Trib6_1.

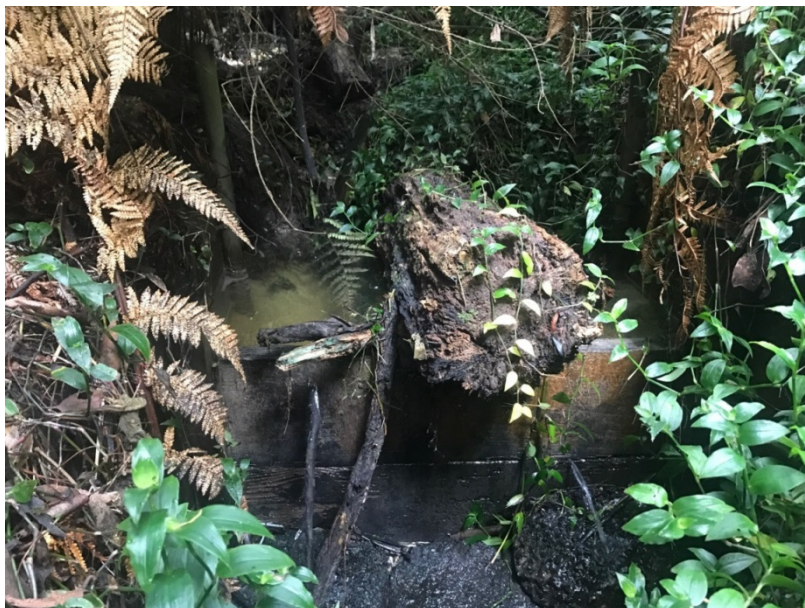
An isolated section (25 m) of the third tributary along the western main channel (MGK_W_Trib3_1) has >60% bank erosion on both banks. The section of stream is incised with steep gully banks >20 m and evidence of high flows from the amount of debris deposited on the upper banks (Figure 139). There was high sediment deposition with little to no flow during survey. There is limited vegetation on the immediate banks however there was good cover from the surrounding canopy. Upstream, a series of wooden weirs and bank lining structures were observed which may contribute to the erosion identified further downstream (see Figure 140).

Figure 140: Wooden weir structures upstream of high erosion reach MGK_W_Trib3_1.

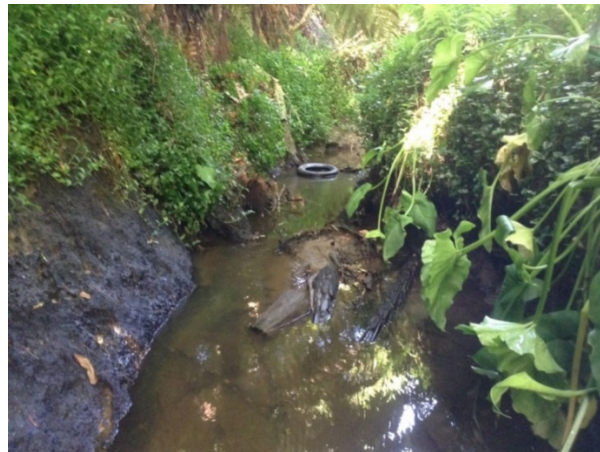
- within the central sub-catchment along the main channel (MGK_C_Main_2) (Figure 142),
- the first tributary in the central sub-catchment (MGK_C_Trib1),
- the first fork along the first tributary in the western sub-catchment (MGK_W_Trib1_Fork1) and,
- the small (<100 m in length) tributaries in the central catchment (MGK_C_Trib2 to MGK_C_Trib4) also have poor upper bank stability (Figure 143).

Figure 142: MGK_C_Main_2 assessed as poor land slope, poor mass wasting, poor debris jam and good vegetation. Overall stability score is poor.

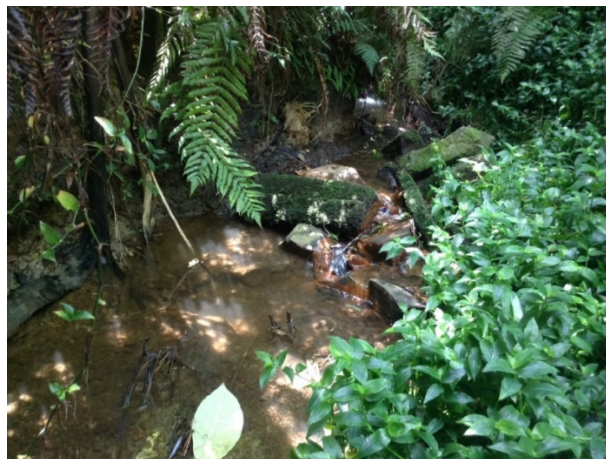
Figure 143: MGK_C_Trib3_1 assessed as poor land slope, poor mass wasting, fair debris jam, and fair bank vegetation. Overall stability score is poor.

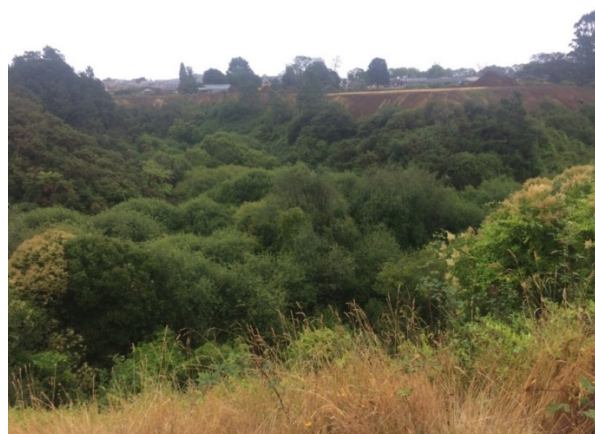
The main channel upstream of the confluence with the Waikato River, the main reaches of the eastern catchment, selected areas of the western sub-catchment and the remaining middle and lower reaches of the central catchment have an overall stability score of fair. For the majority of these reaches, land slope of the upper banks are assessed as poor as the gully banks are steep and between 10 and 25 m high. An example of the upper bank height in the eastern catchment is given in Figure 144.

Figure 144: Confluence of eastern sub-catchment main channel and tributary.
