| Case No: | 2025-0389 | | Date of visit: | 09/10/2025 | | |
| Site No: | FS0237 | Site Name: | Gorsten | | | |
| Business No: | FB0119 | Business Name: | Mowi Scotland Ltd | | | |

# Fish Health Inspectorate visit report

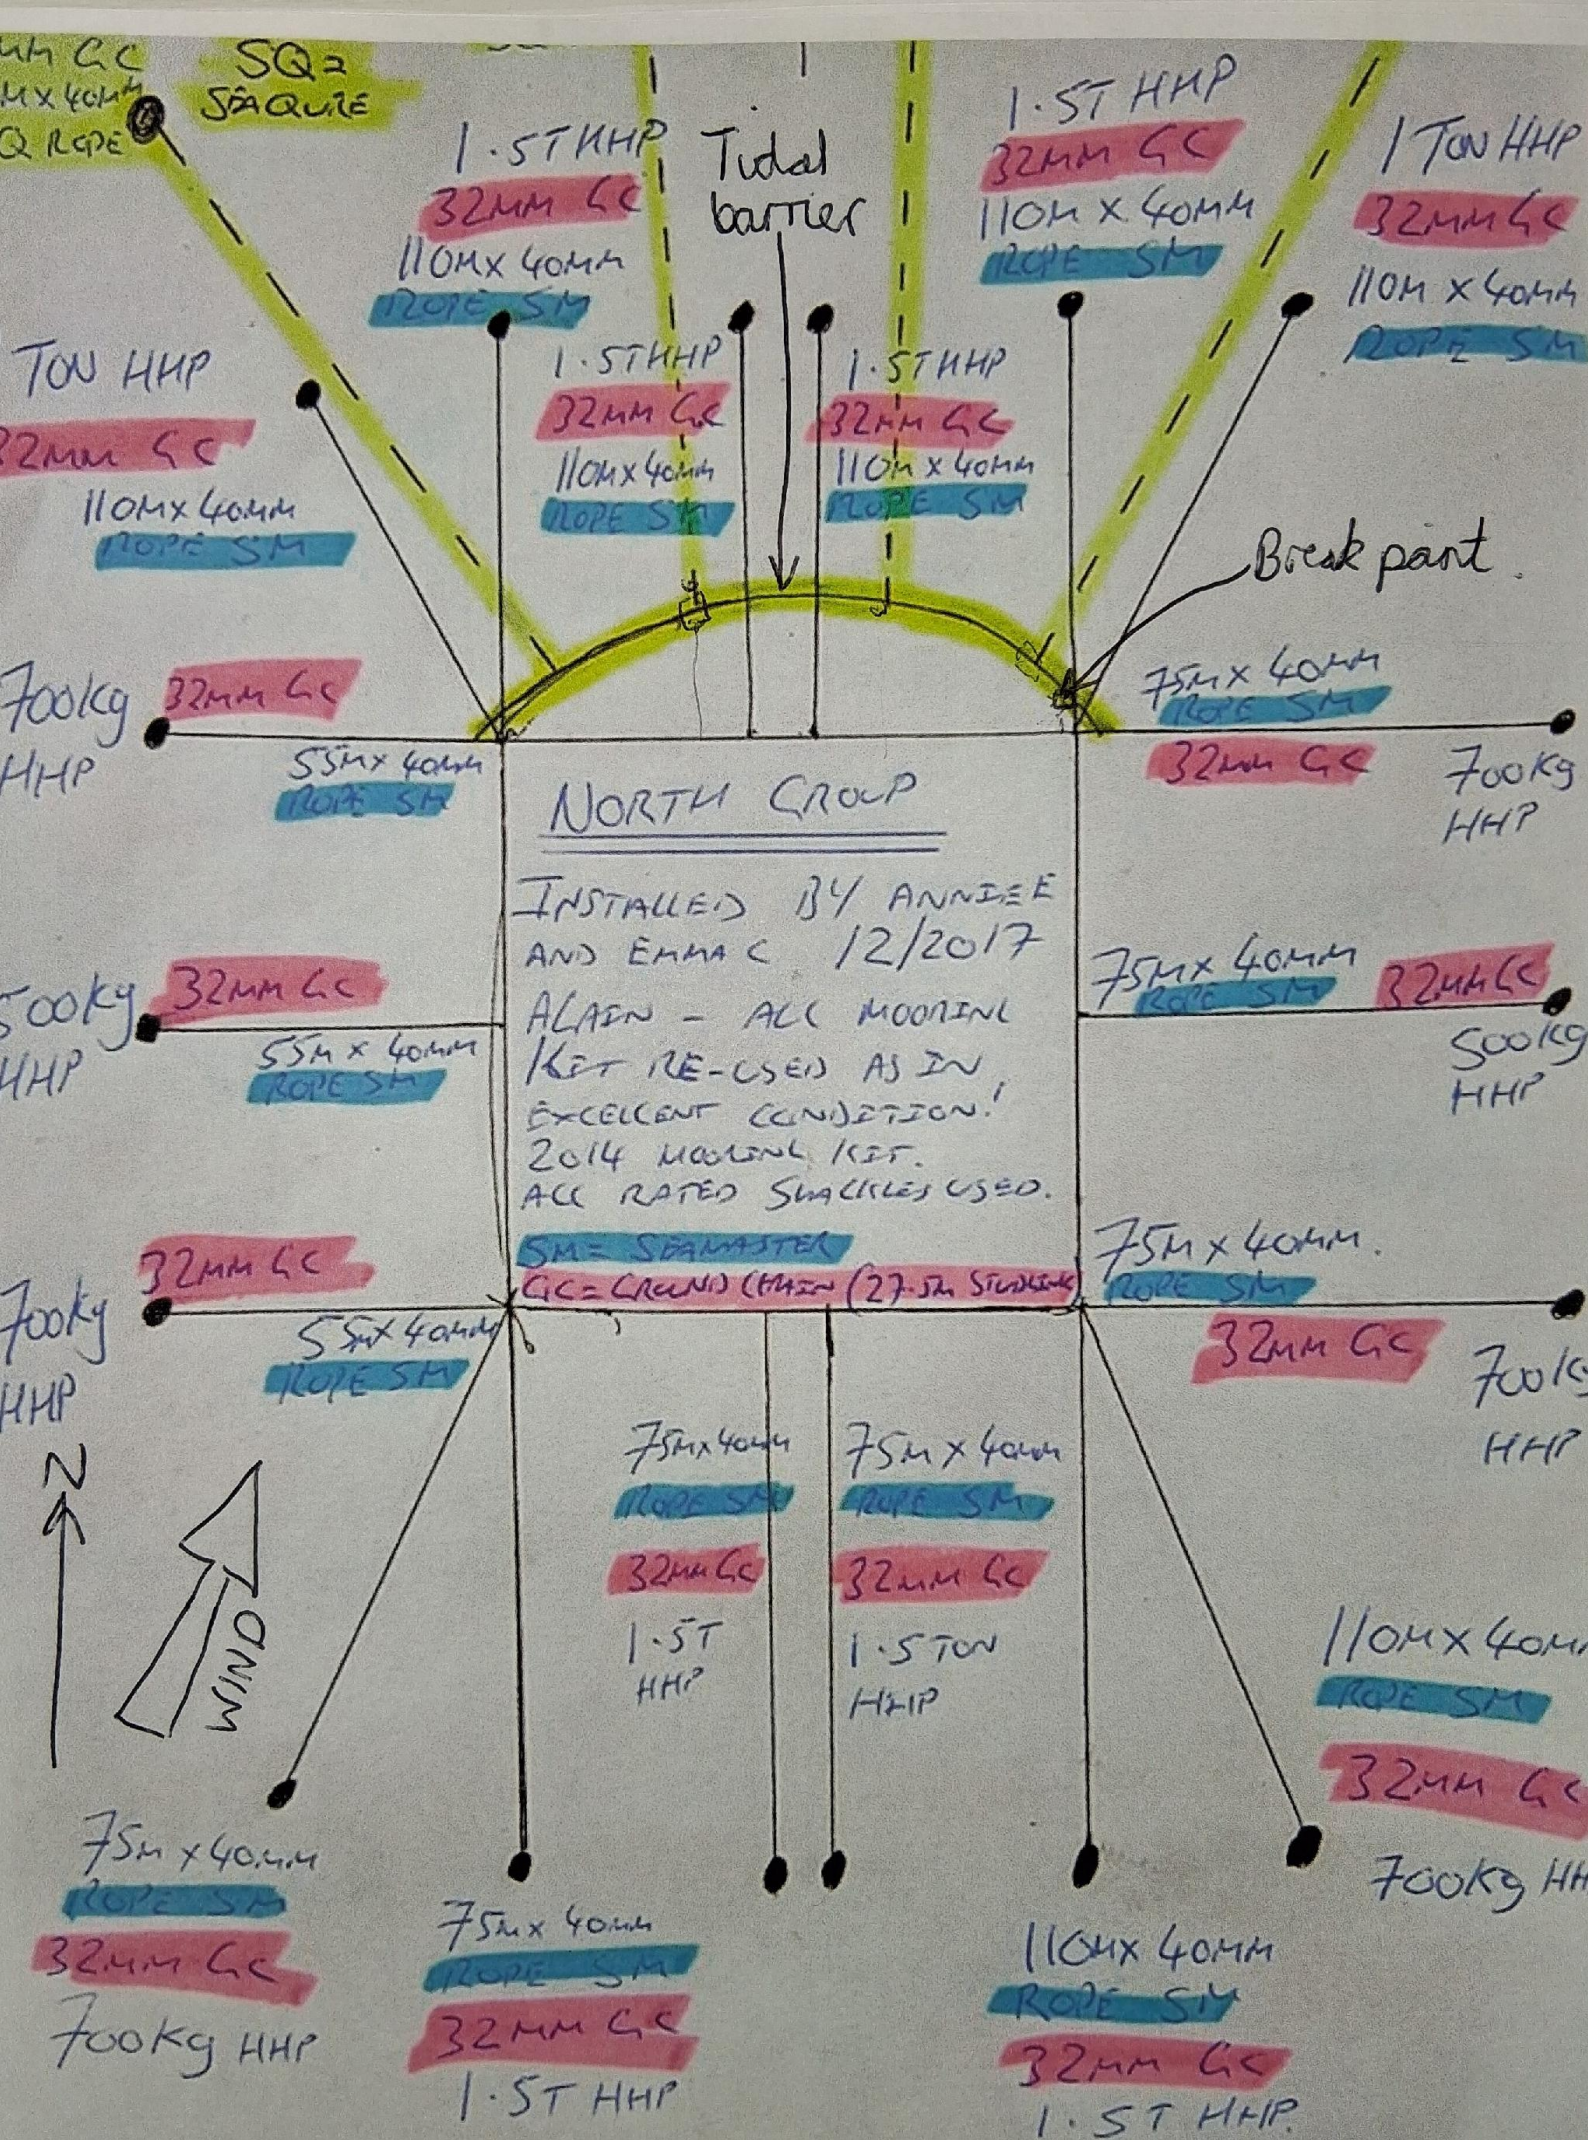
Photo 1: Clamps used to attach tidal barrier floatation tube to mooring chain. One of these clamps broke during the storm.
