**Medway Planning & Economic Development Board
Meeting**

Construction Observation Report

Project Name:	Choate Trail
Location:	Copper Drive (off Highland Street) Medway, MA
Report Number:	9
Inspection Date:	3/8/2022
Inspection Time:	3:00 pm

CONSTRUCTION INSPECTION REPORT

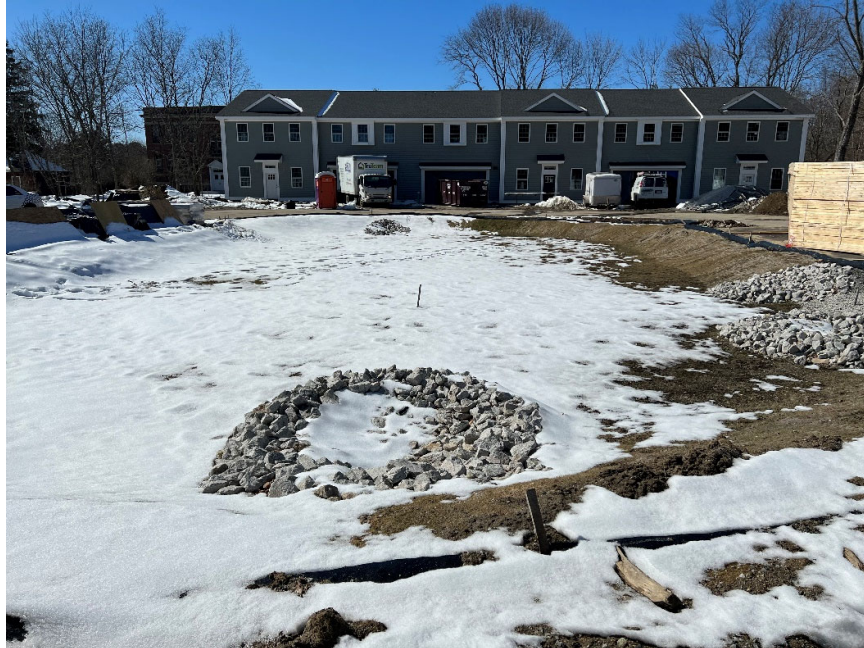
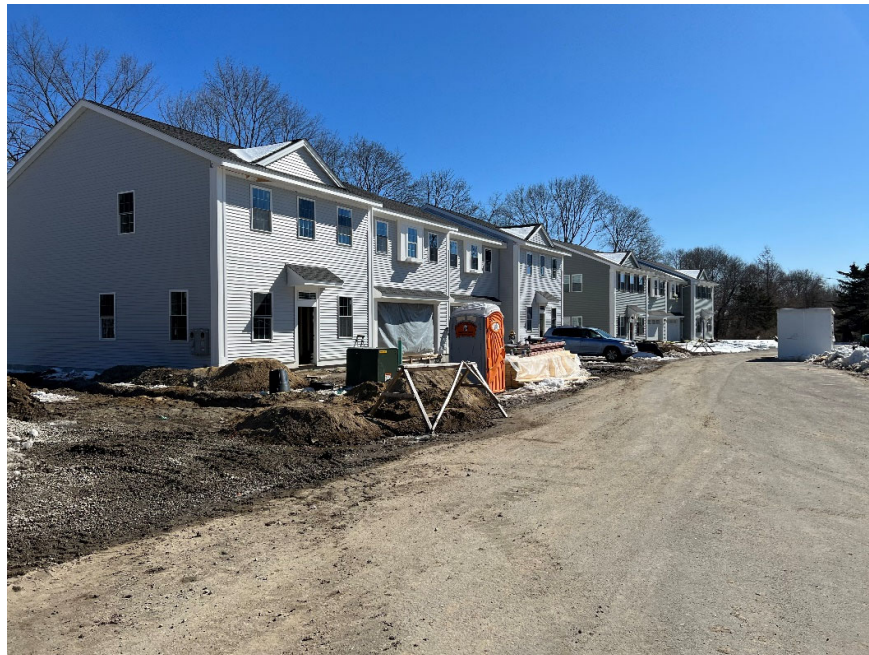
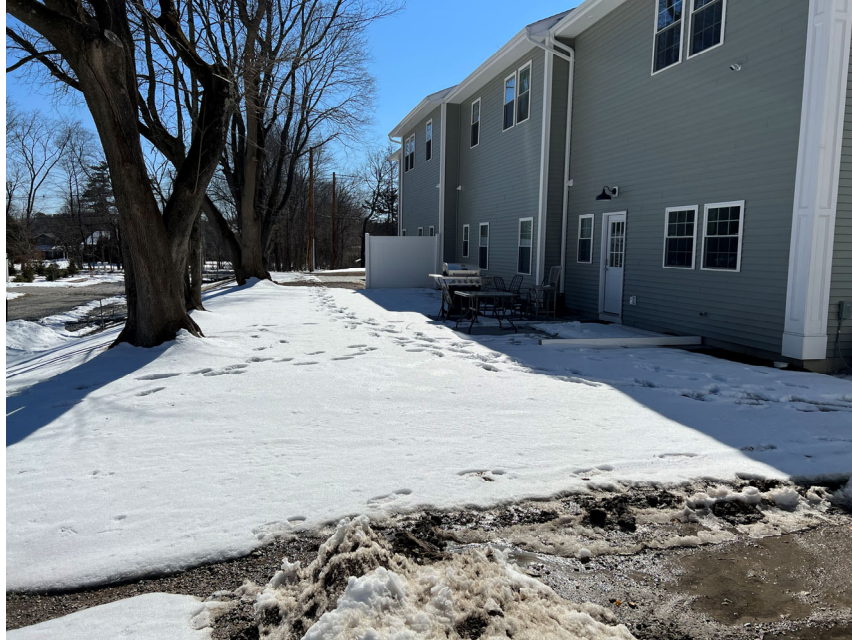
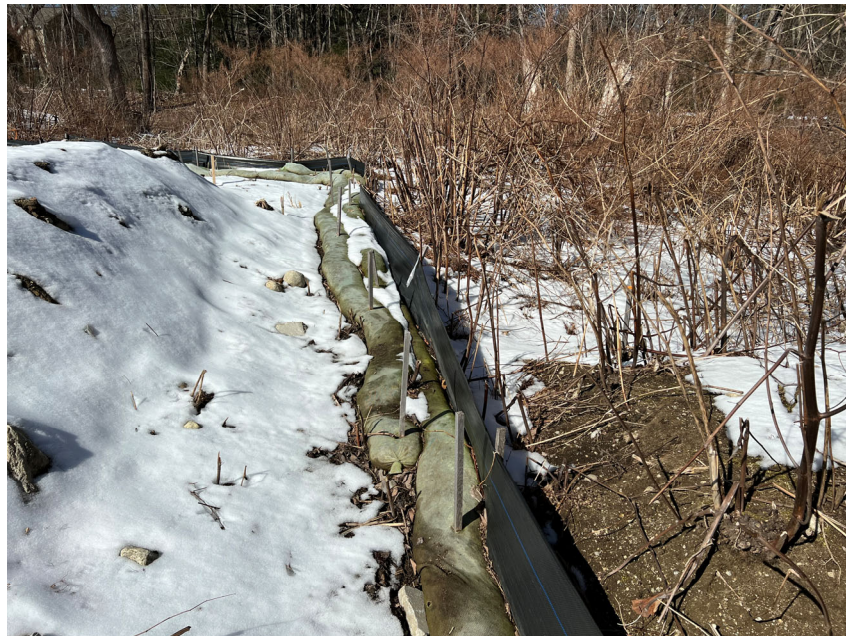
- Perimeter erosion controls were inspected and found to be in good condition.
- Temporary sediment basins appear to be functioning well and newly installed stormwater systems are protected with erosion controls. The partially excavated foundation for unit 14/16 is acting as a temporary sediment basin. Once the foundation is installed, the area will be re-evaluated to determine if additional erosion controls are needed.

1. Perimeter erosion controls will need some refreshing in the next few months.
