The Village of
Saranac Lake
New York

Emergency Services
Facilities Assessment
(ESFA)

September 24, 2012

Historic Building Condition Assessment Report of the **SARANAC LAKE FIRE STATION**

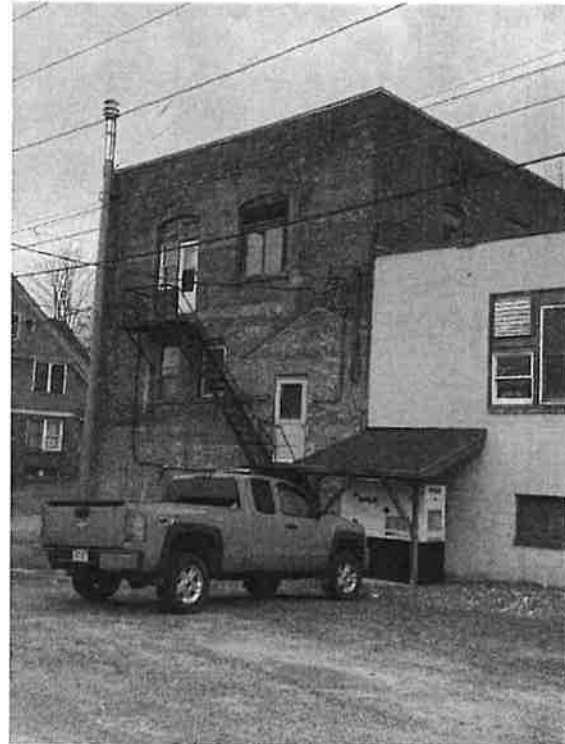
View of north elevation showing altered window openings and c.1960s CMU addition.

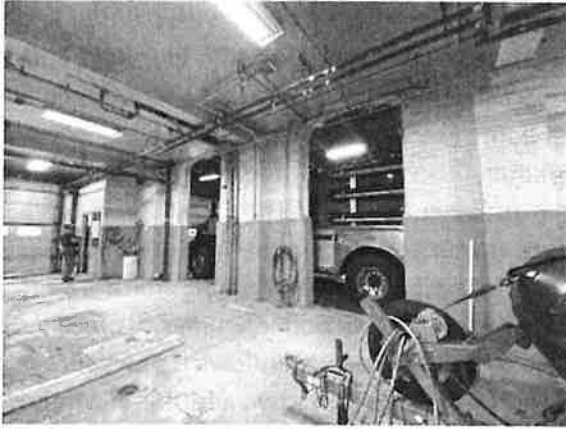
North wall where orig. window openings have been opened to created doorways to new addition.

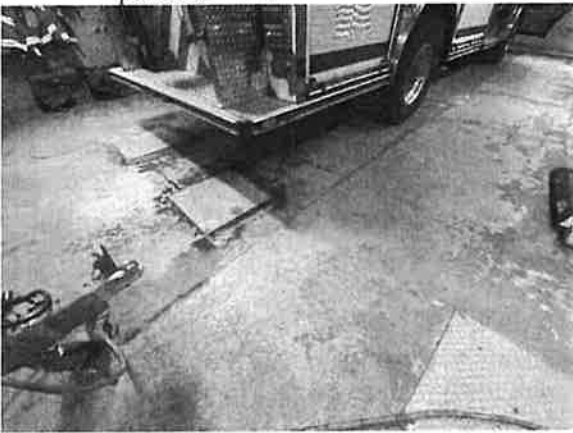
perimeter (exterior) walls, painted poured concrete floors, ceilings furred down with painted drywall finish with encased steel beams. The length of the garage is organized into four bays with three brick piers on each side (north & south) wall supporting the steel beams that carry the second floor and allow for the clear open span within the first floor. From the ceiling there is hung numerous exposed pipes, surface mounted electric conduit, flush mounted fluorescent lighting fixtures, and a propane ceiling heater. There is a cast iron sewer stack alongside the second brick pier on the north side. The number of window openings was originally minimal as the front garage doors would have had a lot of glass panes. There is a pair of ganged windows on the south wall separated by a wood mullion as well as a single window on this wall. In both openings the original windows have been replaced with modern/late 20th century double hung windows that required the framing down of the original opening. On the rear (east) wall there are two additional window openings that also have been altered with the original windows replaced either with a smaller double hung window unit or infilled with plywood and an exhaust fan. Near the northeast corner on the rear wall there is a doorway with a wood paneled door with upper glass lite framed into what was likely an original window opening. This door would have been created to lead into the 1920s addition, but now is used as an egress door out to the fire escape. On the north wall, three original window openings were altered when the addition was constructed in the mid-1960s in order to provide connection between the garage spaces. The segmental arched masonry window opening was retained with the sill removed and the brick wall beneath the window cut out to the floor level to create a large opening between buildings. Where the brick was cut, it has been patched with concrete and painted. The existing floor would have replaced a wood floor system. Inspection from the basement suggests that it is constructed with wire mesh and tar paper over the floor joists, on top of which concrete was poured and troweled. There are expansion cracks that have resulted given the broad span, and floor drains have been added despite the lack of pitch for sufficient drainage. The painted finish is worn in a number of locations and several patches are evident.

Detail view of patched concrete floor of garage bay.

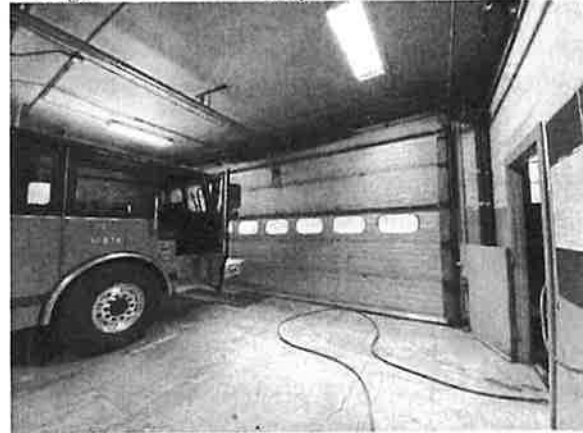
Detail view of modern overhead door on front wall.

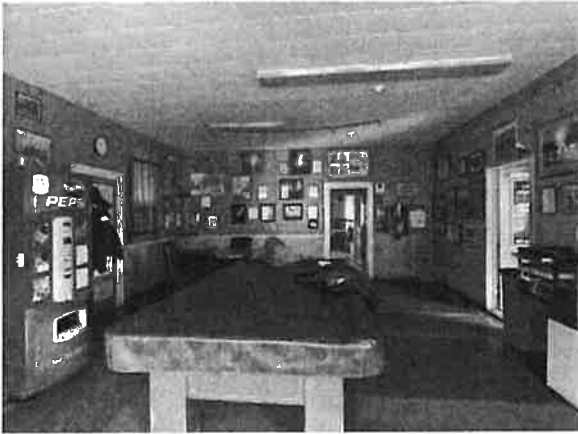
2nd floor Day Room with modern (mid 20th c) wall, ceiling & floor finishes.

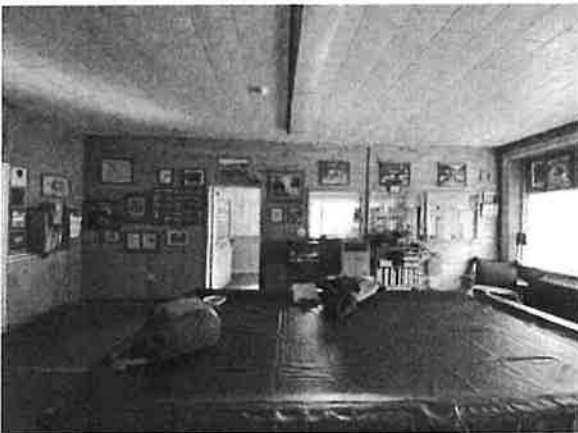
Modern south partition wall of Day Room constructed of knotty pine boards & fixed windows – out of character of orig. finishes.

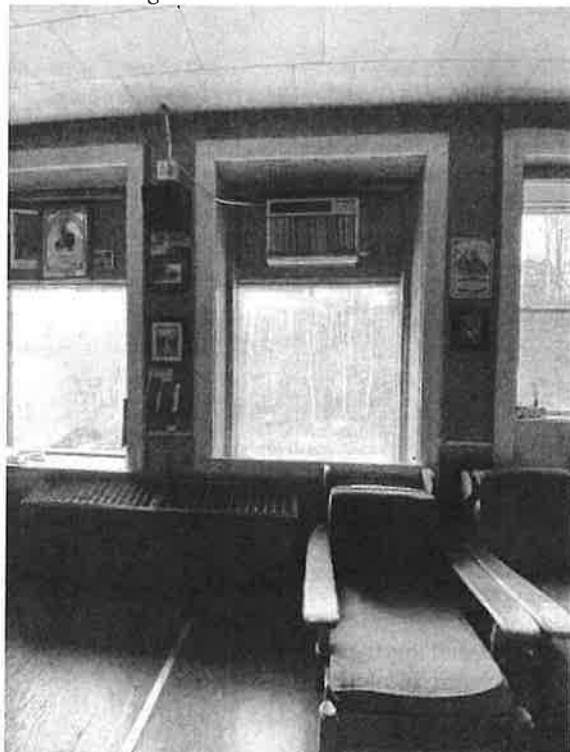
View of centered windows on front wall of Day Room with plywood infills and fixed window units replacing orig. double hung sash.

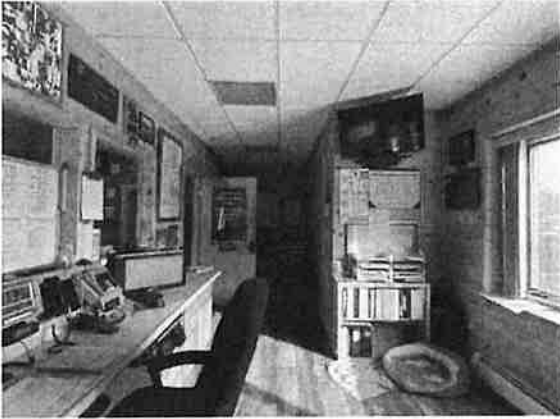
Subdivided Dispatch Room finished all in knotty pine horiz. boards with acoustical tiled ceiling.

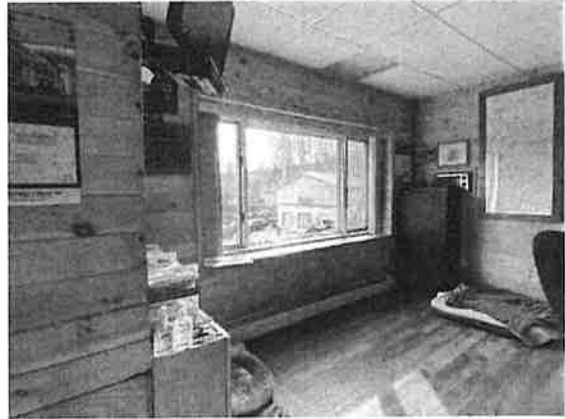
Large original window opening infilled & framed down with smaller plate glass and casement windows.

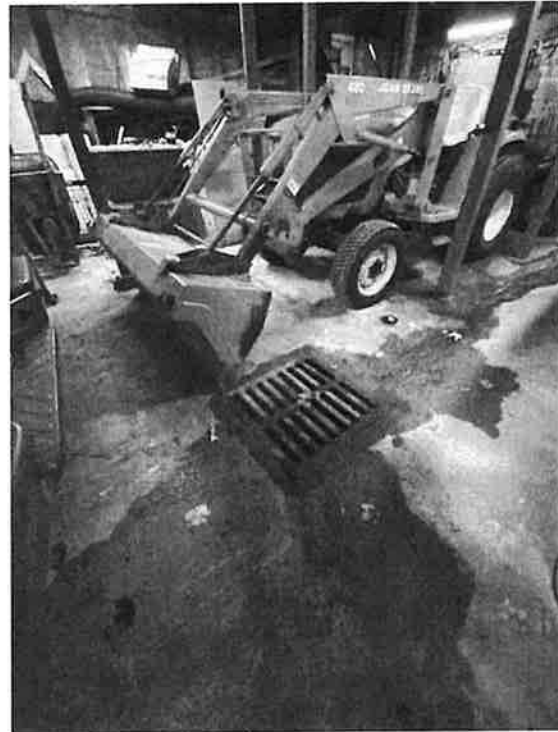
Large drainage grate positioned in center of basement floor for site water from rear yard.
