C3 PROPERTY INSPECTIONS INC.

INSPECTION REPORT

58 Lower Main Street Johnson, VT 05656

> Town of Johnson 10/16/2025

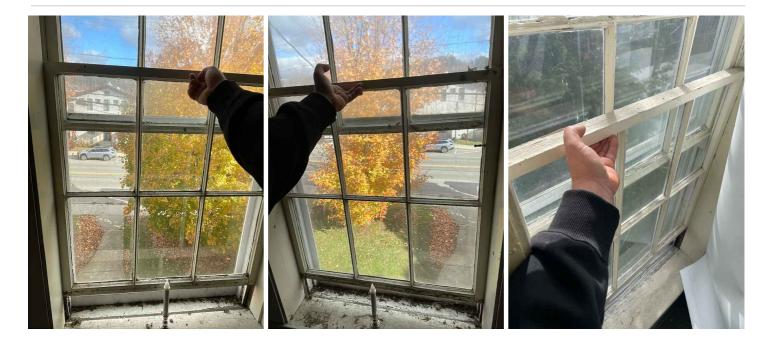
Multiple older single-pane windows did not have suitable counter weights to balance the sashes. It is recommended to use caution when operating the windows and consider installing replacement windows for smoother operation and increased R-value.

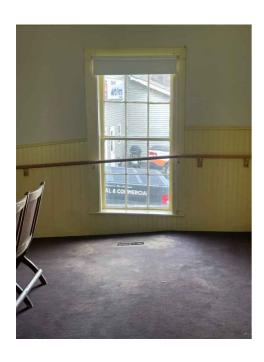
3.8.4 Windows (a representative number)

- 3.8.4 Exterior Windows (a representative number): Seized Sashes
- 3.8.5 Exterior Windows (a representative number): Single Pane Windows Deteriorated Glazing
