To: Village of Cambridge
From: MSA Professional Services
Subject: Vineyards Pond Inspections and Maintenance Recommendations
Date: November 11th, 2024

INTRODUCTION

On September 17th, 2024, MSA Professional Services performed visual inspections of four stormwater ponds in the Village of Cambridge, Dane County, WI. The purpose of the inspections was to address Village and resident concerns regarding performance, visual observations, modifications made by the previous developer and sump backup issues. Inspections included visual checks of detention basins, infiltration basins, inlet and outfall structures, bank erosion, berms, erosion control such as rip rap and erosion fabrics, as well as checking pond footprints to construction plans. Observations and recommended maintenance are included in this memo to maintain pond function in the Vineyards Development.

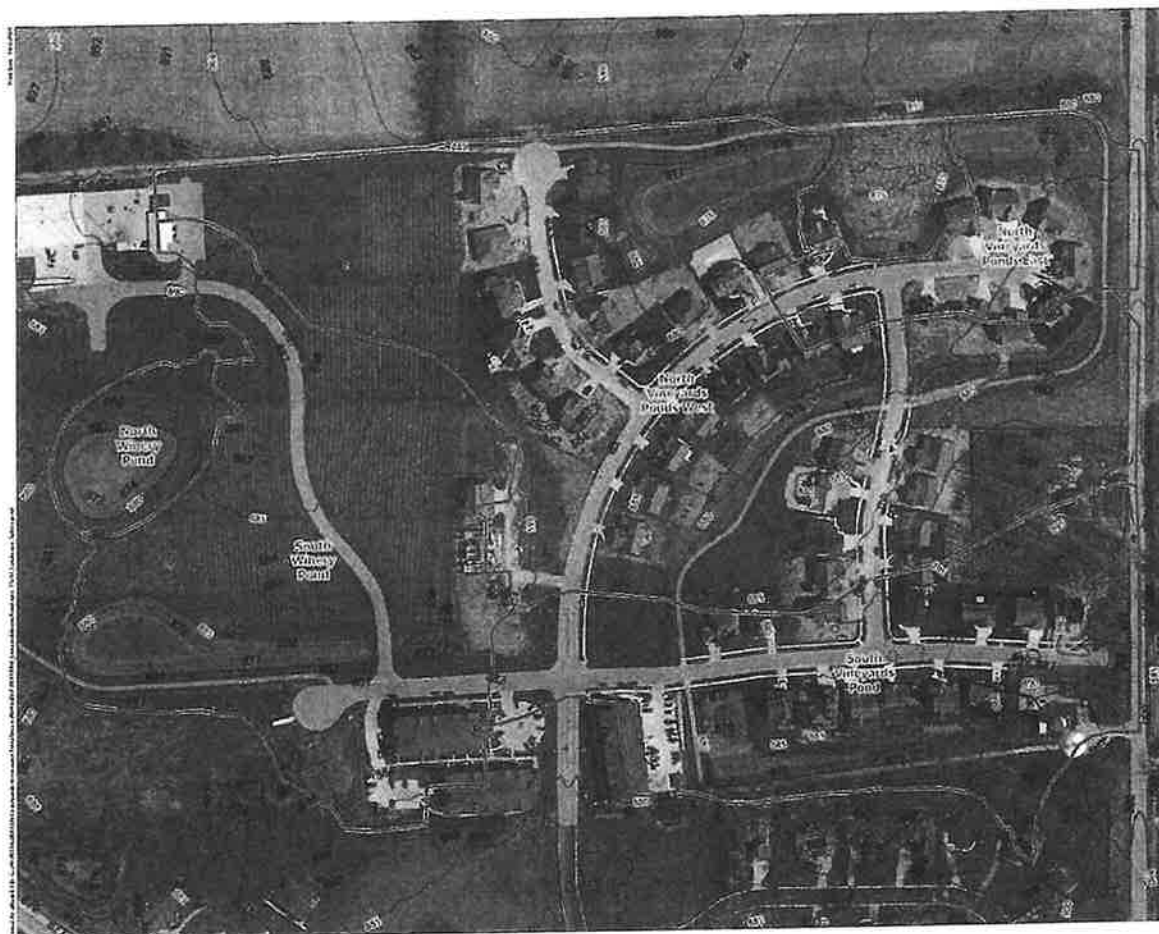
Drainage Map

Figure 1: Watersheds for storm ponds in the Vineyards
Village of Cambridge
Dane County, WI

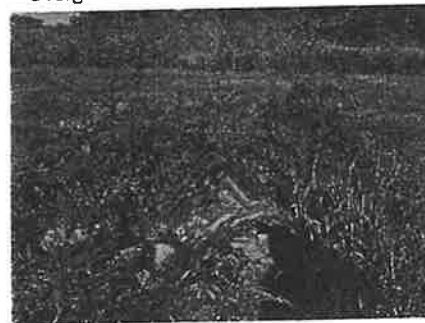
North Vineyards Ponds – West: Observations and Recommendations

1. Large cattails are present within the majority of the wet detention basin and extend into the designed permanent pool, which is indicative of insufficient depth of permanent pool.
2. Trash was observed at the southern inlet rip rap.
