# FACILITY CONDITION ASSESSMENT

Jersey Elementary  
9400 Jersey Avenue  
Santa Fe Springs, California 90670

*159753.22R000-002.017*

*October 27, 2022*

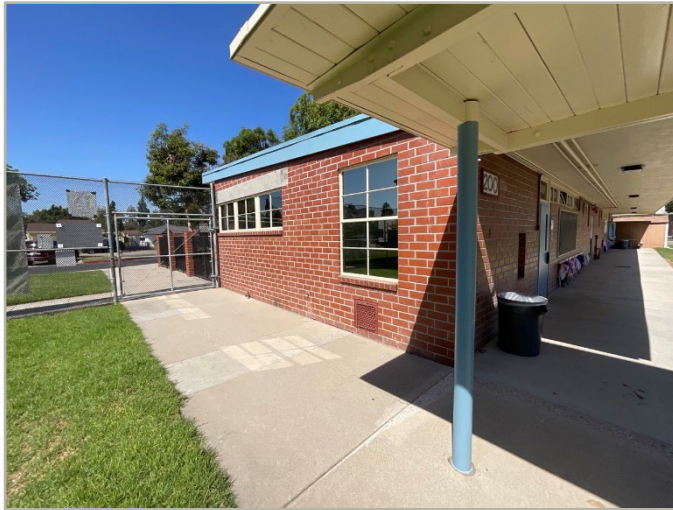
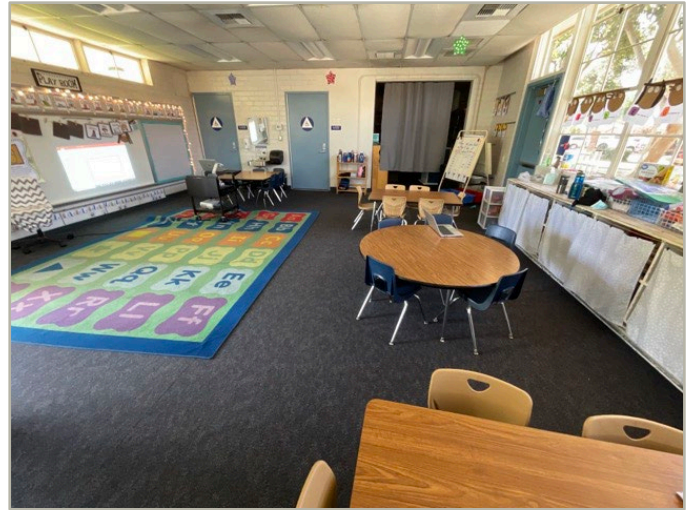
## 2. Building 200

<b>Building 200: Systems Summary</b>		
<b>Fire Alarm</b>	Smoke detectors, alarms, and strobes	Fair
<b>Equipment/Special</b>	None	--
<b>Accessibility</b>	Presently it does not appear an accessibility study is needed for this building. See Appendix D.	
<b>Key Issues and Findings</b>	Roof leaks and should be replaced Suspended ACT ceiling is aged and discolored. Replacement is recommended

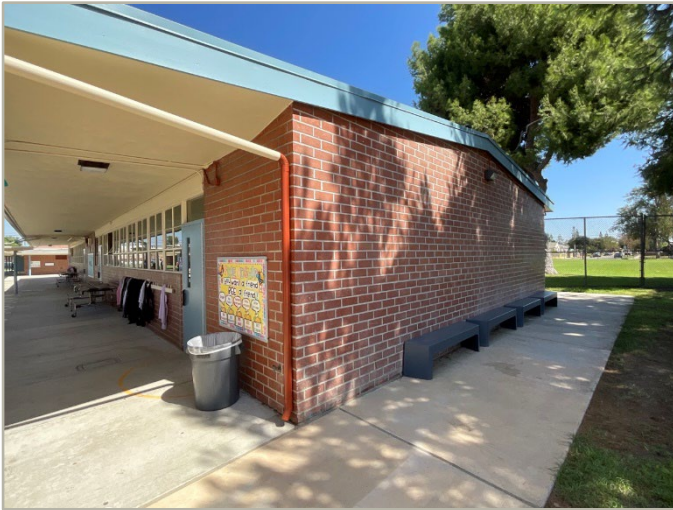
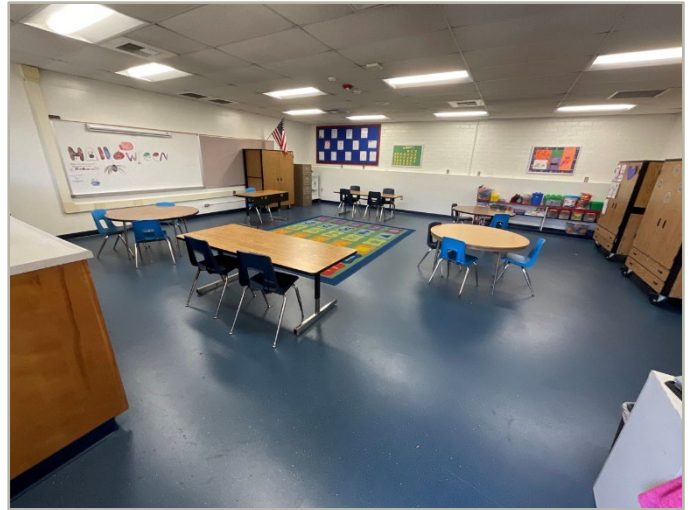
### 3. Building 300

<b>Building 300: Systems Summary</b>		
<b>Fire Alarm</b>	Smoke detectors, alarms, and strobes	Fair
<b>Equipment/Special</b>	None	--
<b>Accessibility</b>	Presently it does not appear an accessibility study is needed for this building. See Appendix D.	
<b>Key Issues and Findings</b>	Roof leaks and should be replaced Suspended ACT ceiling is aged and discolored. Replacement is recommended Rooftop package units perform poorly and should be replaced

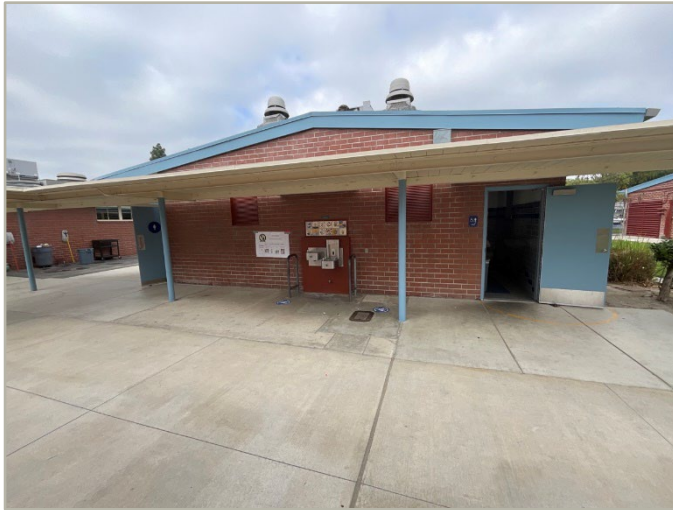
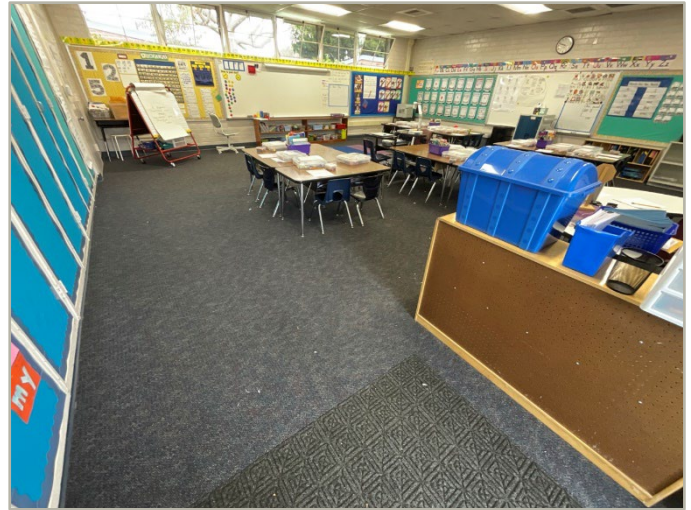
## 4. Building 400

<b>Building 400: Systems Summary</b>		
<b>Fire Alarm</b>	Smoke detectors, alarms, and strobes	Fair
<b>Equipment/Special</b>	None	--
<b>Accessibility</b>	Presently it does not appear an accessibility study is needed for this building. See Appendix D.	
<b>Key Issues and Findings</b>	Roof leaks and should be replaced Suspended ACT ceiling is aged and discolored. Replacement is recommended Rooftop package units perform poorly and should be replaced

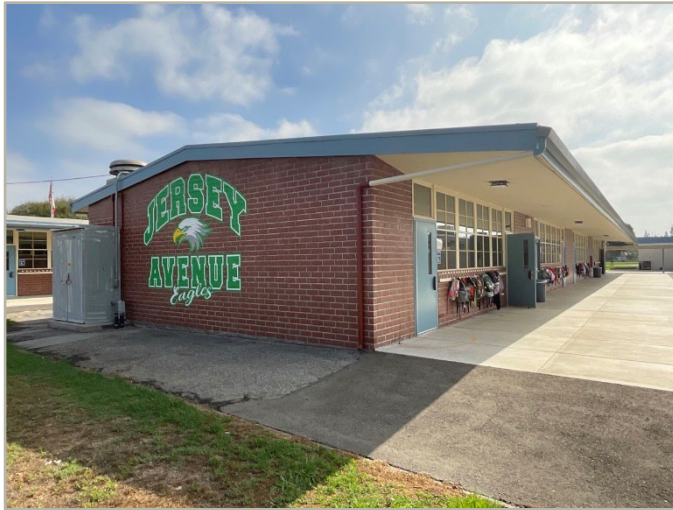
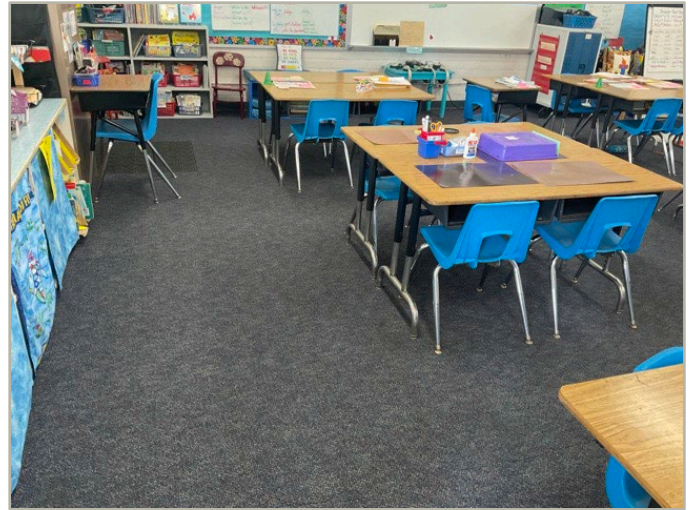
## 5. Building 500

<b>Fire Alarm</b>	Smoke detectors, alarms, and strobes	Fair
<b>Equipment/Special</b>	None	--
<b>Accessibility</b>	Presently it does not appear an accessibility study is needed for this building. See Appendix D.	
<b>Key Issues and Findings</b>	Roof leaks and should be replaced Rooftop package units perform poorly and should be replaced

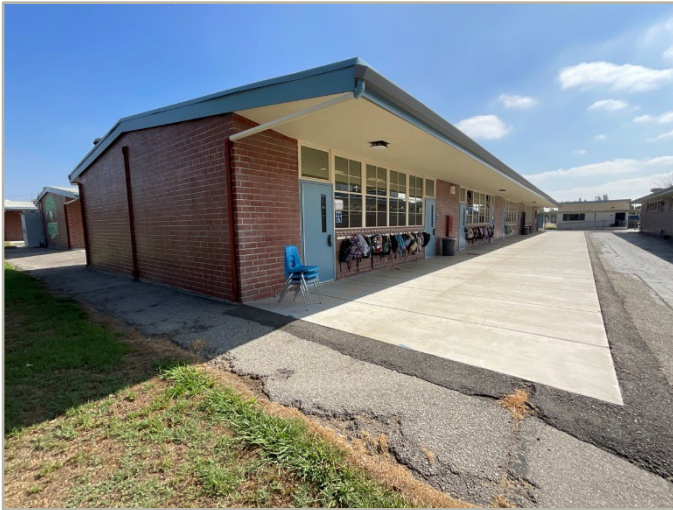
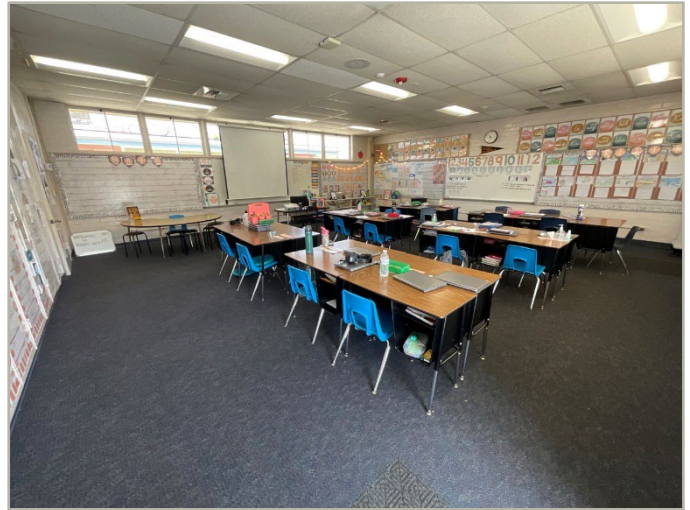
## 6. Building 600

<b>Building 600: Systems Summary</b>		
<b>Fire Alarm</b>	Smoke detectors, alarms, and strobes	Fair
<b>Equipment/Special</b>	None	--
<b>Accessibility</b>	Presently it does not appear an accessibility study is needed for this building. See Appendix D.	
<b>Key Issues and Findings</b>	Roof leaks and should be replaced RTUs are at end of life and should be replaced. Suspended ACT ceiling is aged and discolored. Replacement is recommended

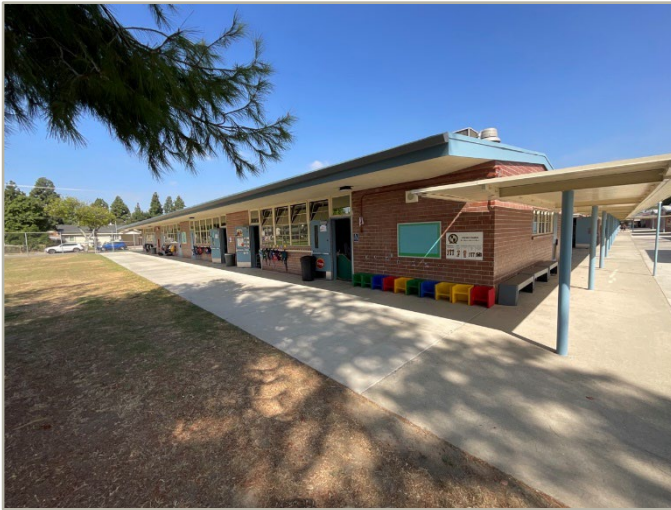
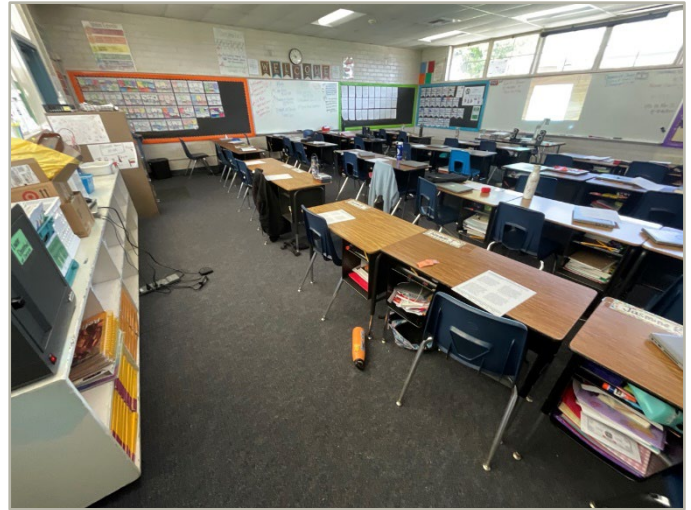
## 7. Building 700

<b>Fire Alarm</b>	Smoke detectors, alarms, and strobes	Fair
<b>Equipment/Special</b>	None	--
<b>Accessibility</b>	Presently it does not appear an accessibility study is needed for this building. See Appendix D.	
<b>Key Issues and Findings</b>	Roof leaks and should be replaced Suspended ACT ceiling is aged and discolored. Replacement is recommended

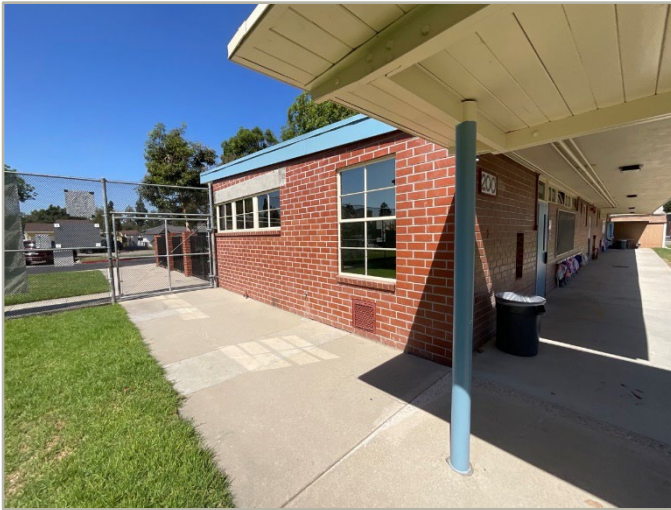
## 8. Building 800

<b>Building 800: Systems Summary</b>		
<b>Fire Alarm</b>	Smoke detectors, alarms, and strobes	Fair
<b>Equipment/Special</b>	None	--
<b>Accessibility</b>	Presently it does not appear an accessibility study is needed for this building. See Appendix D.	
<b>Key Issues and Findings</b>	Roof leaks and should be replaced Suspended ACT ceiling is aged and discolored. Replacement is recommended

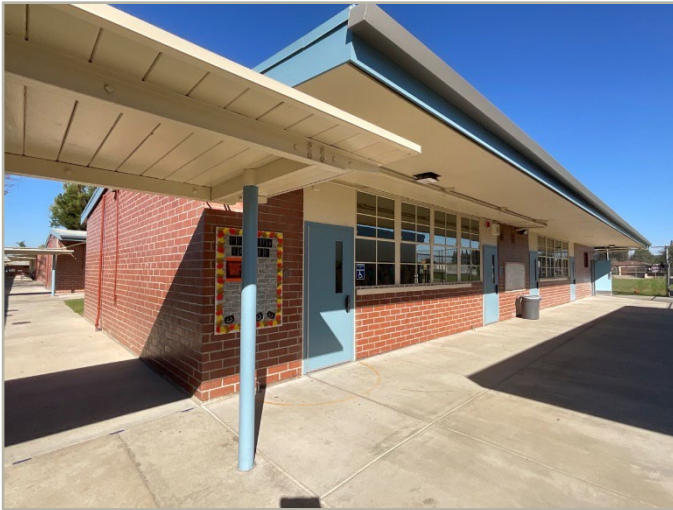
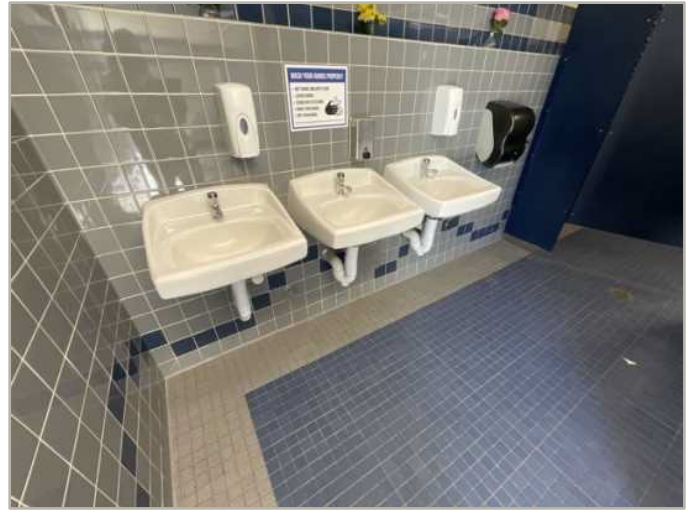
## 9. Building 900

<b>Building 900: Systems Summary</b>		
<b>Fire Alarm</b>	Smoke detectors, alarms, and strobes	Fair
<b>Equipment/Special</b>	None	--
<b>Accessibility</b>	Presently it does not appear an accessibility study is needed for this building. See Appendix D.	
<b>Key Issues and Findings</b>	Roof leaks and should be replaced Suspended ACT ceiling is aged and discolored. Replacement is recommended

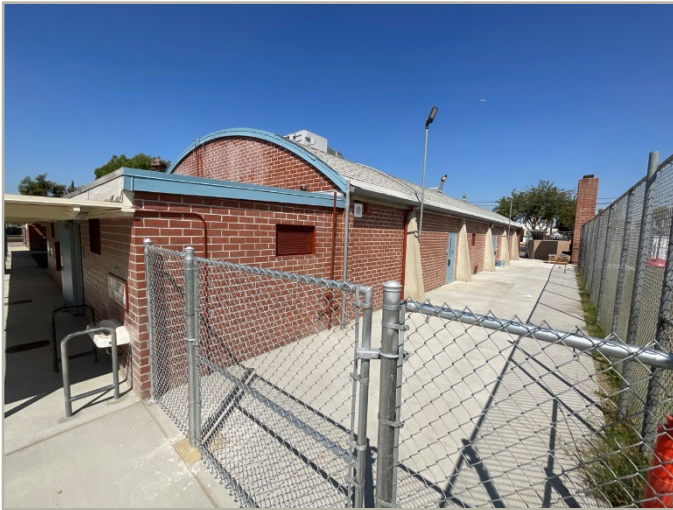
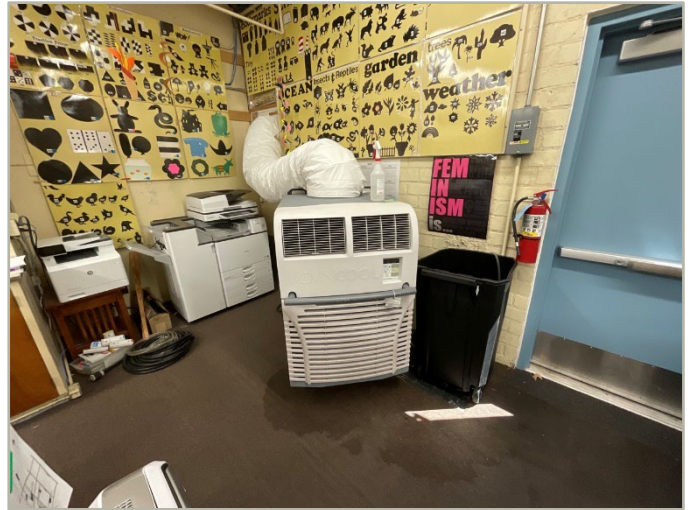
## 10. IMC Building

<b>IMC Building: Systems Summary</b>		
<b>Fire Alarm</b>	Smoke detectors, alarms, and strobes	Fair
<b>Equipment/Special</b>	None	--
<b>Accessibility</b>	Presently it does not appear an accessibility study is needed for this building. See Appendix D.	
<b>Key Issues and Findings</b>	Rubber and vinyl sheet flooring has deteriorated and should be replaced Roof leaks and should be replaced Drinking fountain does not function and should be replaced

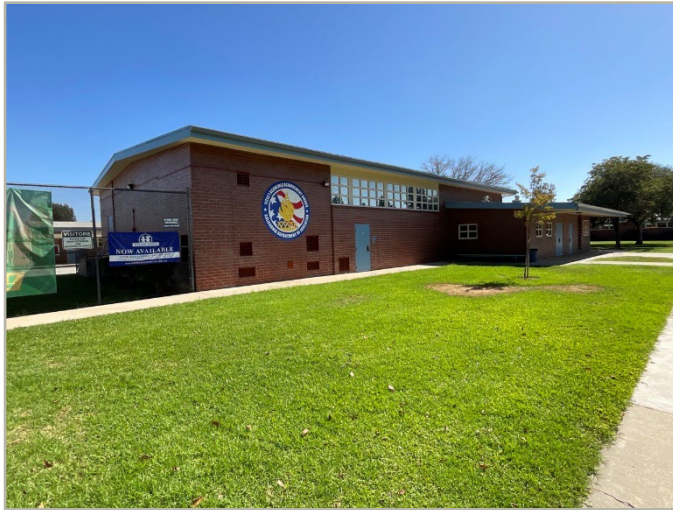
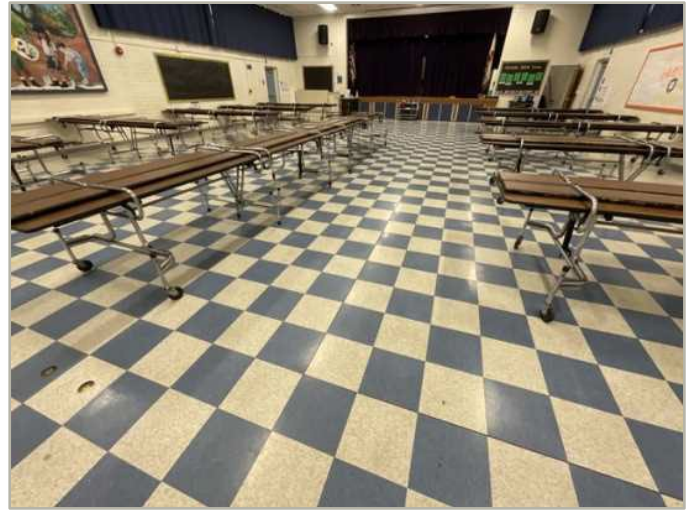
## 12. Multipurpose Room

<b>Multipurpose Room: Systems Summary</b>		
<b>Fire Alarm</b>	Smoke detectors, alarms, and strobes	Fair
<b>Equipment/Special</b>	Kitchen	--
<b>Accessibility</b>	Presently it does not appear an accessibility study is needed for this building. See Appendix D.	
<b>Key Issues and Findings</b>	Roof leaks and should be replaced Evaporative coolers are severely rusted and should be replaced Suspended ACT ceiling is aged and discolored. Replacement is recommended

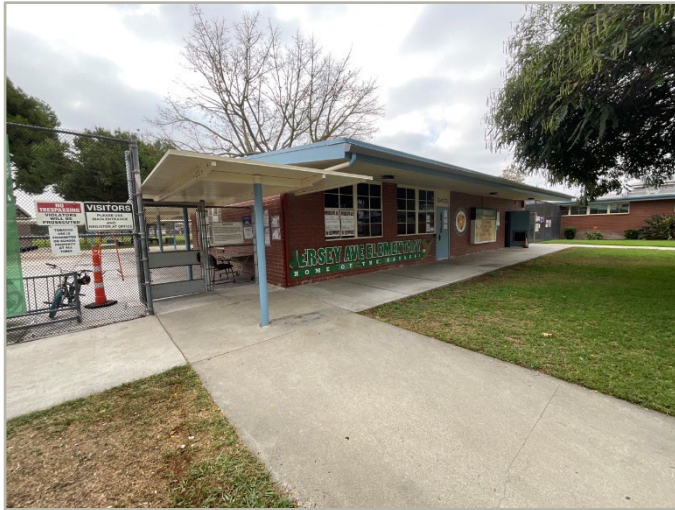
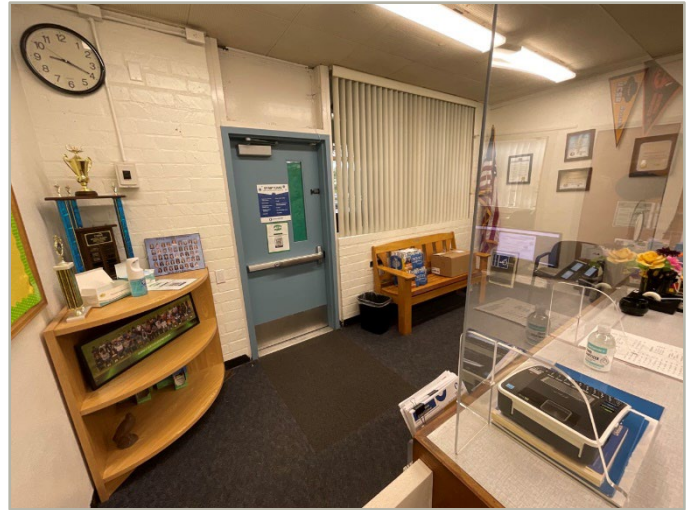
### 13. Office

<b>Office: Systems Summary</b>		
<b>Fire Alarm</b>	Smoke detectors, alarms, and strobes	Fair
<b>Equipment/Special</b>	None	--
<b>Accessibility</b>	Presently it does not appear an accessibility study is needed for this building. See Appendix D.	
<b>Key Issues and Findings</b>	Roof leaks and should be replaced Suspended ACT ceiling is aged and discolored. Replacement is recommended
