FACILITY CONDITION ASSESSMENT

Cresson Elementary School
11650 Cresson Street
Norwalk, California 90650

159753.22R000-001.017

October 27, 2022

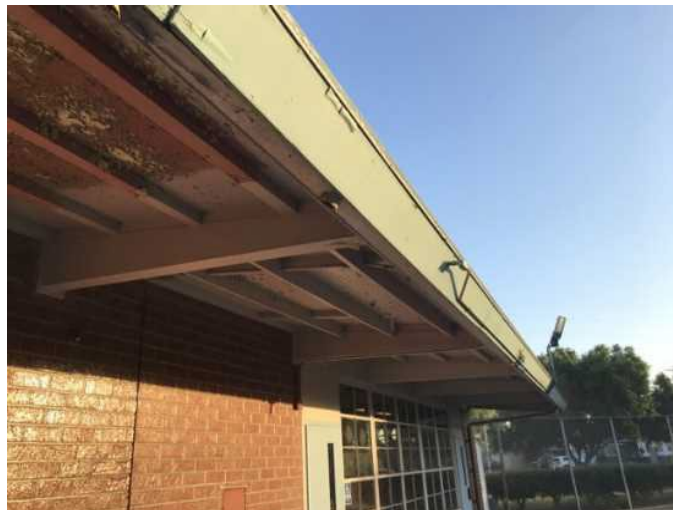
6 - DETERIORATED EXTERIOR FAÇADE
