FACILITY CONDITION ASSESSMENT

Lake Center Middle
10503 Pioneer Boulevard
Santa Fe Springs, California 90670

159753.22R000-003.017

October 13, 2022

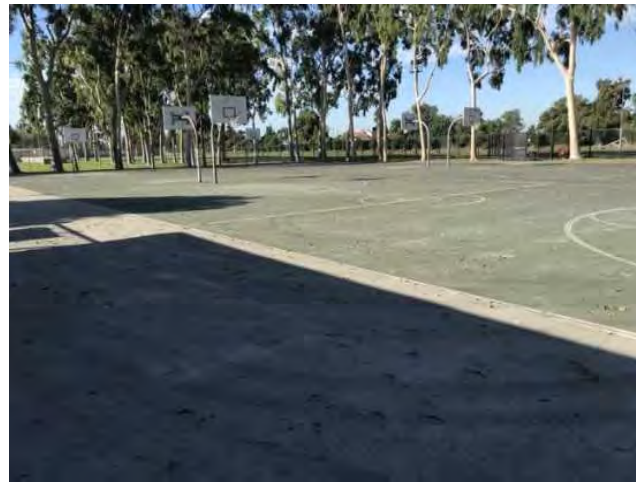
10 - BASKETBALL COURT

Sidewalk in Poor condition.

Cracked concrete surface throughout, repair is required. - AssetCALC ID: 4270680

Uniformat Code: G2030
Recommendation: **Repair in 2022**
