FACILITY CONDITION ASSESSMENT

DLR Group

Administration
10515 South Pioneer Boulevard
Santa Fe Springs, California 90670

October 7, 2022

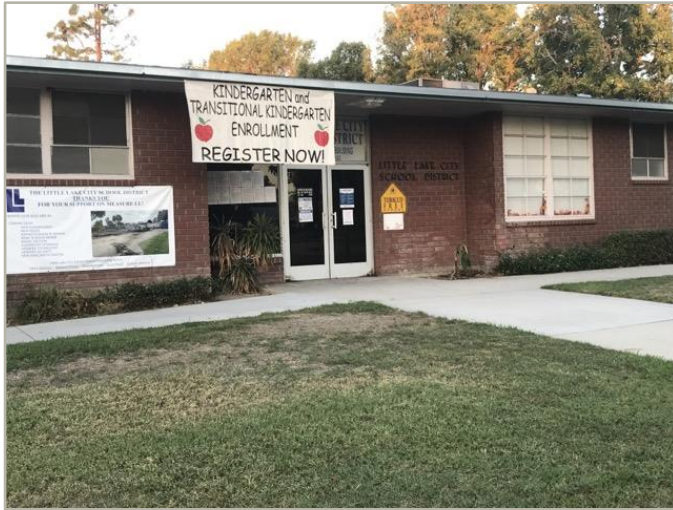
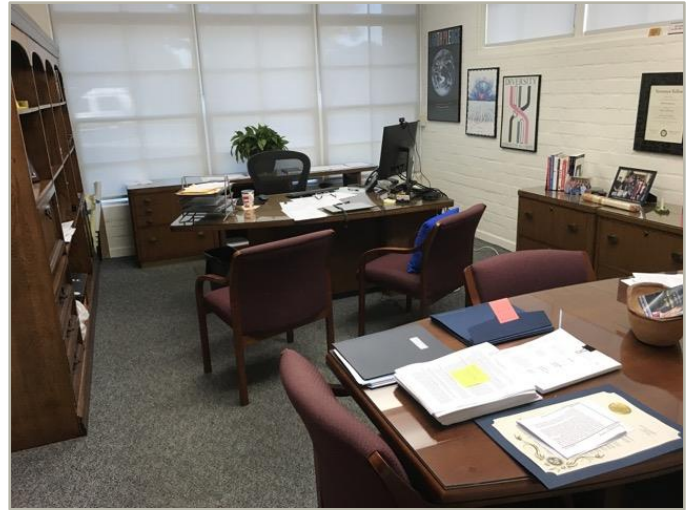
2. Administration Building

Electrical	Source and Distribution: Main panel with copper wiring Fed from adjacent building with copper wiring Interior Lighting: Linear fluorescent and incandescent Emergency Power: None	Fair
Fire Alarm	Alarm system with smoke detectors, alarms, and exit signs	Fair
Equipment/Special	None	--
Accessibility	Potential moderate/major issues have been identified at this building and a detailed accessibility study is recommended. See Appendix D.	
Key Issues and Findings	Structural decking repair, building lacks fire suppression system

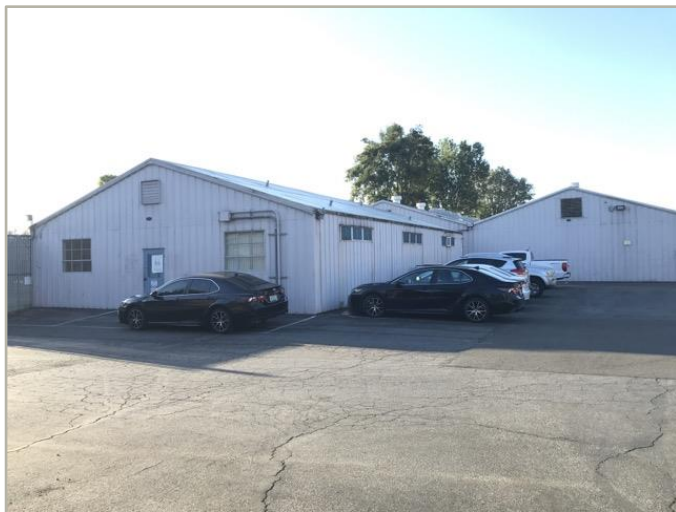
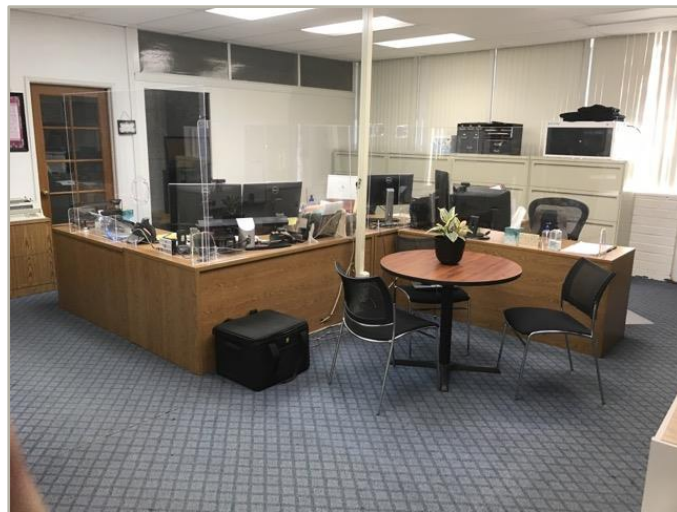
3. Maintenance Warehouse

Electrical	Source and Distribution: Main panel with copper wiring Interior Lighting: Linear fluorescent, and incandescent Emergency Power: None	Fair
Fire Alarm	None	--
Equipment/Special	Commercial kitchen equipment	Fair
Accessibility	Potential moderate/major issues have been identified at this building and a detailed accessibility study is recommended. See Appendix D.	
Key Issues and Findings	Exterior wall repair, replace unit heater, building lacks fire alarm system, building lacks fire suppression system

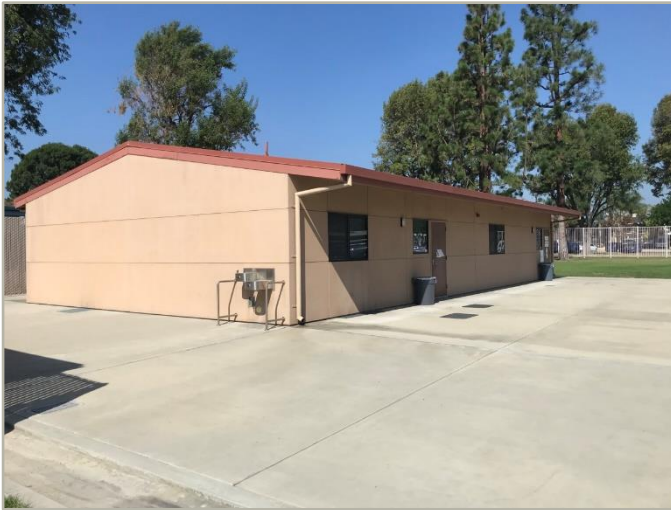
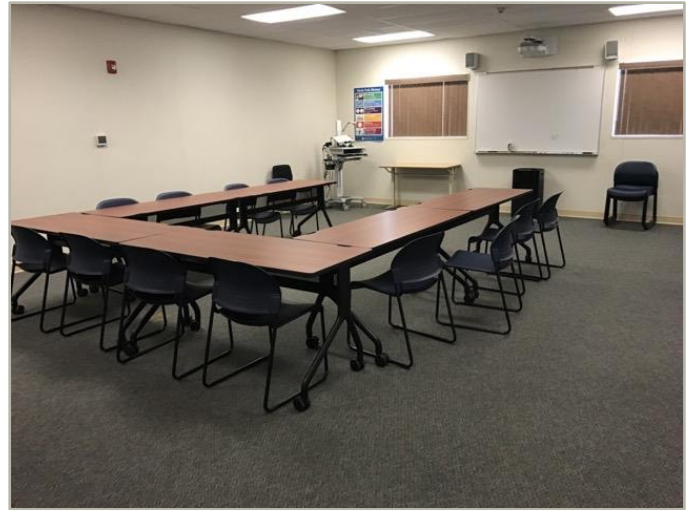
4. Portable

Electrical	Source and Distribution: Main panel with copper wiring Interior Lighting: LED, and linear fluorescent Emergency Power: None	Fair
Fire Alarm	Alarm system with smoke detectors, alarms, strobes, pull stations, and exit signs	Fair
Equipment/Special	None	--
Accessibility	Presently it does not appear an accessibility study is needed for this building. See Appendix D.	
Key Issues and Findings	Building lacks fire suppression

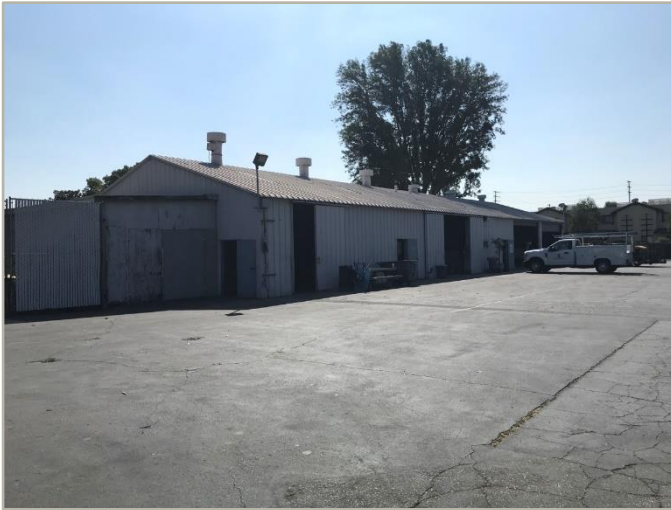
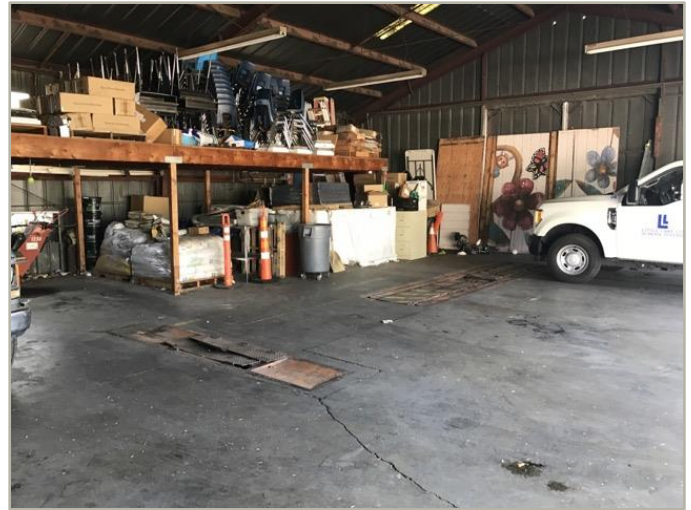
5. Shop Warehouse

Electrical	Source and Distribution: Main panel with copper wiring Interior Lighting: Linear fluorescent, and incandescent Emergency Power: None	Fair
Fire Alar	None	--
Equipment/Special	None	--
Accessibility	Presently it does not appear an accessibility study is needed for this building. See Appendix D.	
Key Issues and Findings	Building lacks fire suppression, building lacks fire alarm system

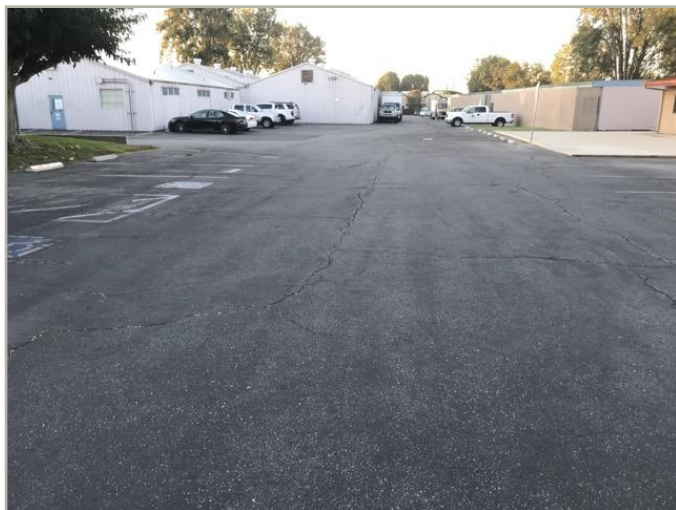
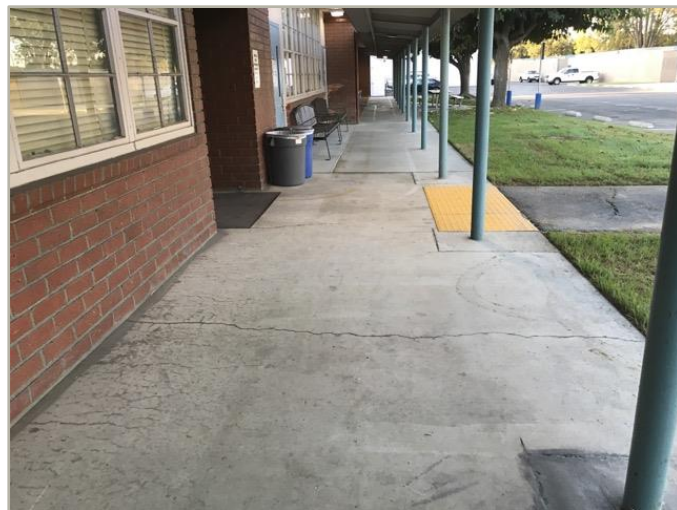
6. Site Summary

<i>System</i>	<i>Description</i>	<i>Condition</i>
Pavement/Flatwork	Asphalt lots with limited areas of concrete aprons and pavement and adjacent concrete sidewalks, and curbs	Poor
Site Development	No signage; chain link fencing	Fair
Landscaping and Topography	Limited landscaping features including lawns, trees, and bushes Irrigation present No retaining walls Low to moderate site slopes throughout	Fair
Utilities	Municipal water and sewer Local utility-provided electric and natural gas	Good
Site Lighting	Pole-mounted: None Building-mounted: Incandescent	Fair
Ancillary Structures	None	--
Accessibility	Presently it does not appear an accessibility study is needed for the exterior site areas. See Appendix D.	
Key Issues and Findings	Severe alligator cracking and potholes

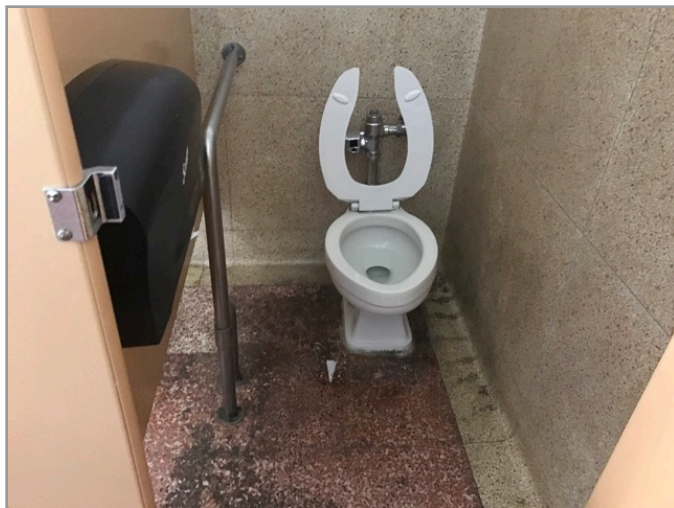
Restrooms are not ADA accessible. Bureau Veritas recommends a study be performed to take measurements, provide additional itemized details, research local requirements, and, if necessary, estimate the scope and cost of any required improvements. - AssetCALC ID: 4257836

TOILET STALL OVERVIEW

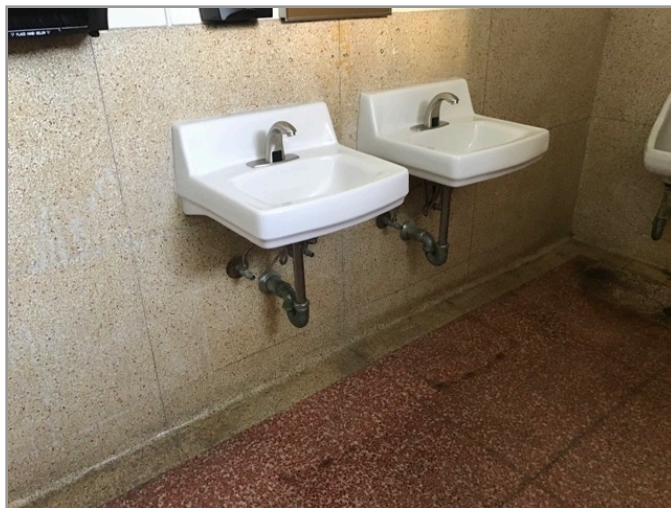
SINK, FAUCET HANDLES AND ACCESSORIES

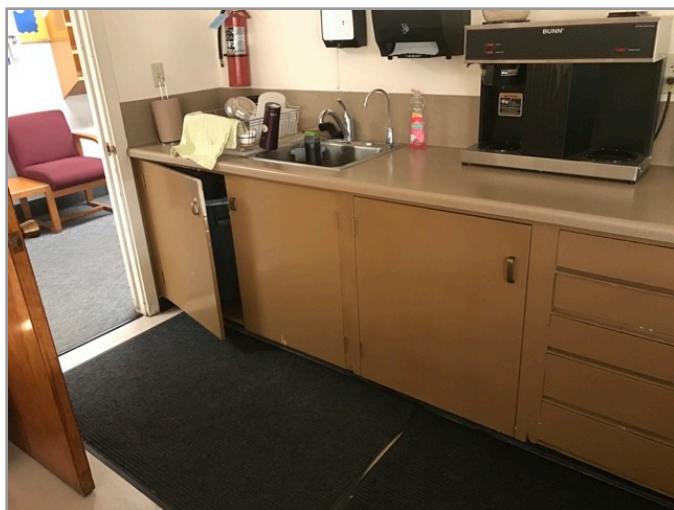
KITCHEN CABINETS

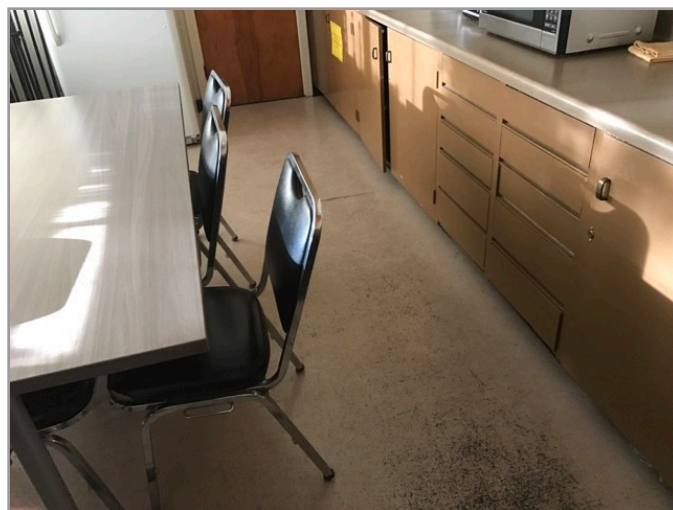
KITCHEN PATH OF TRAVEL
