FACILITY CONDITION ASSESSMENT

Manhattan Beach USD
325 South Peck Avenue
Manhattan Beach, California 90266

Meadows Elementary School
1200 North Meadows Avenue
Manhattan Beach, CA 90266

June 13, 2024

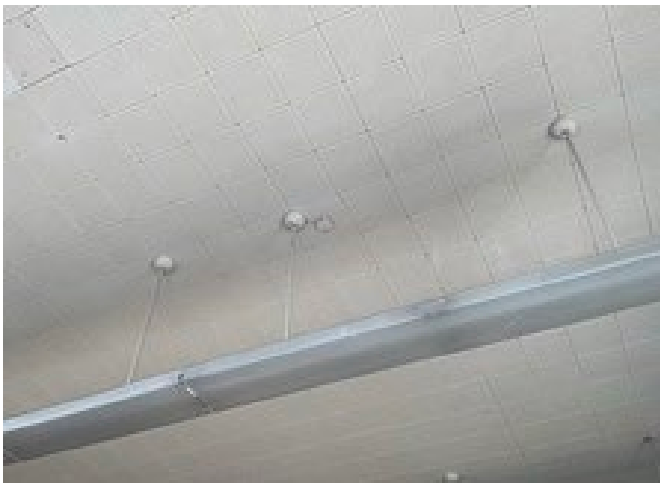
5 – SUSPENDED CEILINGS

Suspended Ceilings in Poor condition.

Ceiling tiles are falling down. - AssetCALC ID: 7505848

Unifomat Code: C1070
Recommendation: **Replace in 2026**

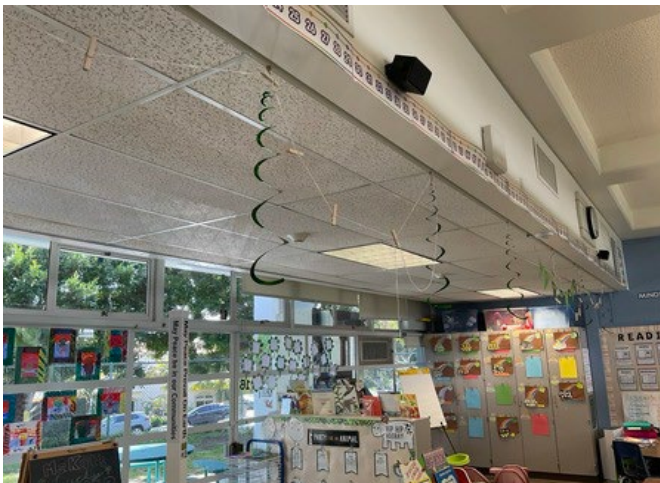
5 – SUSPENDED CEILINGS

Suspended Ceilings in Poor condition.

Tiles are falling from the ceiling. - AssetCALC ID: 7505938

Unifomat Code: C1070
Recommendation: **Replace in 2029**

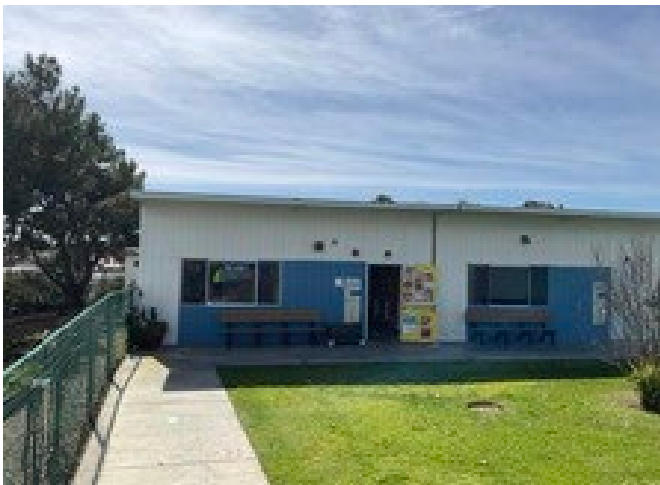
3 – ROOFING

<p>Roofing in Poor condition.</p> <p>Modified Bitumen Classroom 22-24 Roof</p> <p>Uniformat Code: B3010 Recommendation: Replace in 2026</p>	<p>Plan Type: Performance/Integrity</p> <p>Cost Estimate: \$56,400</p>
<p>Leaking noted during heavy rain. - AssetCALC ID: 7505965</p>
