Electromagnet Performance

Models Affected: All Magnet Equipped Battery Extractors

Tech Tip
TT-910

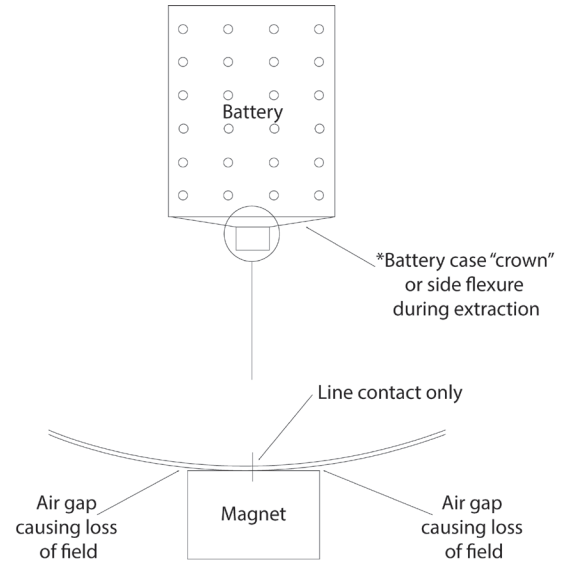
with a battery bouncing around for an entire work shift, causes the slide strip to cold-flow or conform to the irregularities of the bottom of the battery case. When this occurs, an excessive amount of force is necessary to start battery movement to overcome the increased friction between the battery case and the slide strip.

1. High loading in center slide strip
2. Minimal loading on outer slide strips

*Battery case conditions shown exaggerated for illustration purposes only.
