RCWD BOARD OF MANAGERS WORKSHOP

MEMO

Date: January 8, 2015

Subject: Washington County Judicial Ditches 5, 6,
and 7 (WJD 5, 6, & 7) Historical Review

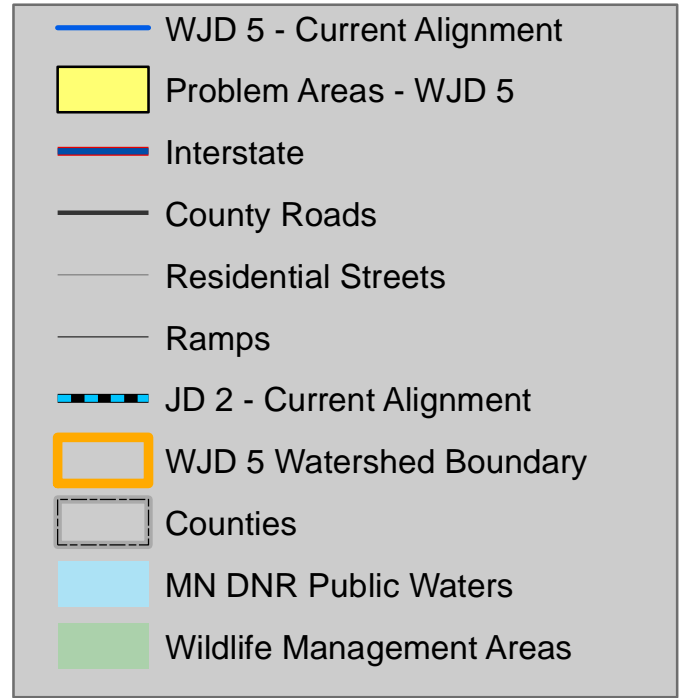
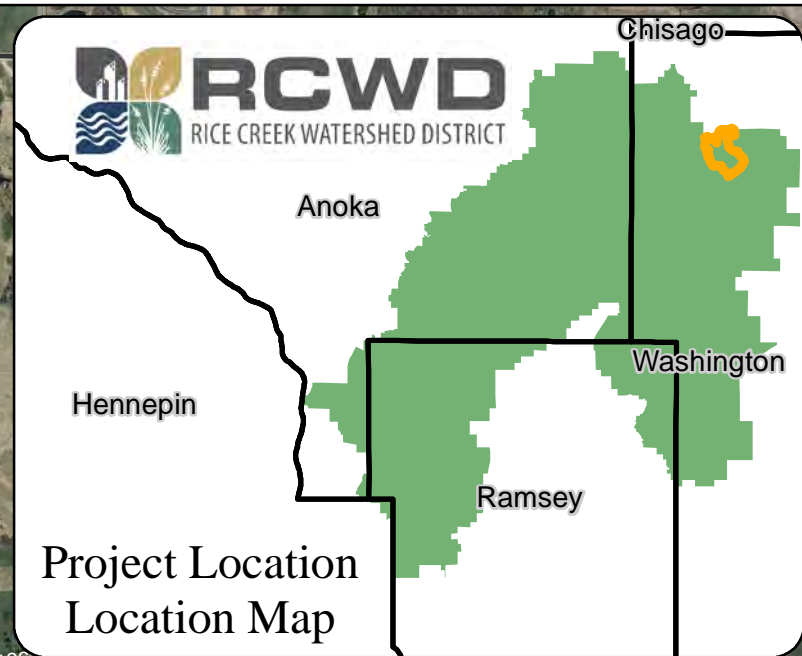
Figure 7: Problem Areas - Washington County Judicial Ditch 5					
Scale: AS SHOWN	Drawn by: SMW	Checked by:	Project No.: 5555-233	Date: 10/10/2014	Sheet: 1 of 1
			Maple Grove P: 763.493.4522 F: 763.493.5572

Tile blowouts, or ruptures, are the primary known problems within the drainage system which need to be addressed. Because of the large contributing drainage area and flat tile grades, the original clay tile system has experienced blowouts at various locations throughout the tile system.

Problem areas on the WJD 5 public drainage system consist primarily of blow outs on both the Main Trunk and Branch 1, as well as tiles that are broken, in poor condition, or plugged with roots on the Main Trunk. These problem areas are shown in **Figure 7**.

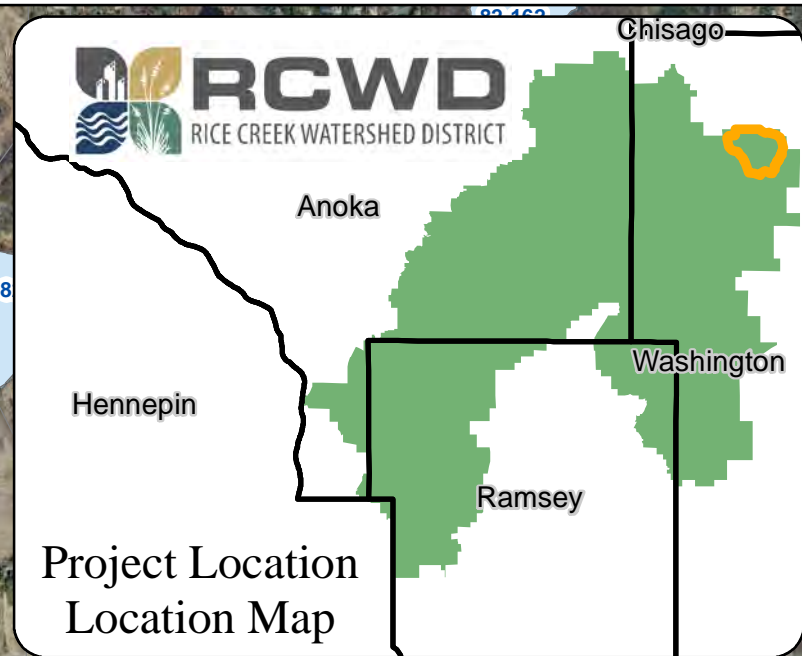
Rice Creek Watershed District Problem Areas Washington County Judicial Ditch 6

The WJD 6 public drainage system is in general disrepair, with many tiles clogged with sediment and tree roots. Much of the system is located in deep marshes and in forested areas which have accelerated the deterioration of the system. Several open channels have been excavated parallel to or crossing the historic alignment, presumably damaging portions of the tile system (if the tiles were intact at the time of the excavation). Very few remnants of the historic tile system are visible at the surface, even at locations where the excavated channels cross the tile system. Some of the problem areas are shown in **Figure 10**.

Due to the fact that WJD 6 drains to the north out of the RCWD boundary, we recommend that the District enter into discussions with the Comfort Lake Forest Lake Watershed District (CLFLWD) regarding the transfer of the authority of the public drainage system to them. We also recommend that the RCWD collaborate with the Board of Water and Soil Resources (BWSR) and the CLFLWD to modify the district boundaries to more closely reflect the contributing drainage area for both districts. The modification of the district boundaries and transfer of the drainage system authority will likely need occur concurrently.

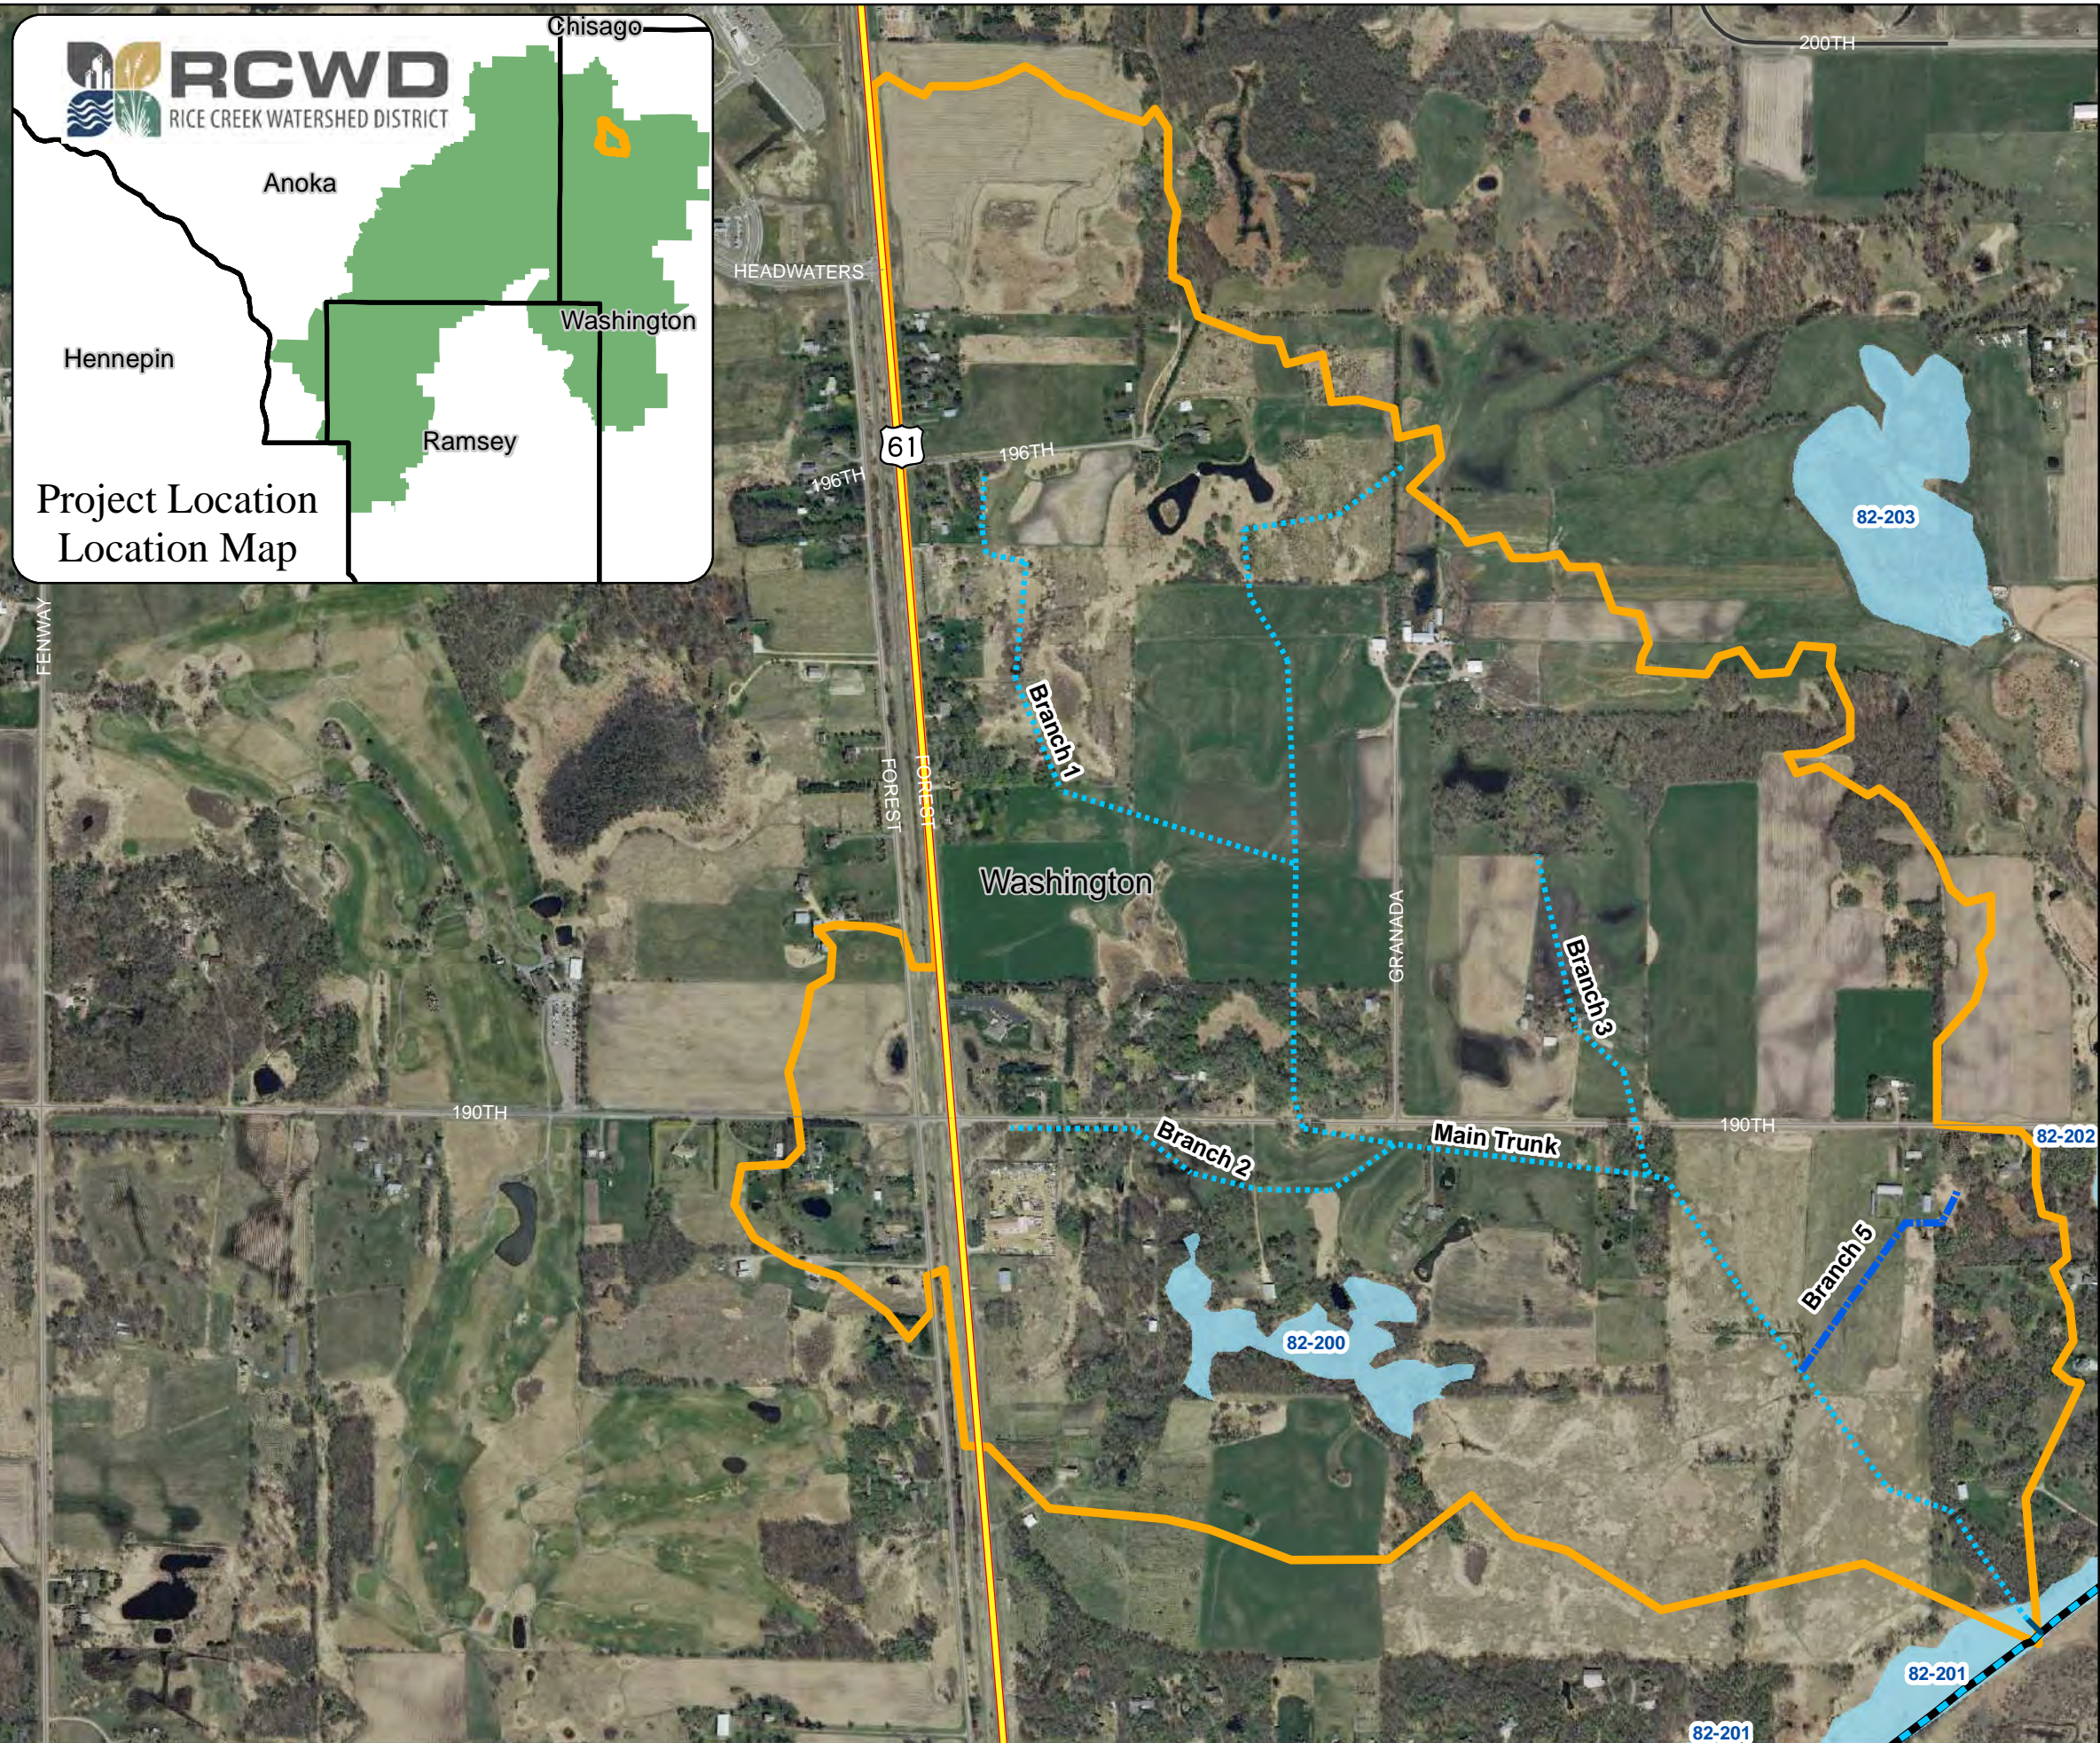
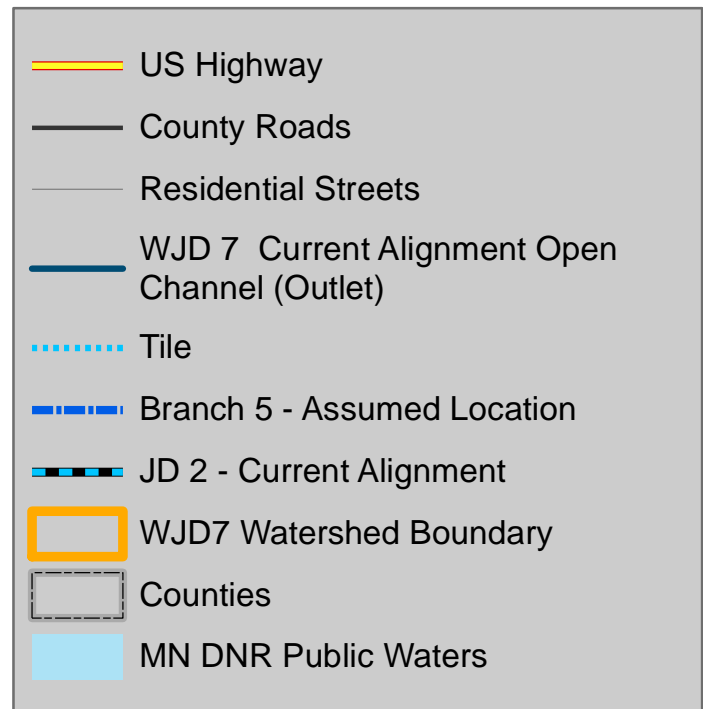
Figure 12: Current Alignment - Washington County Judicial Ditch 7

No alterations to the drainage system were found in the review of historical records. The existing public system is shown in **Figure 12**.

The stationing used to describe the alignment is derived from the existing As-Constructed and Subsequently Improved Alignment (which deviates from the As-Designed alignment in some cases) proceeding from downstream to upstream. The current, functional alignment of the WJD 7 public drainage system is shown in **Figure 12**. See **Figures 16 through 18** for stationing on WJD 7.
